Report

Building Report

Property Address: 4 Hann St, Griffith ACT 2603
Client: Dodds & Hilton
Inspection Date: Thursday, March 5th 2026
Inspection carried out by: Michael Robinson

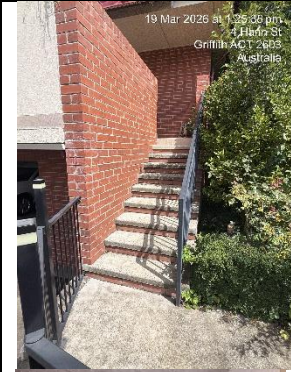
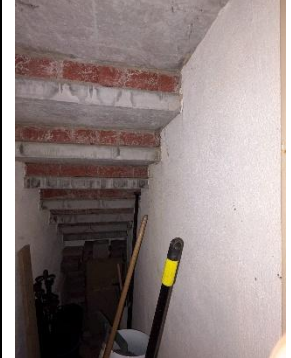
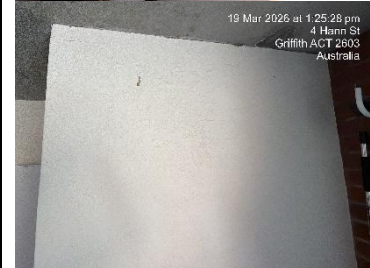
- Investigated water ingress beneath basement staircase causing paint bubbling
- Issue likely due to inadequate sealing between staircase and adjacent brick wall
- Recommend internal waterproofing of the wall or sealing of the junction to prevent further ingress

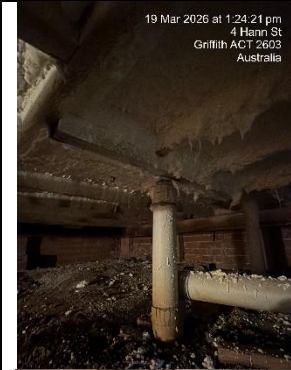
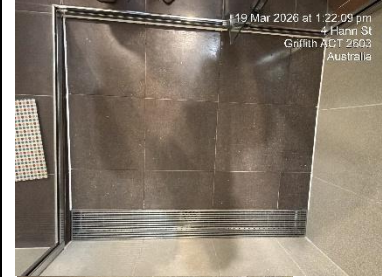
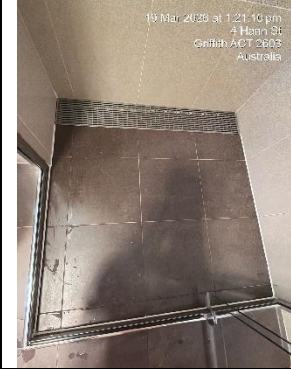
- Damaged and deteriorated seals identified to shower bases, allowing water ingress into basement sub-floor
- Existing sealant removed and 2 x showers resealed using high-grade polyurethane to restore waterproof integrity

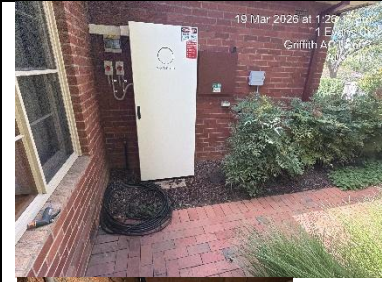
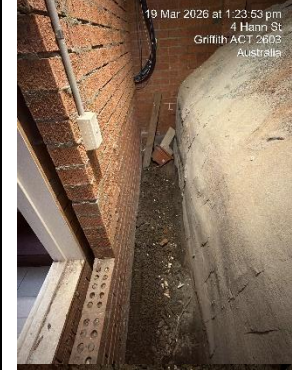
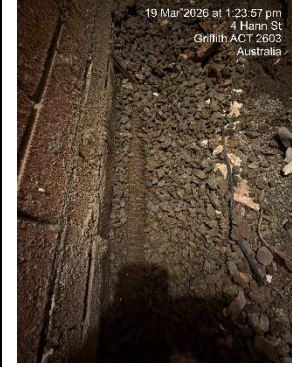
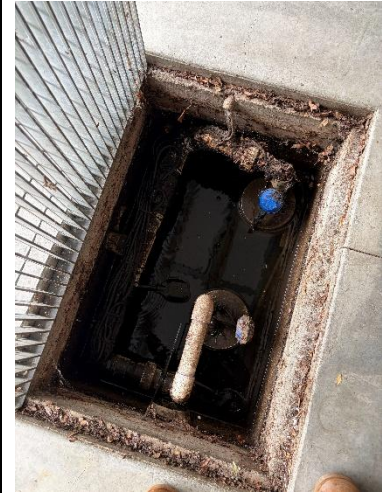
- Inspected basement retaining wall agricultural (agg) drain; system found to be in good working condition
- Checked basement stormwater pit, including submersible pumps and float switches; all components confirmed operational at time of inspection
