# Report

# Building Report

## CONCLUSION AND SUMMARY

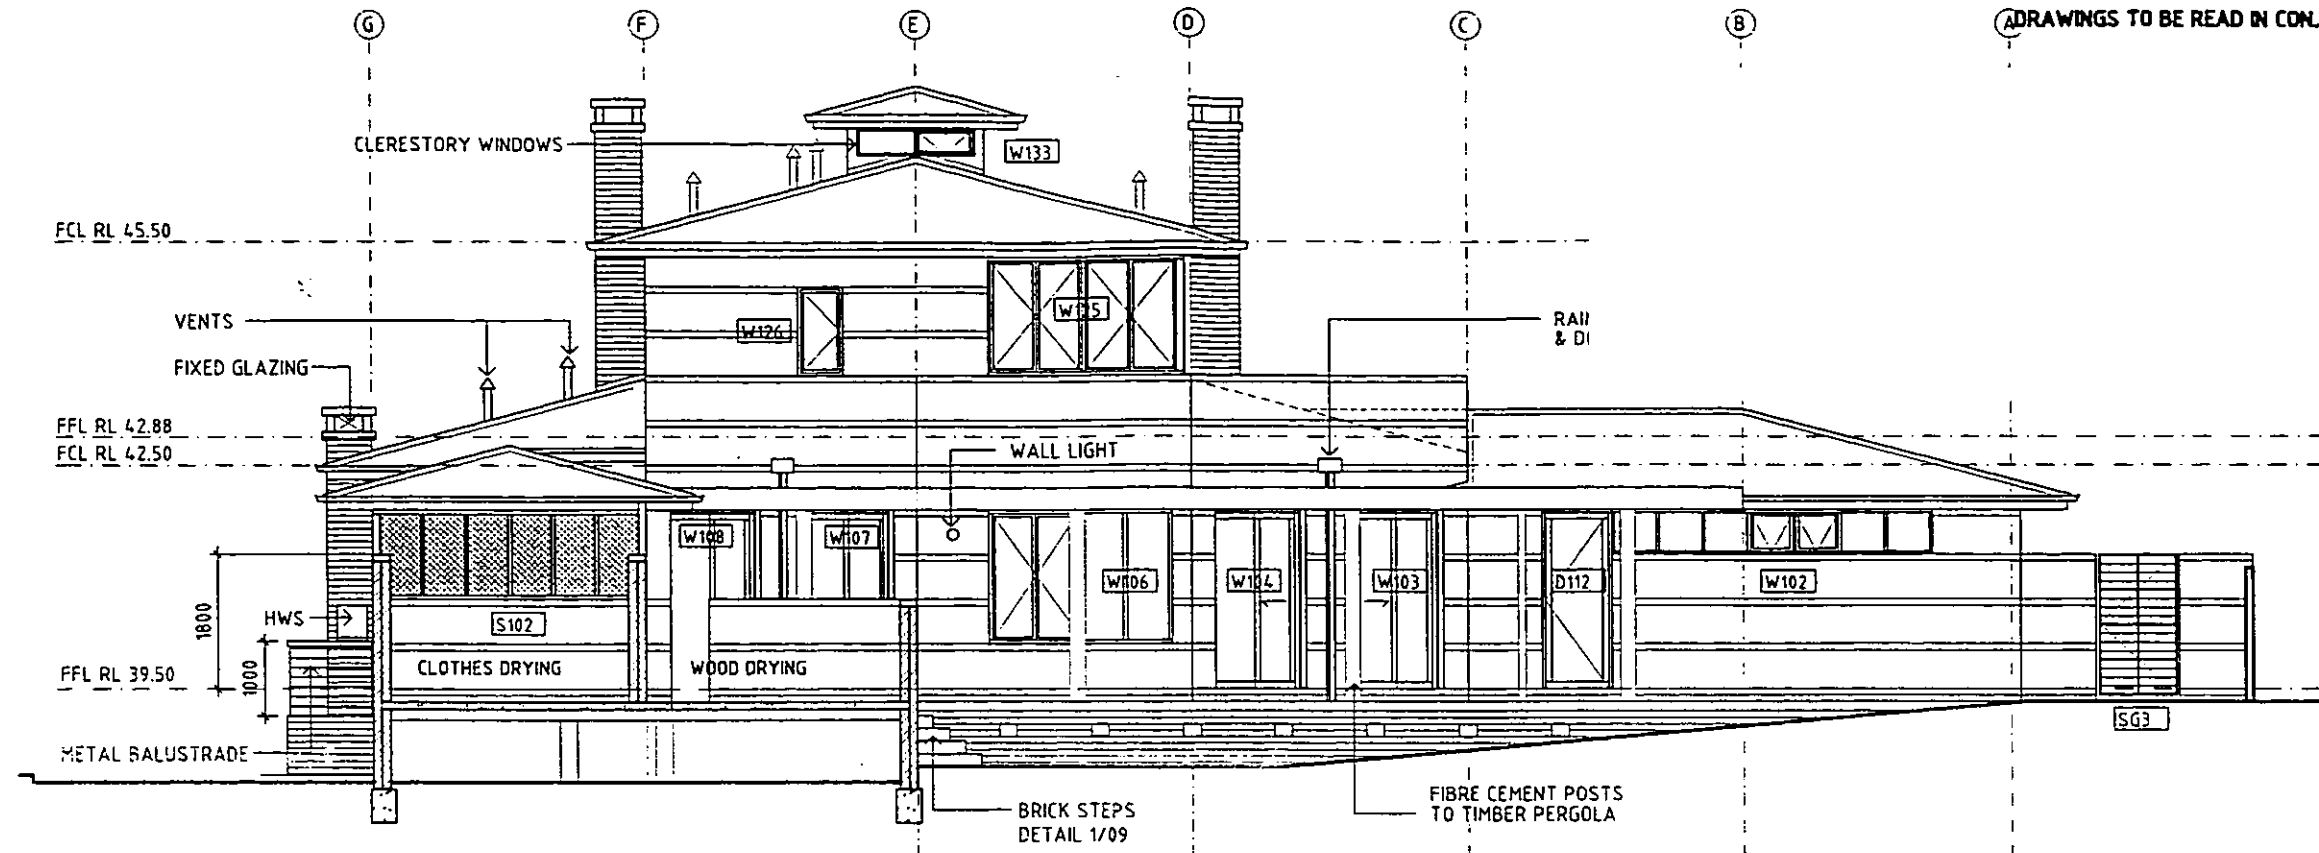
**1** UNIT 1 - NORTH EAST ELEVATION  
SCALE 1:100

Fire damaged area

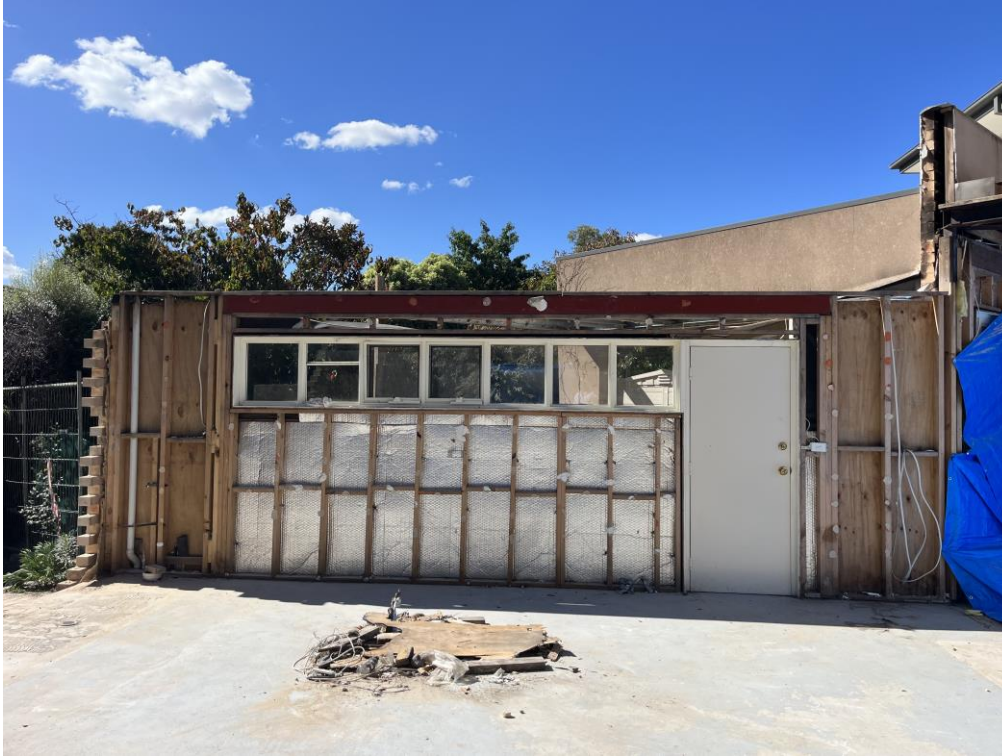
**Image 3.** View of the Brick Veneer Timber Stud Work to Removed and Replaced, Veneer to Remain in Place
