VORTEX FIRE

4.2 Context of Assessment

Sedgwick – Building Façade Material Investigation Report

Indicative Flammability Potential, Composition and Preliminary Toxicity Screening of Exterior Cladding Systems

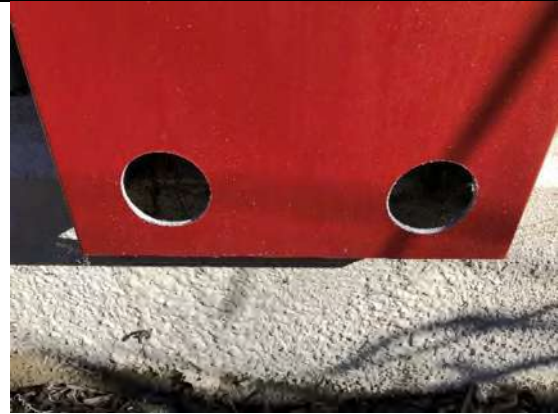
Photo 5: Sample Number 122534

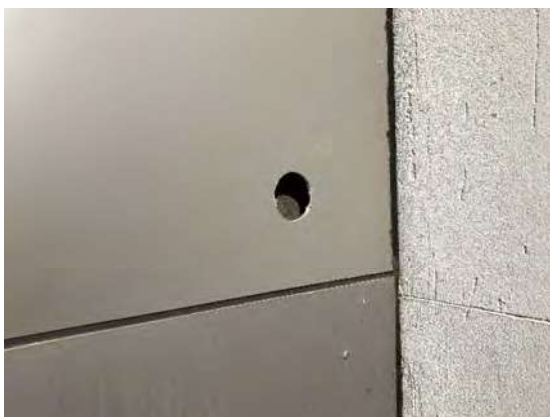
Photo 8: Location where sample 122534 was taken

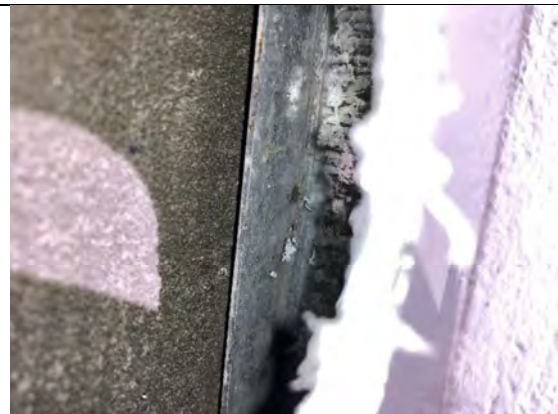
Photo 9: Façade from where sample 122534 was taken

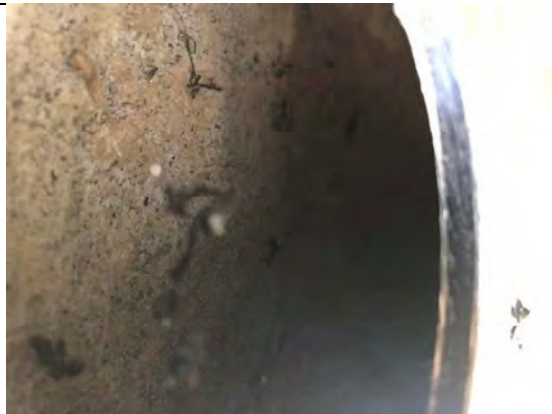
Photo 34: Sample number 122541 – behind panel view

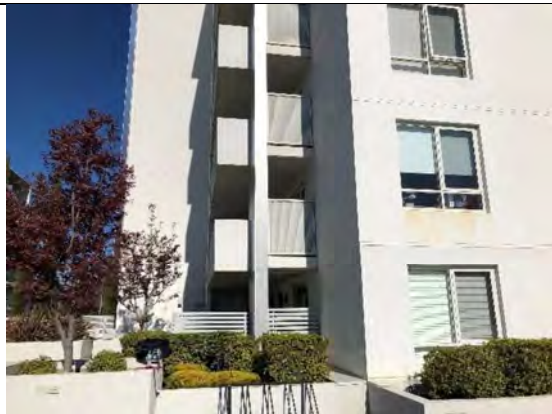
Photo 36: Sample number 122541 – façade view
