# Report

# Building Report

## CONCLUSION AND SUMMARY

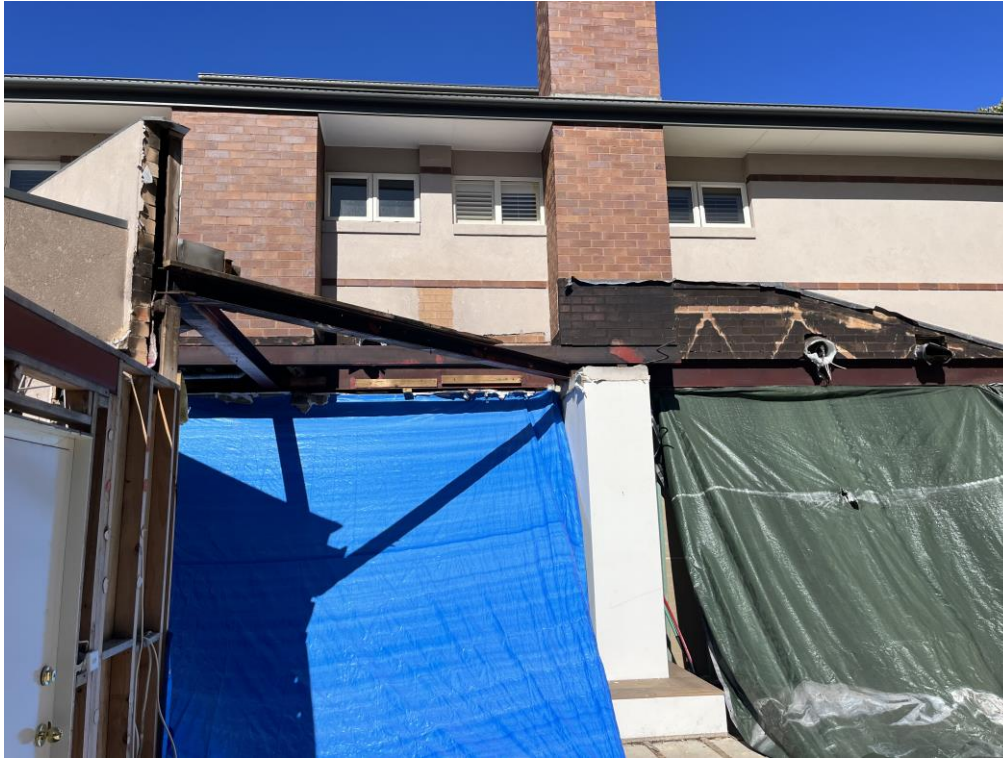
#### Image 1

1. Current steel work which is exposed is structurally sound and does not require replacement. We advise the current steel work can remain in place, be reused and painted with anti-corrosive paintwork [where necessary] following cleaning down and sanitating of all soot and smoke staining.
2. We also advise that the current external exposed brickwork which is soot and smoke stained can remain in place and requires cleaning down and sanitating of all soot and smoke staining.

**Image 1.** View of the Exposed Beams and Soot/Smoke Affected Brickwork

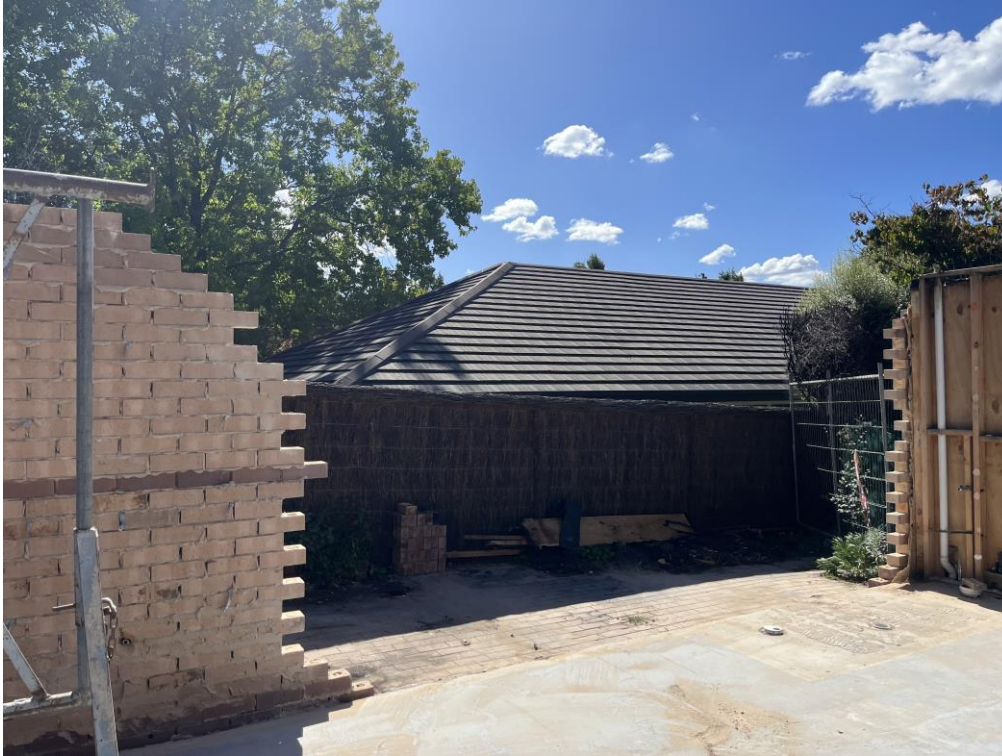
#### Image 2

**Image 2.** View of the Existing Brickwork to Remain and New Brickwork to Integrate and Tooth Into
