Report

Building Report

Property Address: 12 Mirri Cl, Throsby ACT 2914
Client: Bontha & Cheerale
Inspection Date: Thursday, September 18th 2025
Inspection carried out by: Dylan Mitchell

BLOCK 6 SECTION 23 THROSBY

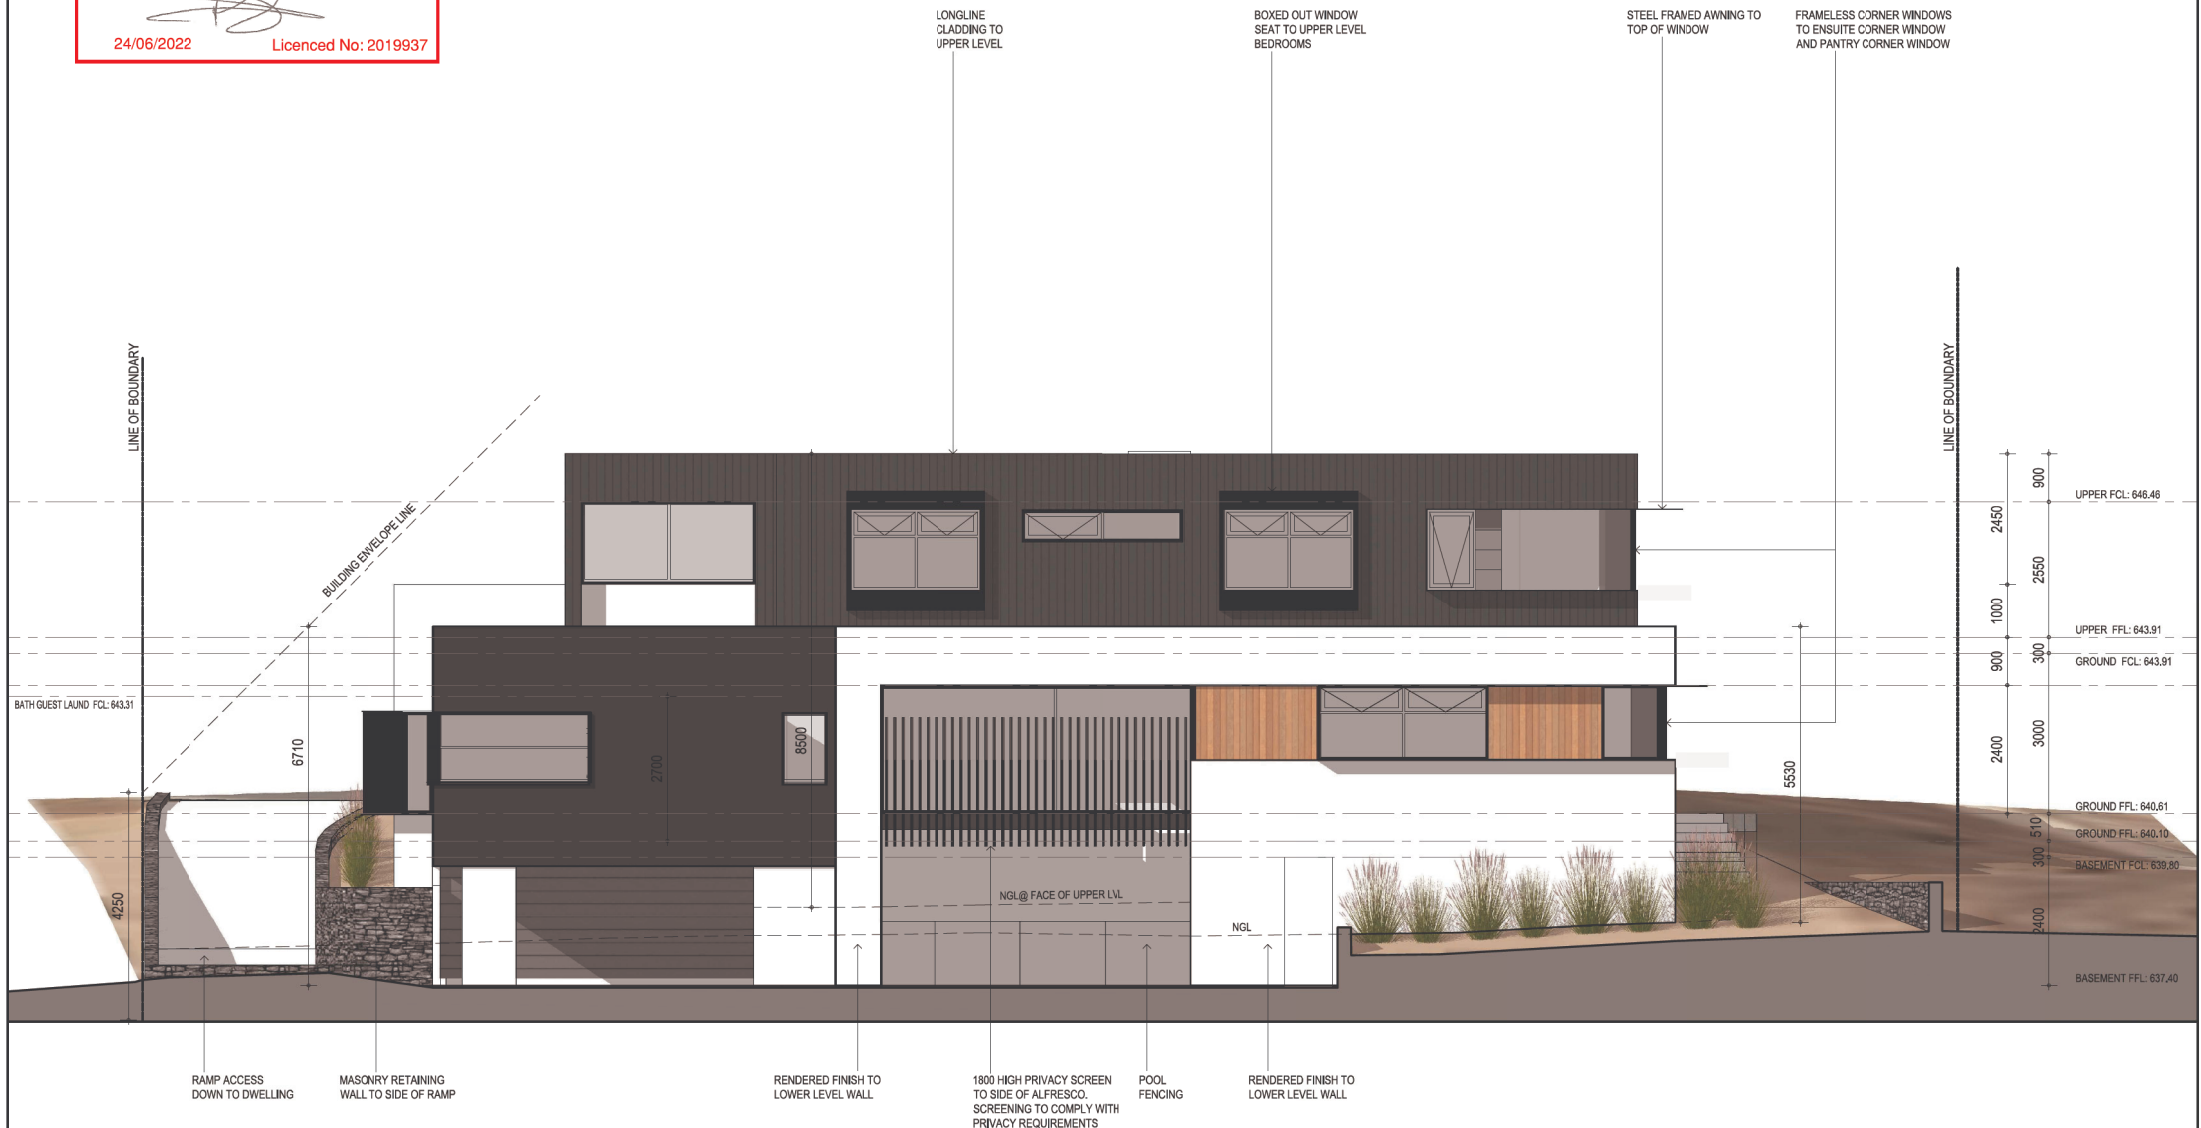
03 WEST ELEVATION

LONGLINE
CLADDING TO
UPPER LEVEL

BOXED OUT WINDOW
SEAT TO UPPER LEVEL
BEDROOM
