Report

Building Report

CONCLUSION AND SUMMARY

Property Address: 2 Caley Crescent, Narrabundah ACT 2604
Client: Baker
Inspection Date: Wednesday, May 8th 2024
Inspection carried out by: Grant Tozer

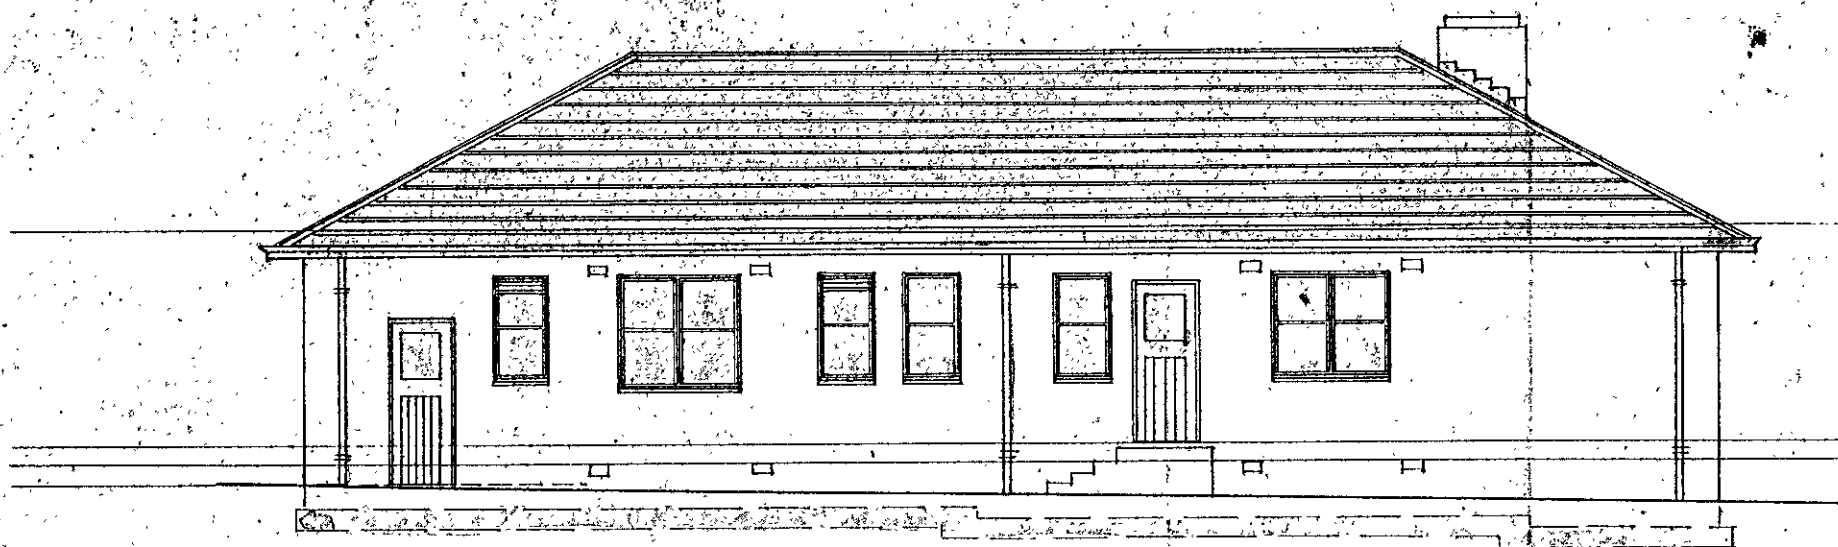
REAR ELEVATION

M^r Spottswood.
 Note:
 The wood workroom
 removed per instructions
 from M^r Fitzgerald. by
 M^r Kelly 24/1/53.
