**BUILDING INSPECTION REPORT
COMPLIANCE INSPECTION REPORT
TIMBER PEST INSPECTION REPORT
ENERGY RATING REPORT**

Prepared in accordance with AS4349.0 and AS4349.1-2007

56 Norman Street, DEAKIN

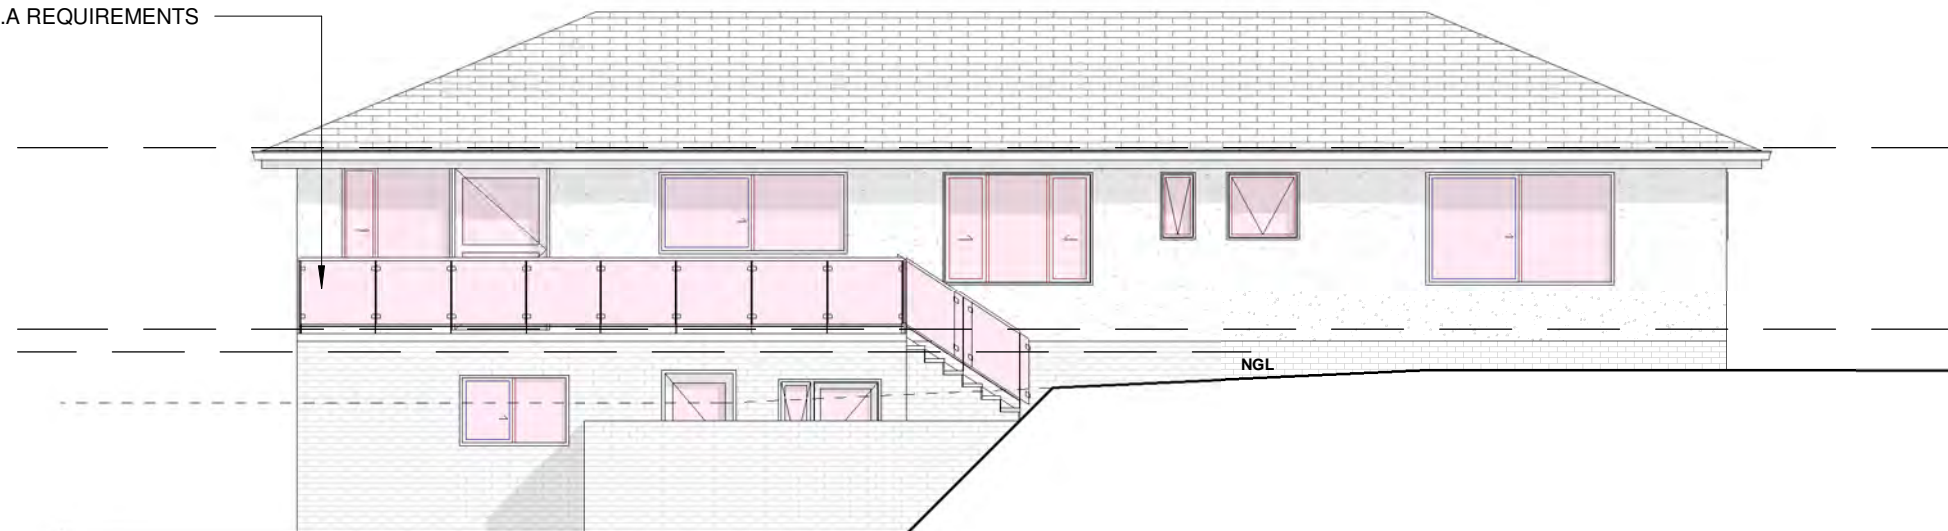
SOUTHERN ELEVATION

1mH GLASS BALUSTRADE TO B.C.A REQUIREMENTS
