# Report

# Building Report

## CONCLUSION AND SUMMARY

<p><b>GROUNDS + GRIFFITHS</b> ARCHITECTURE . LANDSCAPE . PLANNING</p>	<p>Candida Griffiths (02) 6281 2277 56 Munro St Curtin ACT 2605 reg. no. 816</p>	<p>ALTERATIONS &amp; ADDITIONS-- 22 Beauchamp Street - BLOCK : 2 SECTION : 59 - DEAKIN</p>		
	<p>Victoria Grounds (02) 6251 3570 18 Banambila St Aranda ACT 2614</p>	<p>Client Darren &amp; Sharon Orchard</p>	<p>Scale 1 : 200</p>	<p>Date DEC 2006</p>

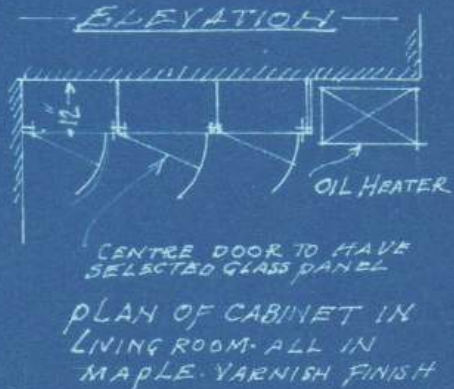
PLAN OF CABINET IN LIVING ROOM. ALL IN MAPLE. VARNISH FINISH
