Report

Building Report

Property Address: 15 Beagle Street, Red Hill ACT 2603
Client: Diamond
Inspection Date: Wednesday, January 28th 2026
Inspection carried out by: Duncan Clark

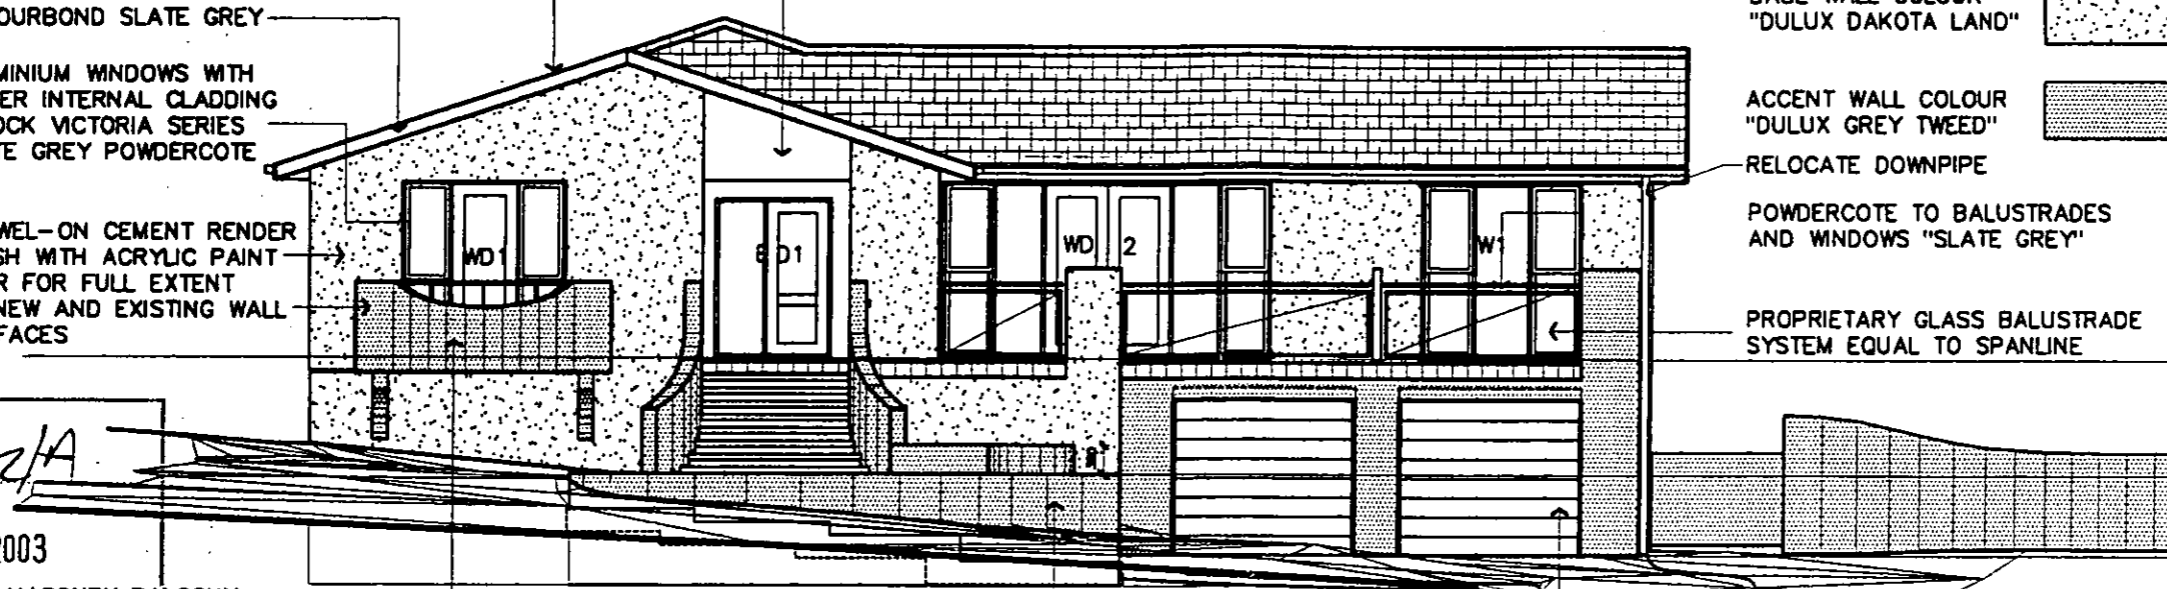
NORTH (BEAGLE STREET) ELEVATION

LIVING F.F.L. 655.78
