Report

Building Report

CONCLUSION AND SUMMARY

Client Name: DEEPAK BAWA
Project: PROPOSED RESIDENCE
Address: BLOCK 3 SECTION 24 DENMAN PROSPECT
Page 45 of 79

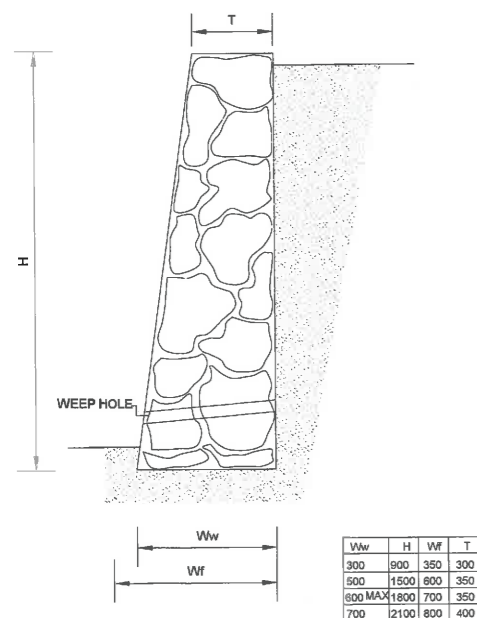
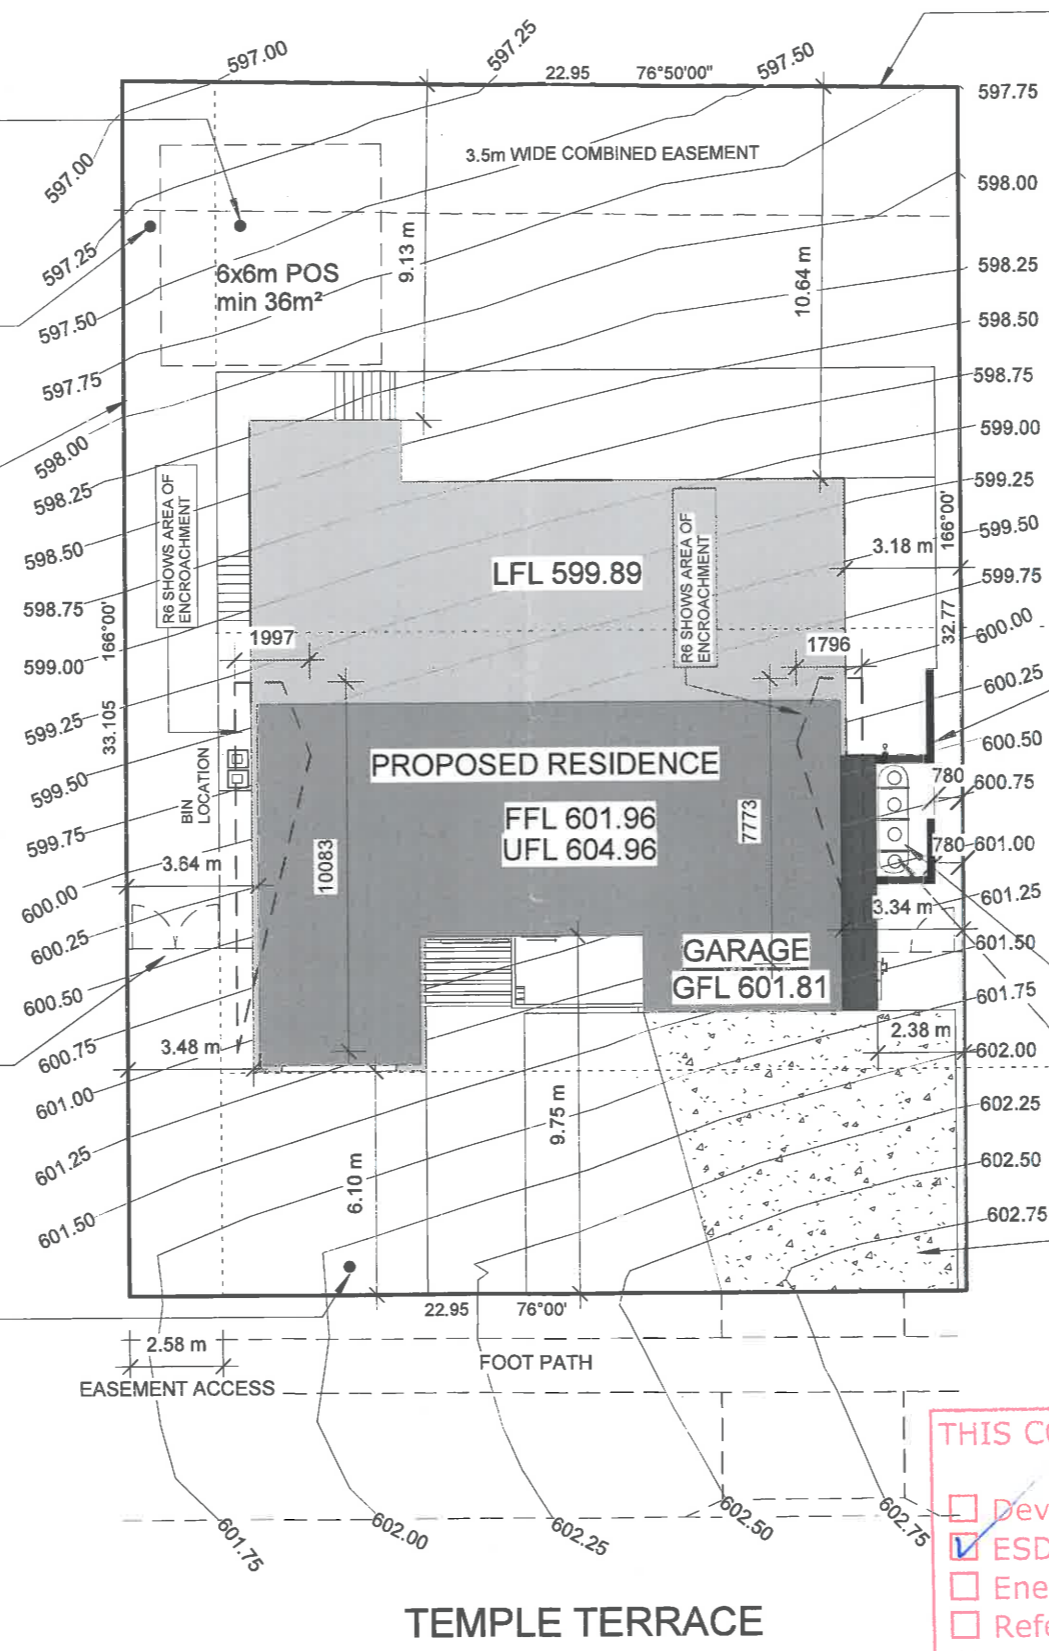
Sheet Name: **SITE PLAN**
Project number: 4197 - A
Date: 18.01.2017
Design by: B.LAW
Scale: 1 : 200
Drawn by: B.LAW
Sheet Number: **100**
Rev No:

APPROX RETAINING WALL AS REQUIRED STEPPED AT 500mm AS PER DENMAN PROSPECTS REQUIREMENTS

WATER TANK TO BE SCREENED AS PER DENMAN PROSPECT GUIDELINES
MIN 4000 LIT RAINWATER TANK 50% OR 100m² OF ROOF AREA, WHICHEVER IS THE LESSER, IS CONNECTED TO THE TANK. TANK IS CONNECTED TO AT LEAST THE TOILET, L'DRY COLD WATER AND ALL EXTERNAL TAPS, AS PER ACT TERRITORY PLAN

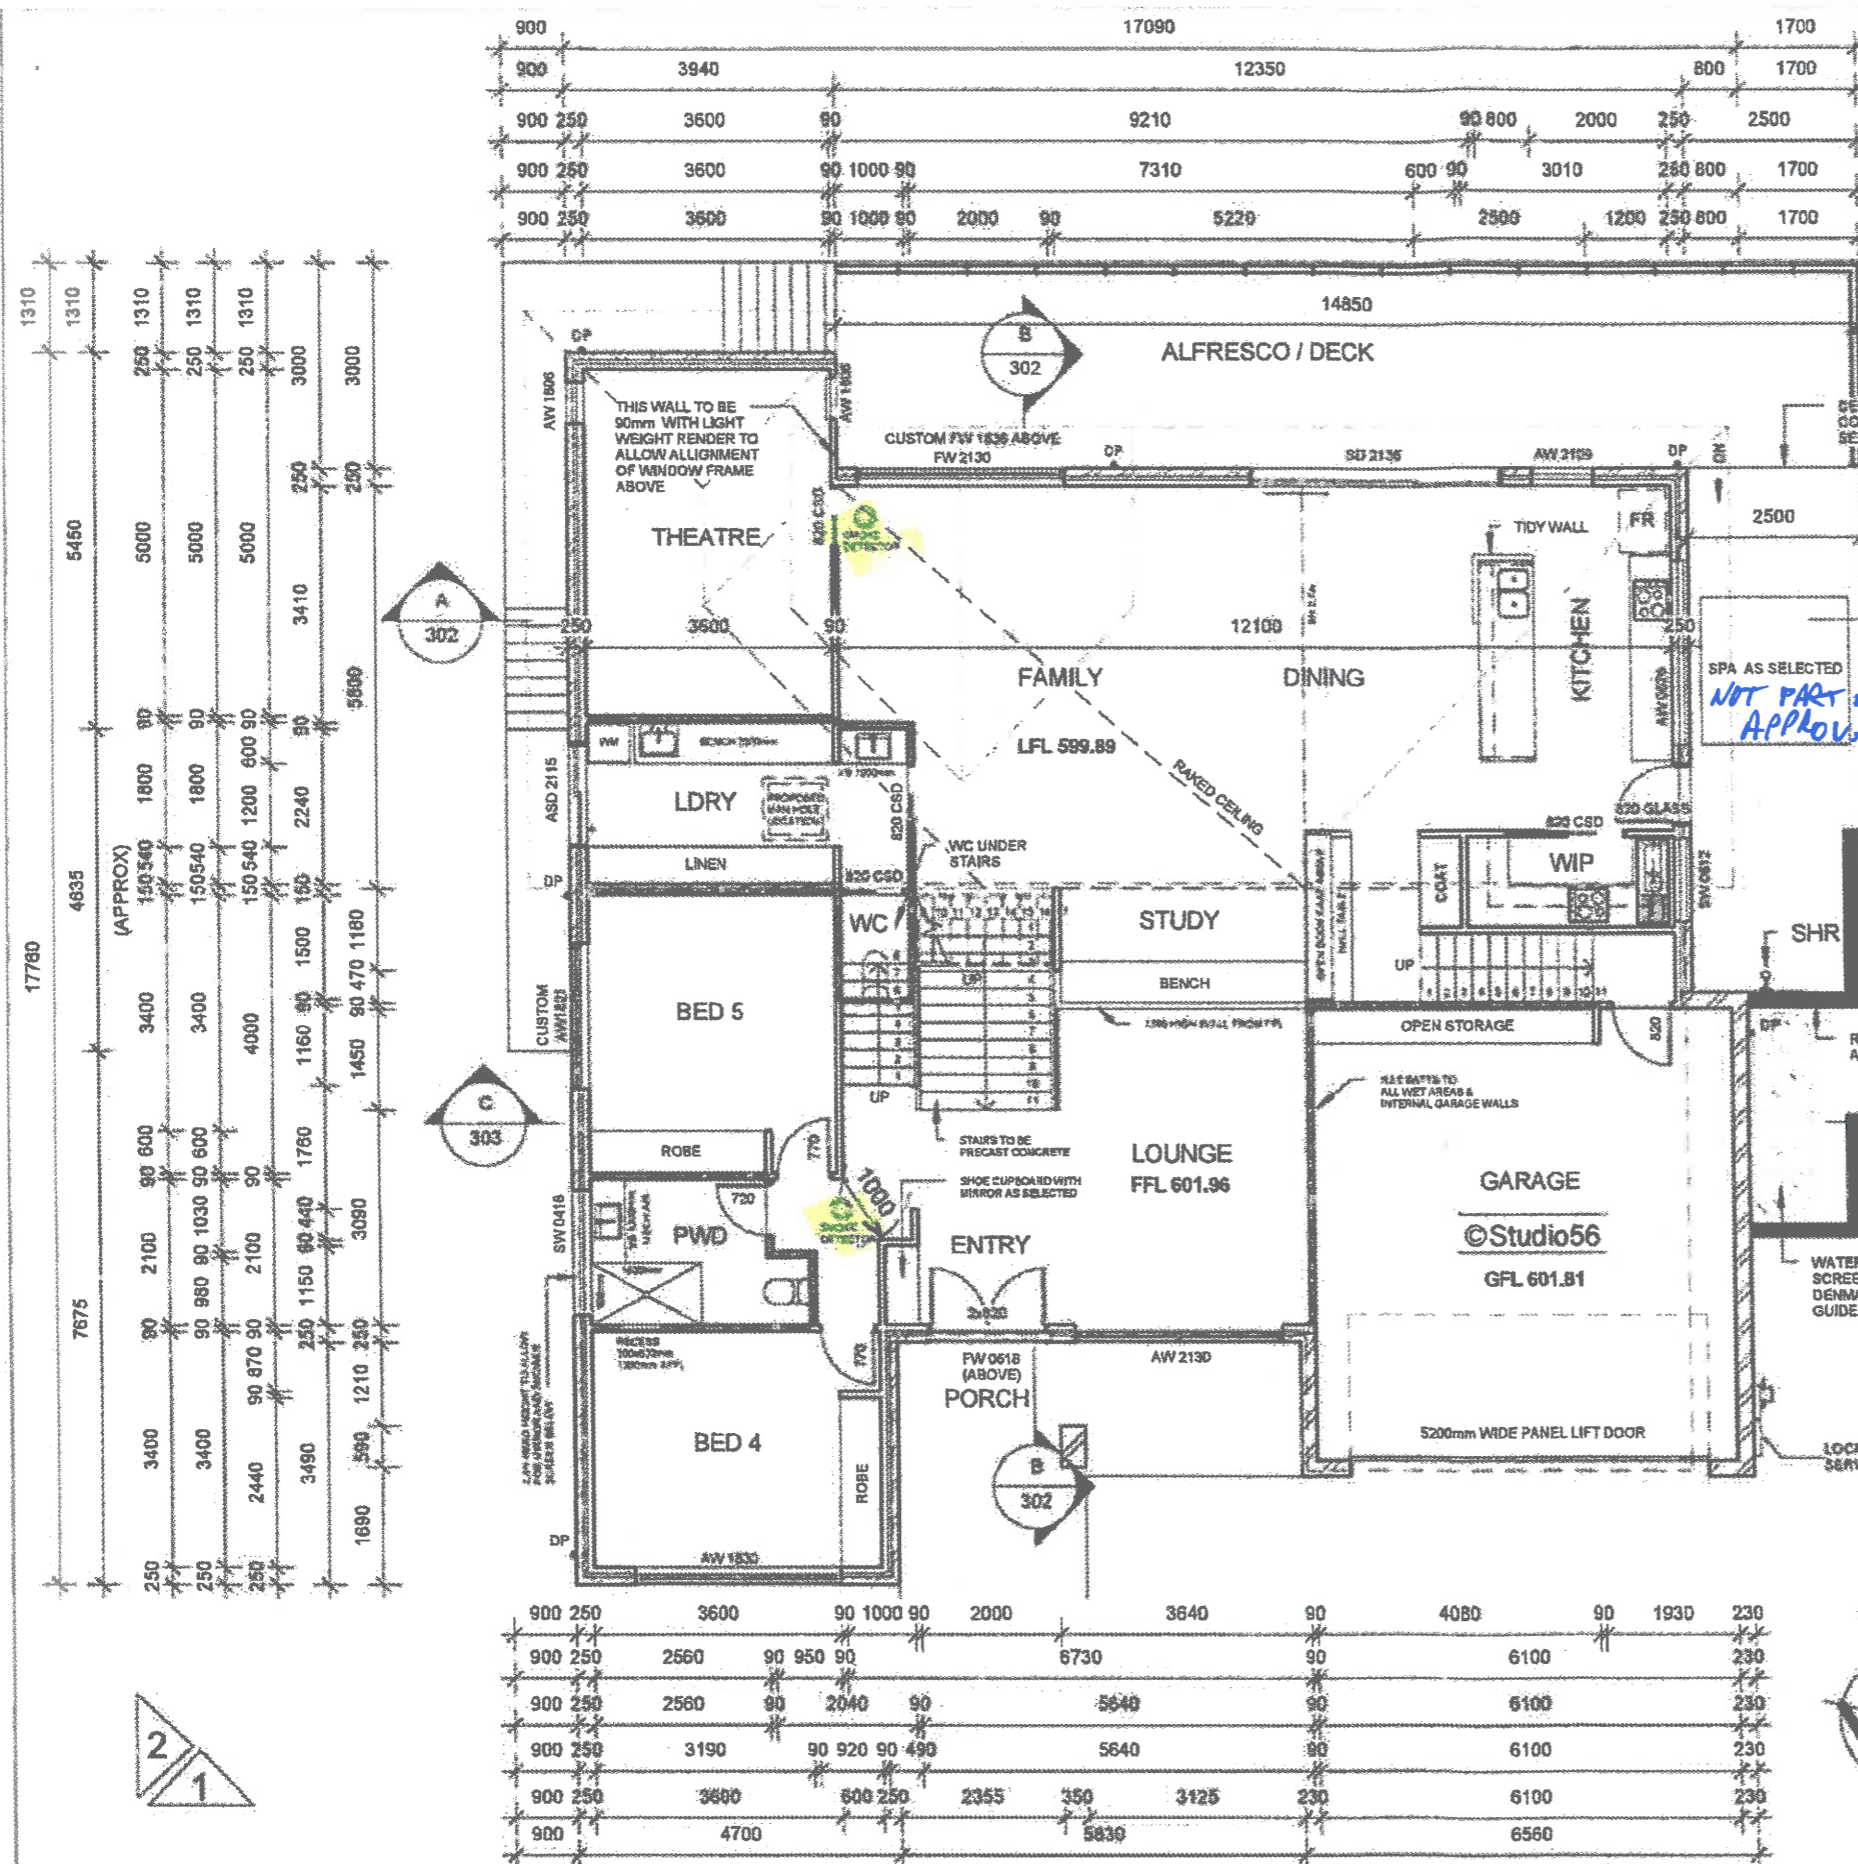
Sheet Name: LOWER FLOOR PLAN
 Project number: 4197 - D
 Date: 21.03.2017
 Design by: B.LAW
 Scale: 1:100
 Sheet Number: 200
 Rev No:

- NOTE:
- ALL WINDOWS TO BE AS PER ENERGY RATING REPORT
 - WATER HEATER IN HOT WATER SUPPLY SYSTEM TO COMPLY WITH CLAUSE 3.12.5.6 OF THE BCA
 - LIGHTING TO COMPLY WITH CLAUSE 3.12.5.5 OF THE BCA
 - WET AREAS TO COMPLY WITH ALL RELEVANT CLAUSES OF THE BCA
 - BRICK PIERS TO COMPLY WITH BCA AND AS4773
 - STAIR NOSING STRIP SLIP RESISTANCE CLASSIFICATION - INDOORS P3 AND OUTDOORS P4
 - LICENSED PLUMBER TO SUBMIT WORKS EXECUTED PLAN
 - LICENSED ELECTRICIAN TO SUBMIT CES FORM
 - SMOKE ALARMS TO BE INSTALLED IN ACCORDANCE WITH THE BCA Part 3.7.2 AND AS 3786
 - TILES & FLASHINGS TO BE INSTALLED IN ACCORDANCE WITH MANUFACTURERS SPECIFICATIONS

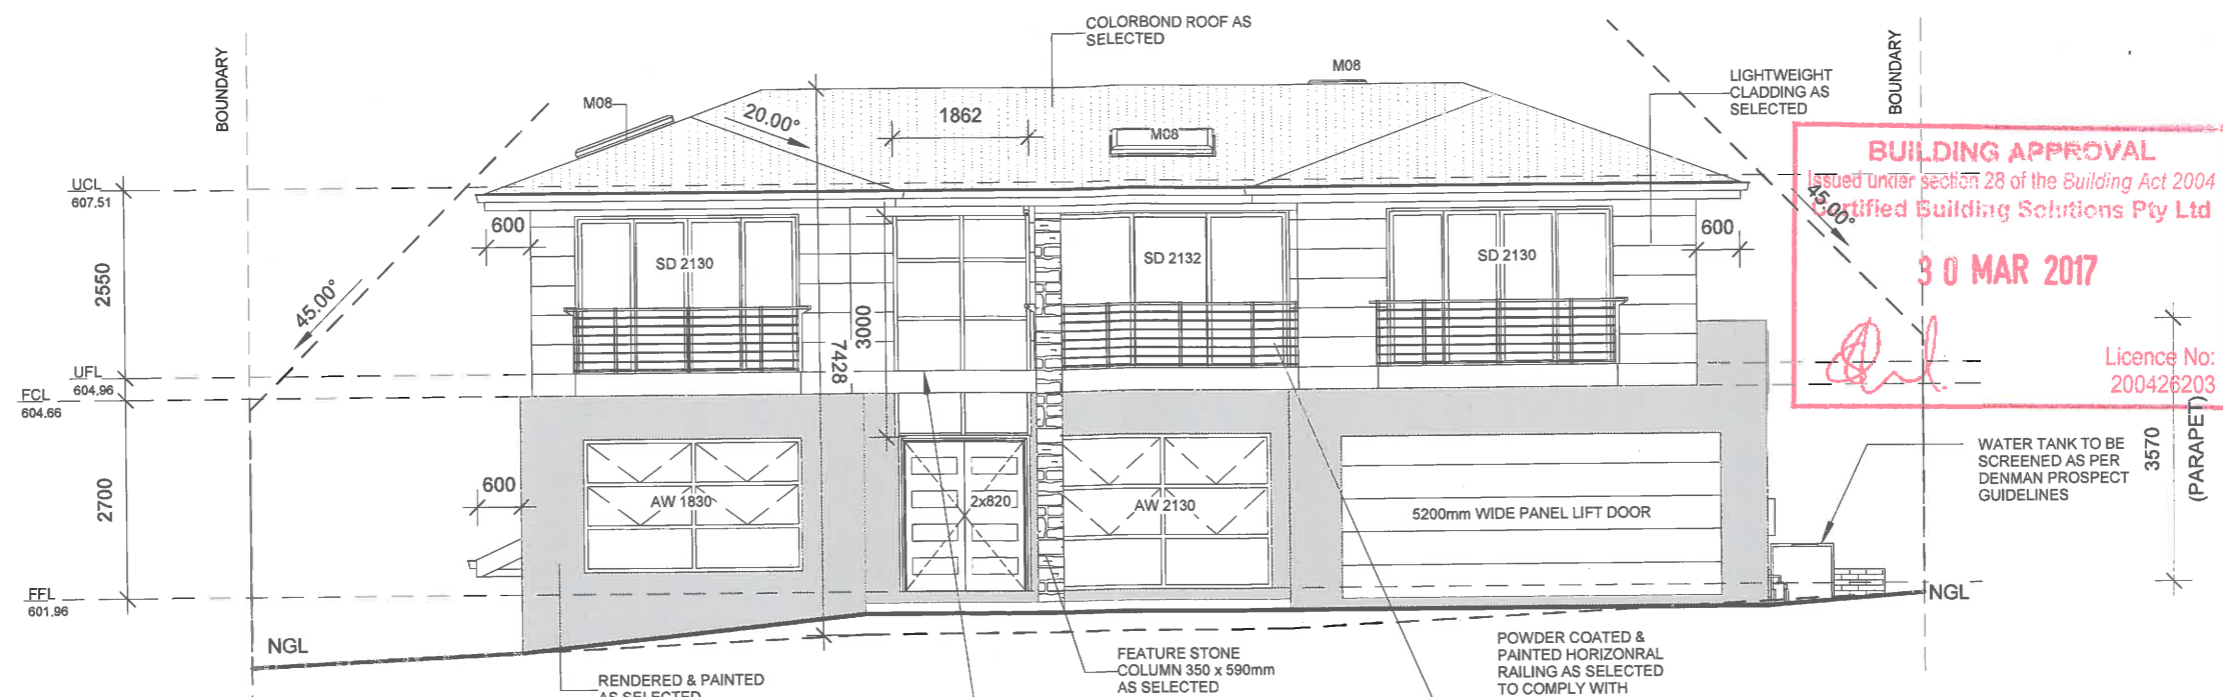
Elevation 1
 1 : 100

APPROVED
 PURSUANT TO SECTION 1.100A/1.100AB OF THE
 PLANNING AND DEVELOPMENT REGULATION 2008
 Delegate: **GEORGE CILLIER**
 Date: **31/1/2017**
DECLARATION OF EXTENDED DISTANCE
 Rule 6 - building envelope departure of a maximum 1222mm for a
 length of 7773mm and 1431mm for a maximum of 10083mm

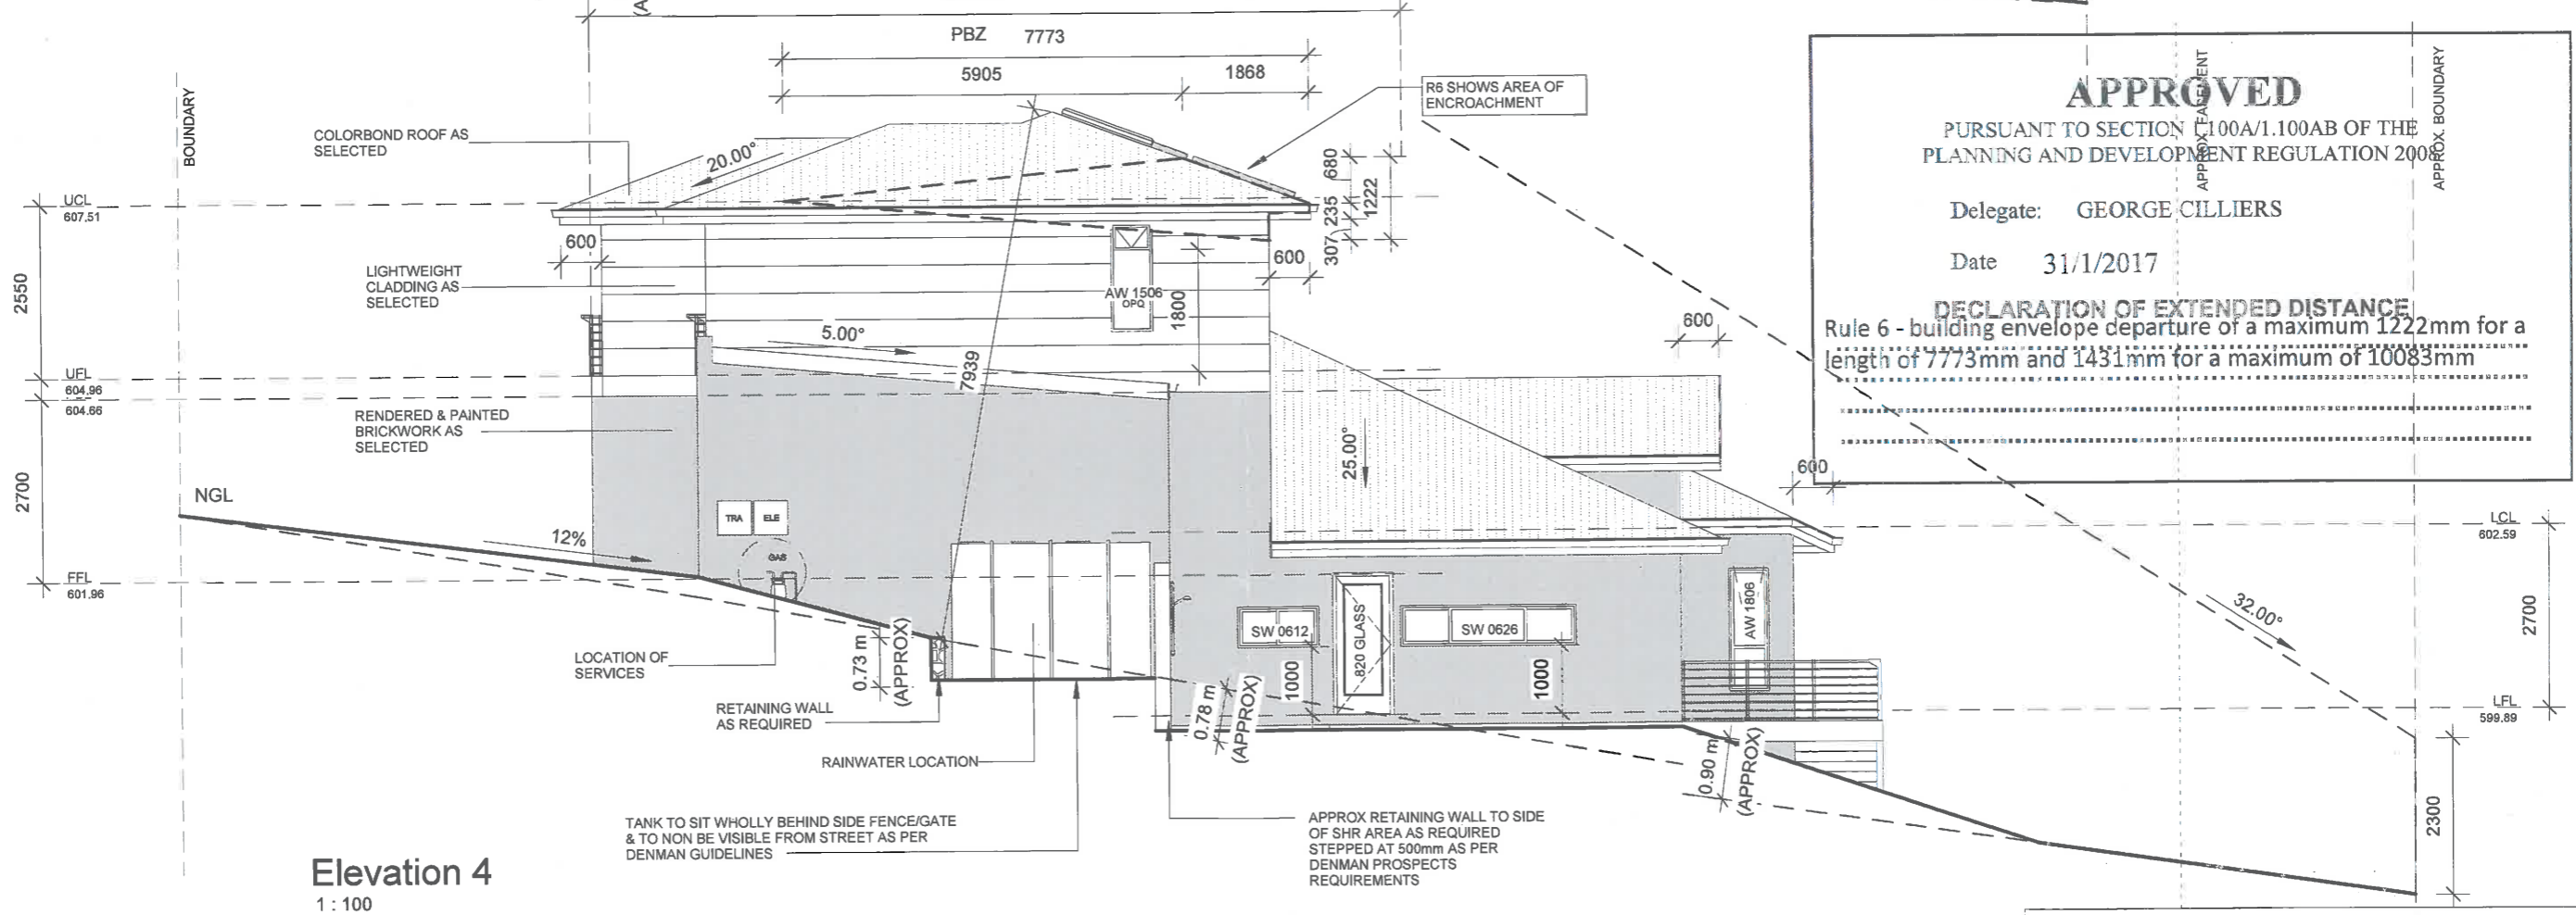
Elevation 4
1:100

APPROVED
PURSUANT TO SECTION 100A/1.100AB OF THE PLANNING AND DEVELOPMENT REGULATION 2006
Delegate: GEORGE CILLIERS
Date 31/1/2017
DECLARATION OF EXTENDED DISTANCE
Rule 6 - building envelope departure of a maximum 1222mm for a length of 7773mm and 1431mm for a maximum of 10083mm

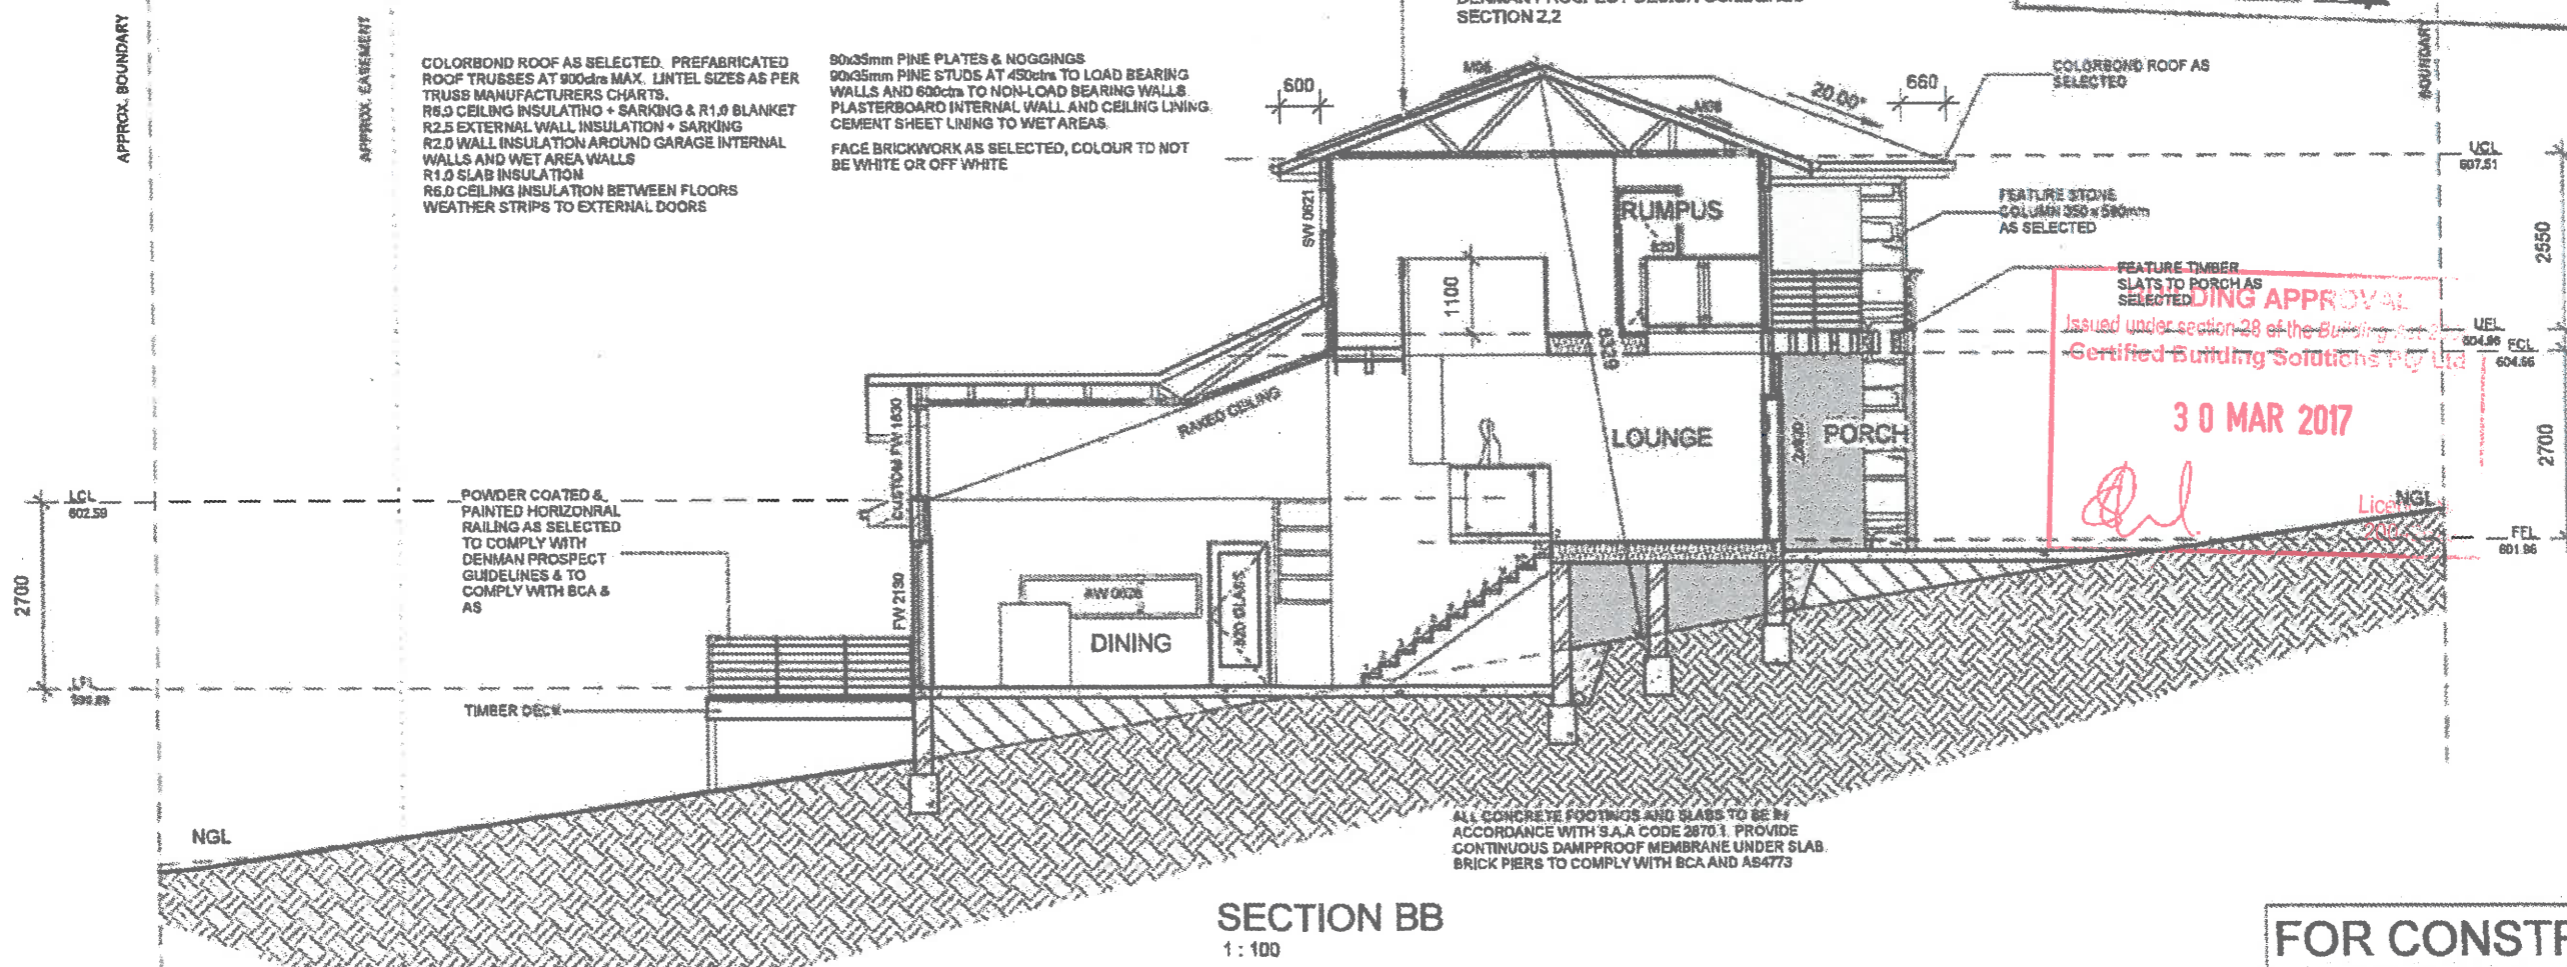
SECTION BB
1 : 100

COLORBOND ROOF AS SELECTED. PREFABRICATED ROOF TRUSSES AT 900ctrs MAX. LINTEL SIZES AS PER TRUSS MANUFACTURERS CHARTS.
 R6.0 CEILING INSULATION + SARKING & R1.0 BLANKET
 R2.5 EXTERNAL WALL INSULATION + SARKING
 R2.0 WALL INSULATION AROUND GARAGE INTERNAL WALLS AND WET AREA WALLS
 R1.0 SLAB INSULATION
 R6.0 CEILING INSULATION BETWEEN FLOORS
 WEATHER STRIPS TO EXTERNAL DOORS

90x35mm PINE PLATES & NOGGINGS
 90x35mm PINE STUDS AT 450ctrs TO LOAD BEARING WALLS AND 600ctrs TO NON-LOAD BEARING WALLS
 PLASTERBOARD INTERNAL WALL AND CEILING LINING
 CEMENT SHEET LINING TO WET AREAS.
 FACE BRICKWORK AS SELECTED. COLOUR TO NOT BE WHITE OR OFF WHITE

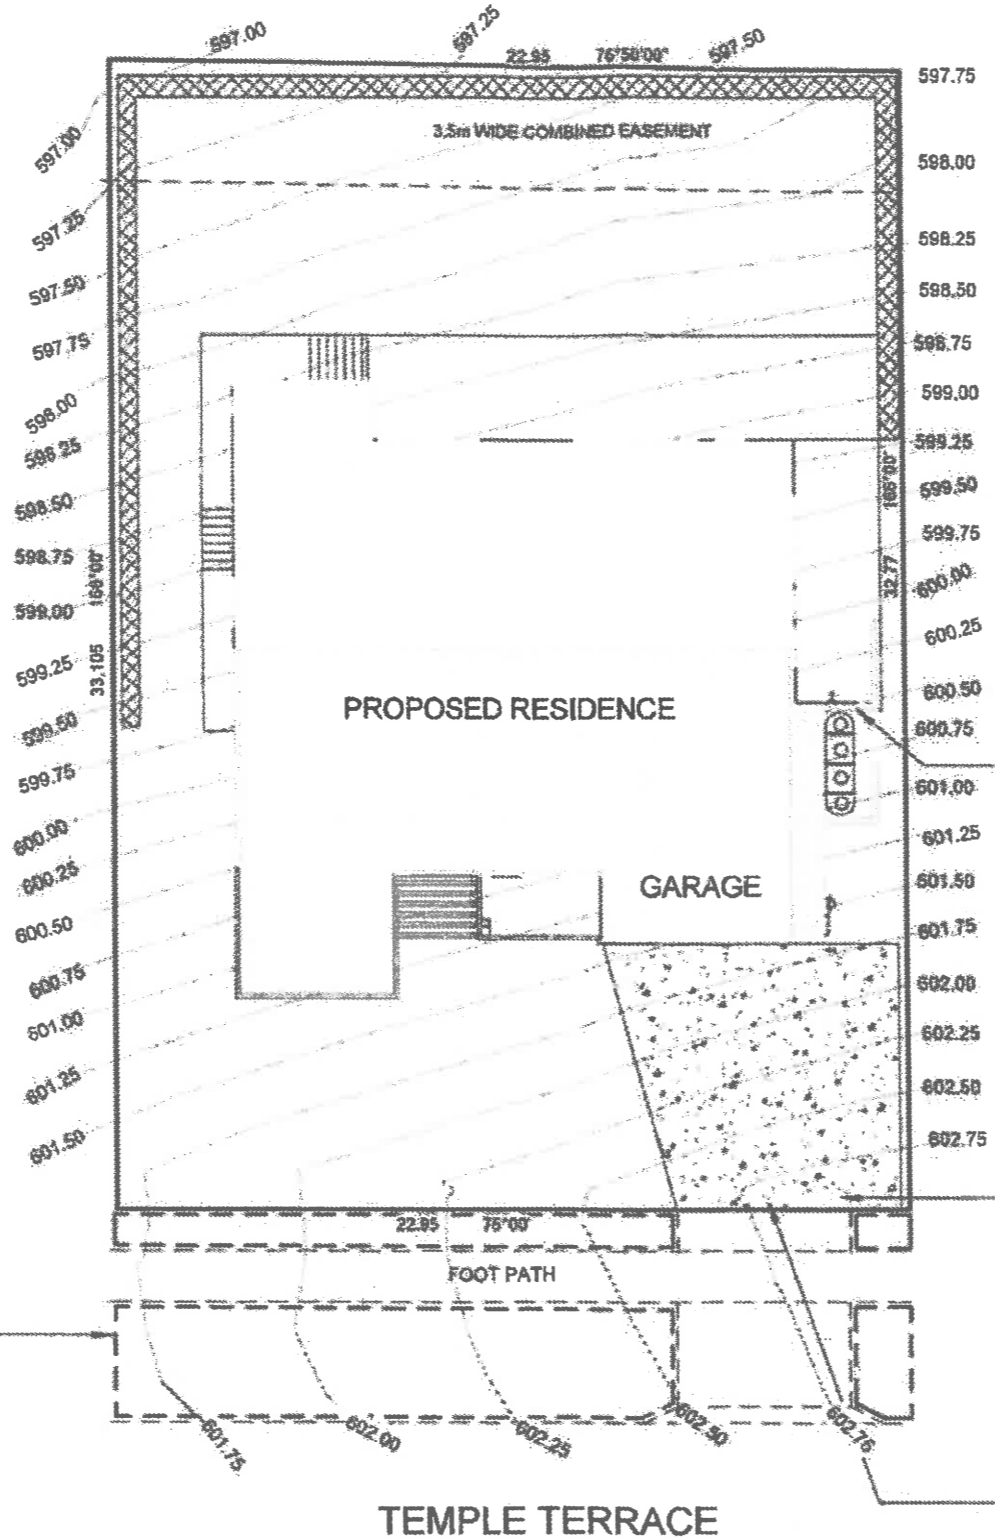
THE DEVELOPMENT WILL COMPLY WITH THE ACT ENVIRONMENT PROTECTION AUTHORITY, ENVIRONMENT PROTECTION GUIDELINES FOR CONSTRUCTION AND LAND DEVELOPMENT IN THE ACT 2009

1.8M HIGH MESH FENCE SUPPORTED BY 2400mm HIGH STEEL POSTS TO BE PROVIDED AROUND PERIMETER OF VERGE

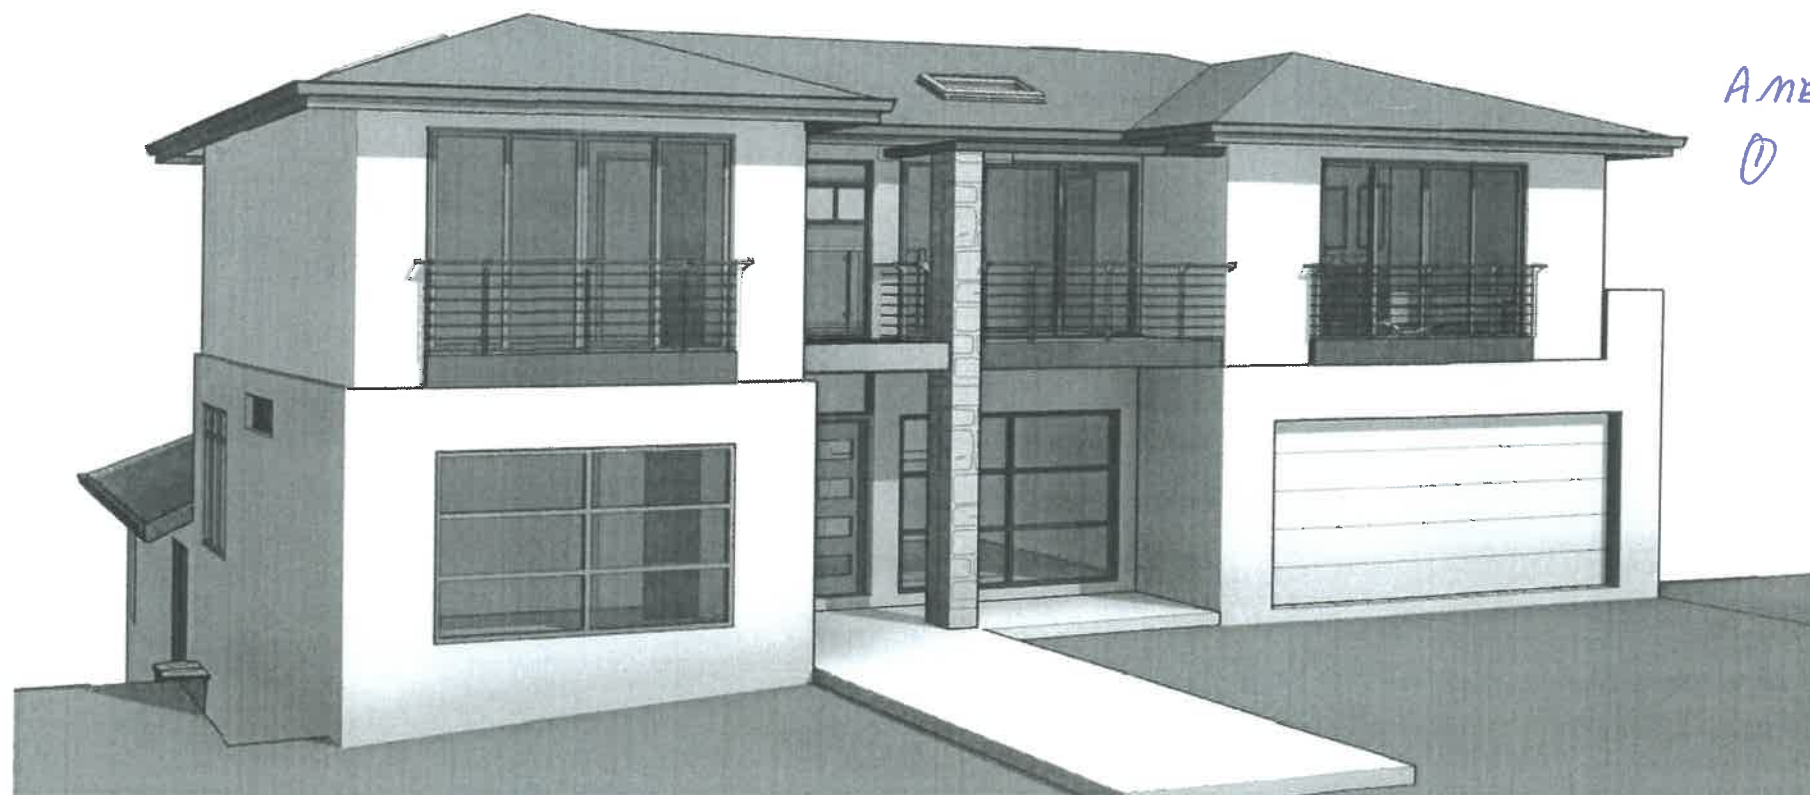
AMENDMENT AUGUST 2017
 ① REDUCE VOID AREA ADJACENT
 TO UFL RUMPUS ROOM.

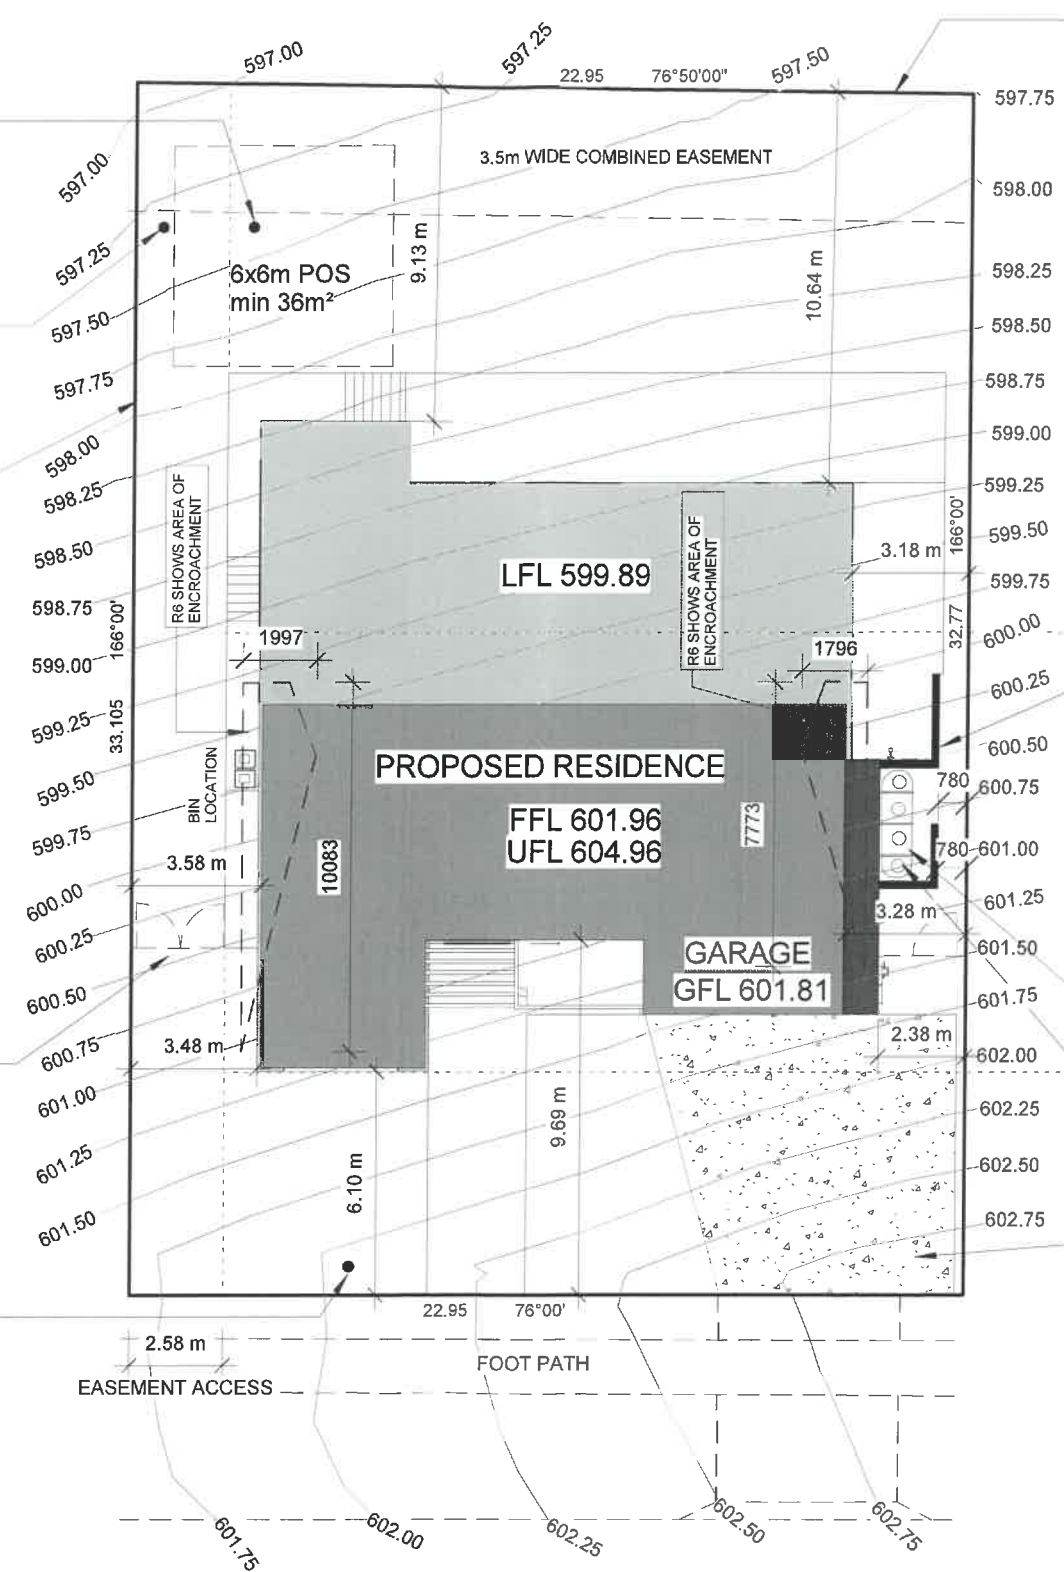
Sheet Name: **SITE PLAN**
Project number: 4197 - F
Date: 21.03.2017
Scale: 1 : 200
Design by: B.LAW
Drawn by: B.LAW
Sheet Number: **100**
Rev No

APPROX RETAINING WALL AS REQUIRED STEPPED AT 500mm AS PER DENMAN PROSPECTS REQUIREMENTS

WATER TANK TO BE SCREENED AS PER DENMAN PROSPECT GUIDELINES

DRIVEWAY TO COMPLY WITH GW/SD/DC.02 & FINISH TO COMPLY WITH ANY LEASE & DEVELOPMENT CONDITIONS AND RELEVANT LOCAL CODES

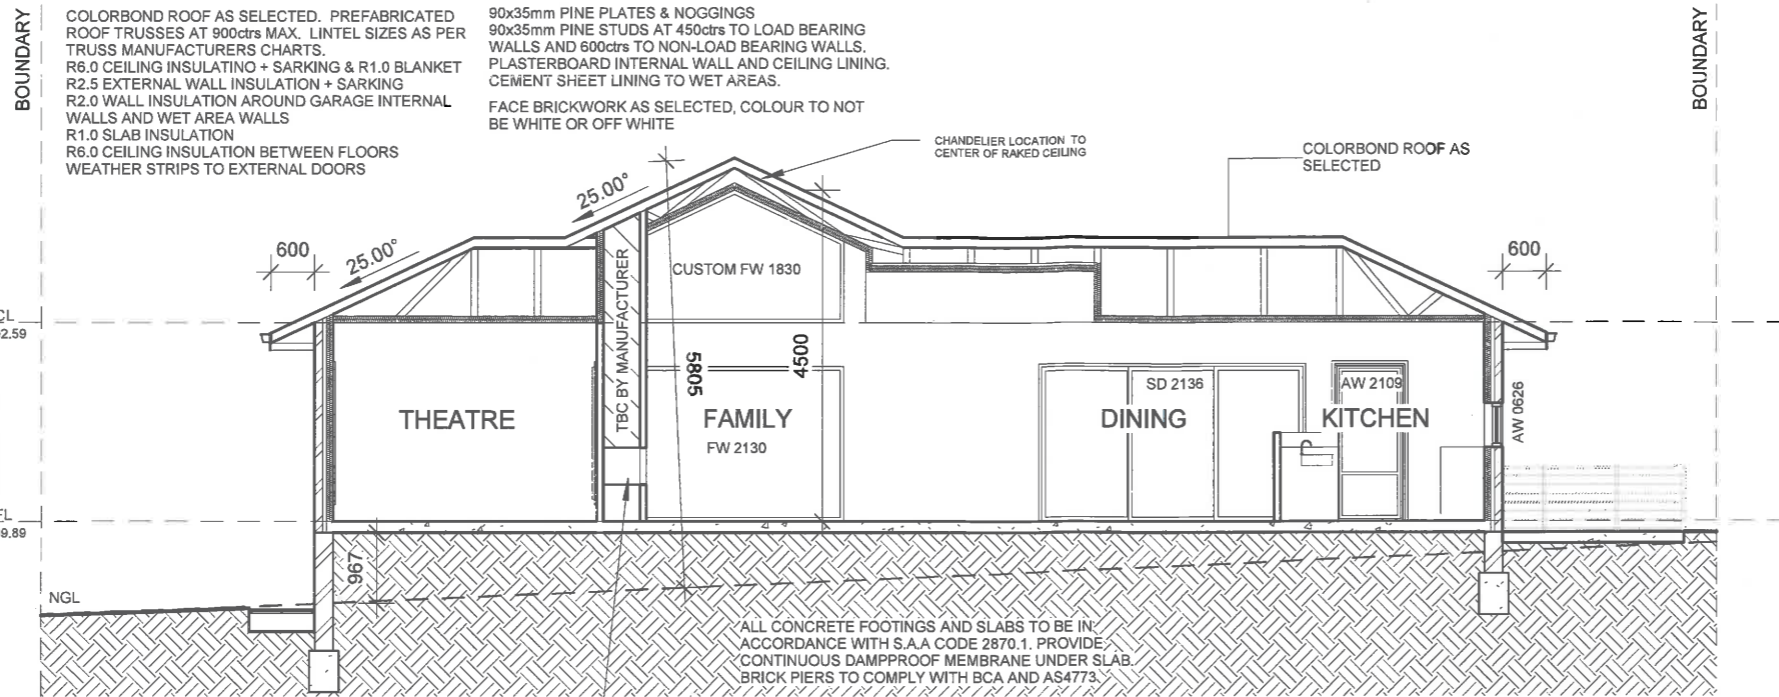
SECTION AA
 1 : 100

MODERN FIREPLACE AS SELECTED WITH TV MOUNT

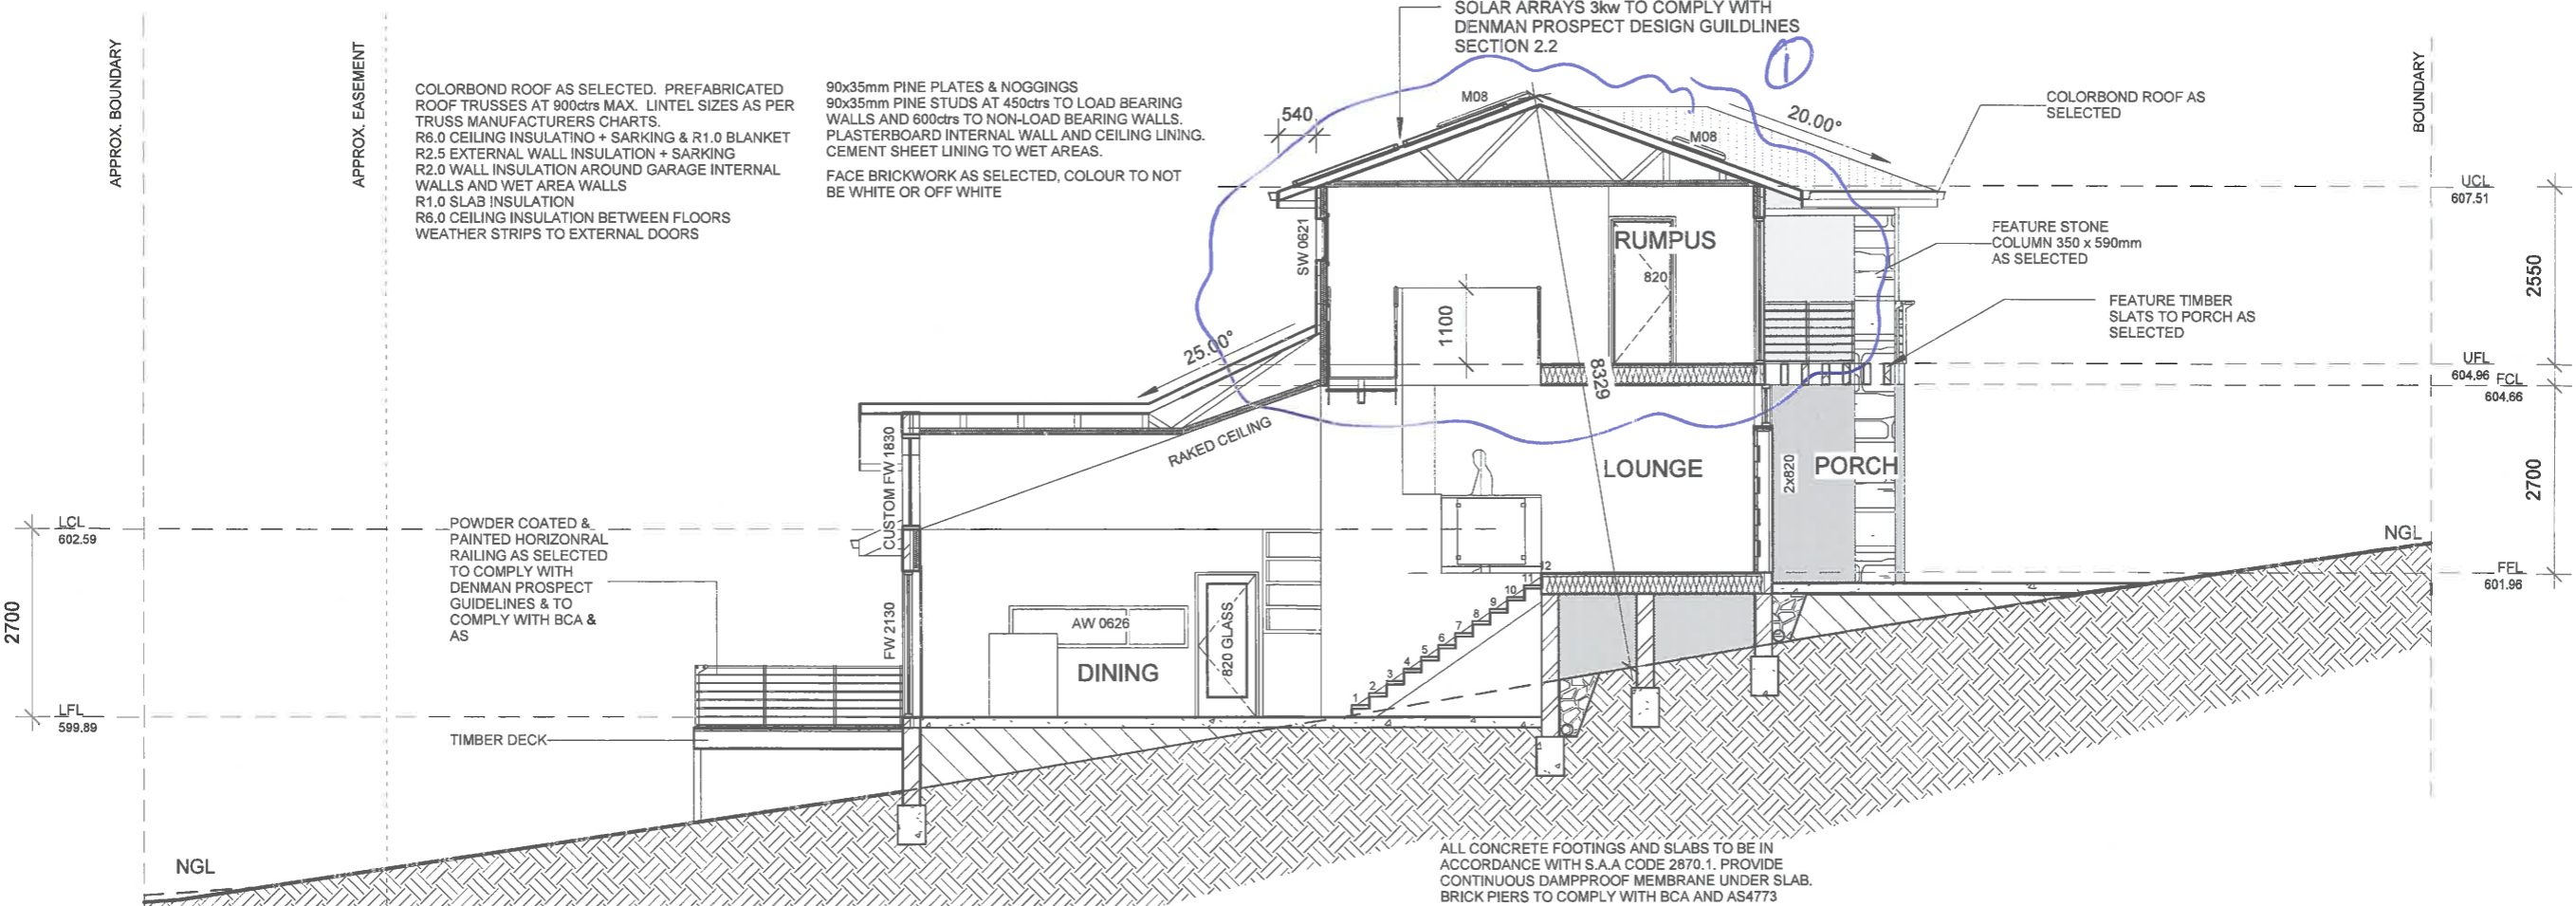
SECTION BB
 1 : 100

COLORBOND ROOF AS SELECTED. PREFABRICATED ROOF TRUSSES AT 900ctrs MAX. LINTEL SIZES AS PER TRUSS MANUFACTURERS CHARTS.
 R6.0 CEILING INSULATION + SARKING & R1.0 BLANKET
 R2.5 EXTERNAL WALL INSULATION + SARKING
 R2.0 WALL INSULATION AROUND GARAGE INTERNAL WALLS AND WET AREA WALLS
 R1.0 SLAB INSULATION
 R6.0 CEILING INSULATION BETWEEN FLOORS
 WEATHER STRIPS TO EXTERNAL DOORS

90x35mm PINE PLATES & NOGGINGS
 90x35mm PINE STUDS AT 450ctrs TO LOAD BEARING WALLS AND 600ctrs TO NON-LOAD BEARING WALLS.
 PLASTERBOARD INTERNAL WALL AND CEILING LINING.
 CEMENT SHEET LINING TO WET AREAS.
 FACE BRICKWORK AS SELECTED, COLOUR TO NOT BE WHITE OR OFF WHITE
