Report

Building Report

CONCLUSION AND SUMMARY

Client Name: DEEPAK BAWA
Project: PROPOSED RESIDENCE
Address: BLOCK 3 SECTION 24 DENMAN PROSPECT
Page 45 of 79

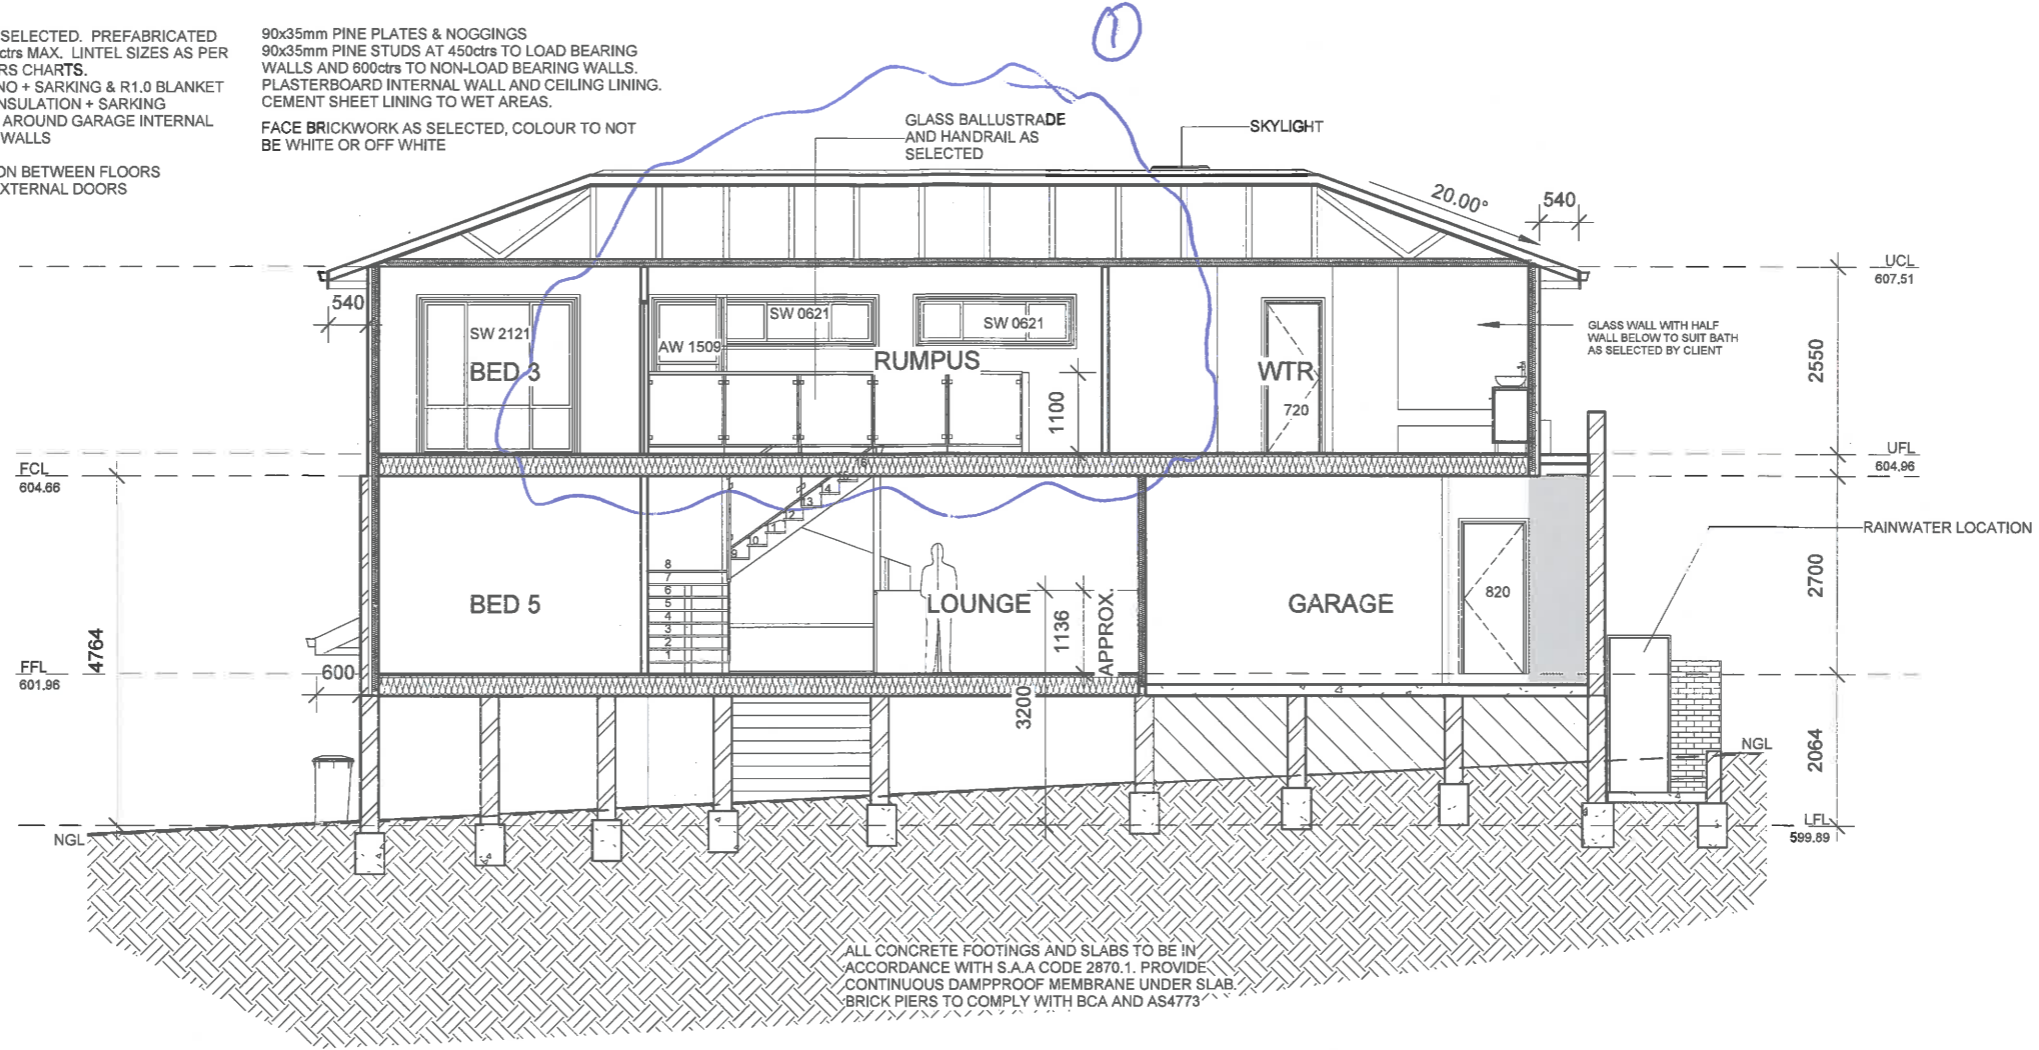
SECTION CC
 1 : 100

ALL CONCRETE FOOTINGS AND SLABS TO BE IN ACCORDANCE WITH S.A.A CODE 2870.1. PROVIDE CONTINUOUS DAMPPROOF MEMBRANE UNDER SLAB. BRICK PIERS TO COMPLY WITH BCA AND AS4773

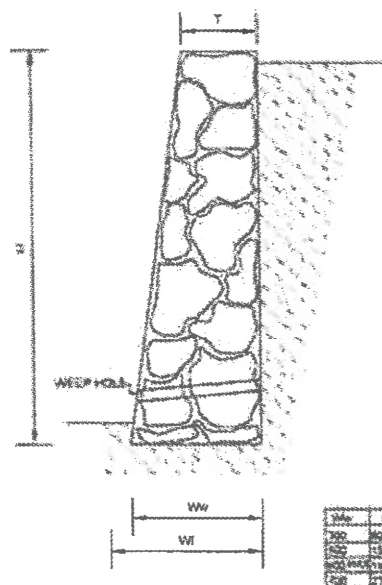
ROCK RETAINING WALL

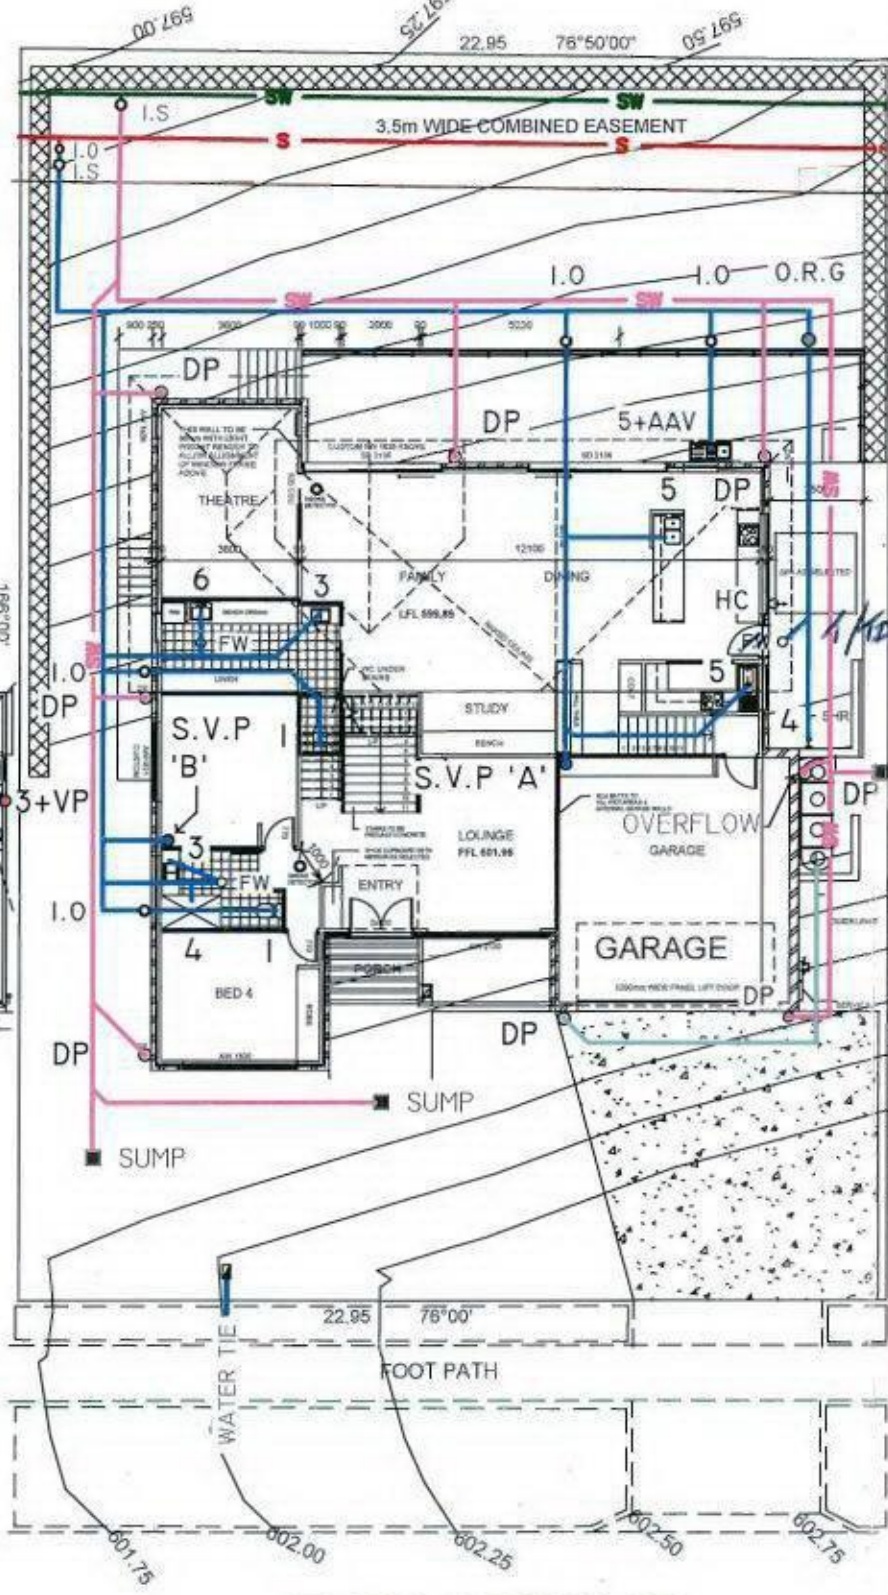
PLEASE NOTE: ON THE TIE IMAGE, RED LINES INDICATE SEWERAGE, GREEN LINES INDICATE STORM WATER AND BLUE LINES INDICATE WATER SUPPLY.

SW NOTE: PROVIDE 100 DIAMETER PIPE TO THE FIRST JUNCTION AND UNDER BUILDINGS UNLESS NOTED OTHERWISE. GREASE LINES SHOWN IN ORANGE LINES. PROPOSED WASTE PLUMBING SHOWN IN YELLOW LINES. PROPOSED SOIL AND DRAINS TO BE LAID SHOWN IN BLUE LINES. DRAINS DELETED SHOWN BY RED 'X'. EXISTING DRAINS SHOWN IN GREEN LINES. PROVIDE INSPECTION OPENINGS ON EACH WC BRANCH OF INTERVALS OF NOT MORE THAN 30m SPACED EQUIDISTANT IMMEDIATELY UP & DOWNSTREAM OF ALL JUMP UPS. VITRIFIED CLAY PIPES TO BE IN ACCORDANCE WITH AS1693 & AS A164. UPVC PIPES TO BE IN ACCORDANCE WITH AS1260. PROVIDE FIRE STOP COLLARS TO ALL UPVC PENETRATIONS OF FIRE RATED FLOORS AND WALLS. THIS BASE DRAINAGE PLAN REMAINS THE PROPERTY OF THE ARCHITECTURAL DESIGN STUDIO & IS NOT TO BE COPIED WITHOUT THE EXPRESS WRITTEN PERMISSION OF ANTHONY BURR. WHILST EVERY PRECAUTION IS TAKEN TO ENSURE THE ACCURACY OF THE NOTES &/OR DRAWINGS NO RESPONSIBILITY &/OR LIABILITY WILL BE ACCEPTED FOR ANY ERRORS &/OR OMISSIONS IN THE TEXT &/OR DRAWINGS. IT IS THE CONTRACTORS RESPONSIBILITY TO ESTABLISH THE LOCATION OF ALL EXISTING SERVICES & THE SUITABILITY OF THE DESIGN PRIOR TO COMMENCING CONSTRUCTION. CHECK POSITION OF TIE PRIOR TO COMMENCING CONSTRUCTION. INSPECTION SHAFT TO BE LOCATED AT THE PROPERTY BOUNDARY IS TO BE RAISED TO GROUND LEVEL IN ACCORDANCE WITH PLUMBING NOTE 3.

- ALL NEW SEWER DRAINS ARE 100Ø UPVC UNLESS NOTED OTHERWISE.
- ALL NEW SW IS 90Ø PVC EXCEPT 100Ø LINE FROM TIE TO FIRST JUNCTION & UNDER SLABS.
