# Report

# Building Report

**DRAWING CROSS SECTIONS 1 - SECTION A-A**  
**PROJECT PROPOSED DISPLAY HOME**  
**CLIENT BETTER BUILDING**  
 DRAWN RN/IM  
 REVISION  
 REVISION DATE  
 PROJECT NO 1593  
 PRINT DATE 30.11.2016  
 DWG NO A401

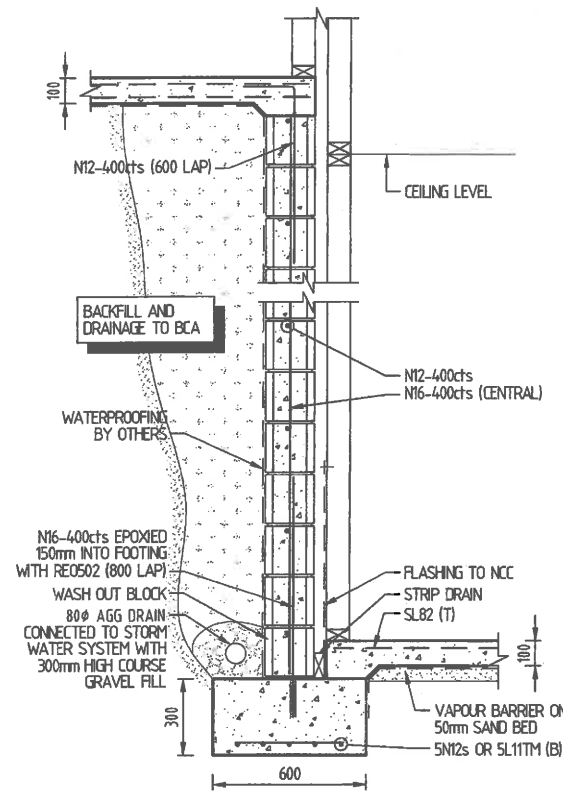
TYPICAL RW1  
SECTION 1  
SCALE = 1:20

- RETAINING WALL NOTES:
1. PROP RETAINING WALLS WHILE FILLING CAVITY AND BACKFILL AGAINST UNTIL SLAB IS CURED.
  2. CONCRETE FILL FOR RETAINING WALL CAVITIES TO BE 20MPa WITH MAXIMUM 10mm AGGREGATE.
  3. CAVITY TO BE FILLED IN SECTIONS HORIZONTALLY TO PREVENT WALL BLOWOUT.
  4. ACTUAL LOCATION AND EXTENT OF RETAINING WALLS TO BE DETERMINED ON SITE.
  5. WATERPROOFING OF RETAINING WALLS BY OTHERS.

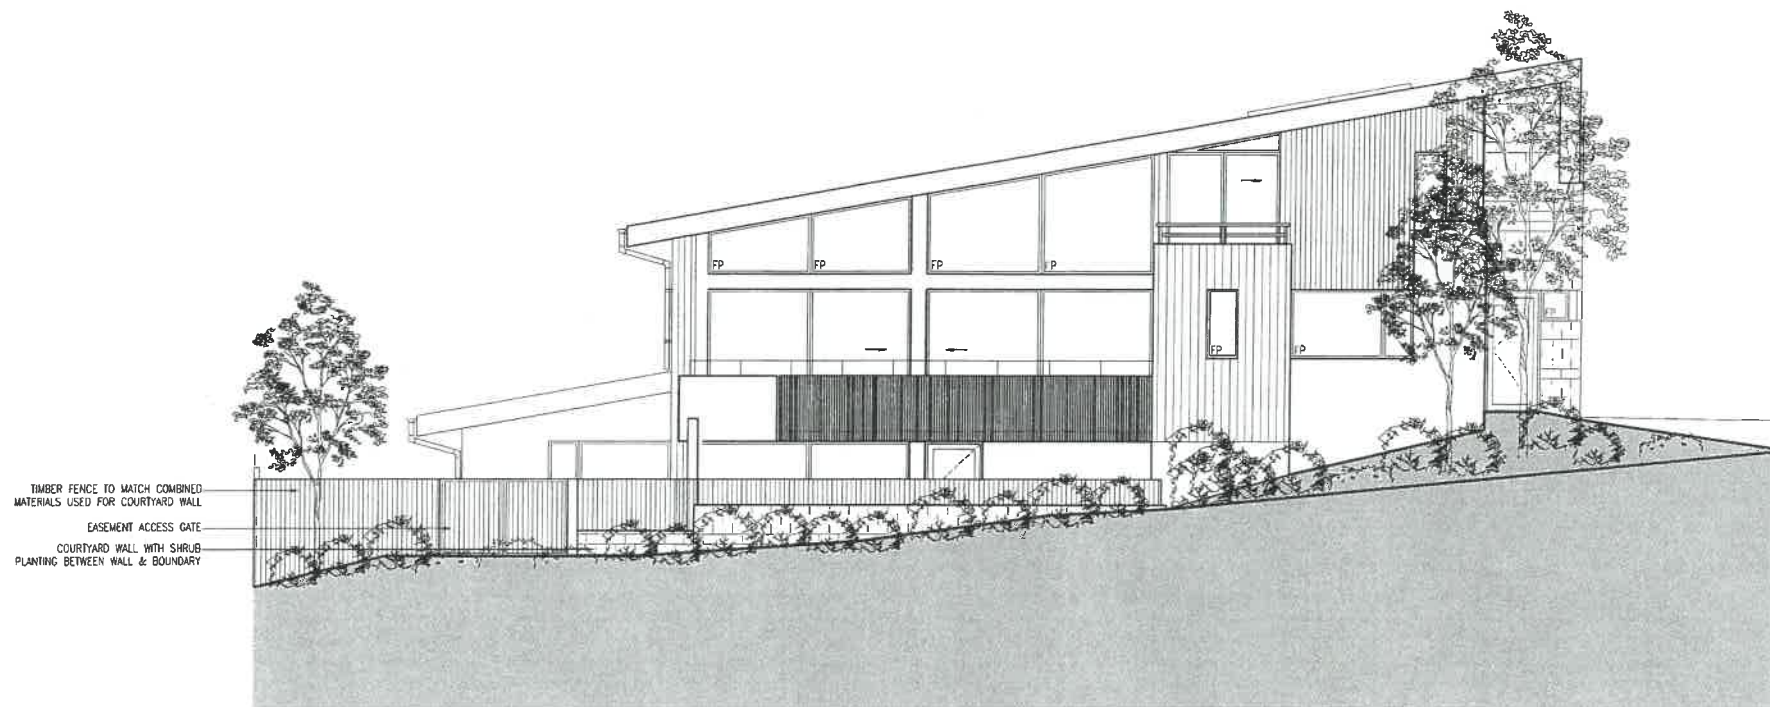
**NORTH ELEVATION**  
 1:100 @ A2

TIMBER FENCE TO MATCH COMBINED MATERIALS USED FOR COURTYARD WALL  
 EASEMENT ACCESS GATE  
 COURTYARD WALL WITH SHRUB PLANTING BETWEEN WALL & BOUNDARY

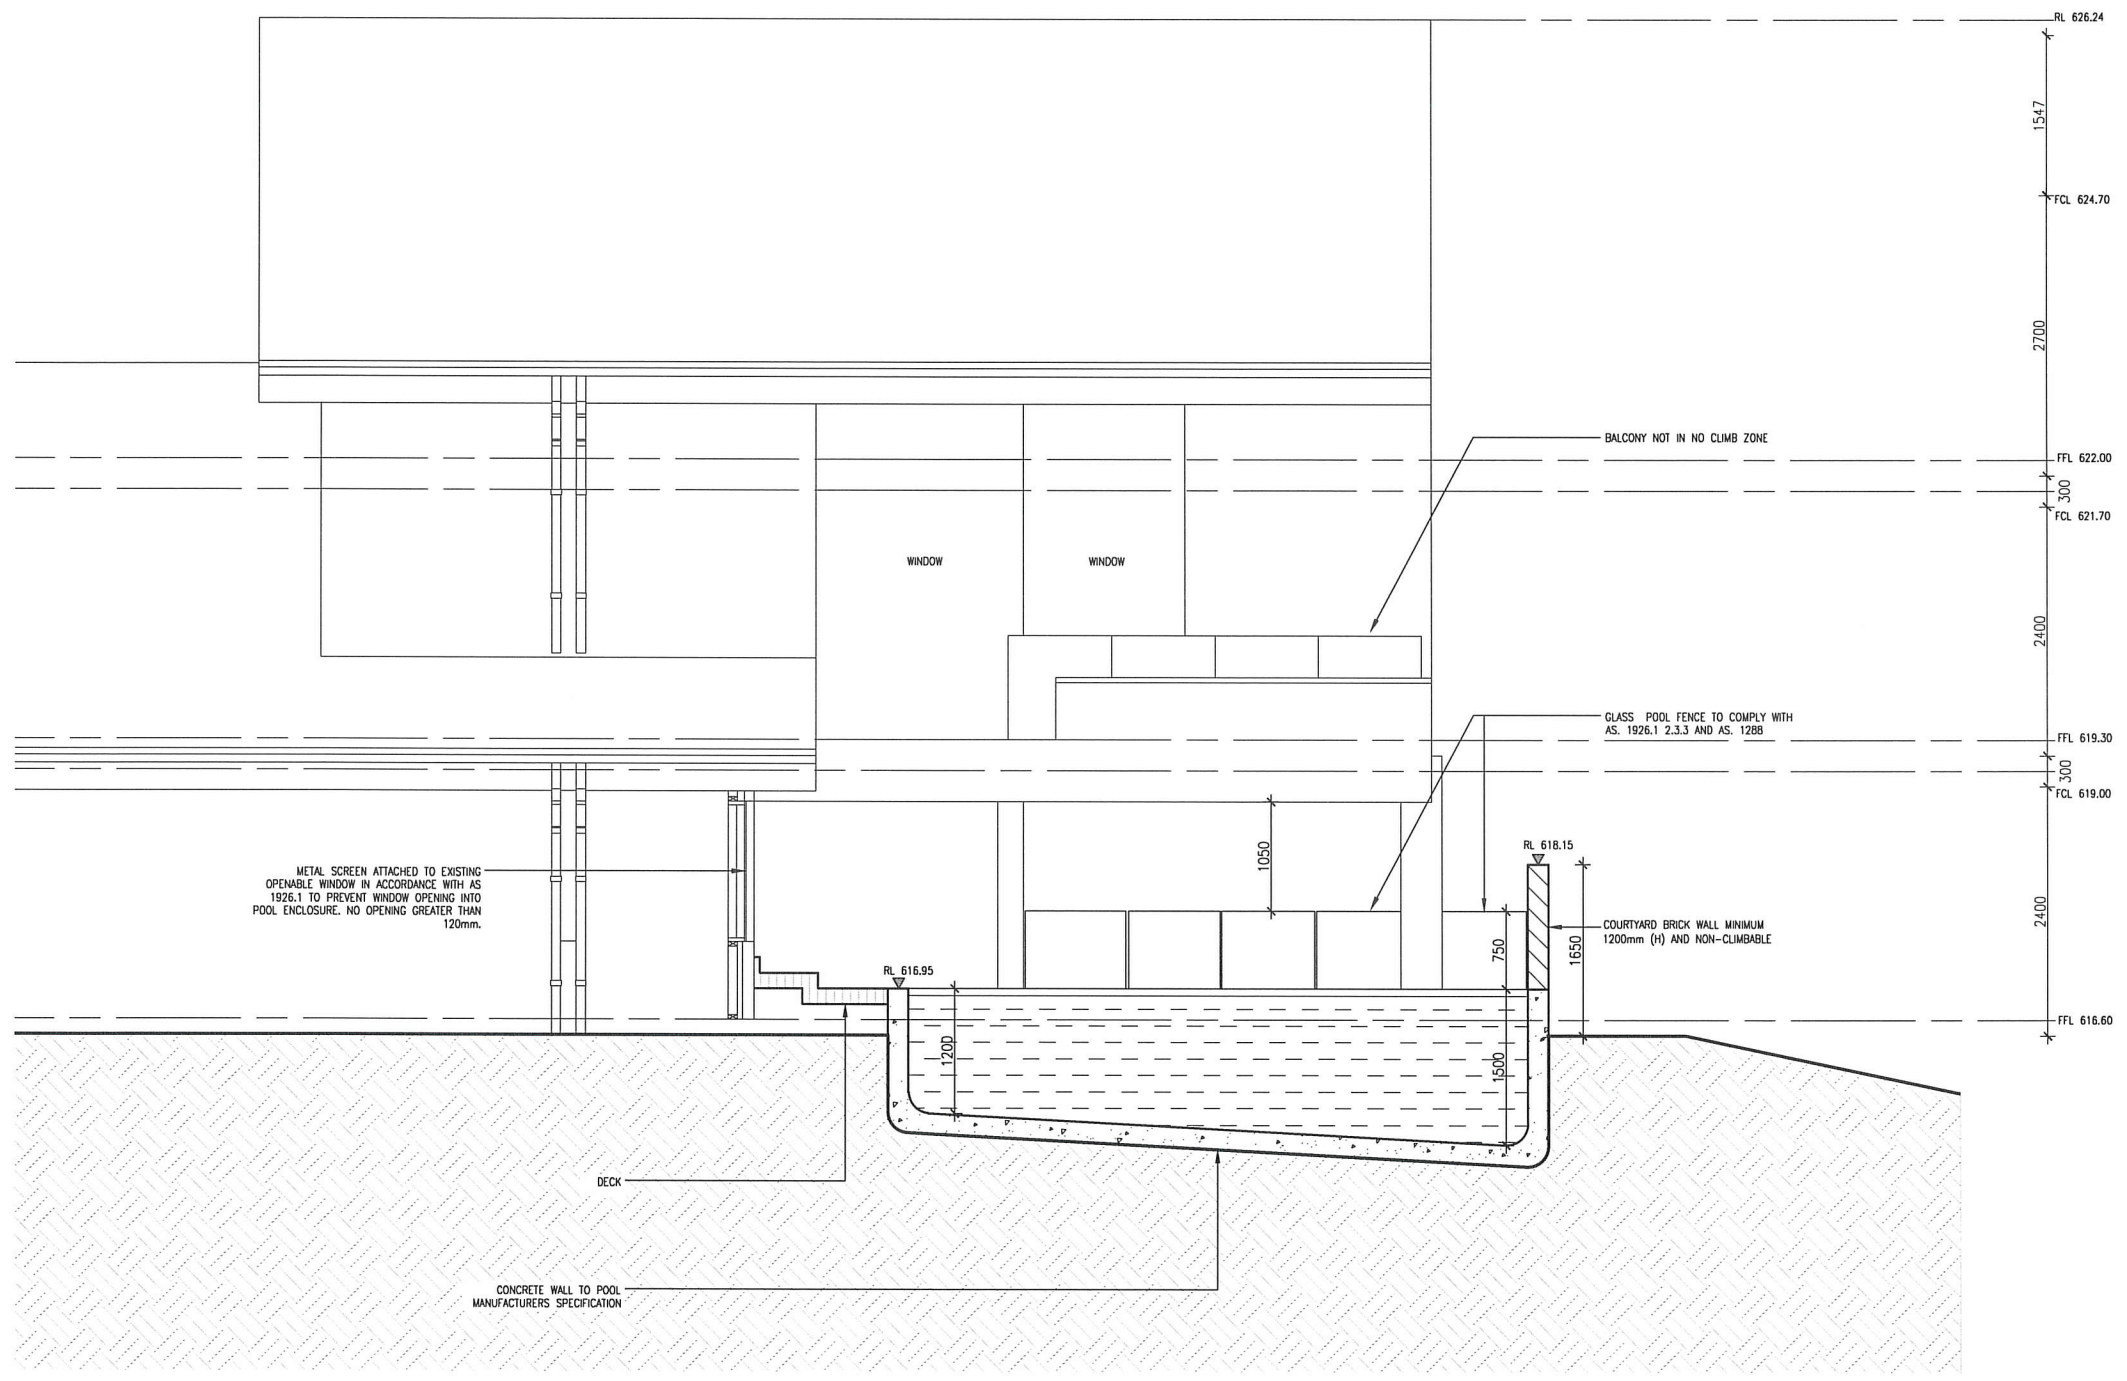
SECTION A  
 1:50 @ A2

DRAWING SECTION- SWIMMING POOL ADDITION  
 SCALE 1:50@ A2  
 PRINT DATE 14.09.2022  
 DRAWN RN/SB

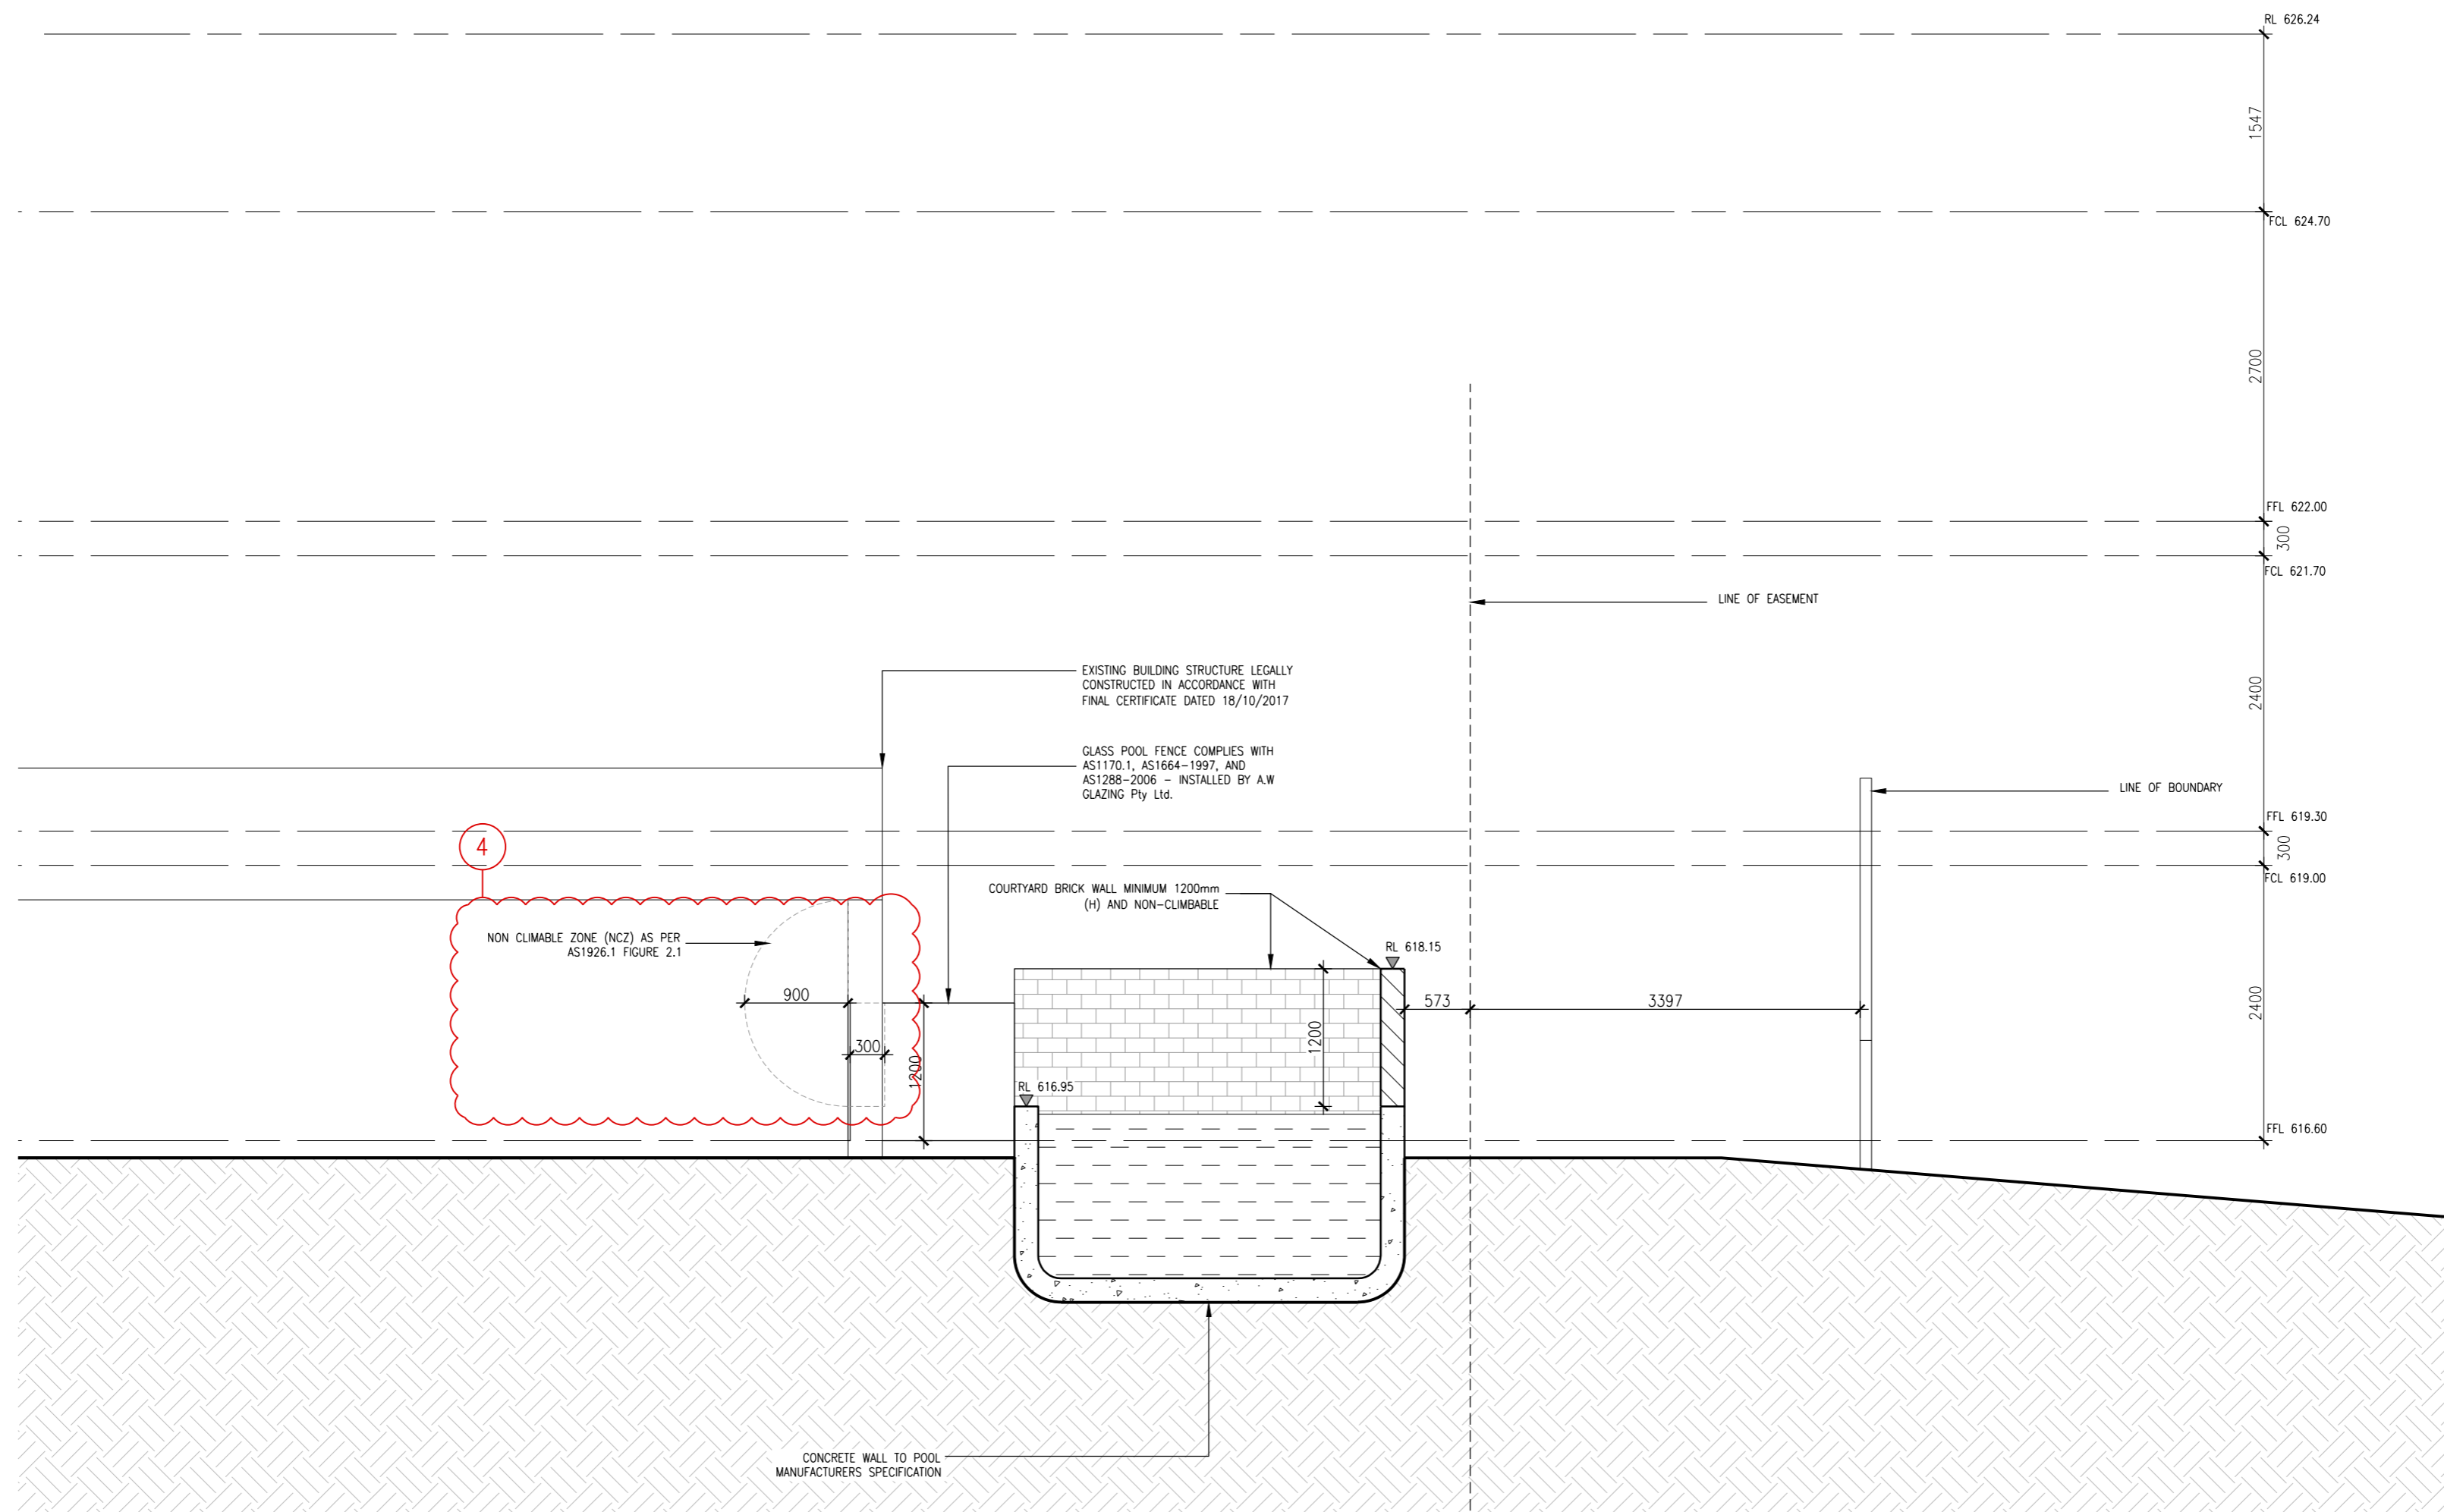
**SECTION B**  
1:50 @ A2

- REV. B** 14.09.2022  
1. DRAFT  
2. POOL BARRIER AMENDMENTS
- REV. C** 07.11.2022  
3. POOL STEPS ADDED  
4. NCZ ADDED TO DRAWING
