# Report

# Building Report

## CONCLUSION AND SUMMARY

BLOCK	14	DRAWING	SITE PLAN	DRAWN	RJ
SECTION	6	PROJECT	PROPOSED NEW TOWN HOUSE DEVELOPMENT	REVISION	
SUBURB	FORREST	CLIENT	LIEBKE & CO PTY LTD	REVISION DATE	2101
SCALE	1:200 @A2	PRINT DATE	17/02/2021	DWG No	BA03

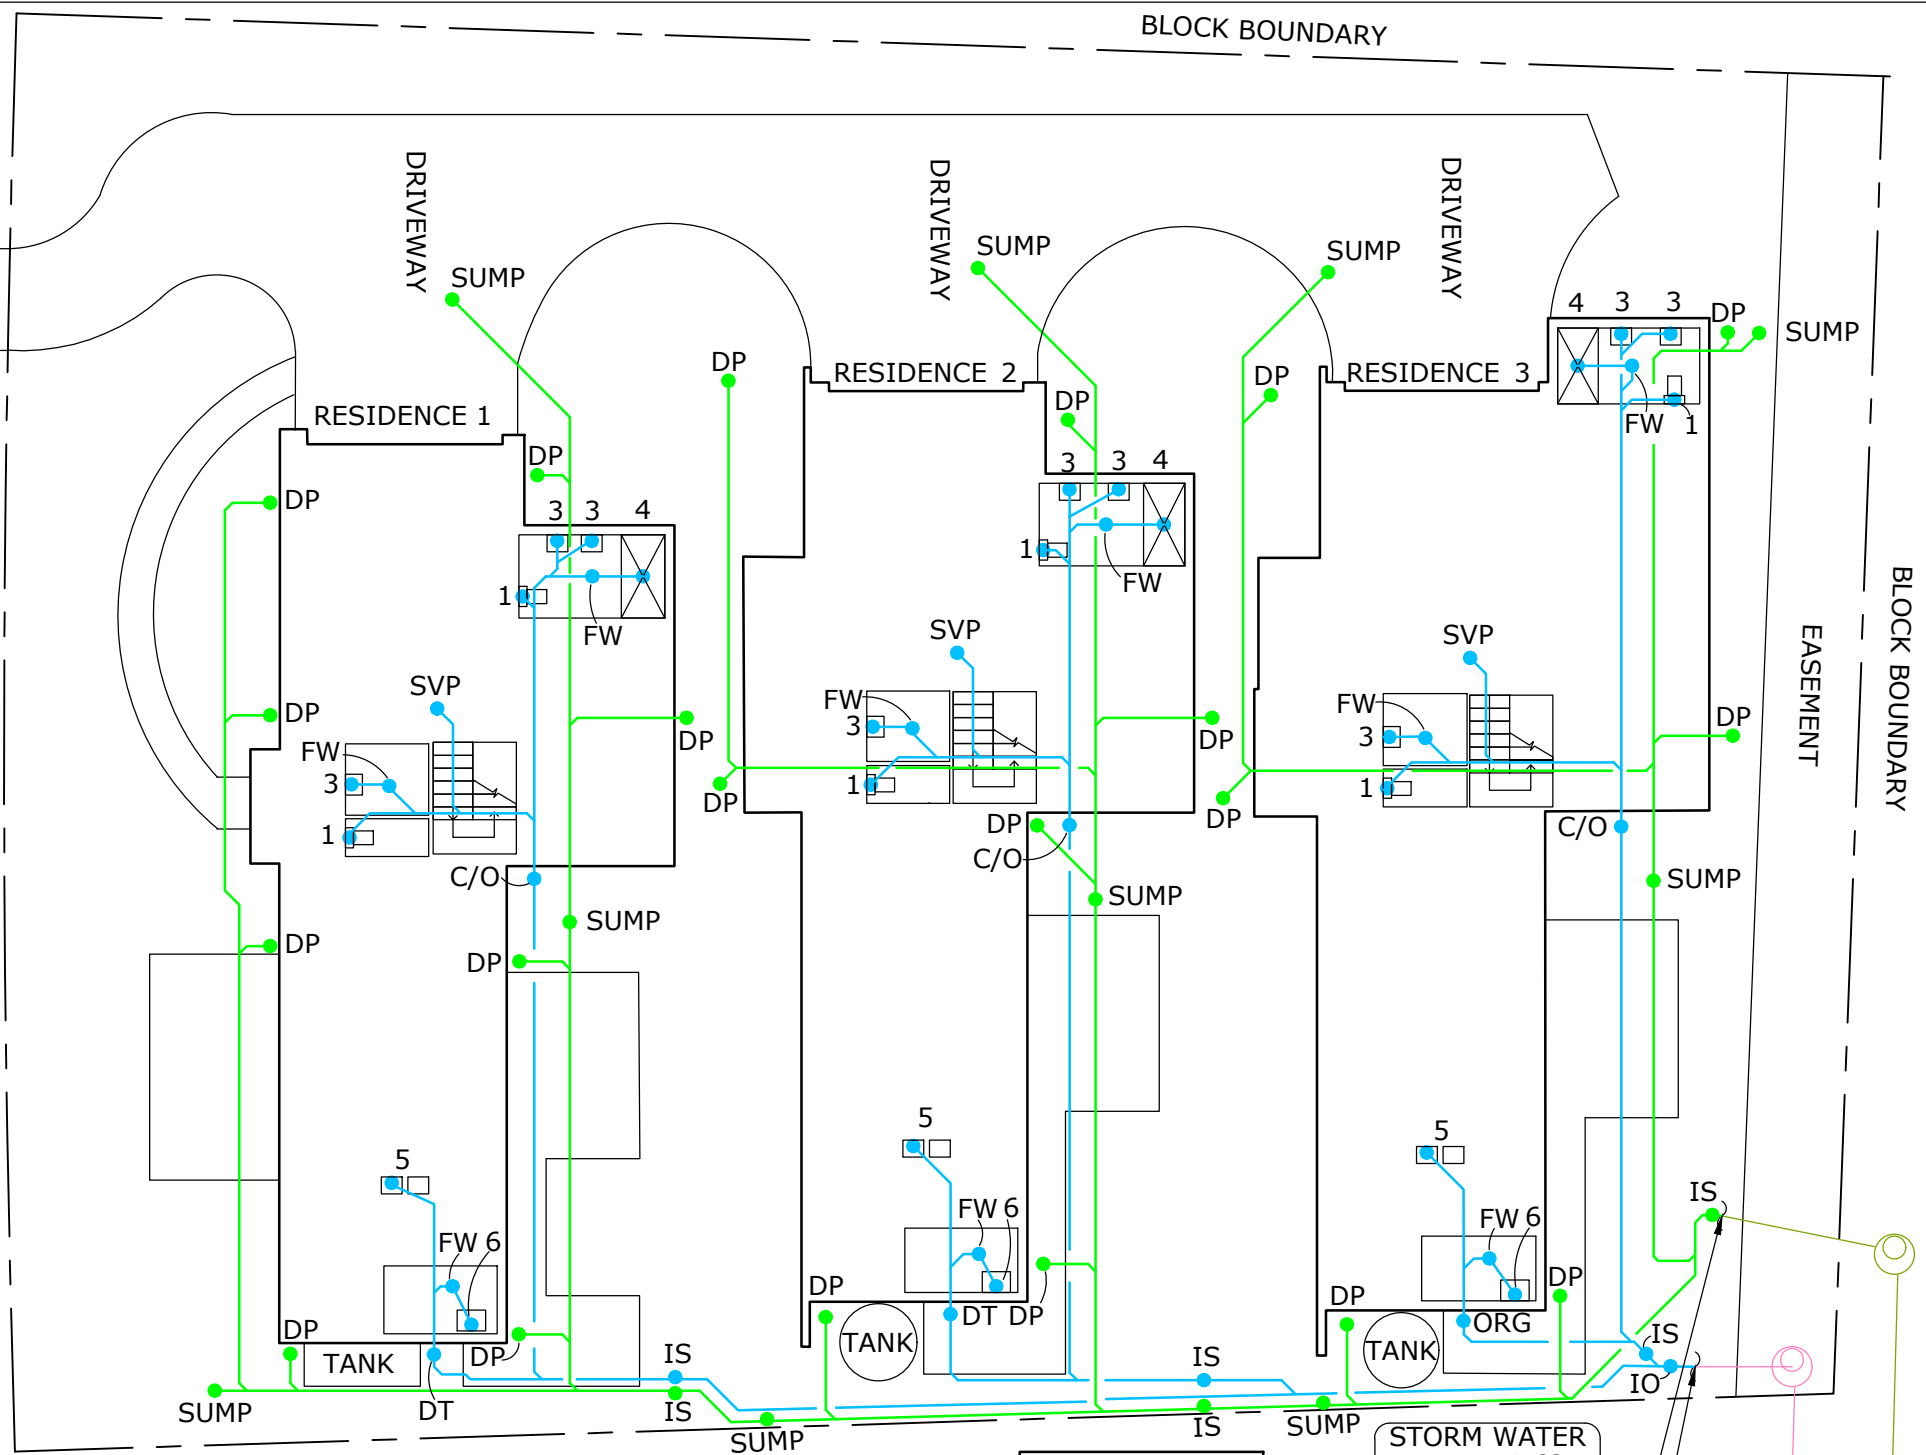
1. DRAINS TO BE LAID SHOWN IN BLUE LINES
2. EXISTING DRAINS SHOWN IN GREEN LINES
3. EXISTING DRAINS X'ED IN RED TO BE ABOLISHED TO APPROVAL
4. DRAINS TO BE SUPPORTED ON OR FROM SOLID GROUND
5. COPPER PIPES TO BE IN ACCORDANCE WITH AS.1432-1973 TABLE 2 TYPE B TUBES
6. UNPLASTICISED POLYVINYL CHLORIDE PIPE DRAIN (U.P.V.C) INCLUDING STACKS, TO BE CONSTRUCTED IN ACCORDANCE WITH AS.2032-997, AS.23500 AND CANBERRA CODE OF PRACTICE.
7. DRAINS UNDER BUILDING MUST BE RETESTED, IF TEST FAILED THEN OLD DRAIN MUST BE REPLACED USING EITHER RRJVC OR UPVC PIPE MATERIAL.
8. SEWER BRANCH TO BE LOCATED ON SITE BEFORE ANY WORK IS COMMENCED
9. THIS PLAN IS TO BE READ IN CONJUNCTION WITH APPROVED ARCHITECTURAL PLANS AND SPECIFICATION.
10. ORG LEVELS TO BE READ IN CONJUNCTION WITH AS.3500.2 CLAUSE 4.6.6.6 AND 4.6.6.7

STORM WATER  
TIE: 1.63m  
DEPTH: 0.91m  
CHANGE: --
