# Report

# Building Report

## CONCLUSION AND SUMMARY

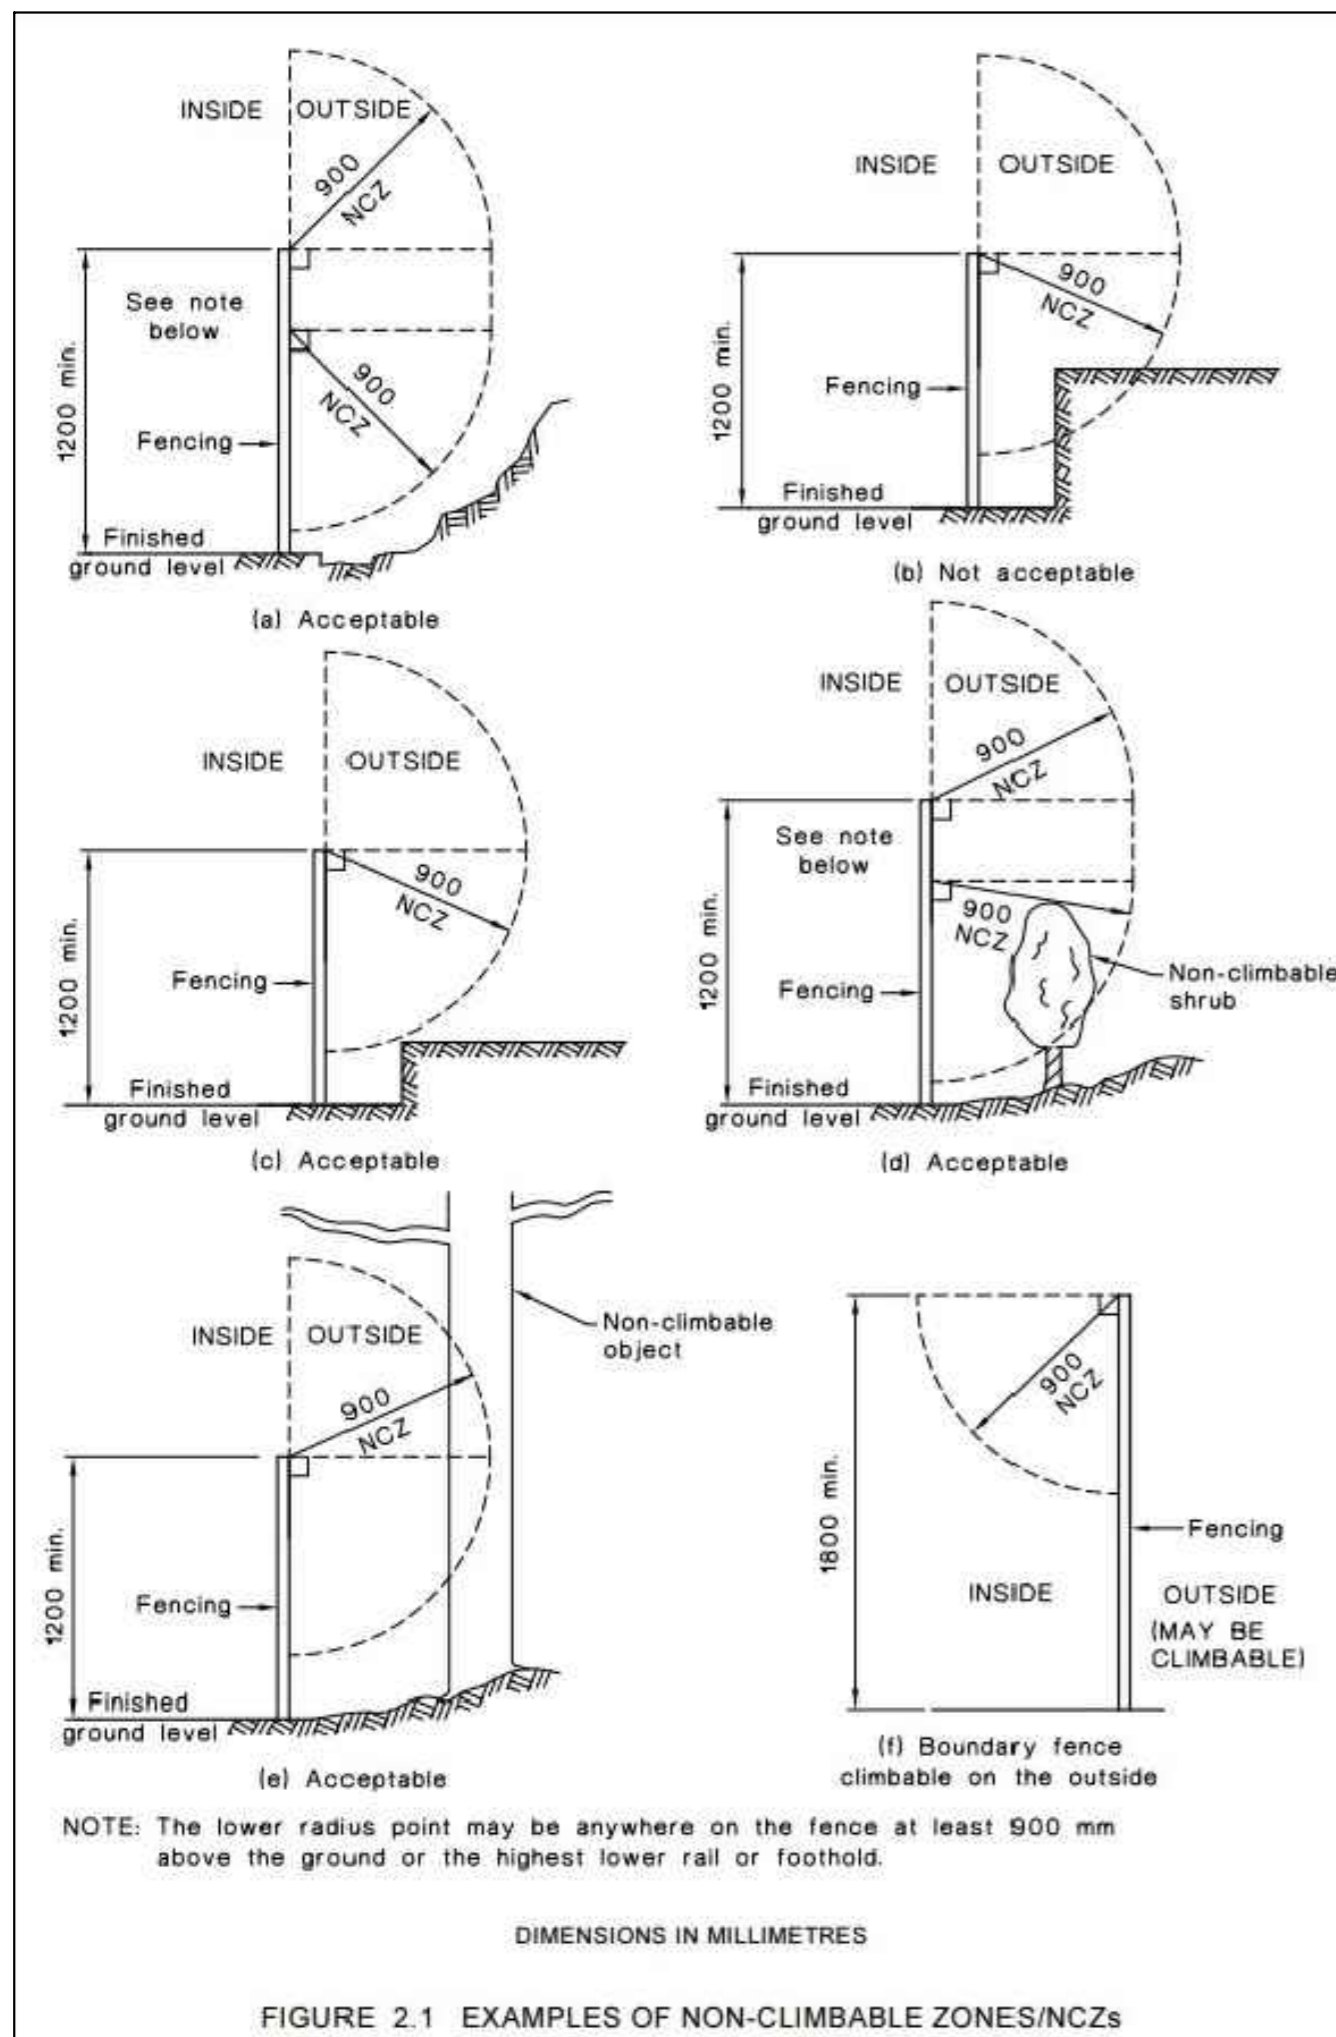
FIGURE 2.1 EXAMPLES OF NON-CLIMBABLE ZONES/NCZs
