Report

Building Report Residence 1

Building Report Residence 2

Property Address: 22 Meyers Place, MacGregor ACT 2615
Client: Ireland
Inspection Date: Friday, February 27th 2026
Inspection carried out by: Duncan Clark

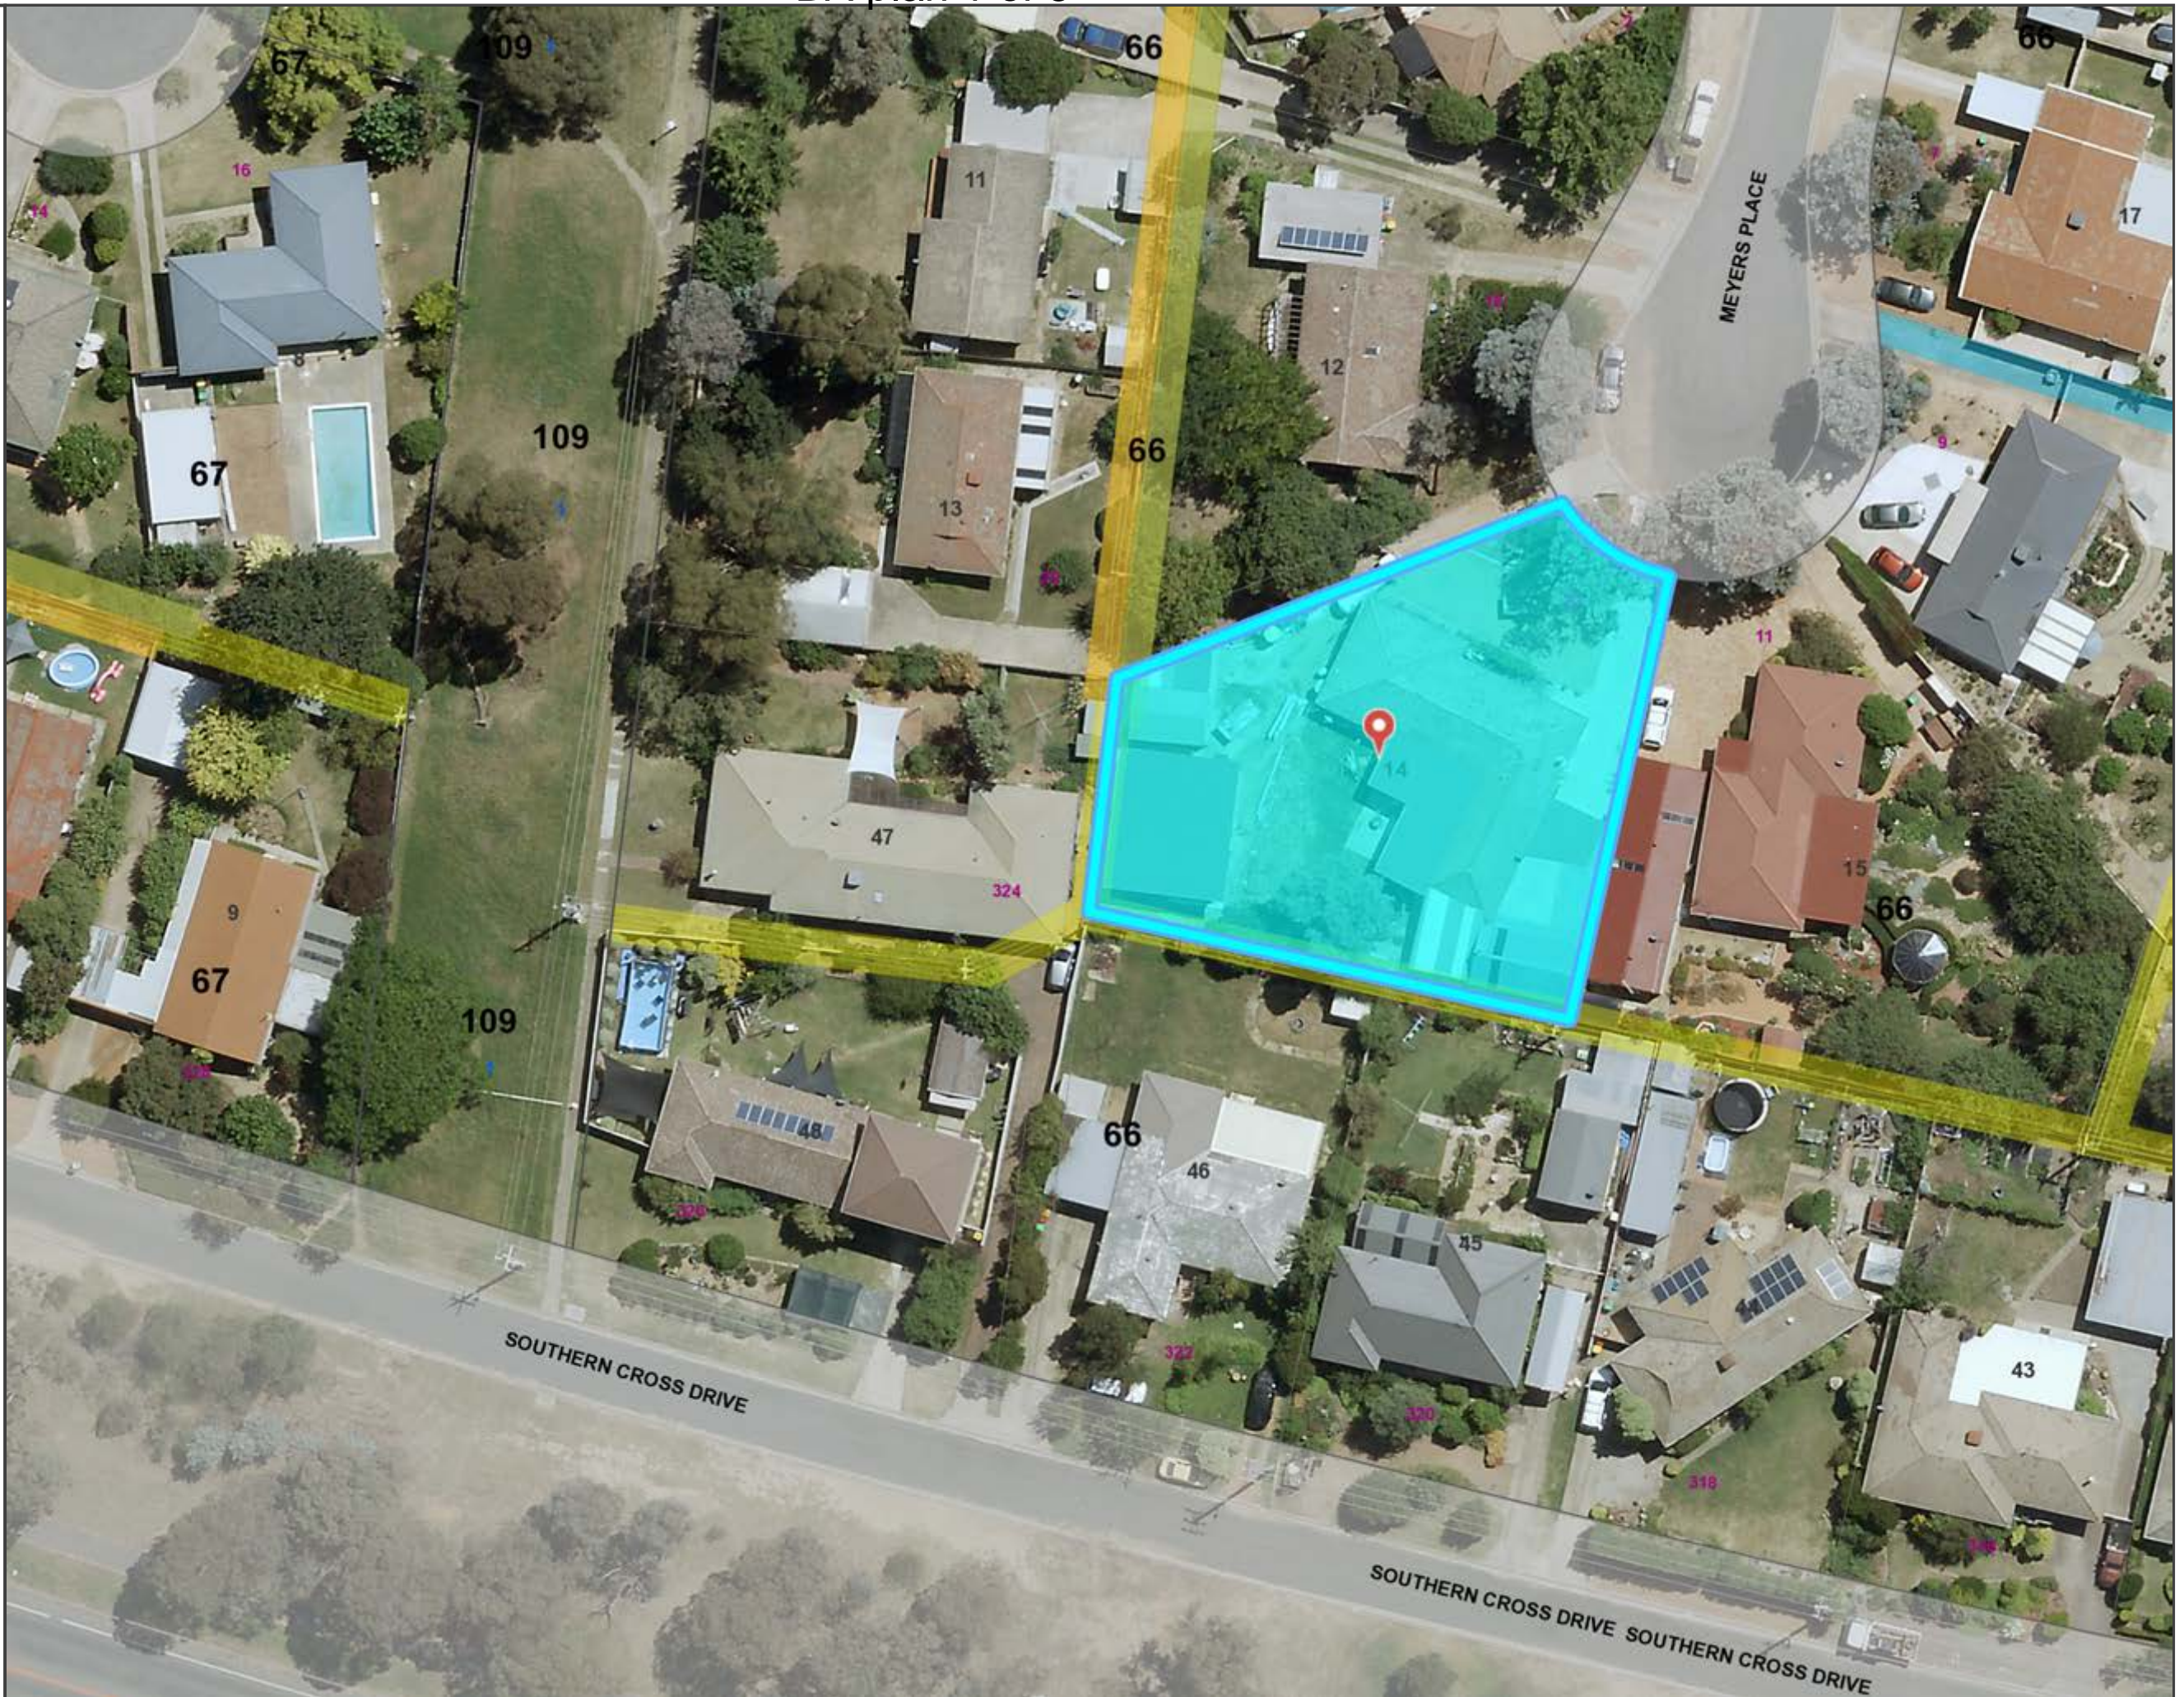
BA plan 2 of 3

Floor Plan
Macgregor
Block 14
Section 66

Location of Solid
Burning fuel
appliance

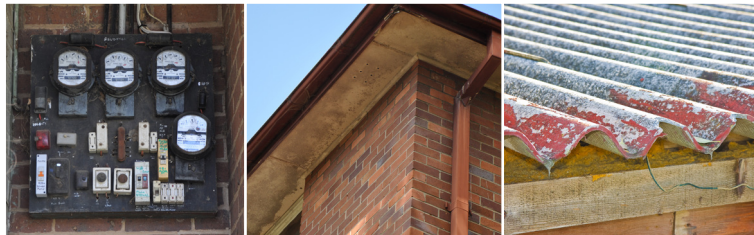
- 1.** Exterior
roof sheeting, gutters, downpipes,
ridge capping, eaves, cladding,
electrical switchboards
