# Report

# Building Report

## CONCLUSION AND SUMMARY

# Conveyancing File

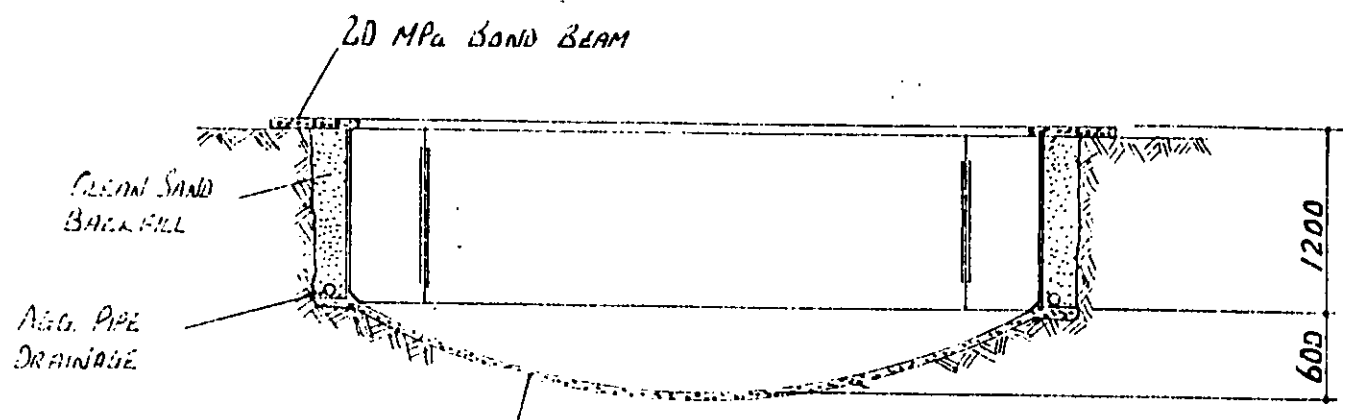
CROSS SECTION.

20 MPa POOL MIX  
 CONCRETE BASE

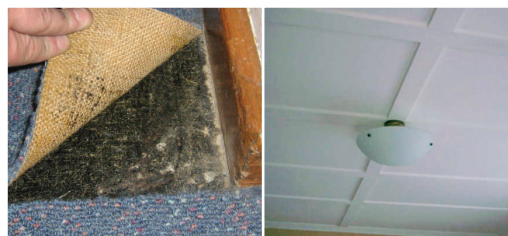
- 3.** Internal areas  
wall and ceiling panels, carpet underlay,  
textured panels, insulation in domestic  
heaters
