Report

Building Report

CONCLUSION AND SUMMARY

Property Address: 34 Collier Street, Curtin ACT 2605
Client: Zhang & Wang
Inspection Date: Tuesday, March 17th 2026
Inspection carried out by: Ben Halse

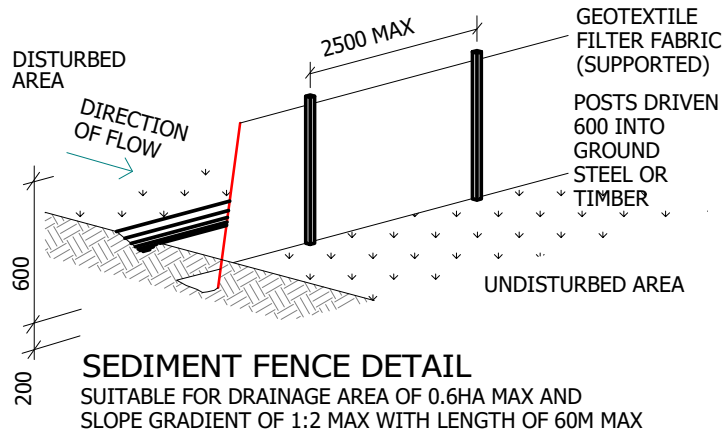
INSTALL SEDIMENT CONTROL STRUCTURES IN LOCATIONS INDICATED ON THIS DRAWING AND AS OTHERWISE REQUIRED TO CONTROL SEDIMENT DURING ALL EXCAVATIONS AND WHILST AREAS OF THE SITE ARE EXPOSED TO EROSION. REVIEW CONTROL MEASURES AND MAINTAIN STRUCTURES DURING CONSTRUCTION.

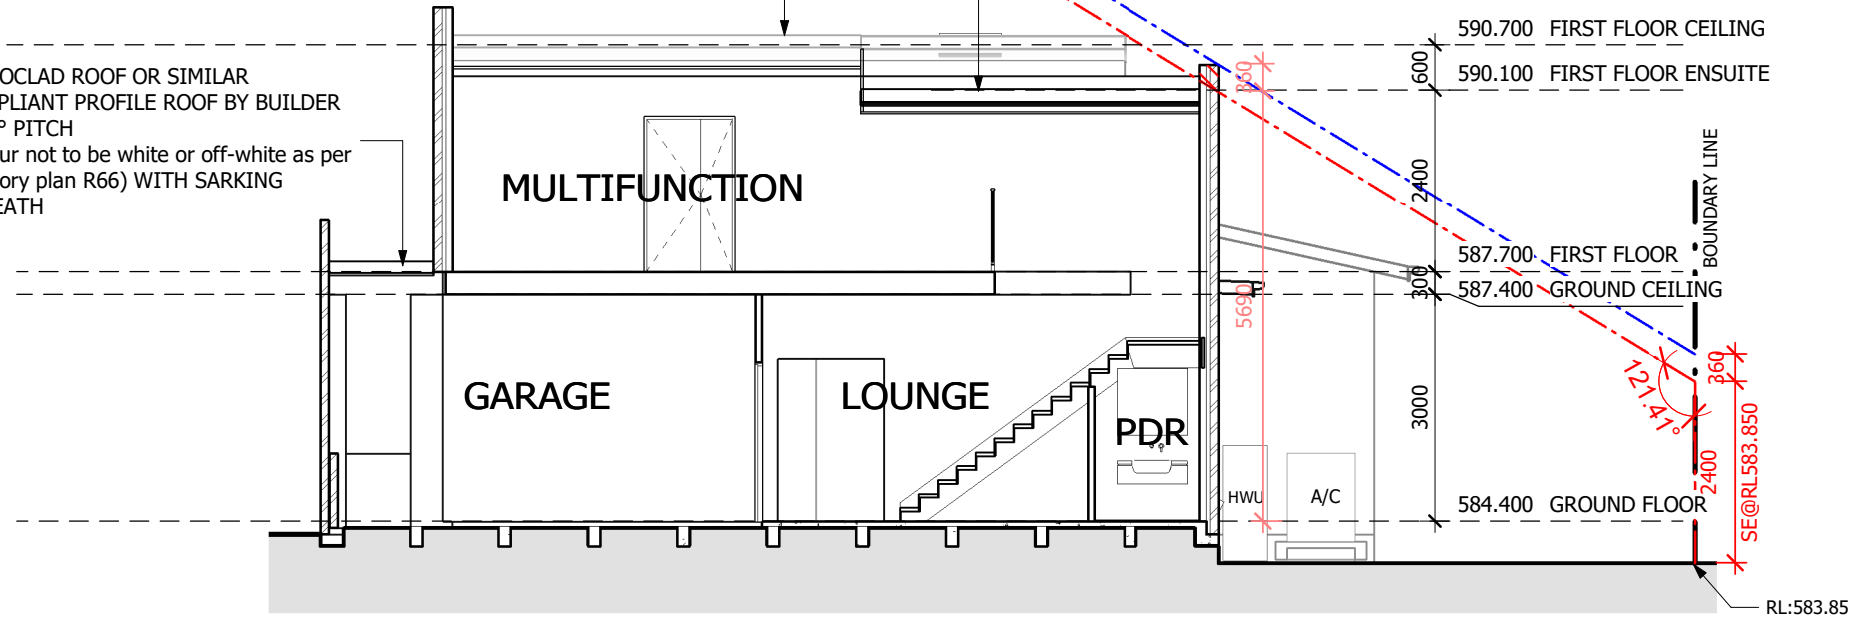
SECTION A-A

MONOCLAD ROOF OR SIMILAR COMPLIANT PROFILE ROOF BY BUILDER @ 2° PITCH (colour not to be white or off-white as per territory plan R66) WITH SARKING BENEATH

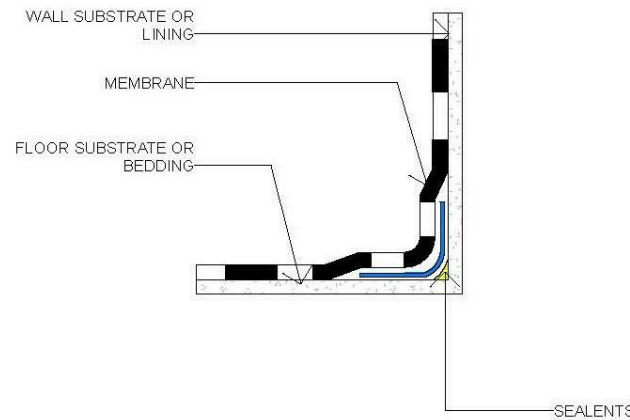
TYPICAL BOND BREAKER CLASS II

INSTALLATION OF THE WATERPROOFING TO THE INTERNAL WET AREAS AND EXTERNAL AREAS TO BE CARRIED OUT IN ACCORDANCE WITH AUSTRALIAN STANDARD 3740-2021 AND THE BUILDING CODE OF AUSTRALIA VOLUME 2, CLAUSE H4D2 THE PRODUCT USED COMPLIES WITH AS/NZS 4654.1:2012; THE INSTALLATION IS IN ACCORDANCE WITH AS/NZS 4654.2:2012. WATER PROOF PRODUCT OR COMPOUND USED : FILLET AND BOND BREAKER USED : NUMBER OF COATS APPLIED :

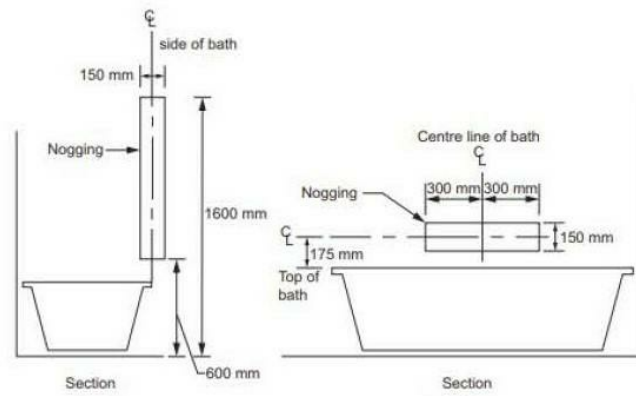
Figure 6.2a: Location of noggings for walls surrounding a bath

- (1) Taps, bath niches, soap holders and the like may be located within the positions designated for wall reinforcing.
- (2) Where the height of the bathtub is not yet known, an assumed height of 500 mm above finished floor level may be used to determine the location of wall reinforcing.

- (1) Reinforcing constructed in accordance with the requirements of (3) must be provided in the locations depicted in—
 - (a) Figures 6.2a or 6.2b for walls surrounding a bath; and

- (a) A minimum of 12 mm thick structural grade plywood, or similar.
 - (b) Timber noggings with a minimum thickness of 25 mm.

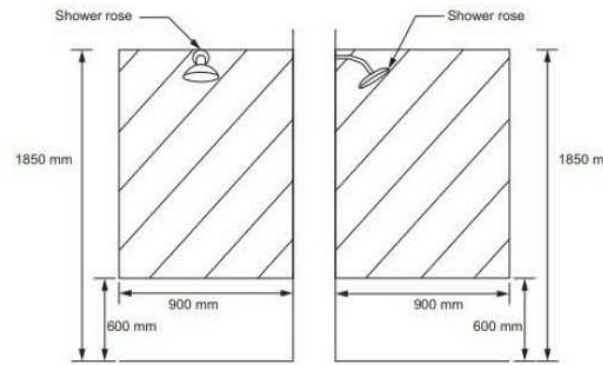
Figure 6.2d: Location of sheeting for shower walls

- (b) Figures 6.2c or 6.2d for shower walls; and
 - (c) Figure 6.2e for a wall adjacent to and within 460 mm of the centreline of a toilet pan; and
 - (d) Figures 6.2f or 6.2g for a wall behind a toilet pan where a wall described in (c) is not provided or a window sill or a door encroaches on the area required to be provided with reinforcing or where the toilet pan is not provided in a corner of the bathroom.

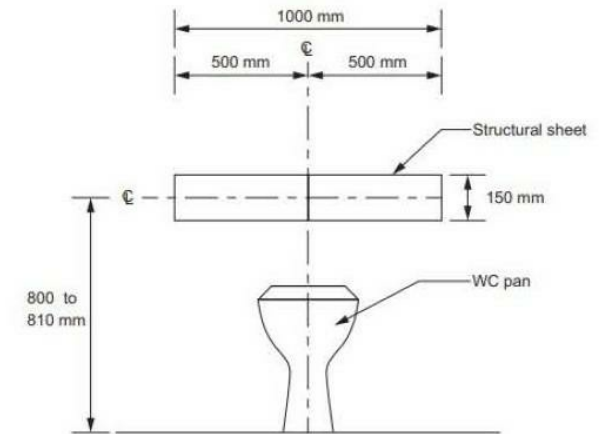
Figure 6.2f: Location of noggings for a wall behind a toilet pan

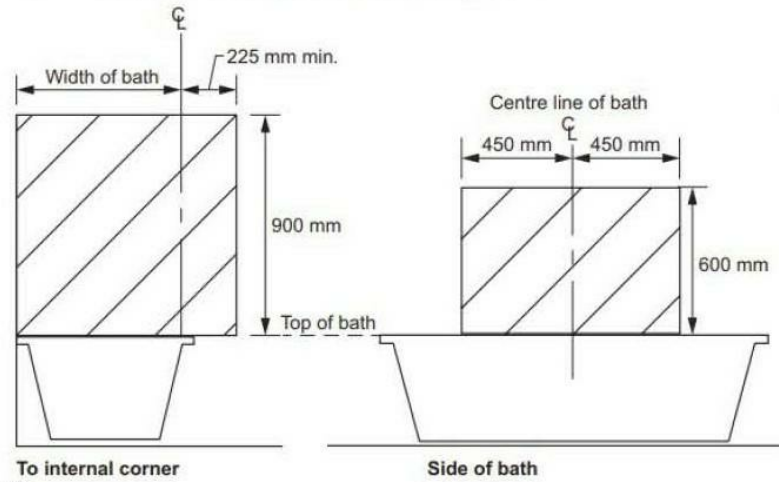
Figure 6.2b: Location of sheeting for walls surrounding a bath

- (1) Taps, bath niches, soap holders and the like may be located within the positions designated for wall reinforcing.
- (2) Where the height of the bathtub is not yet known, an assumed height of 500 mm above finished floor level may be used to determine the location of wall reinforcing.

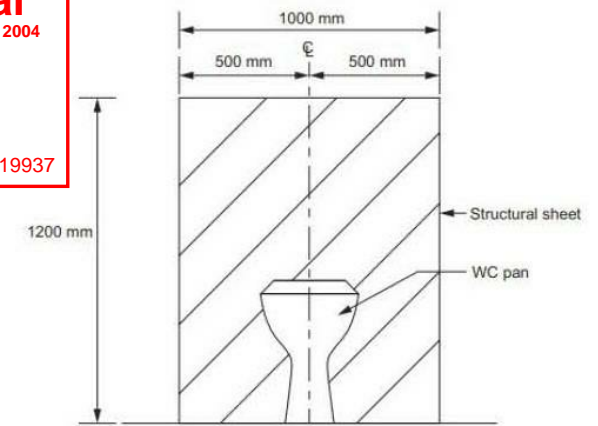
Figure 6.2g: Location of sheeting for a wall behind a toilet pan

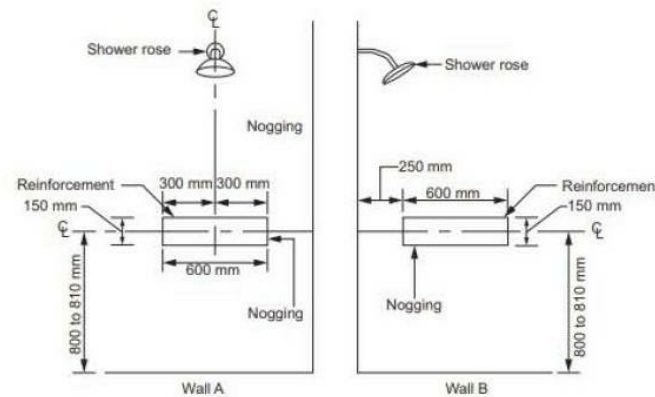
Figure 6.2c: Location of noggings for shower walls

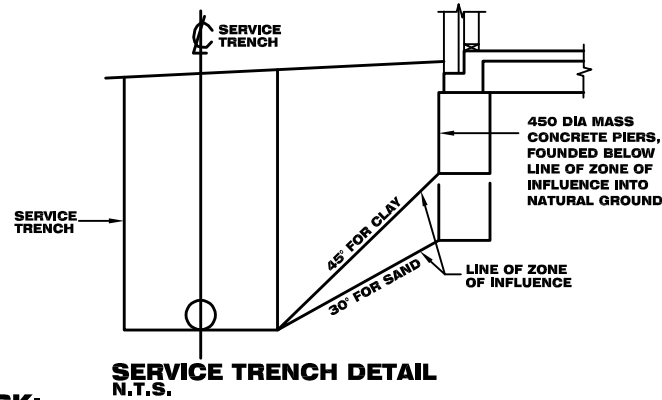
- F.7 TOP SOIL CONTAINING GRASS ROOTS OR OTHER ORGANIC MATERIAL SHALL BE REMOVED FROM THE AREA ON WHICH THE SLAB IS TO REST.
- F.8 IF ANY FOOTING IS LOCATED SUCH THAT A LINE DRAWN AT 45 DEGREES FOR CLAY AND 30 DEGREES FOR SAND FROM ITS BASE INTERSECTS A SERVICE TRENCH THEN PIERS ARE REQUIRED AS PER DETAIL BELOW.

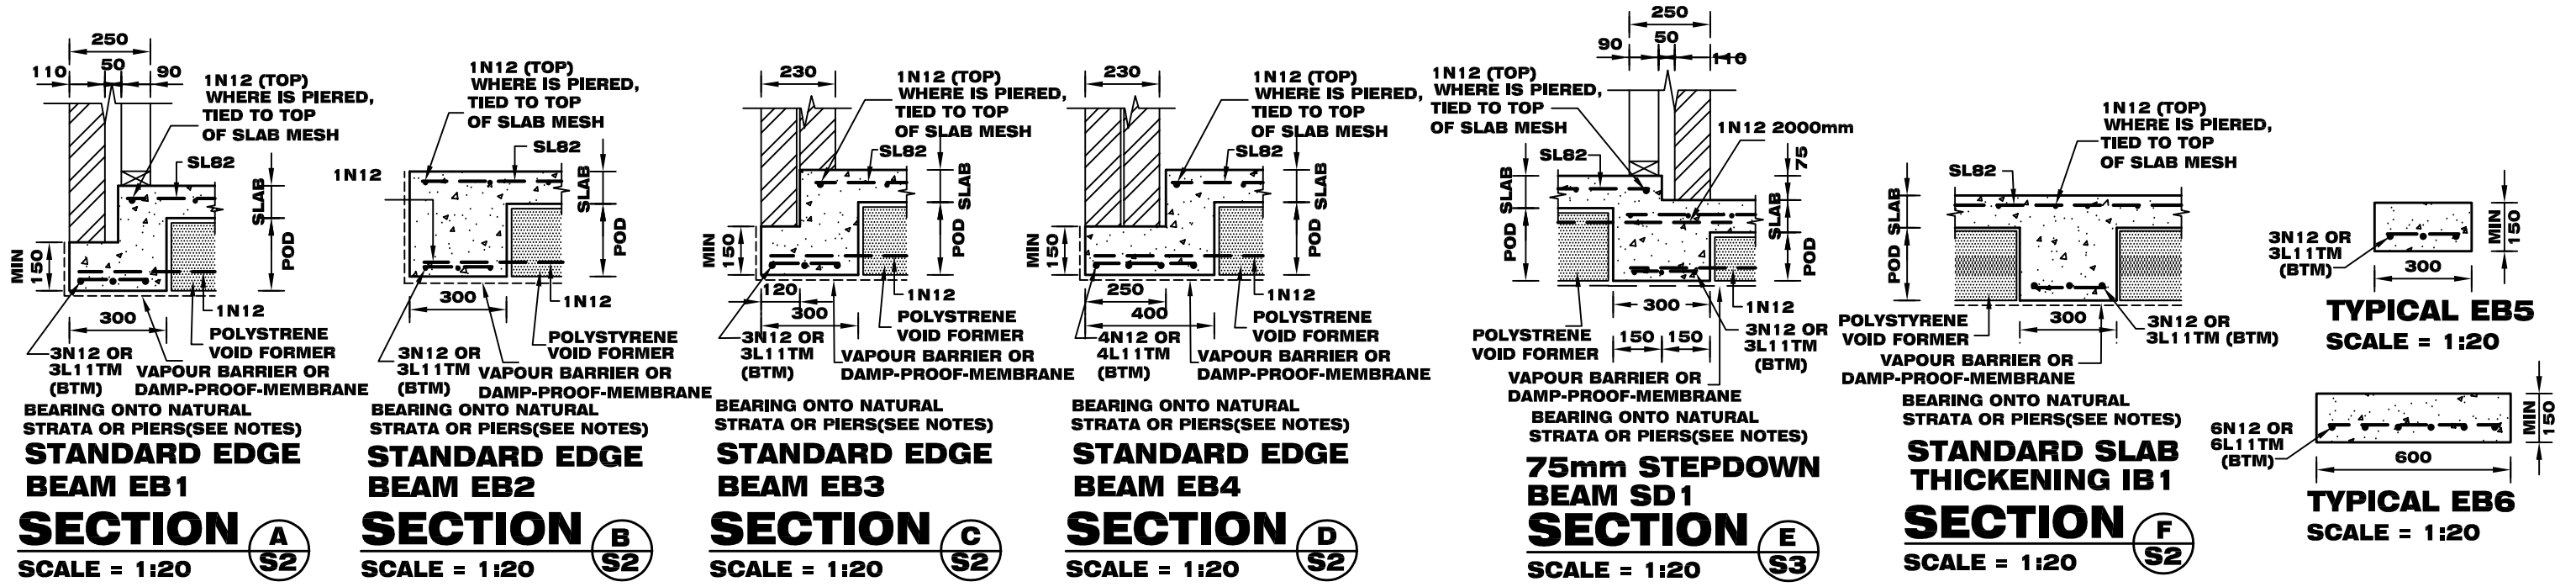
STANDARD EDGE BEAM EB1 SECTION A
SCALE = 1:20

STANDARD EDGE BEAM EB2 SECTION B
SCALE = 1:20

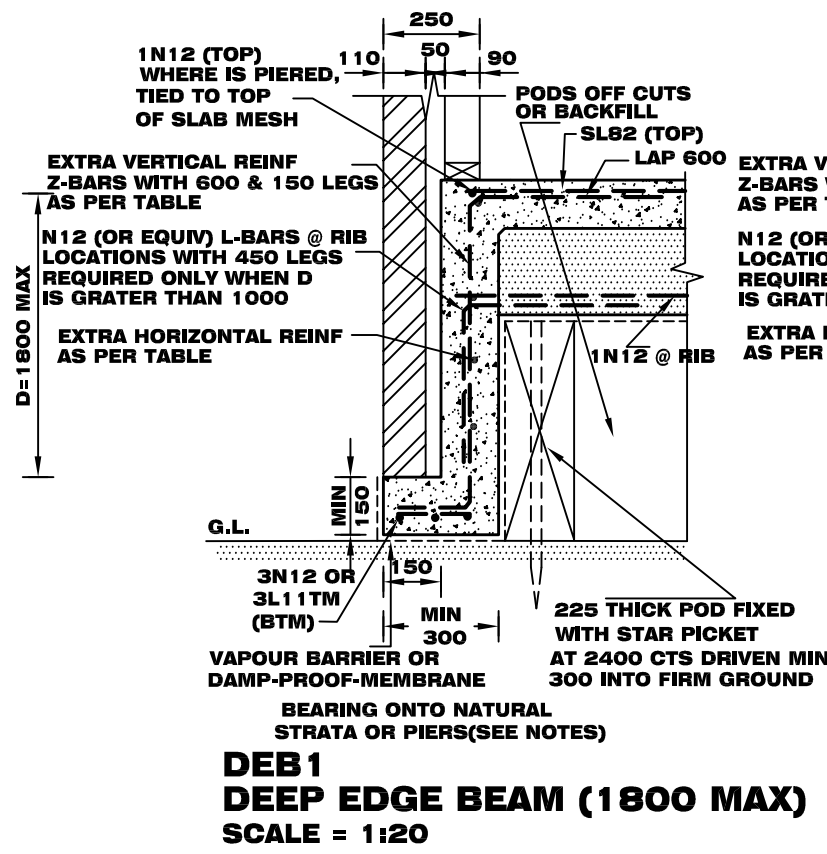
DEB1 DEEP EDGE BEAM (1800 MAX) SCALE = 1:20

EXTRA REINFORCEMENT TO DEEP EDGE & DEEP STEP BEAM		
DEPTH 'D'	EXTRA VERTICAL REINFORCEMENT	EXTRA HORIZONTAL REINFORCEMENT
'D' IS LESS THAN 400	NONE	NONE
'D' IS BETWEEN 401 & 900	N12 @400CTS	N12 @400CTS
'D' IS BETWEEN 901 & 1200	N12 @300CTS	N12 @400CTS
'D' IS BETWEEN 1201 & 1800	N12 @200CTS	N12 @300CTS

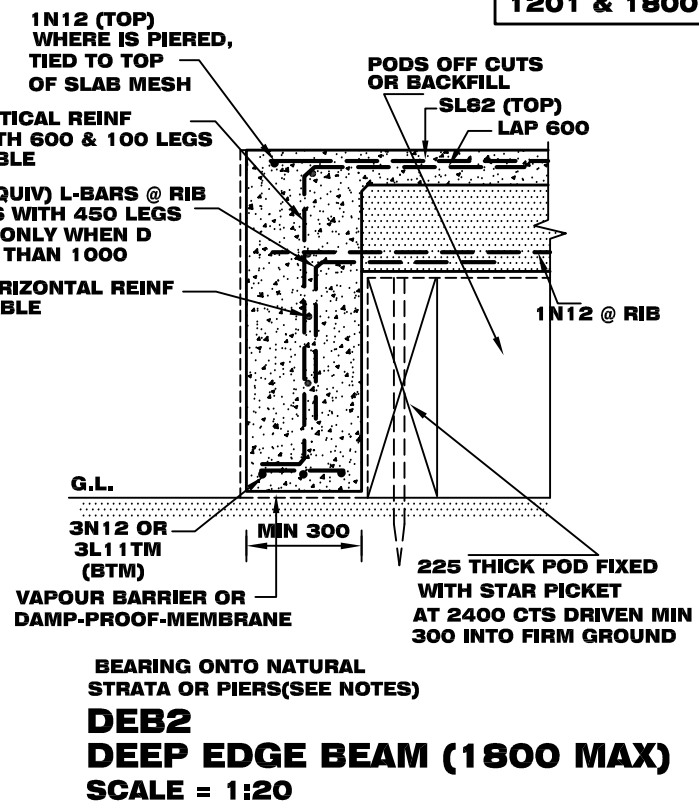
DEB2 DEEP EDGE BEAM (1800 MAX) SCALE = 1:20

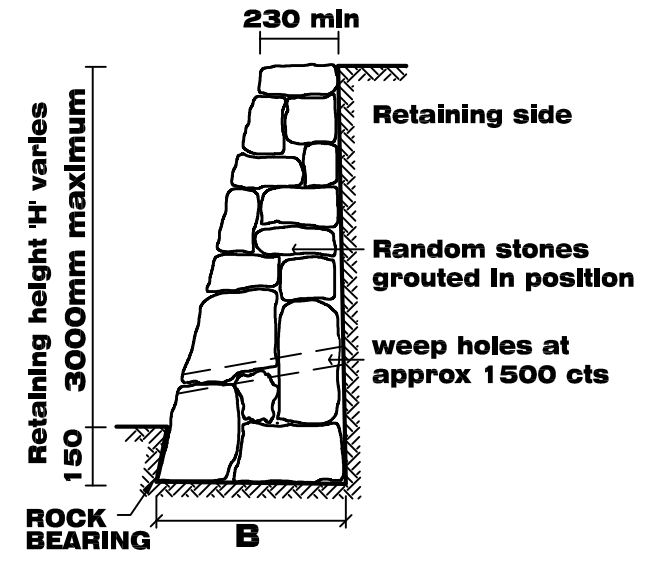
B: For wall retaining fill = 'H' x 0.45
SRW TYPICAL STONE RETAINING WALL SCALE = 1:20

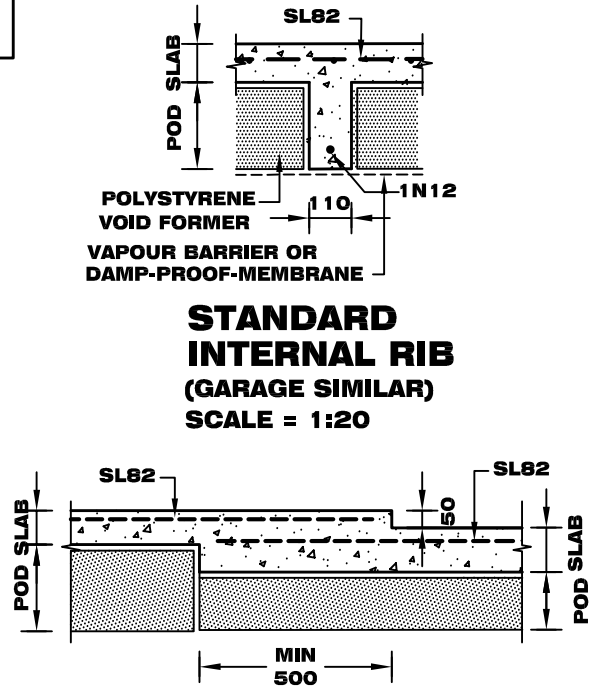
STANDARD INTERNAL RIB (GARAGE SIMILAR) SCALE = 1:20
WET AREAS 50mm SLAB SETDOWN DETAIL SCALE = 1:20

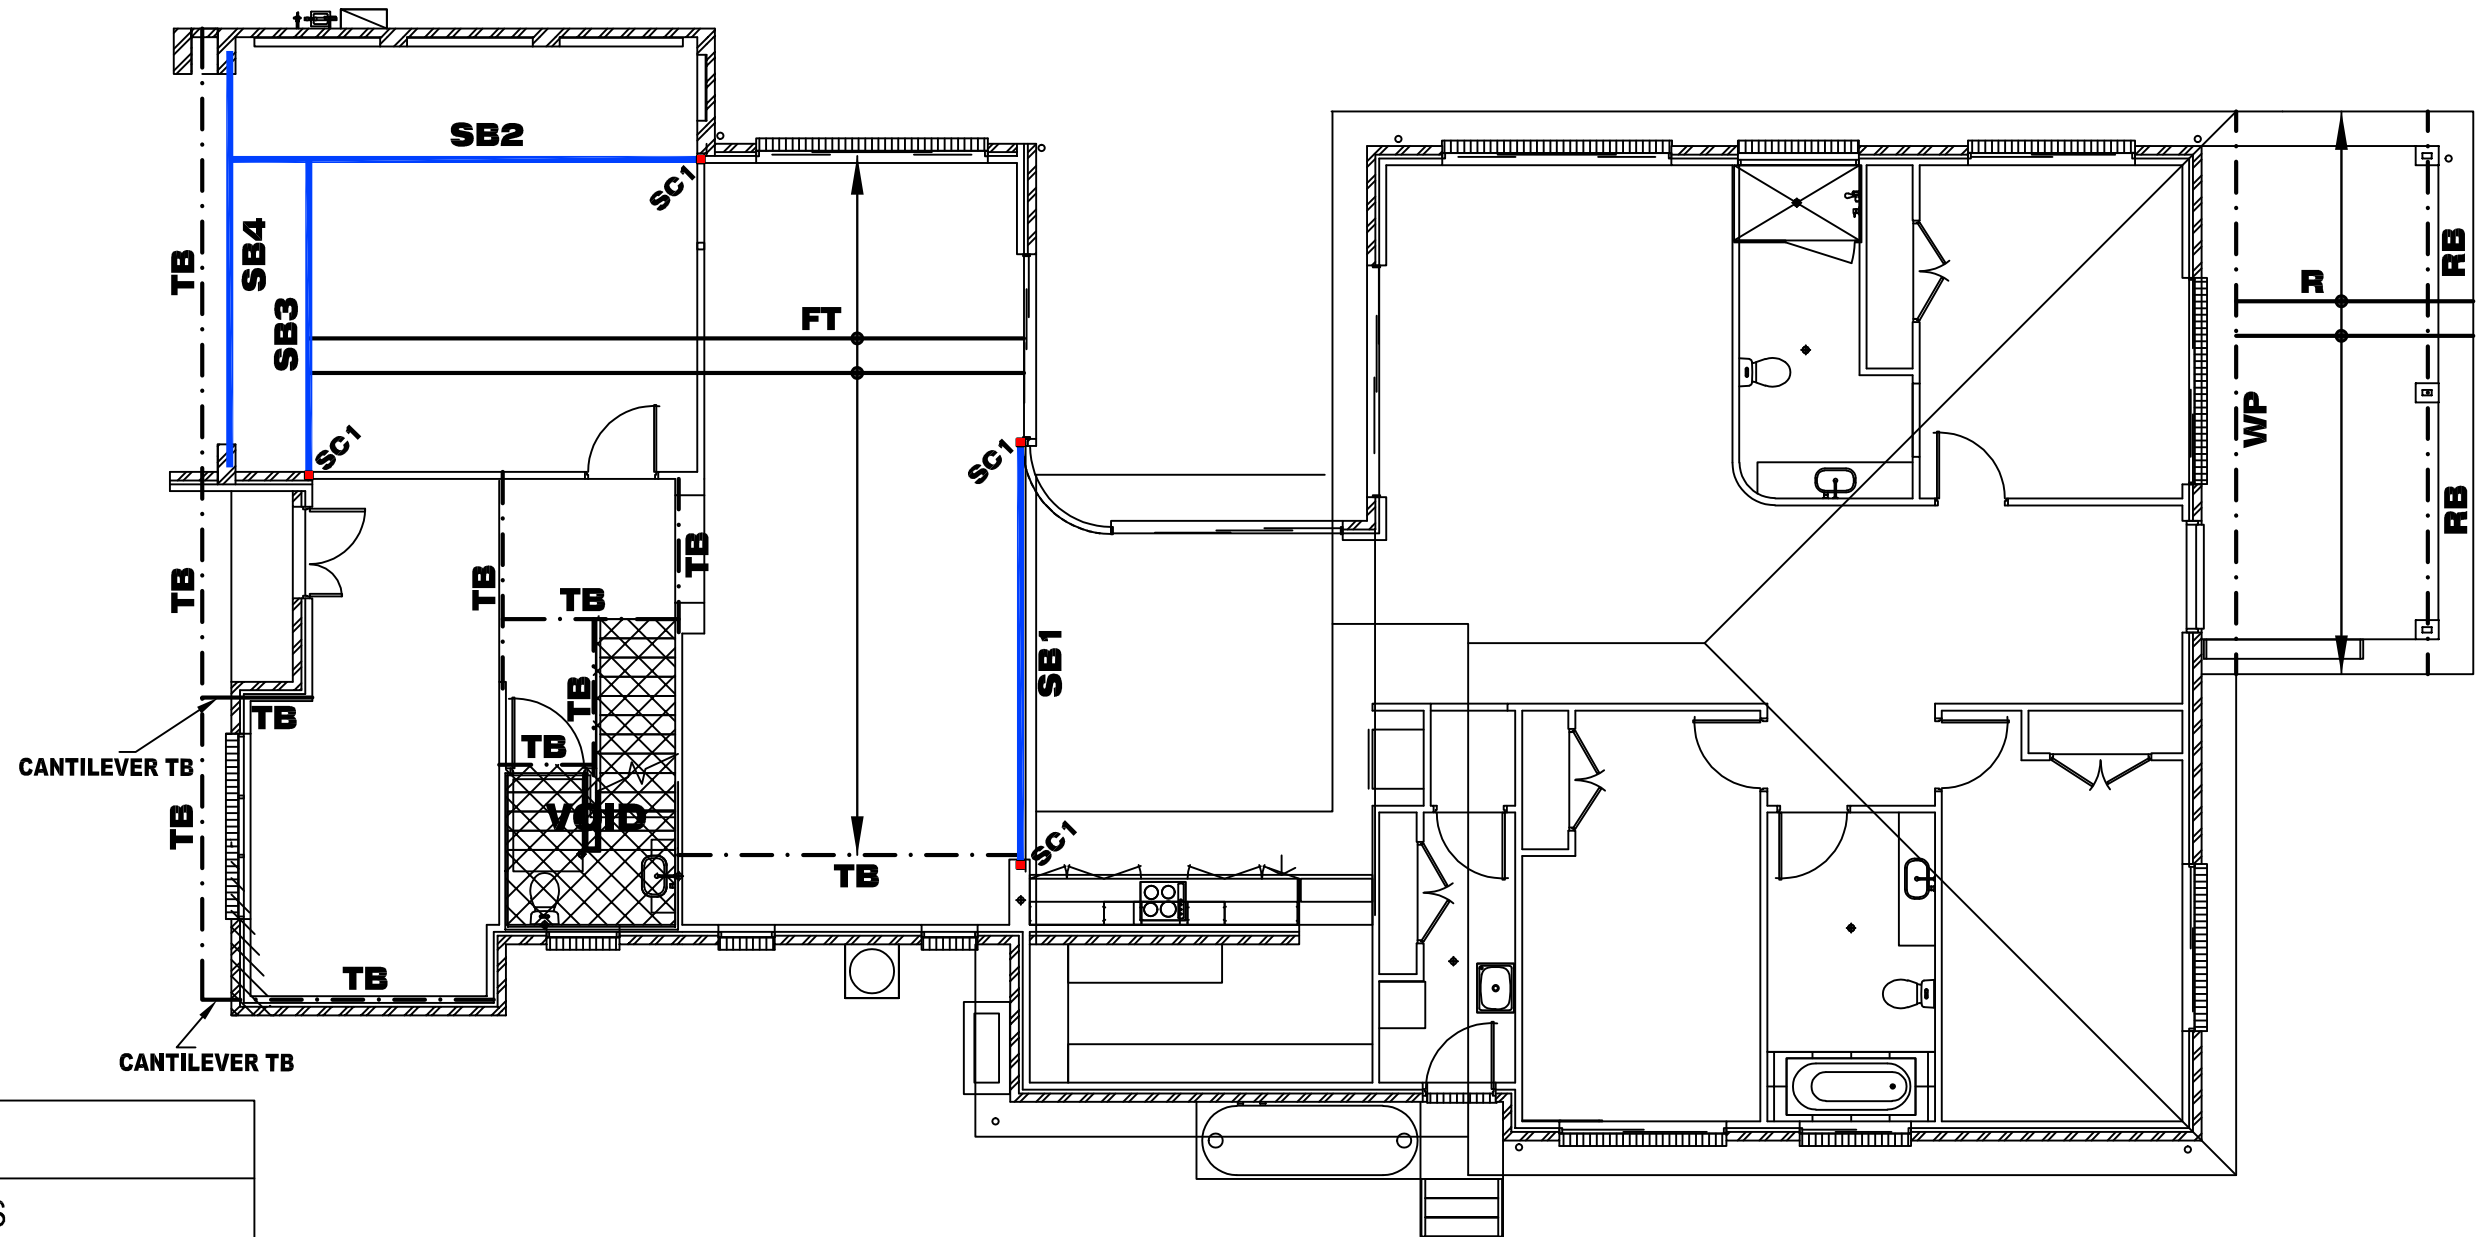
JOISTS & BEAM LAYOUT

MARK	SIZE	REMARKS
SB1	300 PFC FLOOR BEAM	
SB2	300 PFC FLOOR BEAM	
SB3	300 PFC FLOOR BEAM	
SB4	300 PFC+ 200X10 BASE PLATE GARAGE LINTEL, MIN 300mm END BEARING EACH END	
TB	TRUSS BEAM TO MANU. SPEC.	
SC1	89X89X5 SHS	-
FT	FLOOR TRUSS TO MANU. SPEC.	
RB	ROOF BEAM 140X45 MGP12 OR 150X45 LVL	
WP	WALING PLATE 120X35 MGP10	
R	RAFTER 120X35 MGP10 @ 900mm CTS.

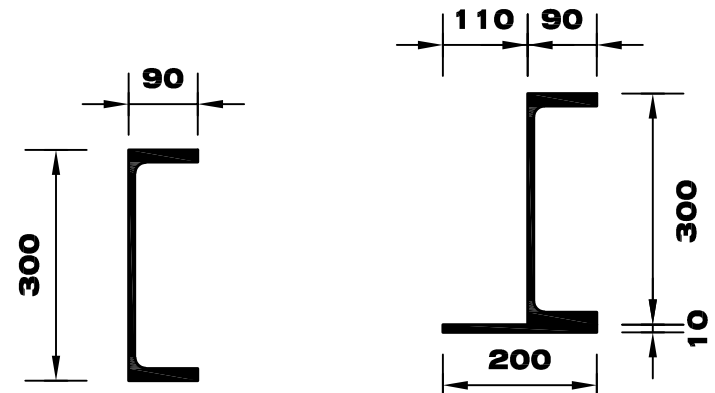
BEAM SB1, SB2 & SB3
300 PFC
SCALE 1:10

BEAM SB4
300 PFC+
200X10 BASE PLATE
SCALE 1:10
