# Report

# Building Report

<b>PROJECT NAME:</b> PROPOSED NEW RESIDENCE	<b>BLOCK:</b> 6 <b>SECTION:</b> 45	<b>SUBURB:</b> THROSBY
--	------------------------------------	------------------------

<b>PROJECT NAME:</b> PROPOSED NEW RESIDENCE	<b>BLOCK:</b> 6 <b>SECTION:</b> 45 <b>SUBURB:</b> THROSBY	<b>TITLE:</b> GROUND FLOOR PLAN	<b>CLIENT:</b> Lingjian Weng 46 of 72	<b>SCALE:</b> 1 : 100@A3	<b>DATE:</b> 14-12-2020	<b>DRAWN BY:</b> LEO.H	<b>JUST DESIGN</b> TEL: 0451 163 306 EMAIL: Info@astdesign.com.au
				<b>SHEET No.:</b> A 101	<b>JOB NO.:</b> WK	<b>CHECK BY:</b>

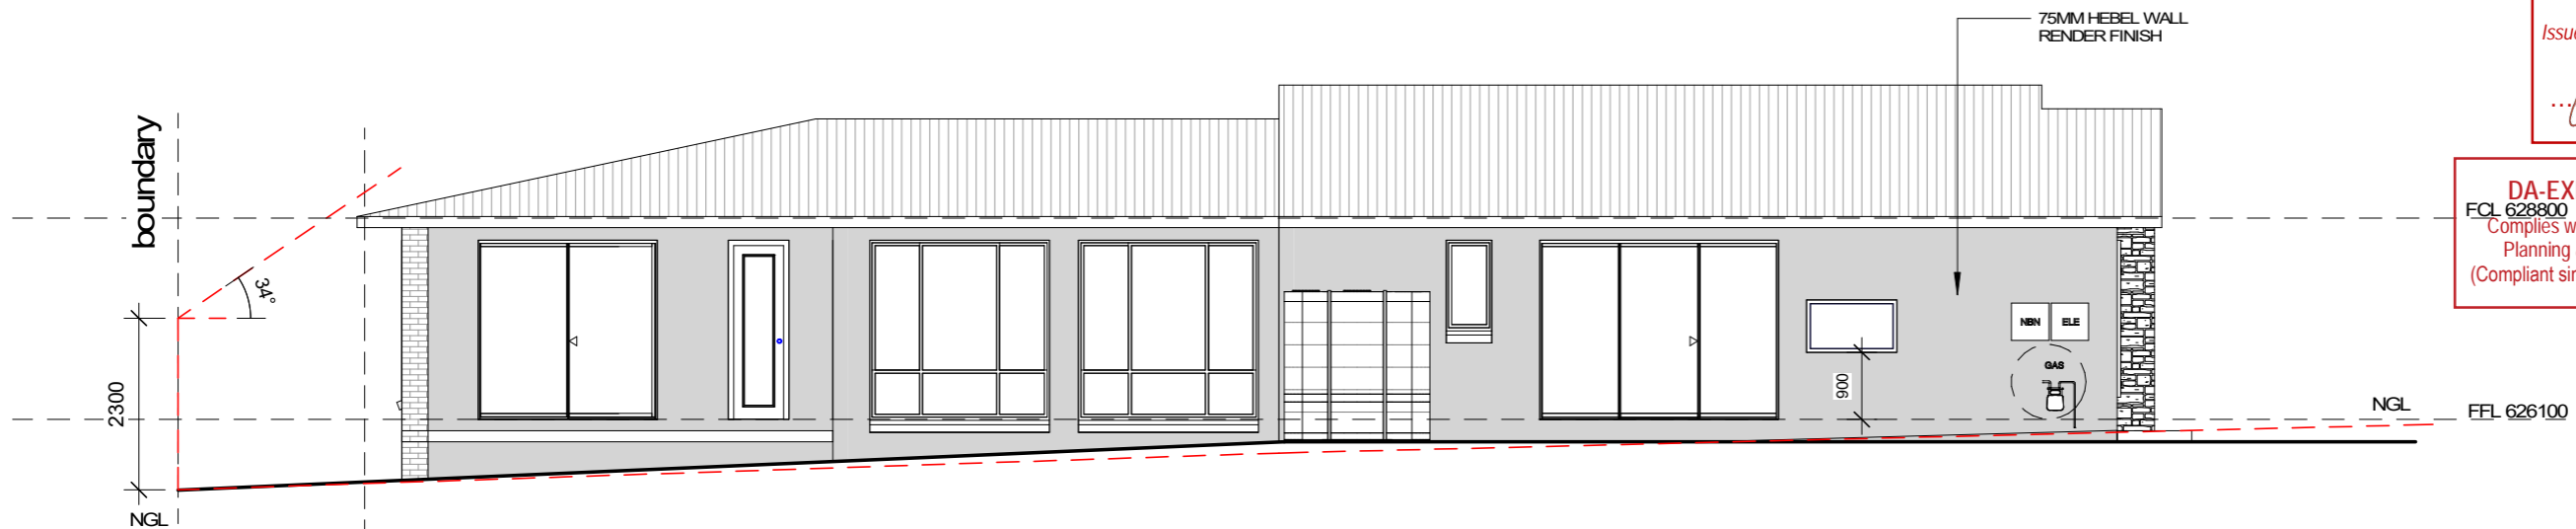
2 ELEVATION 1 : 100  
East Elevation

PROJECT NAME: PROPOSED NEW RESIDENCE	BLOCK: 6 SECTION: 45 SUBURB: THROSBY	TITLE: ELEVATIONS	CLIENT: Lingjian Weng 47 of 72	SCALE: 1 : 100@A3	DATE: 14-12-2020	DRAWN BY: LEO.H	JUST DESIGN TEL: 0451 163 306 EMAIL: Info@astdesign.com.au
				SHEET No: A 201	JOB NO: WK	CHECK BY:
