Report

Building Report

Property Address: 38 Max Purnell St, Forde ACT 2914
Client: Ladiges & Fan
Inspection Date: Tuesday, February 24th 2026
Inspection carried out by: Matthew McGuiness

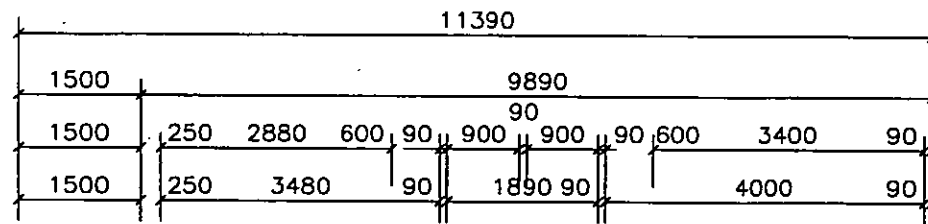
AREA 74.2 SQ M
 UPPER LIVING

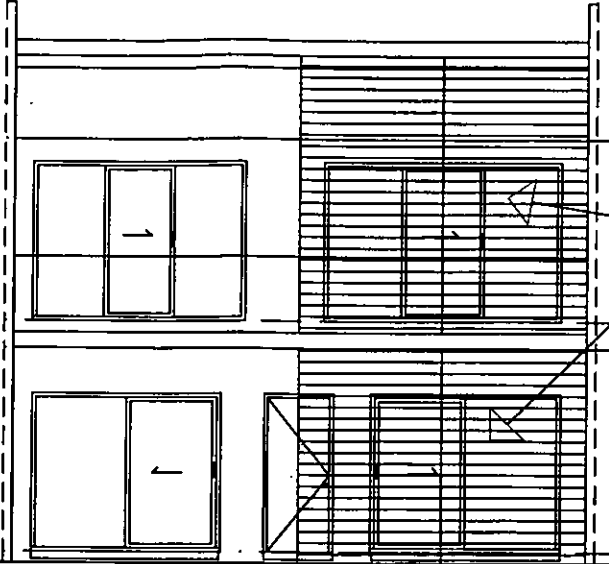
FRONT ELEVATION

SLAT LOUVRES TO 50%
OF BALCONY

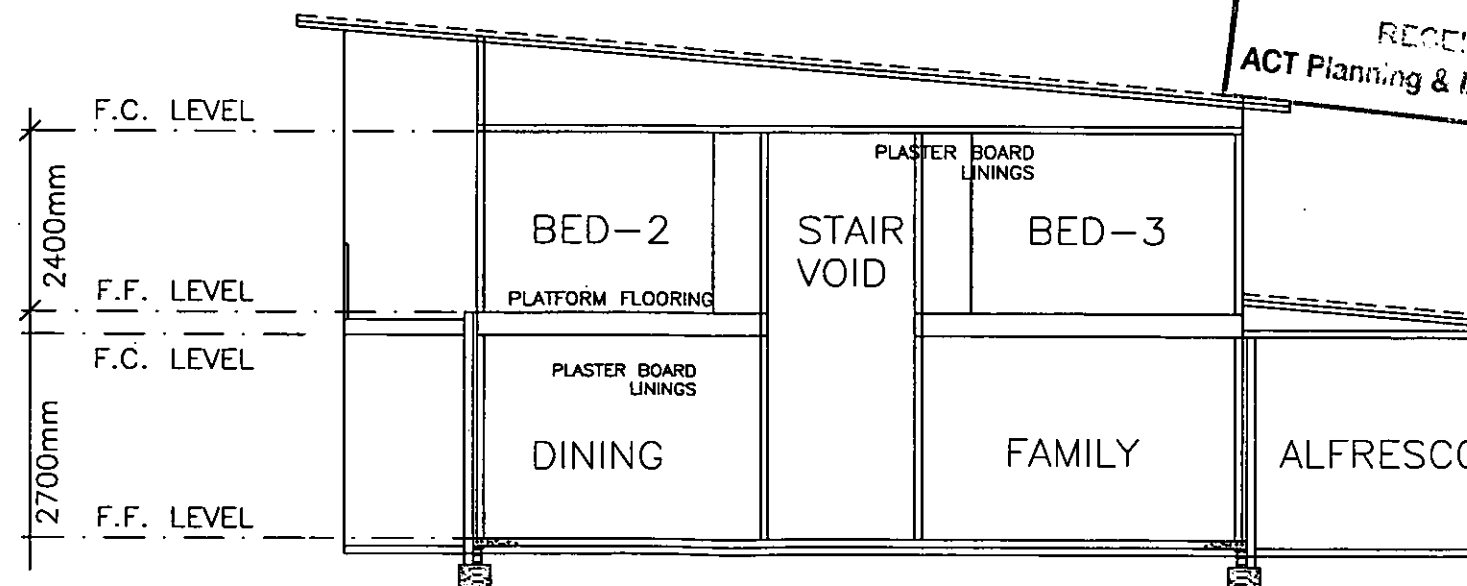
SECTION

COLOURBOND METAL ROOFING
 ON STD. A-TYPE ROOF TRUSSES
 AT 7.0 DEG. PITCH TO MANUFACT.
 SPECIFICATIONS

SLAB AND FOOTINGS TO ENGINEERS SPECIFICATION AND AS 2870.1
 PLATFORM FLOORING TO AS1684
