# Report

# Building Report

# Compliance Report

# Conveyancing File

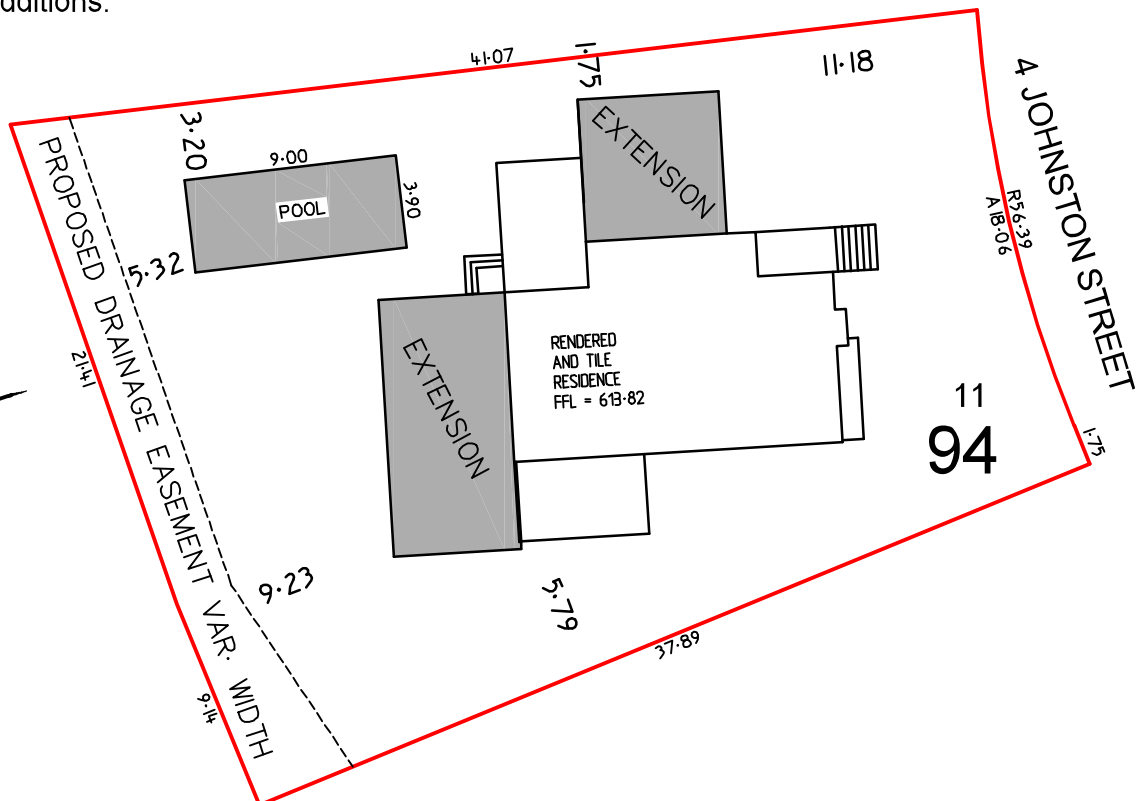
As instructed by you, we have surveyed for identification purposes only, part of the land being Block 11, Section 94, Narrabundah with a frontage to Johnston Street, Narrabundah in the District of Canberra Central of the Australian Capital Territory

- The subject land is shown by red edging on the diagram.
- An easement for services affects the subject land.
- Standing upon and wholly within the boundaries of the subject land are two extensions and a pool under construction at floor level.
- The relationship of the extensions and pool with respect to the boundaries is as indicated on the diagram.
- This survey report is with respect to the extensions and pool only.
- There has been no investigation for any subterranean encroachments.
- This survey report is for the purpose of obtaining a Building Certificate only and should not be used to set out future additions.

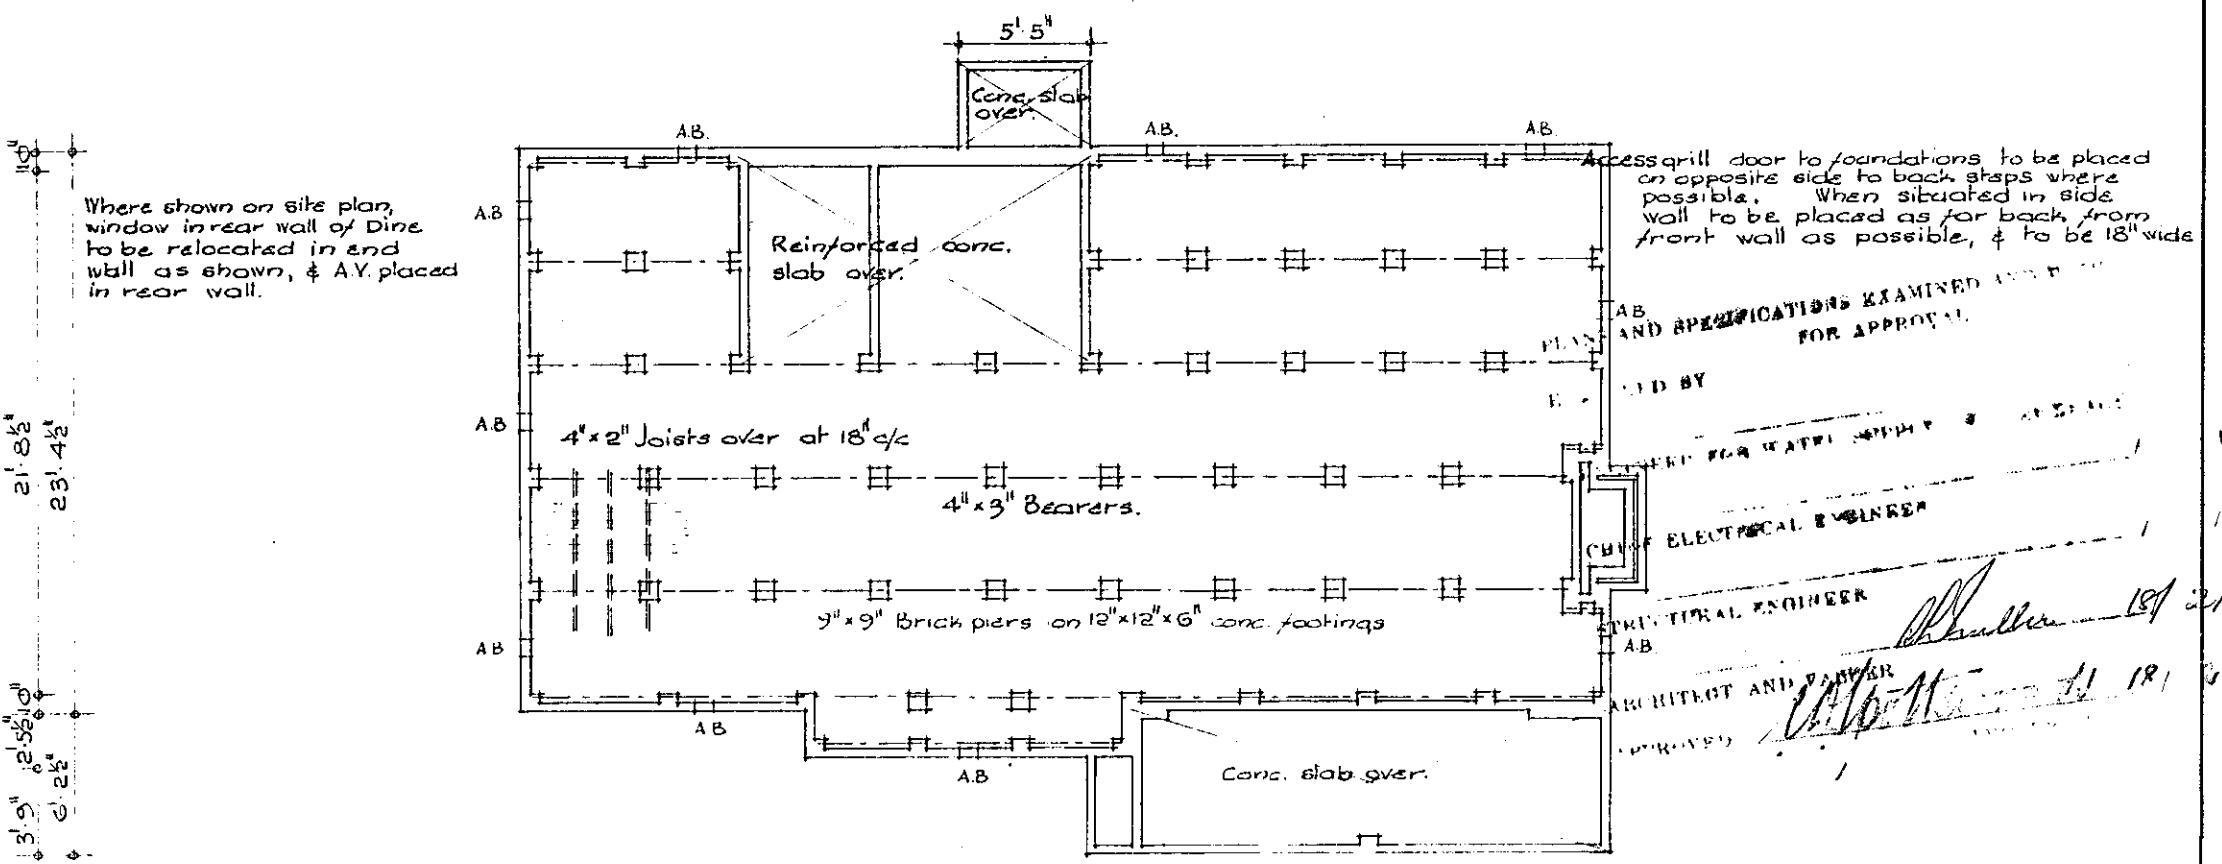
FOUNDATION PLAN

TYPE 3-22. LOT No. 11, SEC. 94, JOHNSTON ST. HARRABUNDAH.  
**'THE WIRRALL'** **BRICK VENEER HOUSE • CANBERRA • A.C.T.**  
 DRAWING No. 132.  
 DATE: SEPT. 1959  
 SCALE: 1/8" = 1'-0"

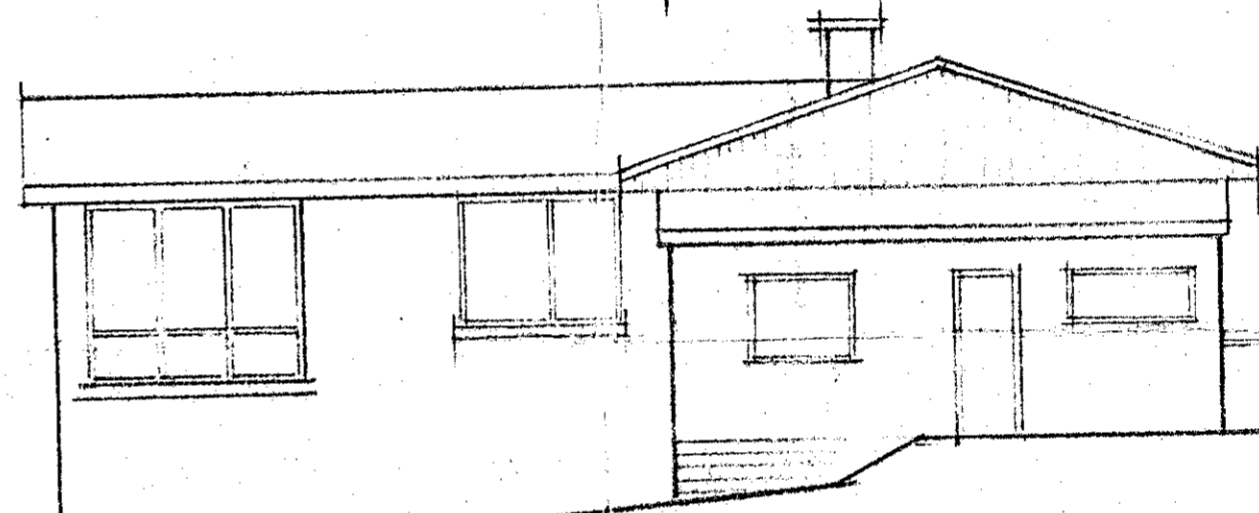
WEST ELEVATION

**DEPARTMENT OF WORKS**  
 DEPARTMENTAL RECORDS INDICATE THAT PORTION OF THE EXISTING SANITARY DRAINAGE SERVICE WILL BE UNDER THE PROPOSED STRUCTURE. AN APPROVED SANITARY DRAINAGE PLAN SHOWING WHAT ACTION IS TO BE TAKEN TO PROTECT OR RELOCATE EXISTING UNDER THE PROPOSED STRUCTURE AND ANY OTHER ALTERATIONS OR ADDITIONS TO SEWER DRAINAGE NECESSARY MUST BE OBTAINED AND FORM PART OF THE WORK CONNECTED WITH THIS PROJECT.

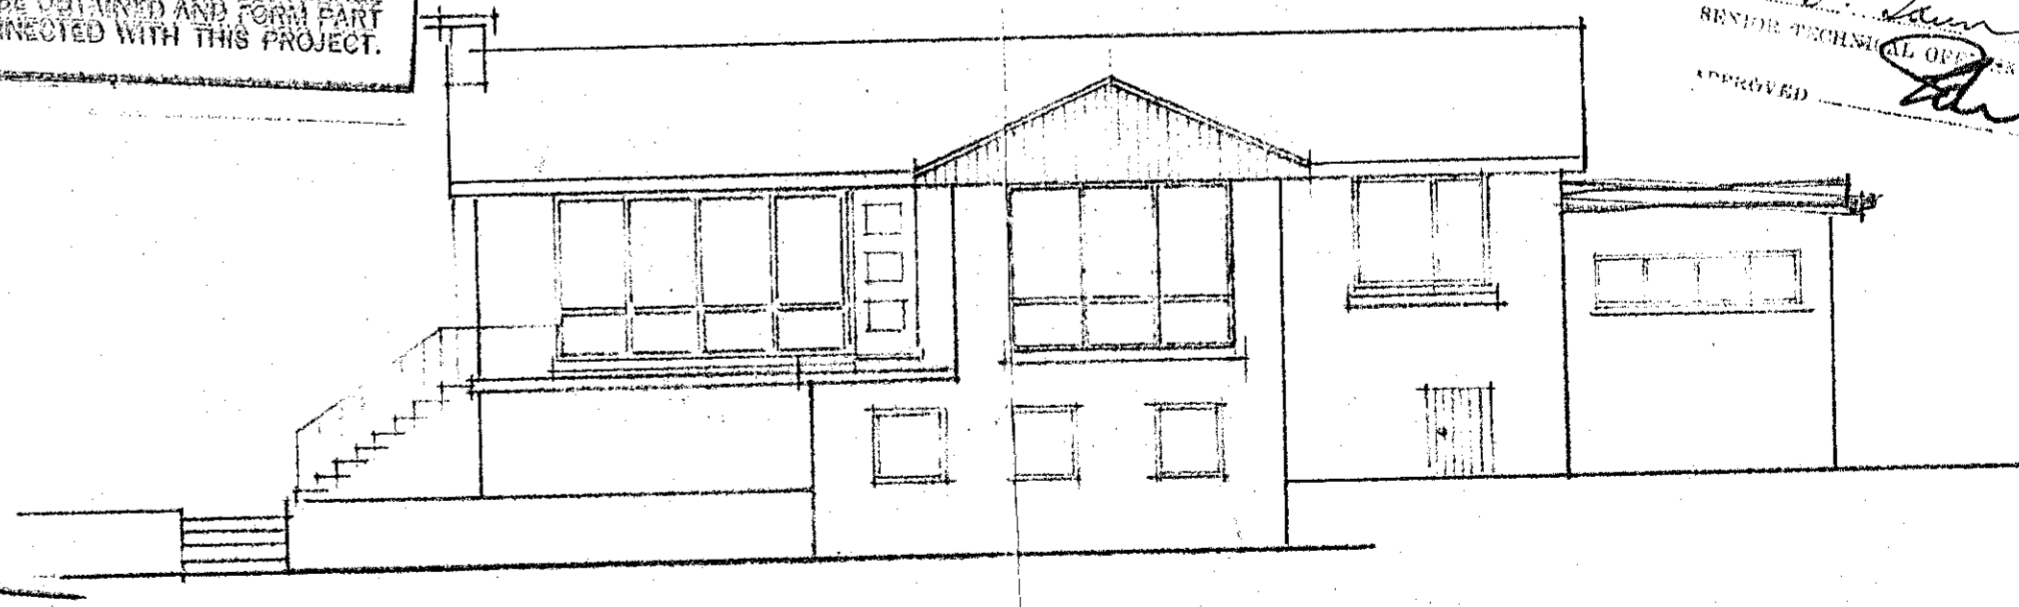
NORTH ELEVATION

APPROVED BY THE NATIONAL CAPITAL DEVELOPMENT COMMISSION AS TO DESIGN AND SITING  
 Roof of store rooms to be steel decking type kept to minimum fall. 1/5/64

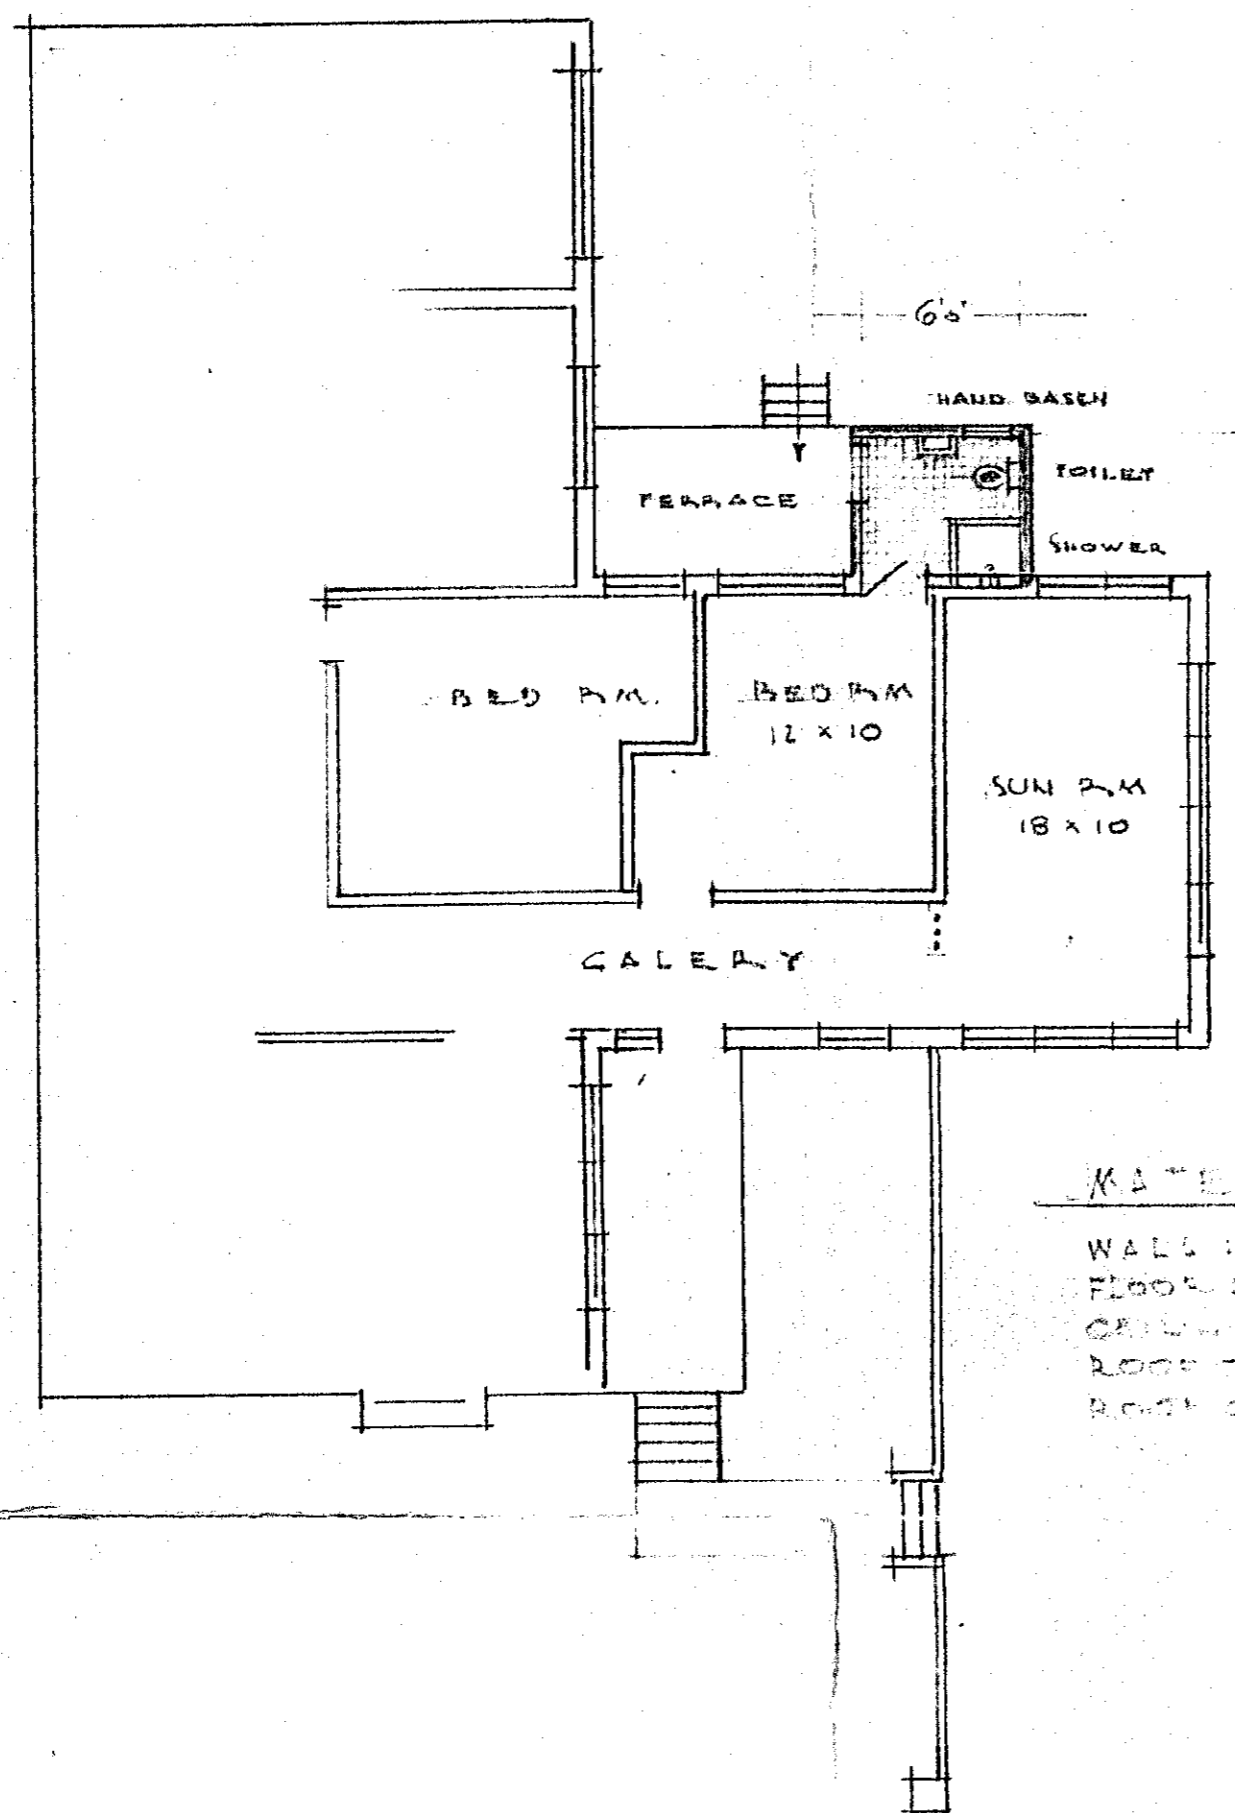
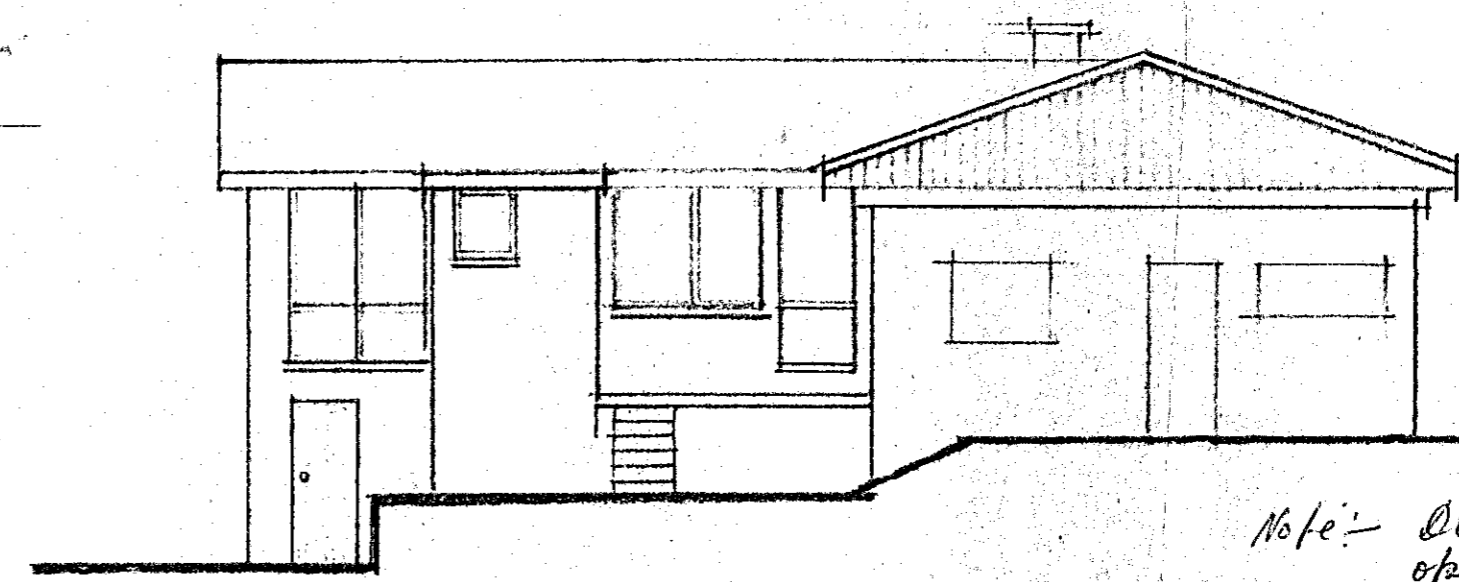
Note: Door to W. Closet to  
 open inwards  
 D.W.H.

MATERIALS:  
 WALLS: BRICK (finished on outside)  
 FLOOR: 2" CONCRETE SLAB REINFORCED  
 CEILING: GYPSONUM  
 ROOF: 4 x 2 U.M. CONSTRUCTION TO APPROVAL  
 ROOF COVER: FLAT STEEL

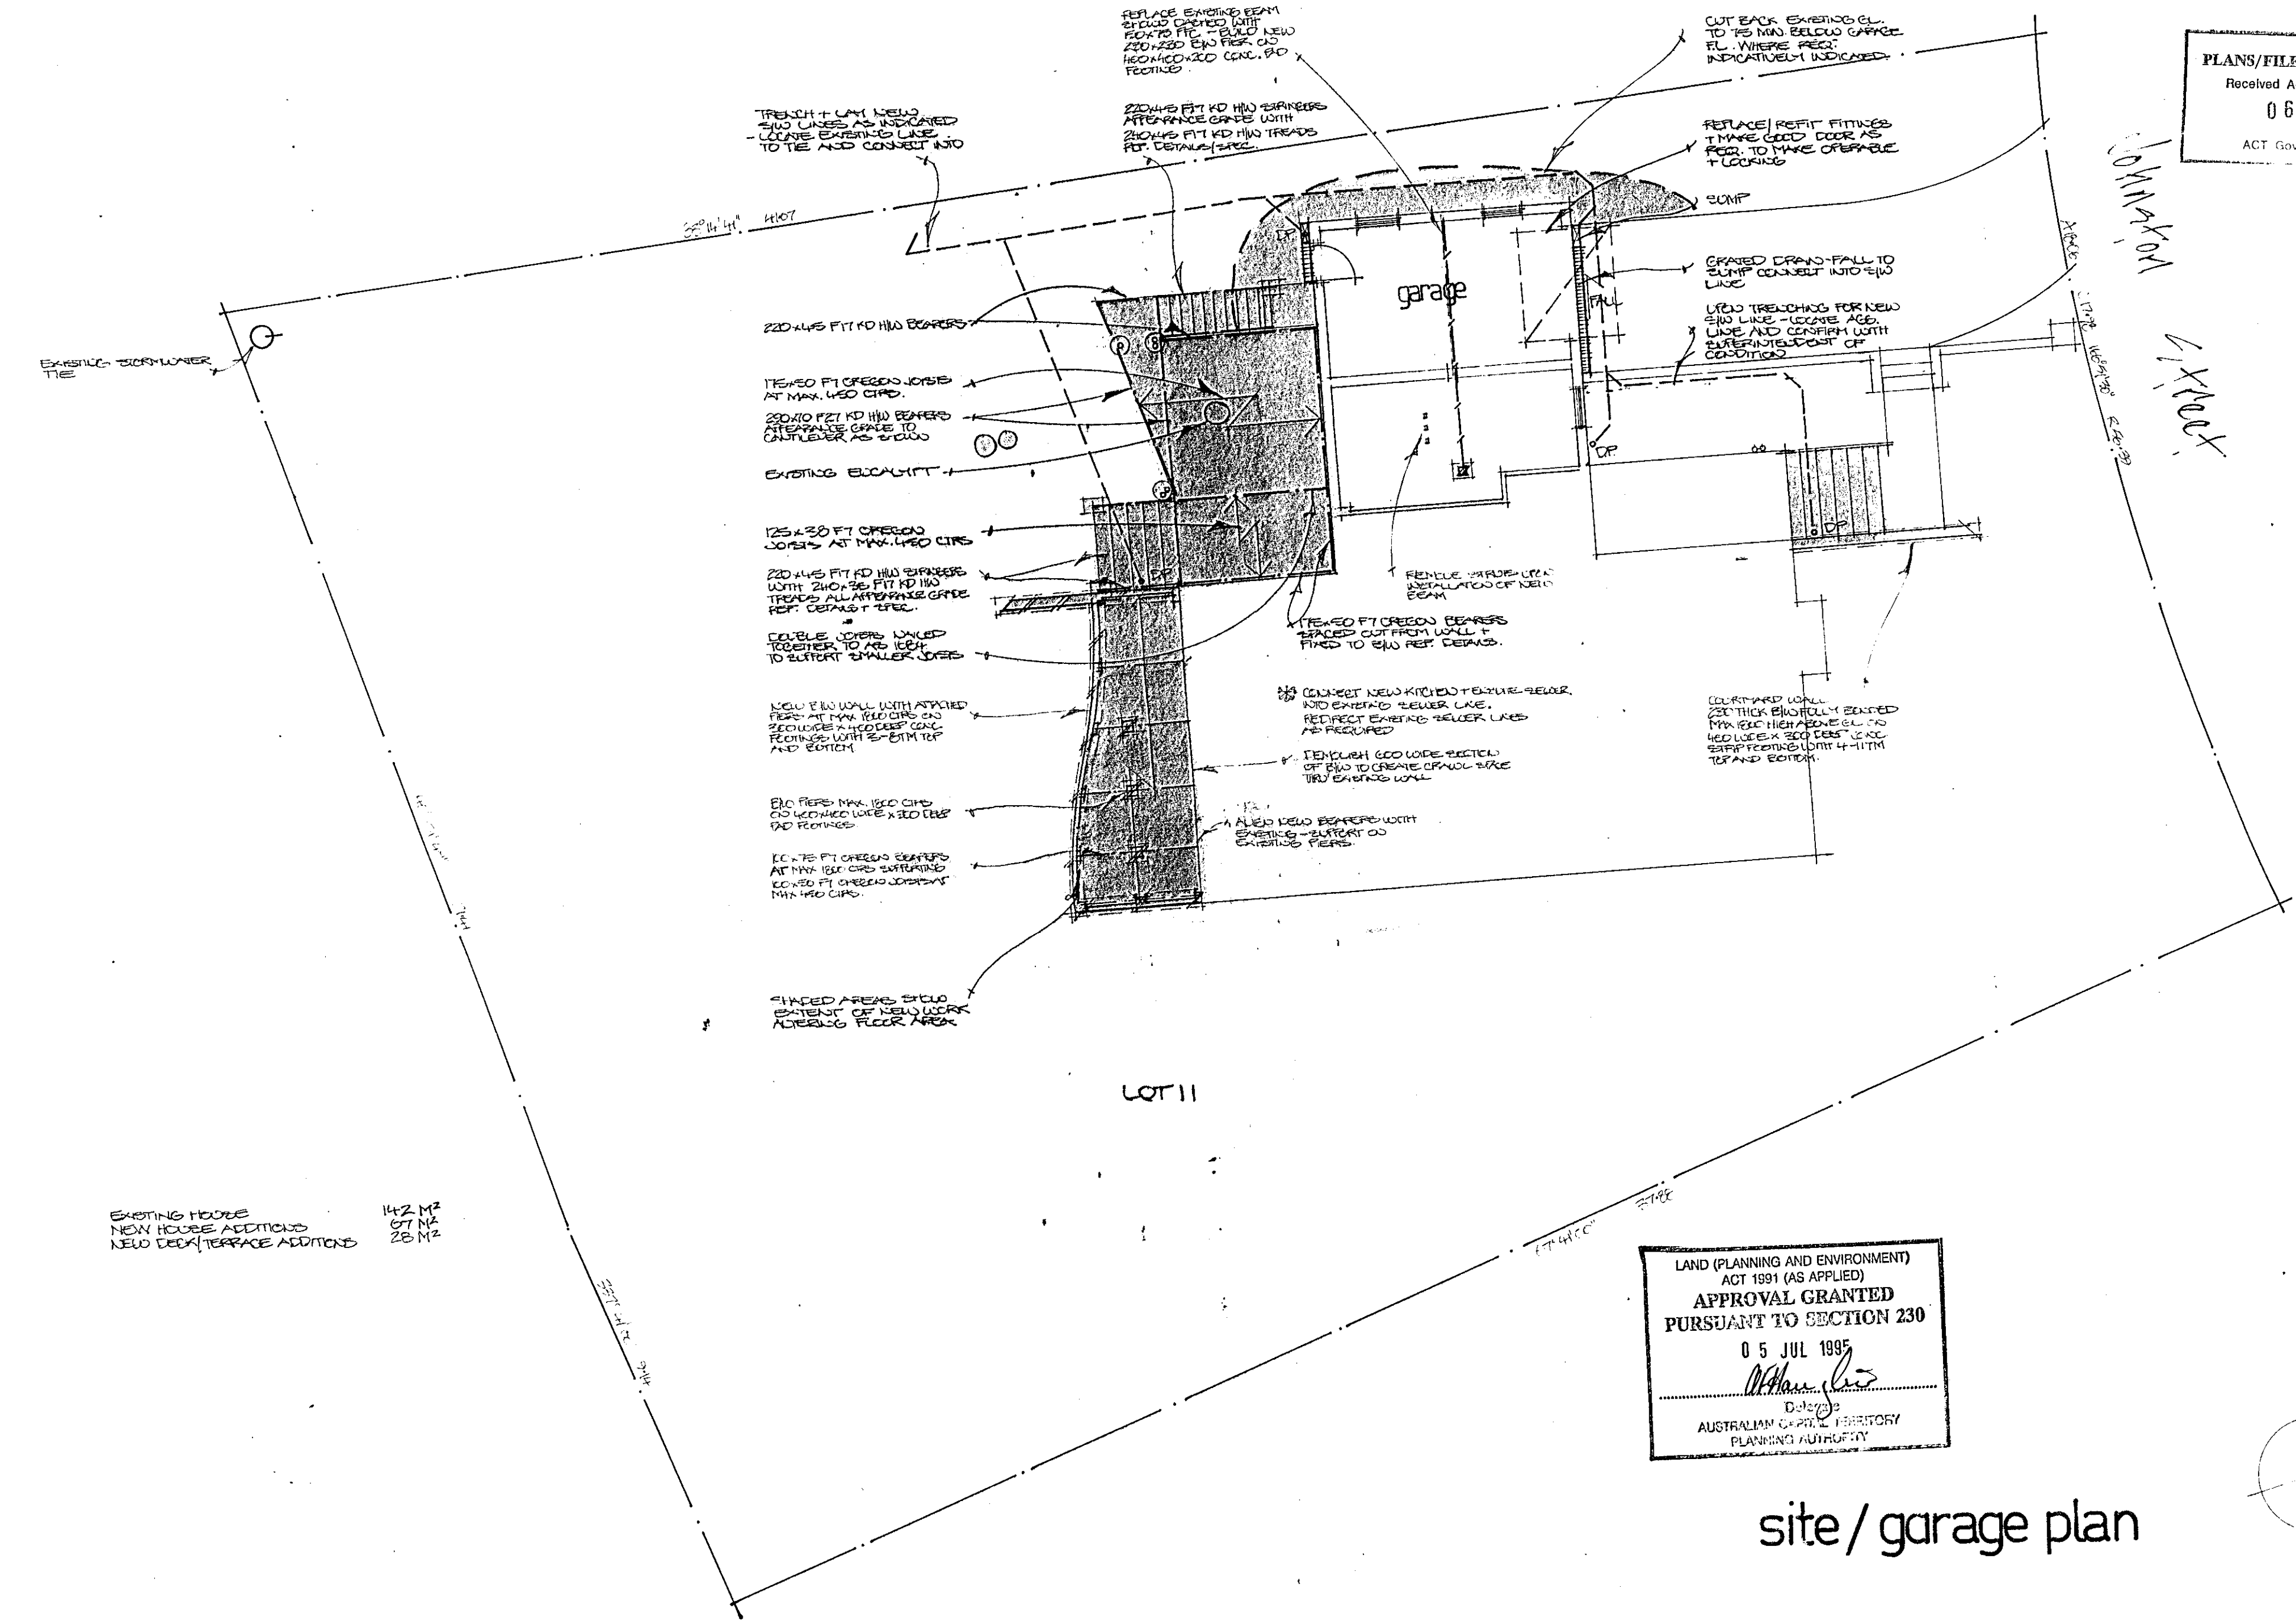
DRAWN site plan	SHEET 2 of 7	<b>alterations &amp; additions</b> FOR: Mary and Stephen Beare AT: block 11, section 94, Johnston St. Narrabundah, ACT.
			SCALE 1:100	DESIGN/DRAWN Noack	
			DATE May'95

EXISTING HOUSE 142 M<sup>2</sup>  
 NEW HOUSE ADDITIONS 97 M<sup>2</sup>  
 NEW DECK/TERRACE ADDITIONS 28 M<sup>2</sup>

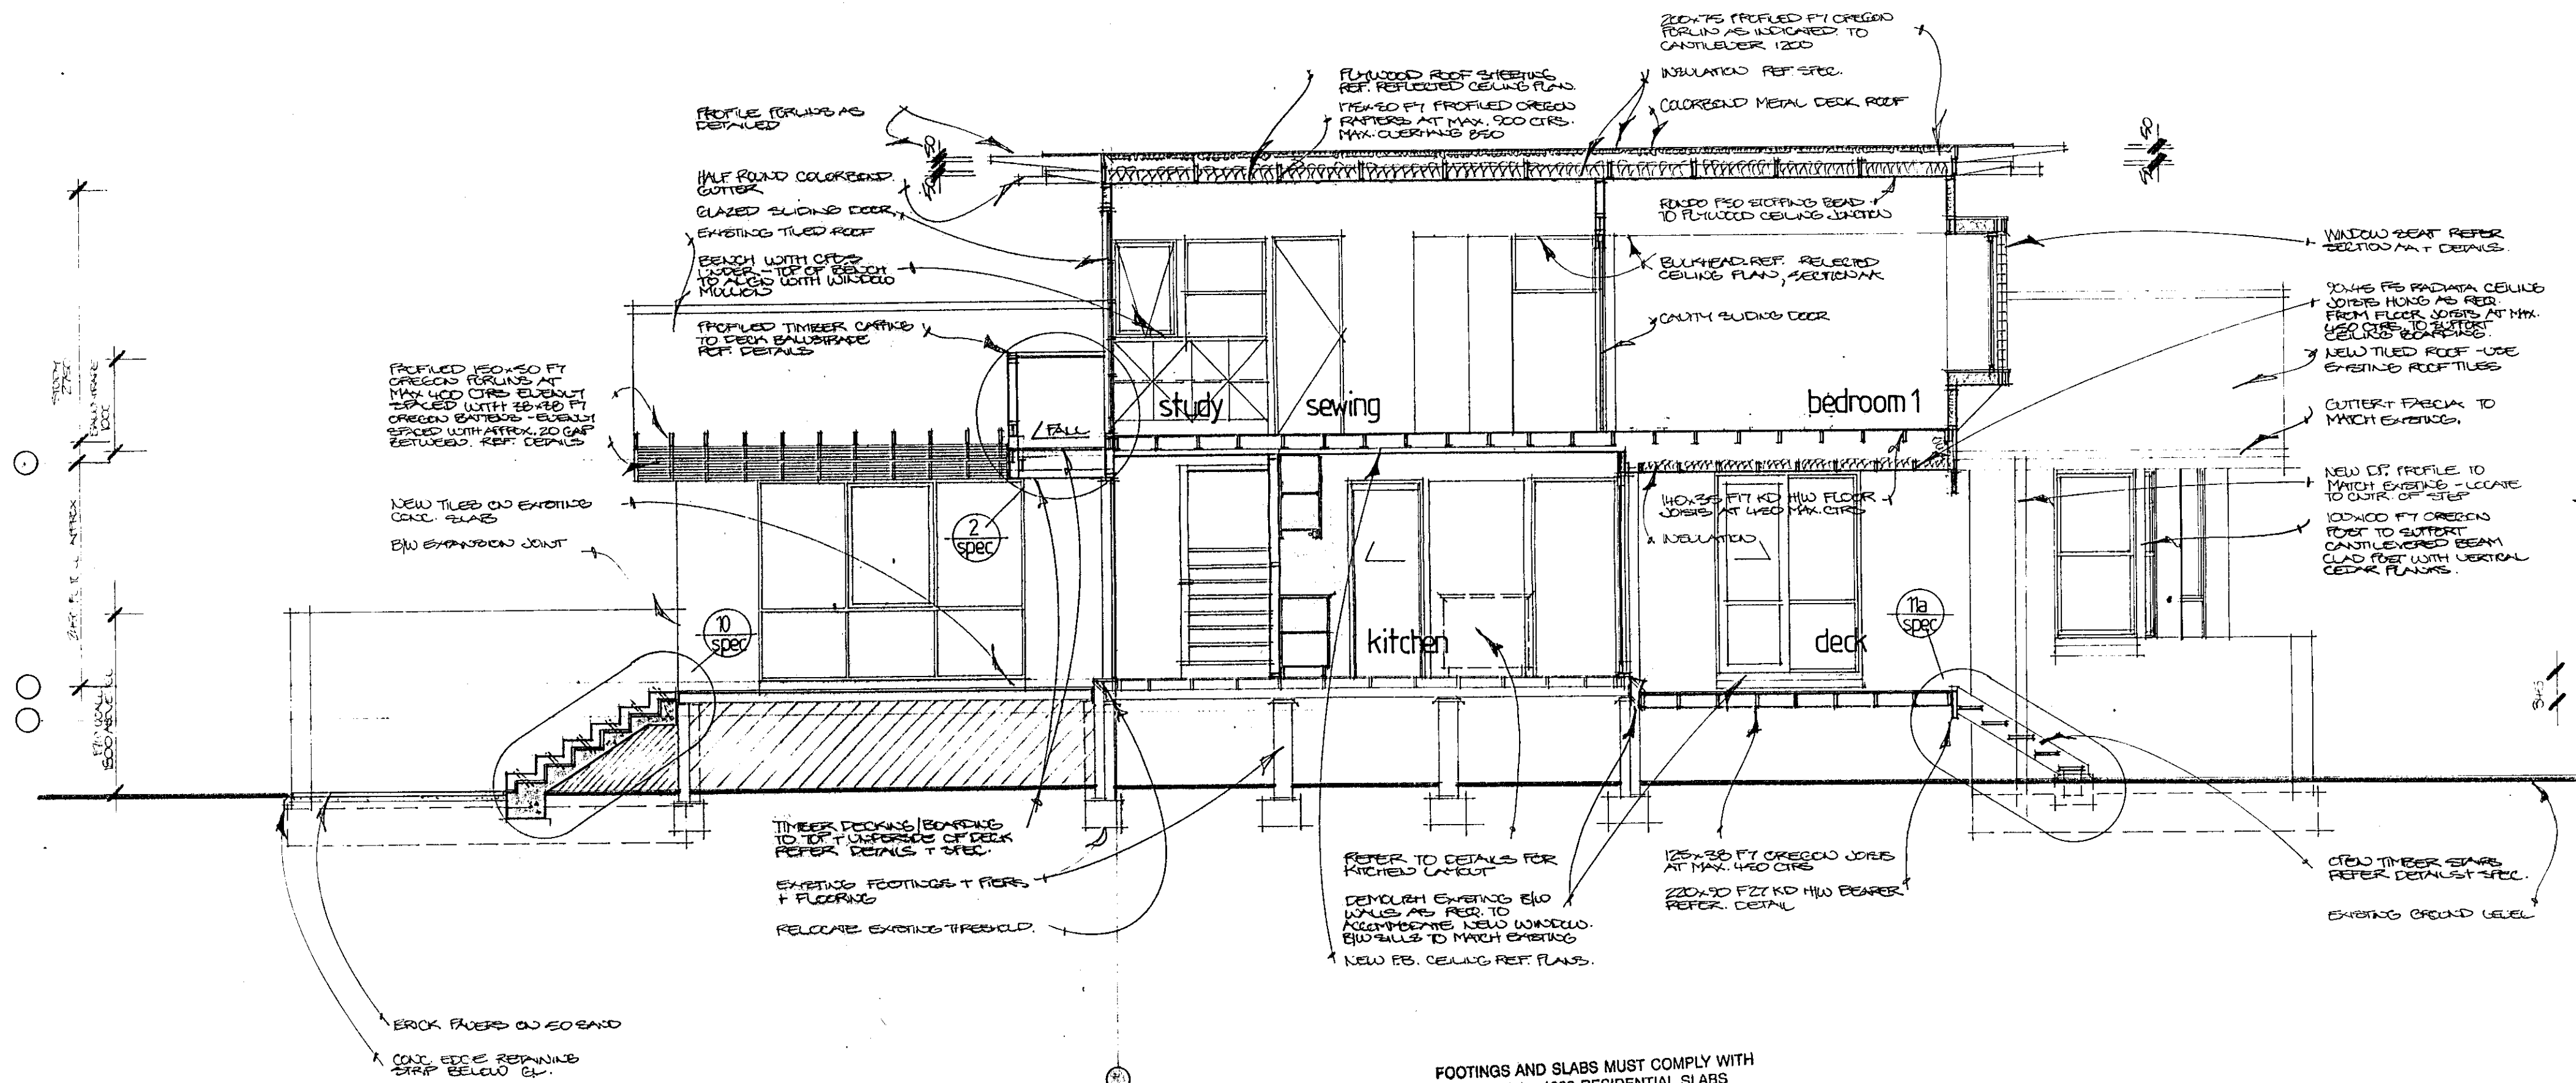
section BB

FOOTINGS AND SLABS MUST COMPLY WITH AS2870.1 - 1988 RESIDENTIAL SLABS AND FOOTING CODE

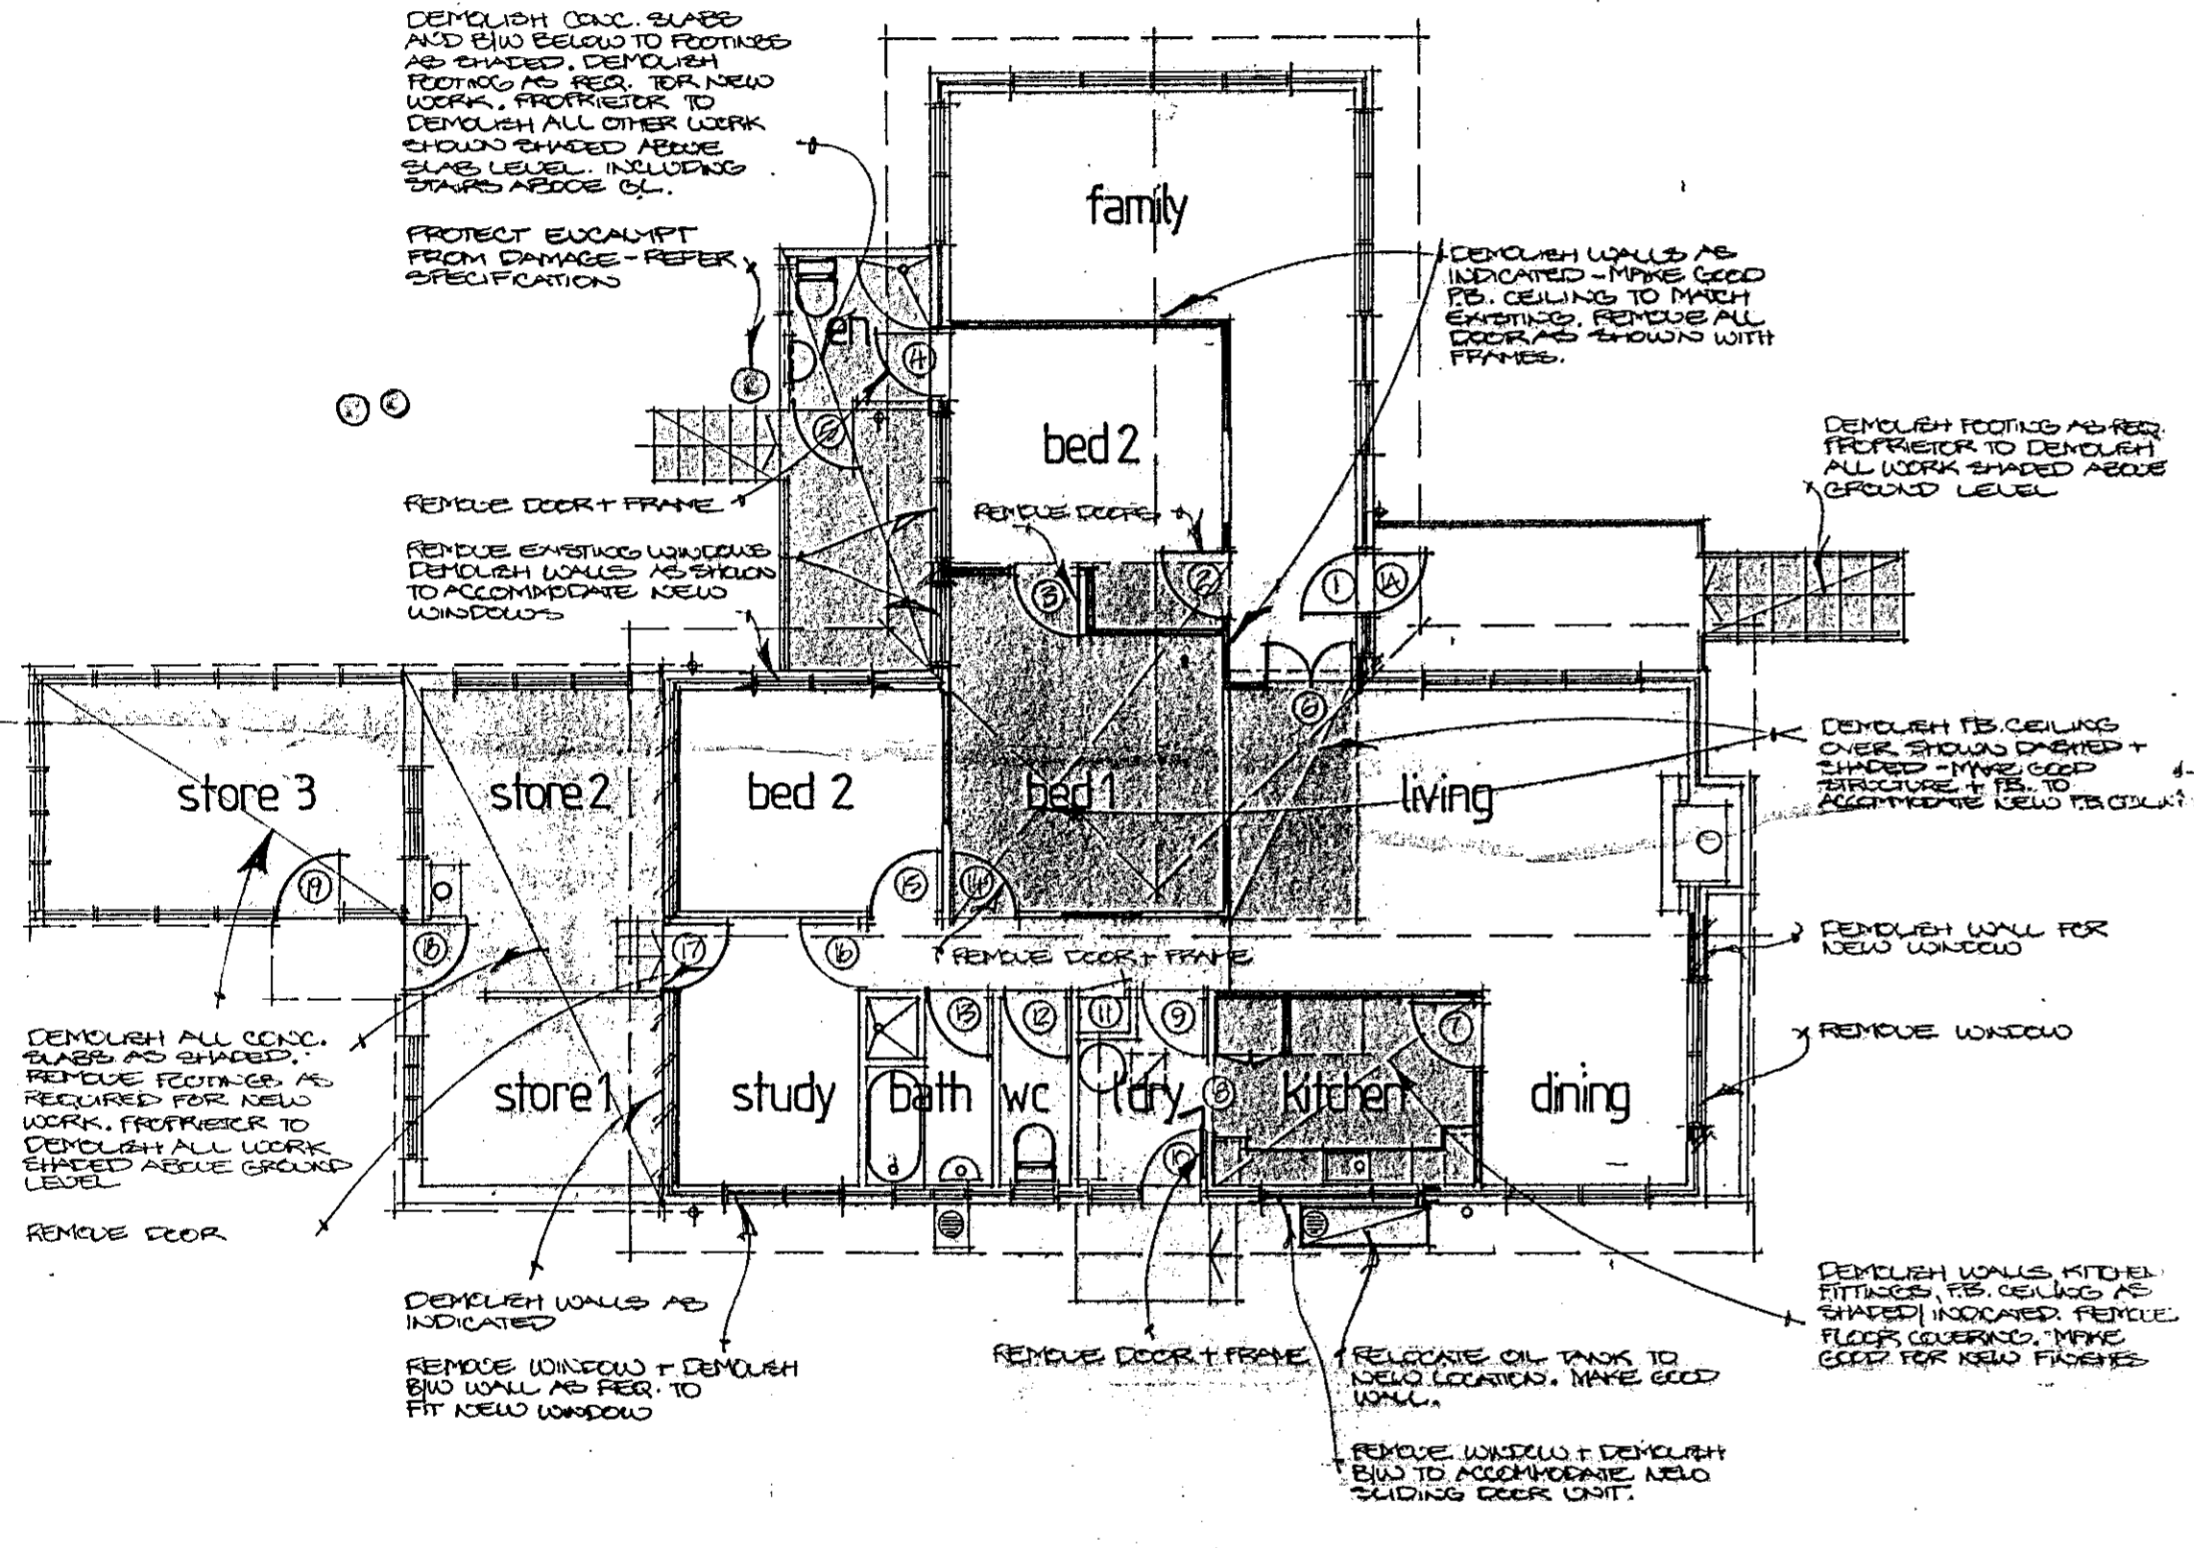
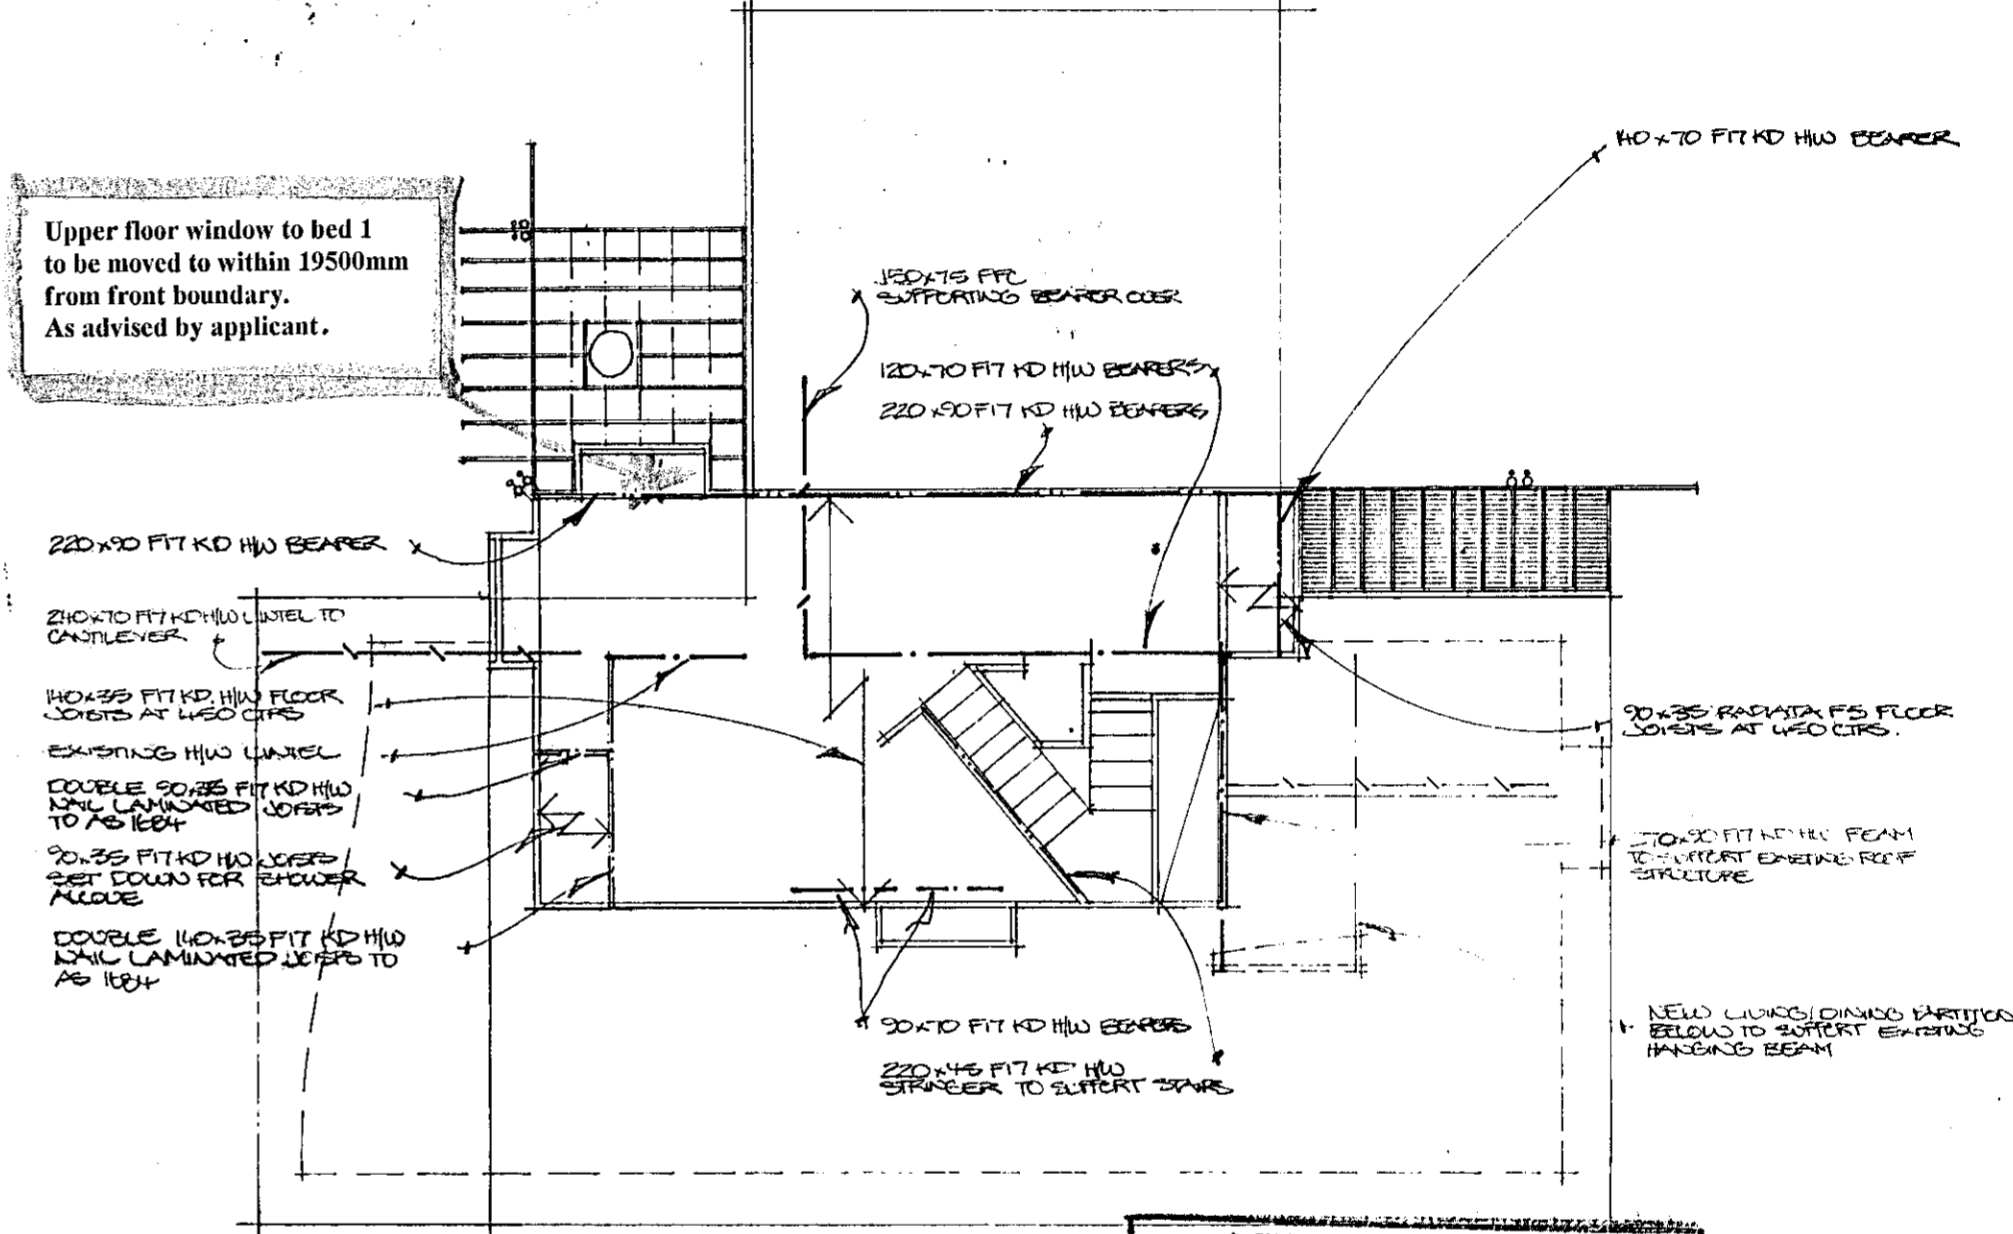
demolition plan

DEMOLITION OF ROOF STRUCTURE NOT SHOWN FOR CLARITY - REFER NOTES.

NOTES: PRIOR TO REMOVE ALL EXISTING CARPET + PARQUET.  
 REMOVE + STORE FOR REUSE EXISTING ROOF TILES TO AFFECTED AREAS OF ROOF - DEMOLISH ROOF STRUCTURE AFFECTED BY NEW FIRST FLOOR WORK - TEMPORARILY SUPPORT EXISTING ROOF AS REQUIRED UNTIL BUILT IN TO NEW WORK.  
 ALL HARDWOOD BEAMS TO BE LED TO APPROPRIATE CANALS UNLESS NOTED.

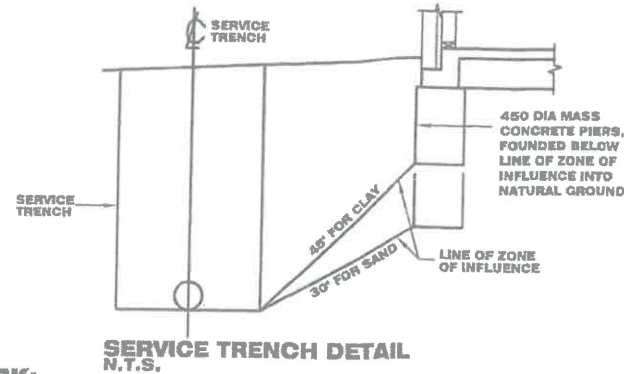
- F.7 TOP SOIL CONTAINING GRASS ROOTS OR OTHER ORGANIC MATERIAL SHALL BE REMOVED FROM THE AREA ON WHICH THE SLAB IS TO REST.
- F.8 IF ANY FOOTING IS LOCATED SUCH THAT A LINE DRAWN AT 45 DEGREES FOR CLAY AND 30 DEGREES FOR SAND FROM ITS BASE INTERSECTS A SERVICE TRENCH THEN PIERS ARE REQUIRED AS PER DETAIL BELOW.

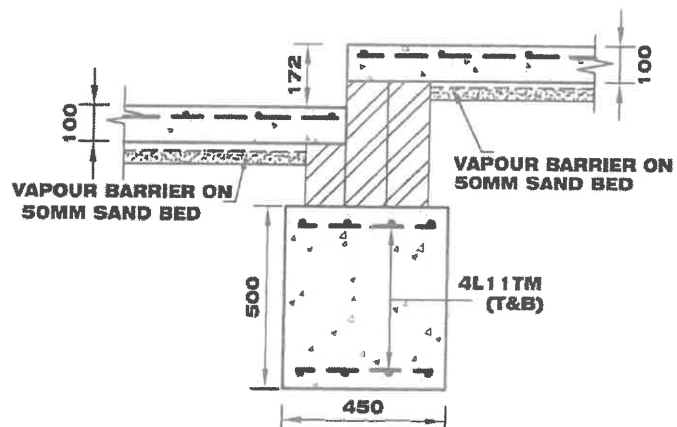
**TYPICAL SF3 SECTION**  
SCALE = 1:20  
B  
S2

NOTE: WHERE FILL OVER 400mm UNDER SLAB, USE 120mm SLAB, SL82(TOP+BTM), CONCRETE PIERS @ 1800mm CTS MAX
