# Report

# Building Report

# Compliance Report

# Conveyancing File

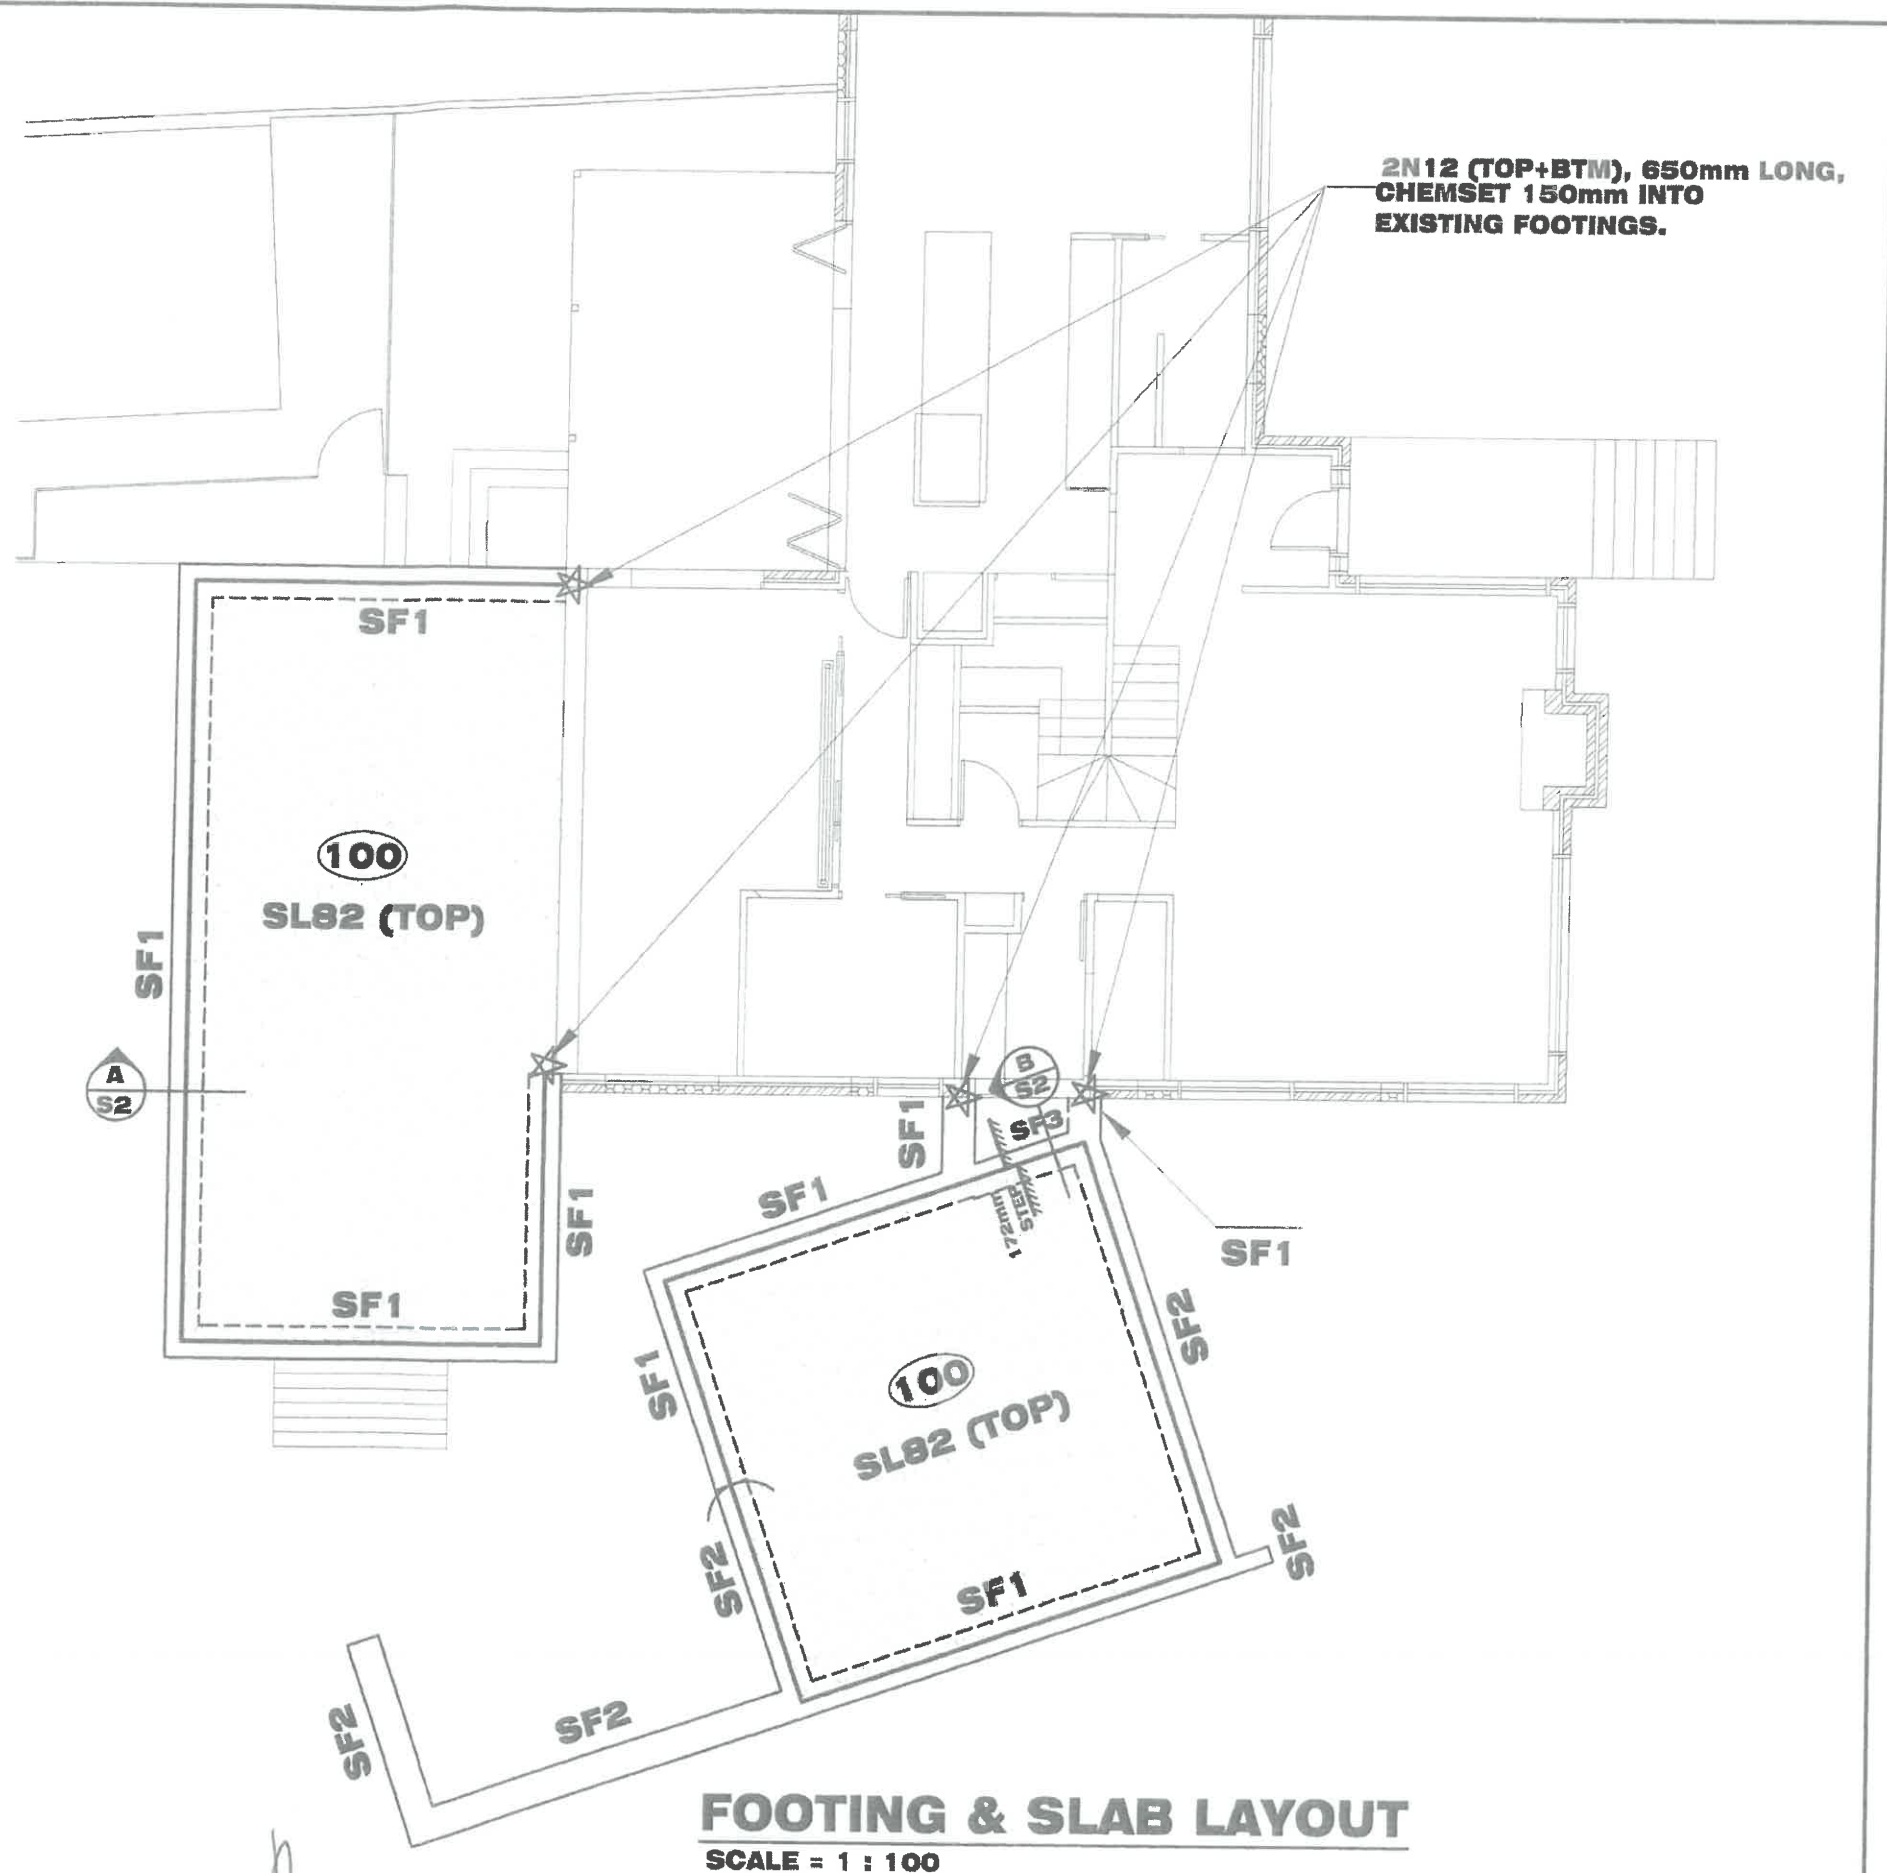
**FOOTING & SLAB LAYOUT**  
SCALE = 1 : 100

DENOTES 3N12 OR 3L11TM (TOP), 2000mm LONG, TIED TO TOP OF SLAB MESH

- F.1 FOOTINGS HAVE BEEN DESIGNED FOR A UNIFORM BEARING PRESSURE (refer to sheet 2). FOUNDATION MATERIAL SHALL BE APPROVED FOR THIS PRESSURE BEFORE PLACING CONCRETE FOOTING.

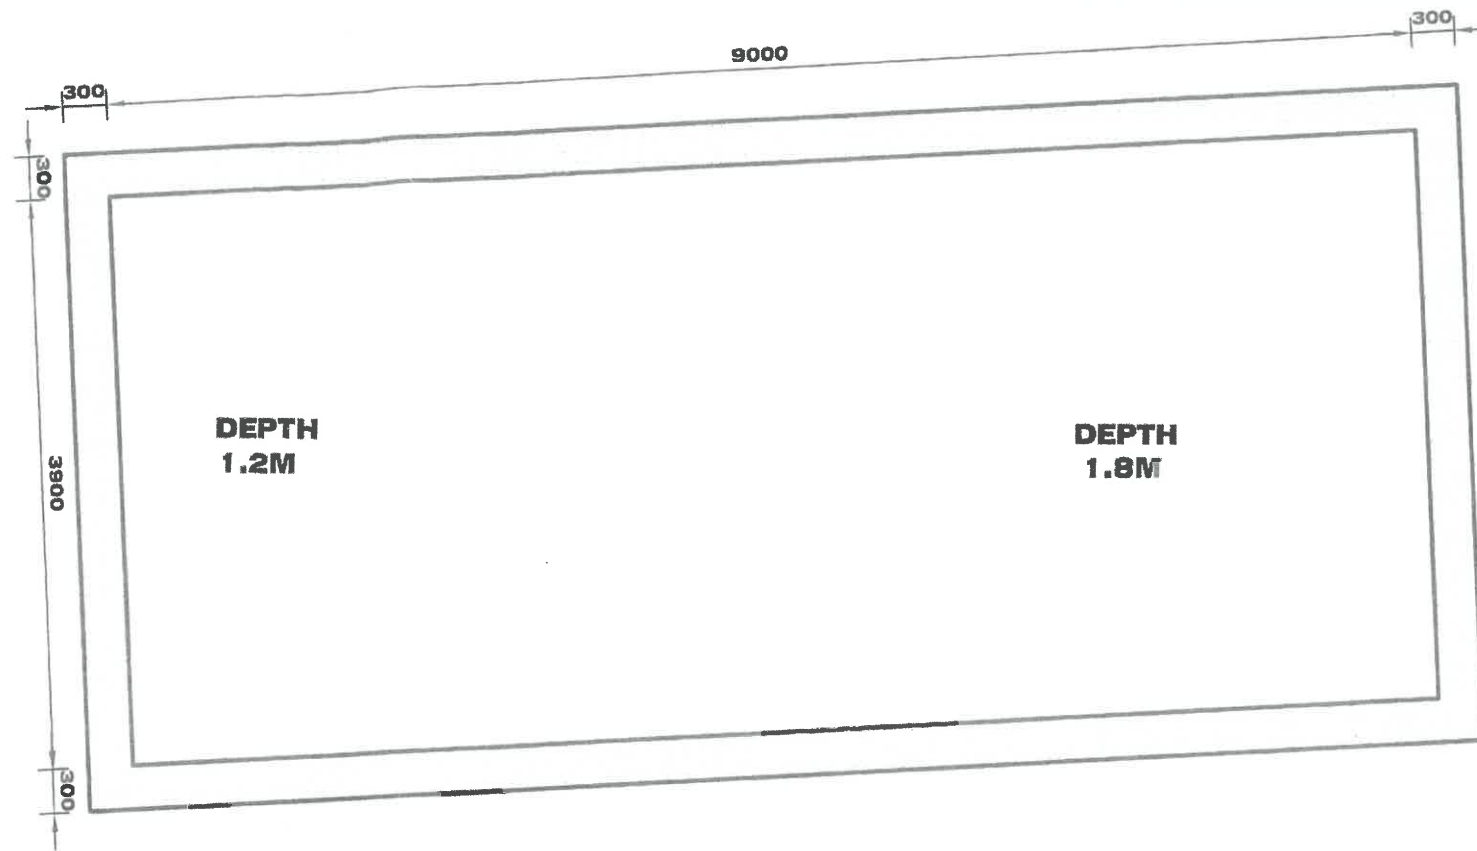
**PROPOSED SWIMMING POOL**

(REFER TO SITE PLAN FOR POOL LOCATION)  
DESIGN BEARING STRATA-160kPa  
TO BE VERIFIED AND CERTIFIED ON SITE BY  
QUALIFIED ENGINEER  
SCALE 1:50

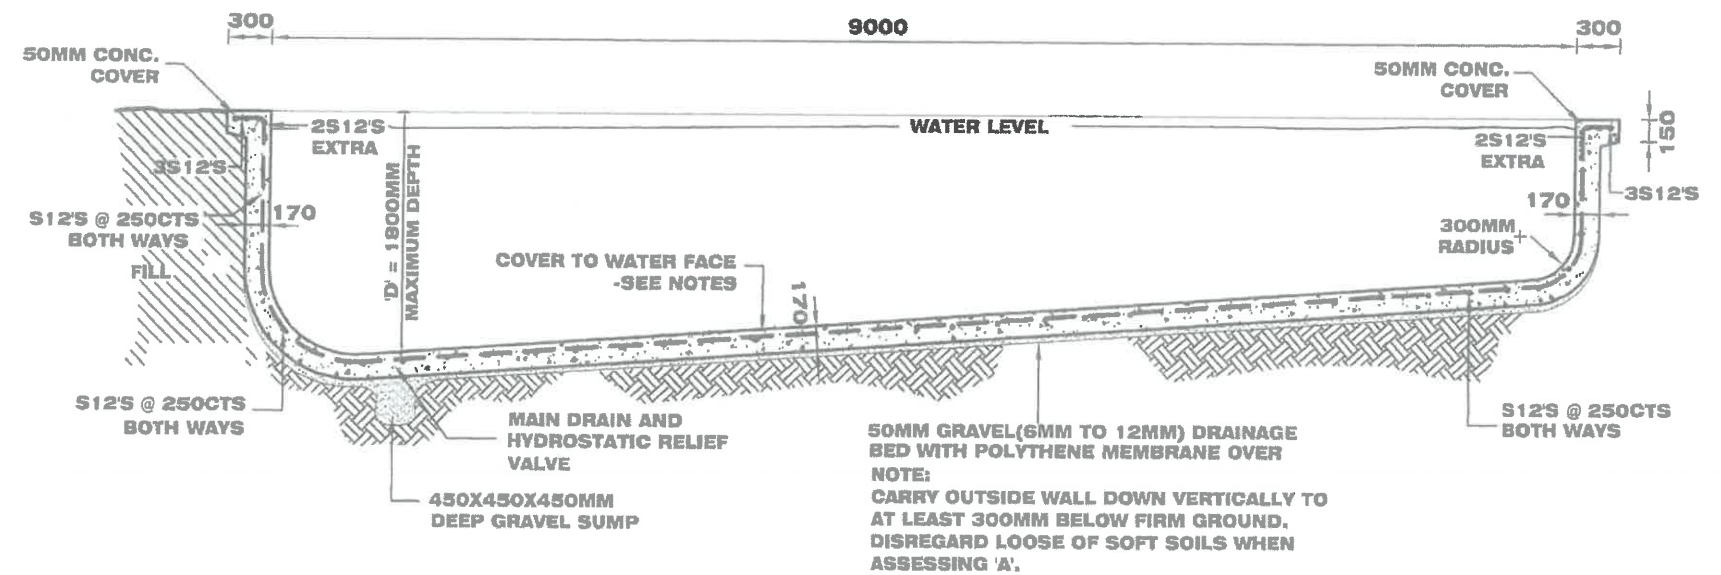
**TYPICAL LONGITUDINAL SECTION**

SCALE 1:50
