Report

Building Report

Property Address: 22 Selwyn Street, Hackett ACT 2602
Client: Champness
Inspection Date: Friday, April 24th 2026
Inspection carried out by: Tom Strickland

22 Selwyn Street Hackett
 Fire place.

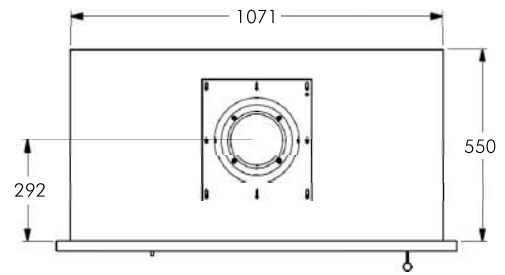
HEATER DIMENSIONS

Top View
