Report

Building Report

CONCLUSION AND SUMMARY

Property Address: 33 Mockridge Crescent, Holt ACT 2615
Client: Deacon
Inspection Date: Friday, May 1st 2026
Inspection carried out by: Dylan Mitchell

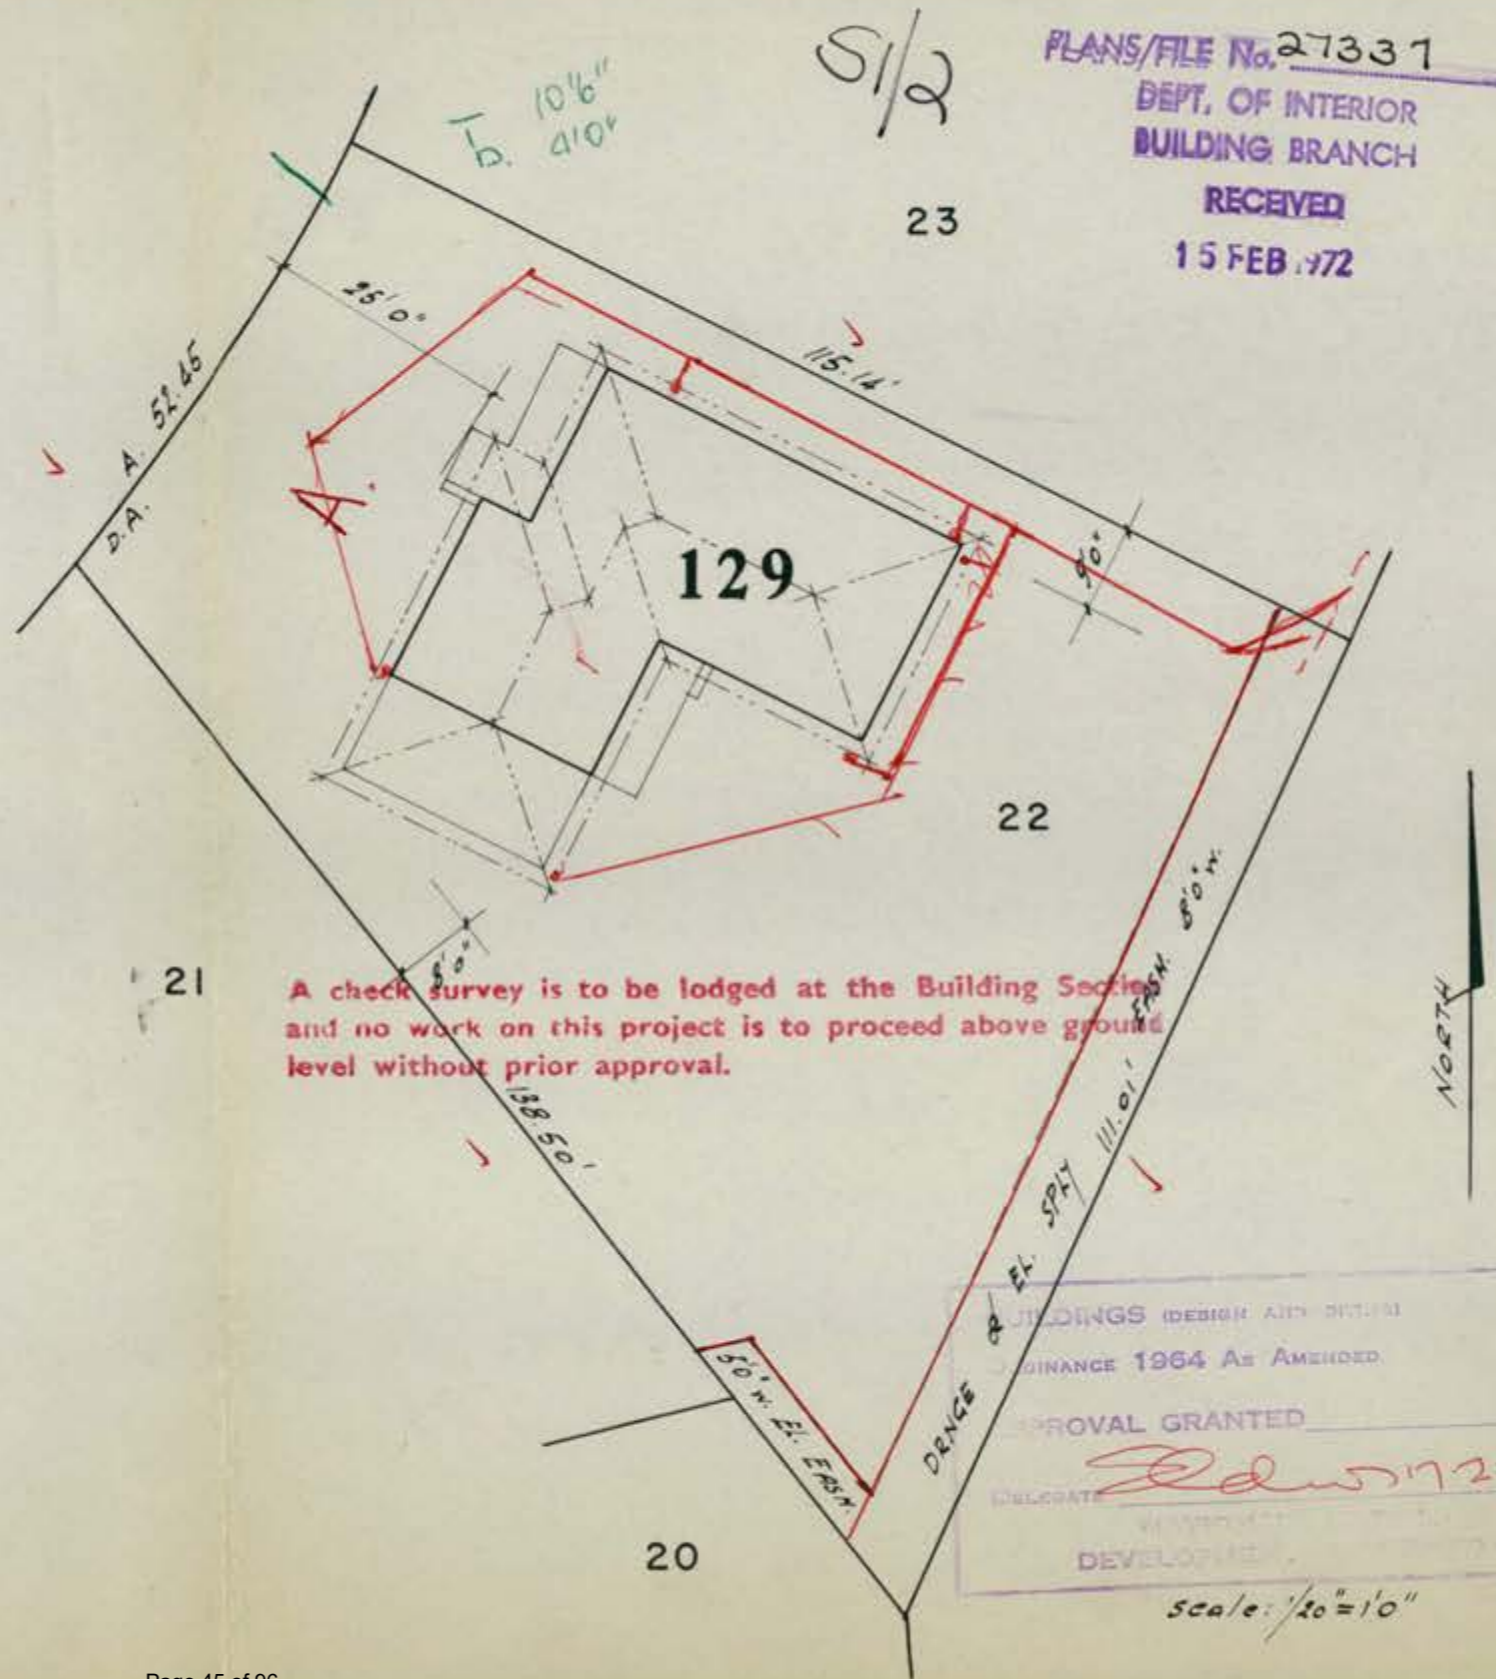
PROPOSED BRICK VENEER RESIDENCE
FOR: MR. & MRS. WEBSTER
AT BLOCK 22 SECTION 25 HOLT
BUILDER: GALLIS HOMES

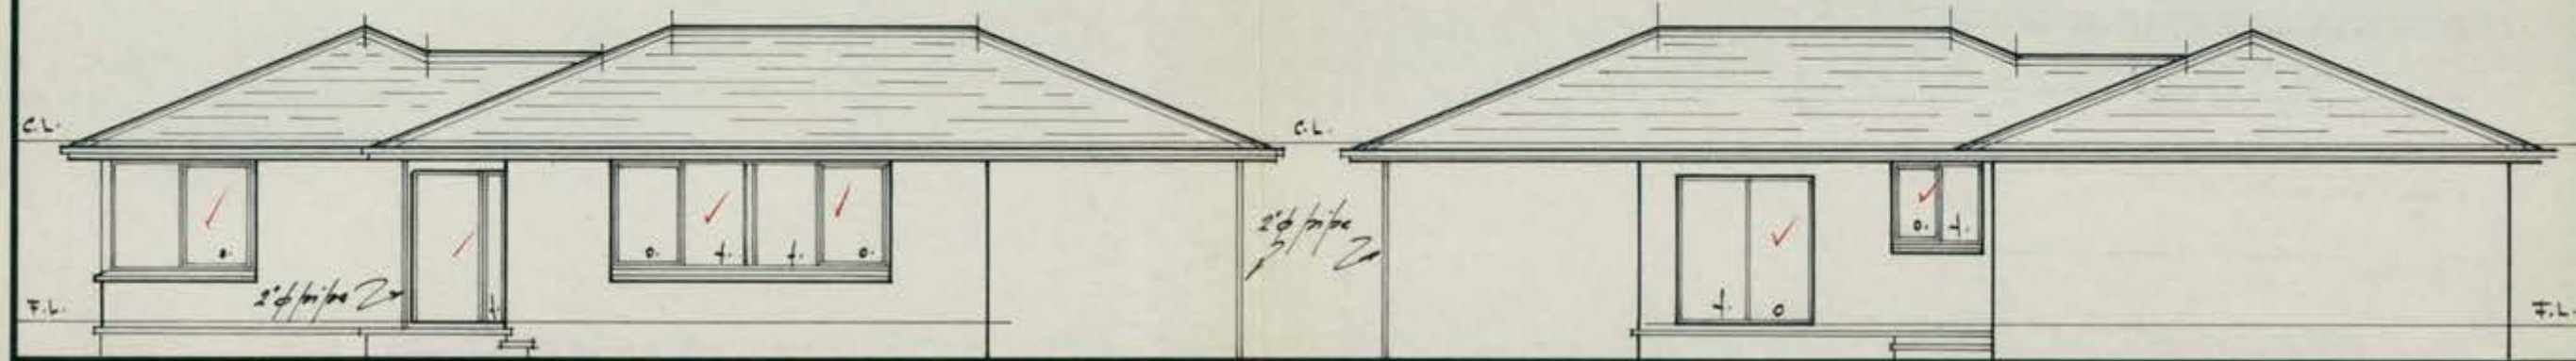
FRONT ELEVATION

REAR ELEVATION

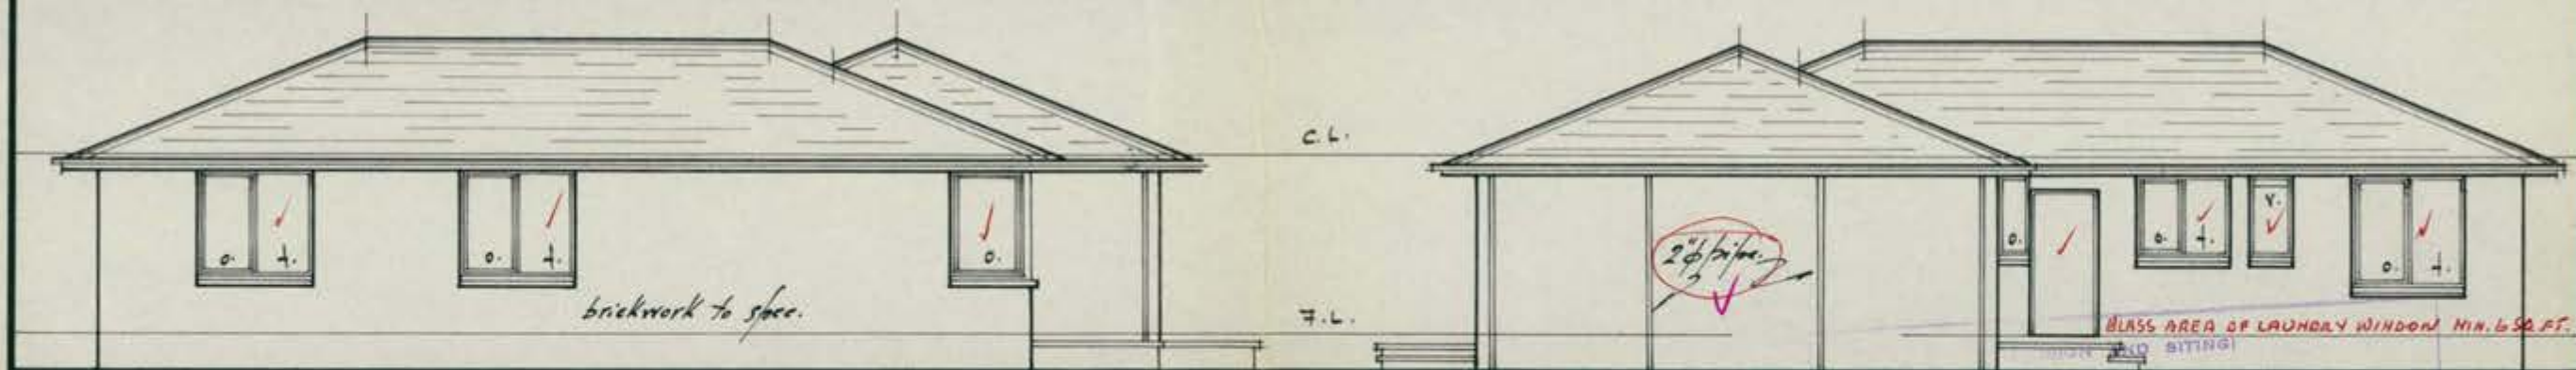
SIDE ELEVATION

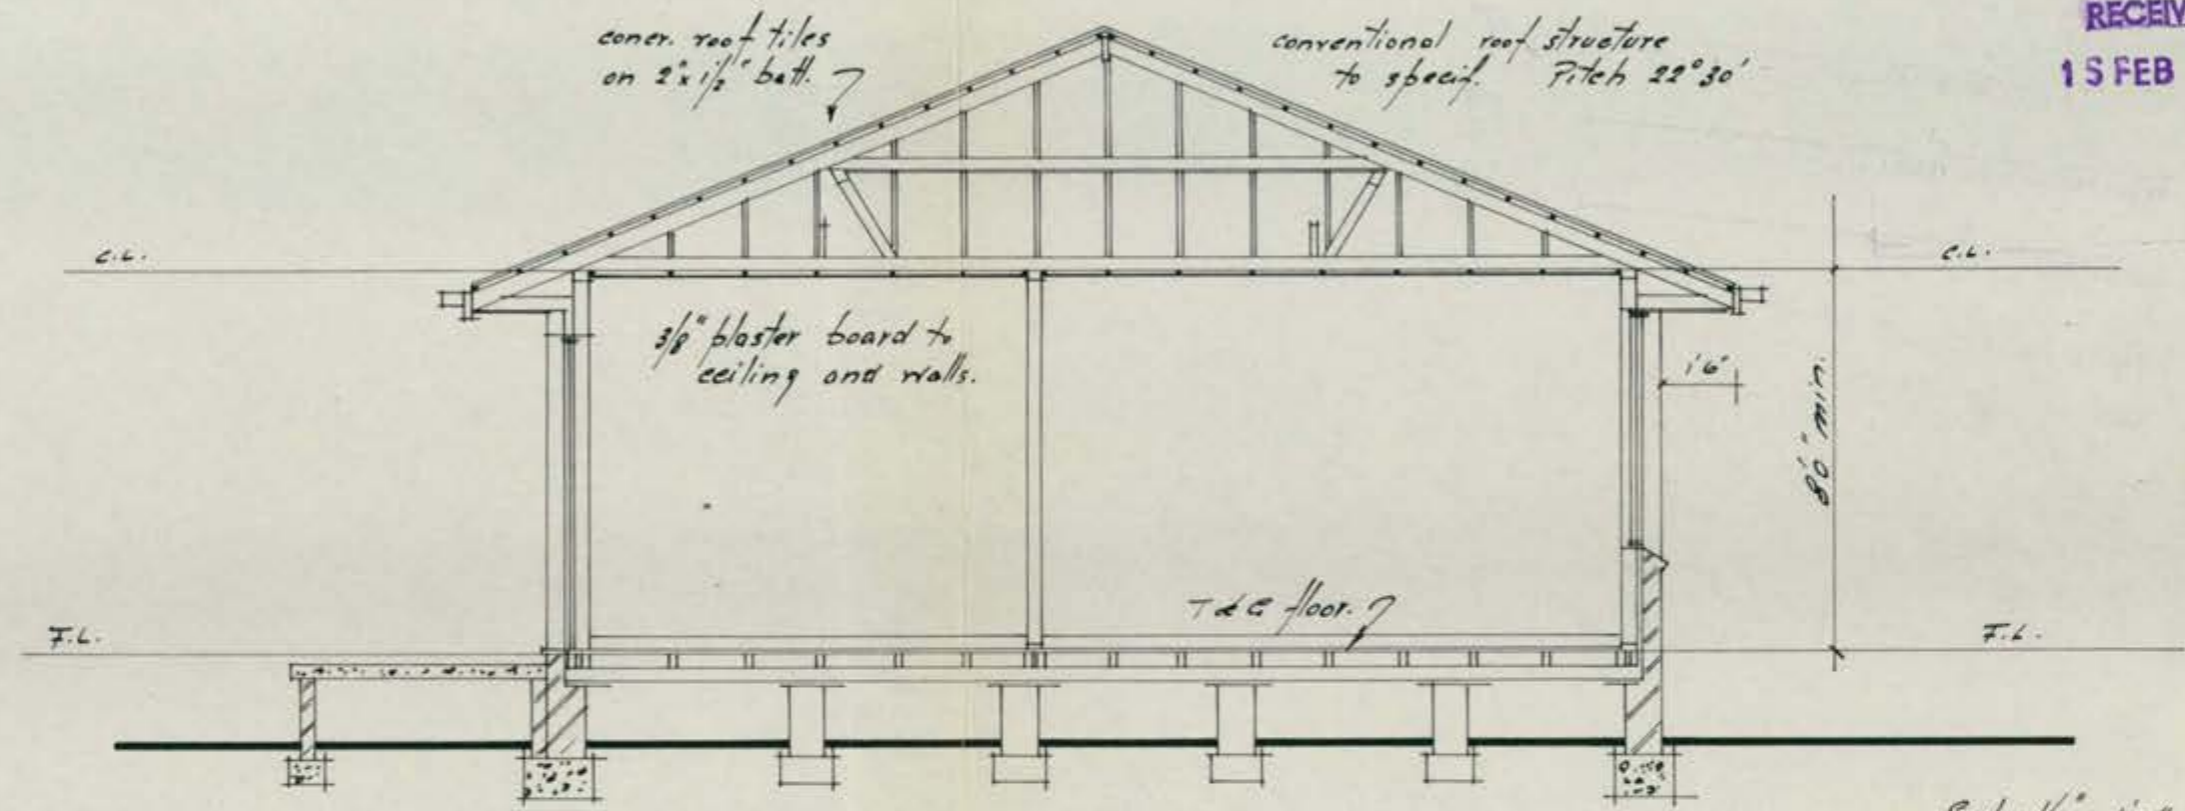
Scale: 1/4" = 1'0"

- 16"x10" r.c. footing to 10" veneer walls.
- 12"x10" r.c. " to 4 1/2" internal walls
- All reinforced with No. 7 trench mesh No. 1 layer only. (bottom)
- 4" r.c. slab to bath room, laundry, w.c. and terraces reinforced with No. 307 A.R.C. mesh.
- 16"x16"x6" coner. pads under 9"x9" brick piers.

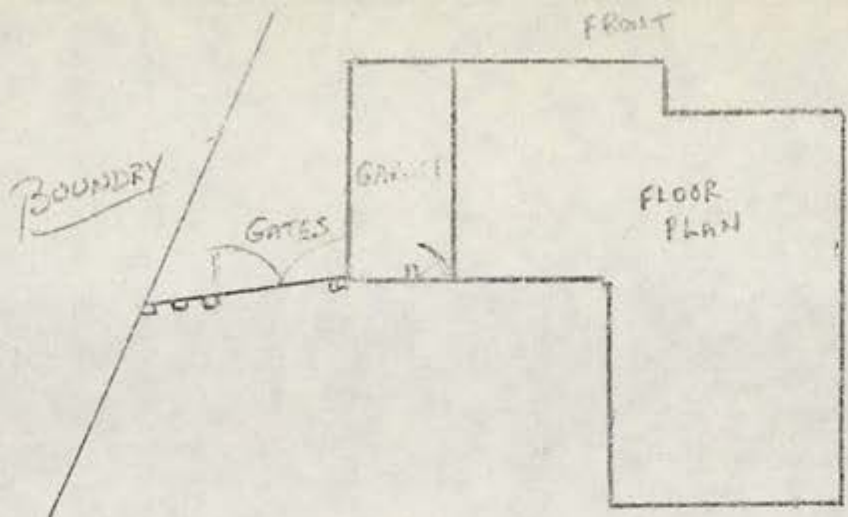
6' x 4'
ALUMINUM
SLIDING
WINDOW

BRICKS TO BE SECURED
TO EXISTING 2" PIPES BY
TIES AT EVERY FOURTH
BRICK. TIES TO BE WELDED
TO PIPES.

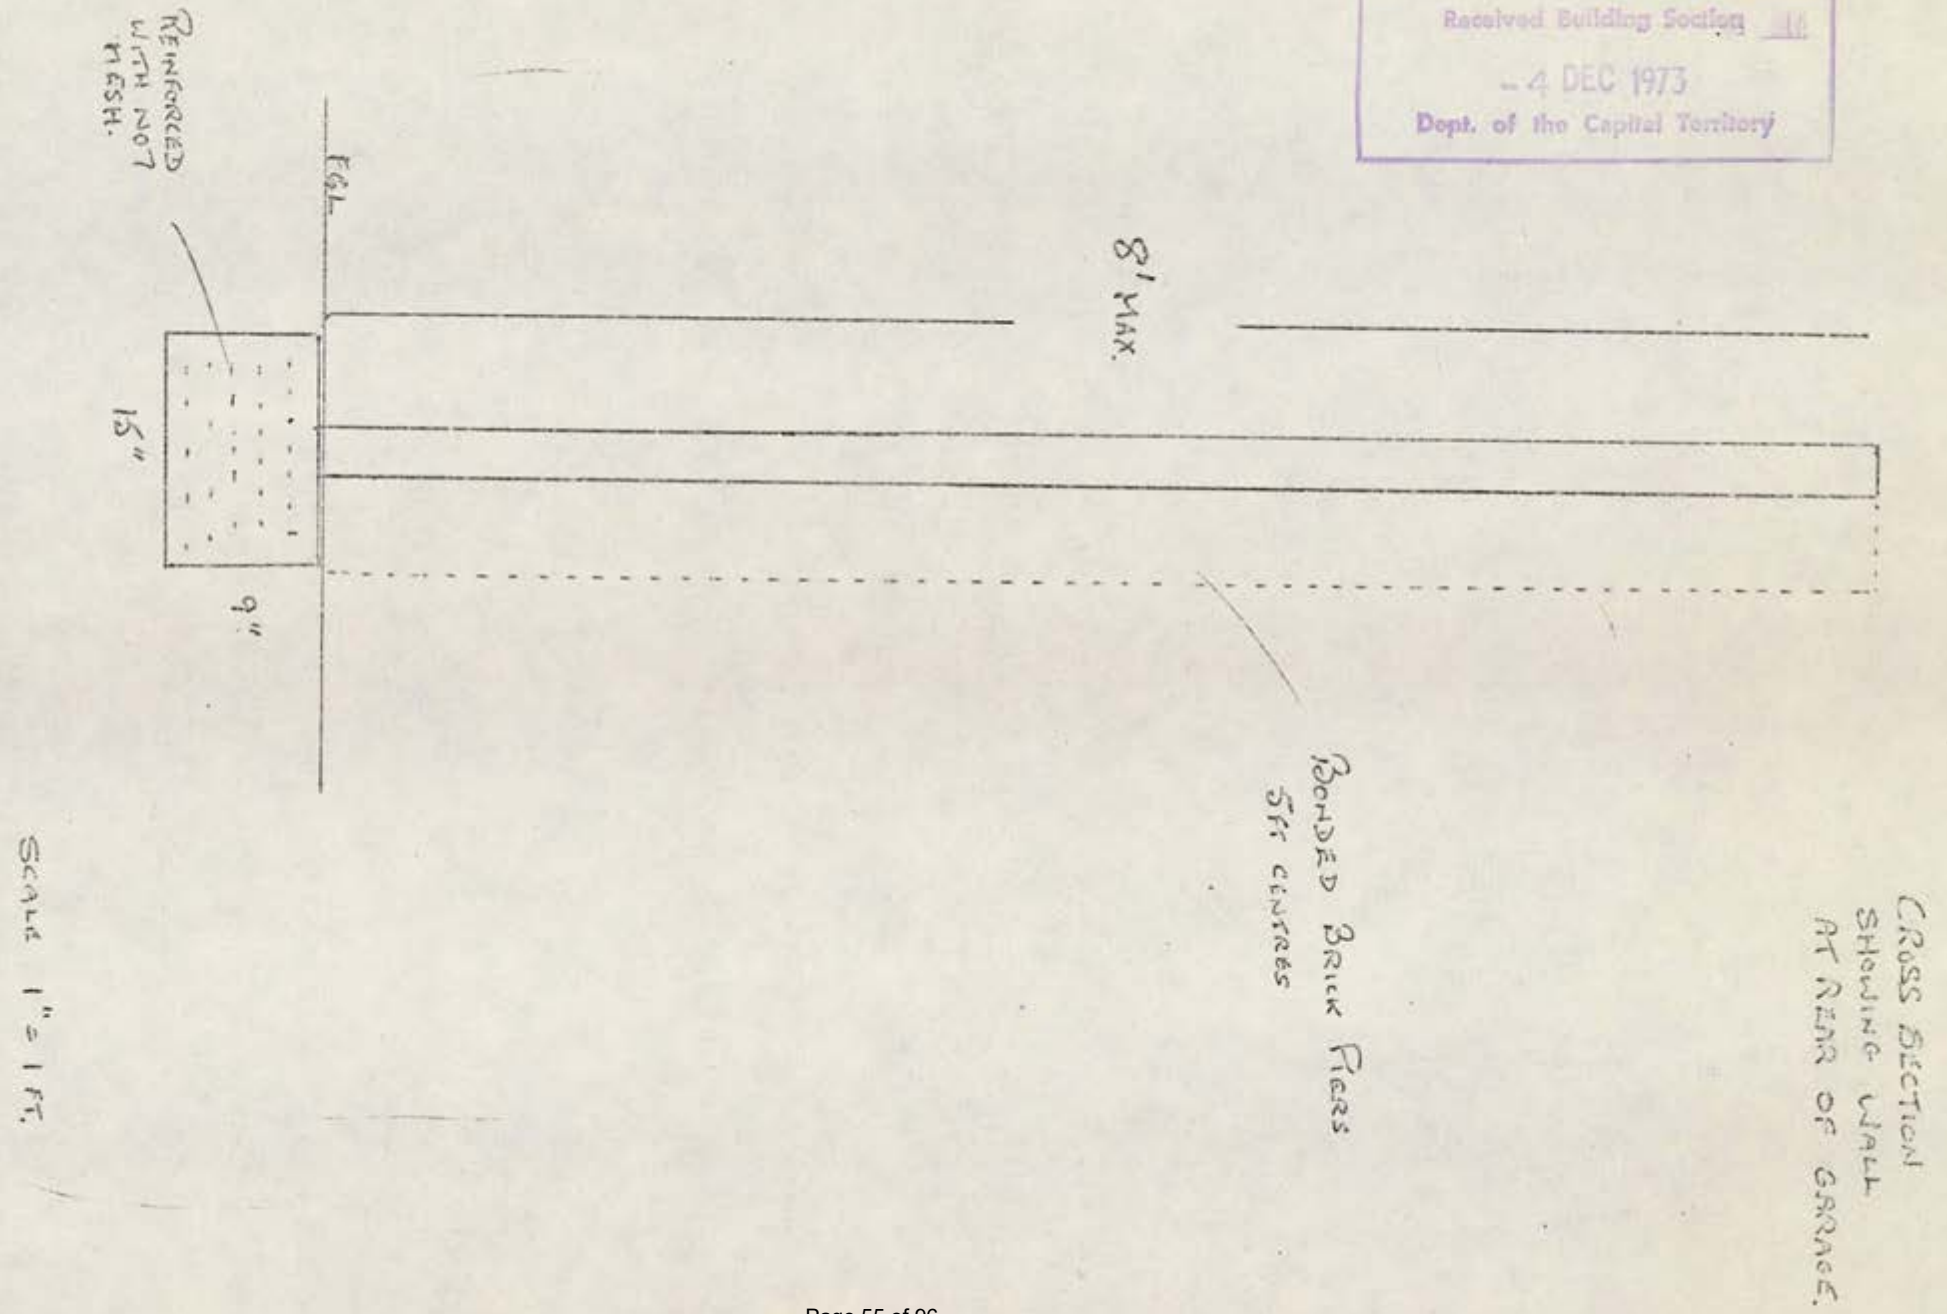
SCALE $\frac{1}{4}'' = 1'$

BRICKS
 BRICKS TO MATCH EXISTING
 OF HOUSE AND TO BE TIED
 EXISTING 2" PIPES BY TIE
 WELDED TO PIPES AT EVERY
 FOURTH BRICK.

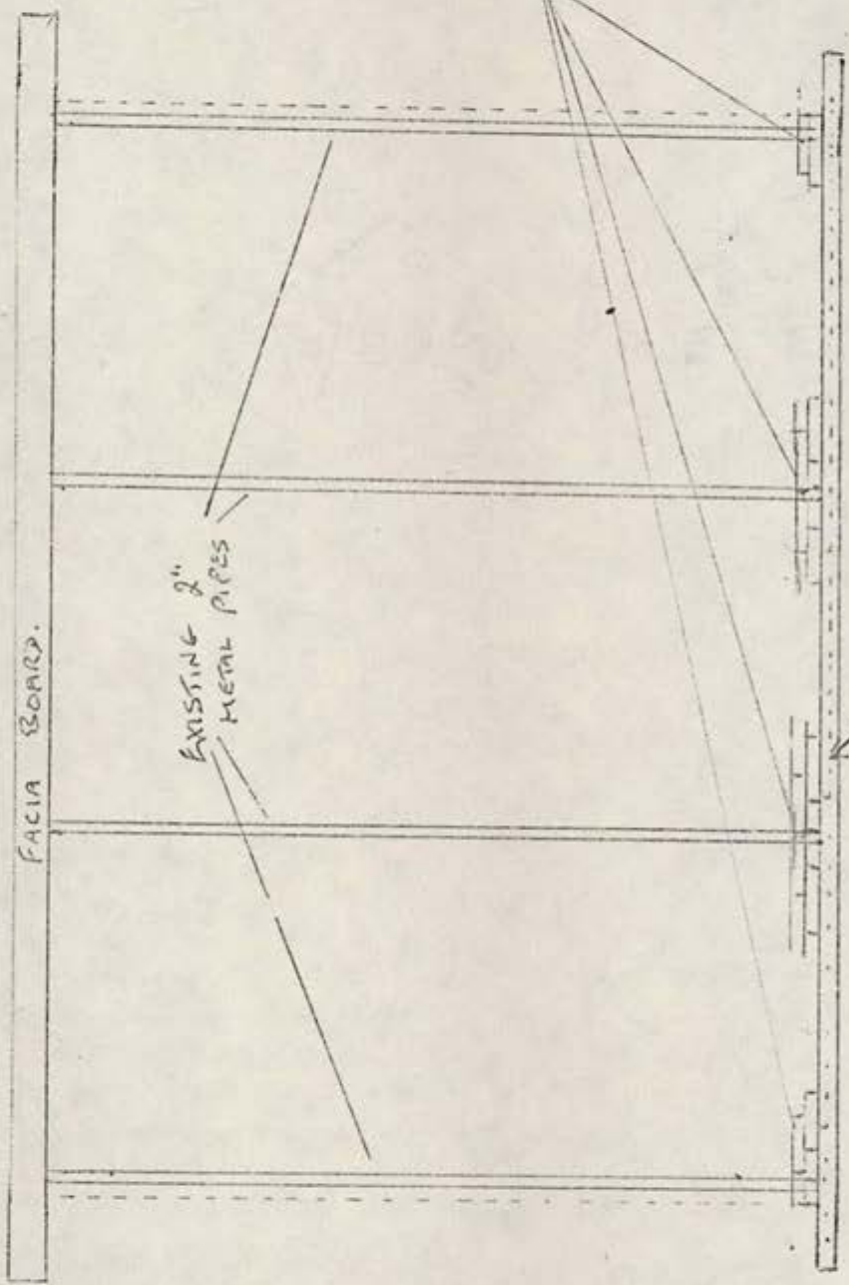
EXISTING CAR PORT FLOOR
 MIN 4" REINFORCED
 WITH No. 7 MESH.

ROOF OF HOUSE.

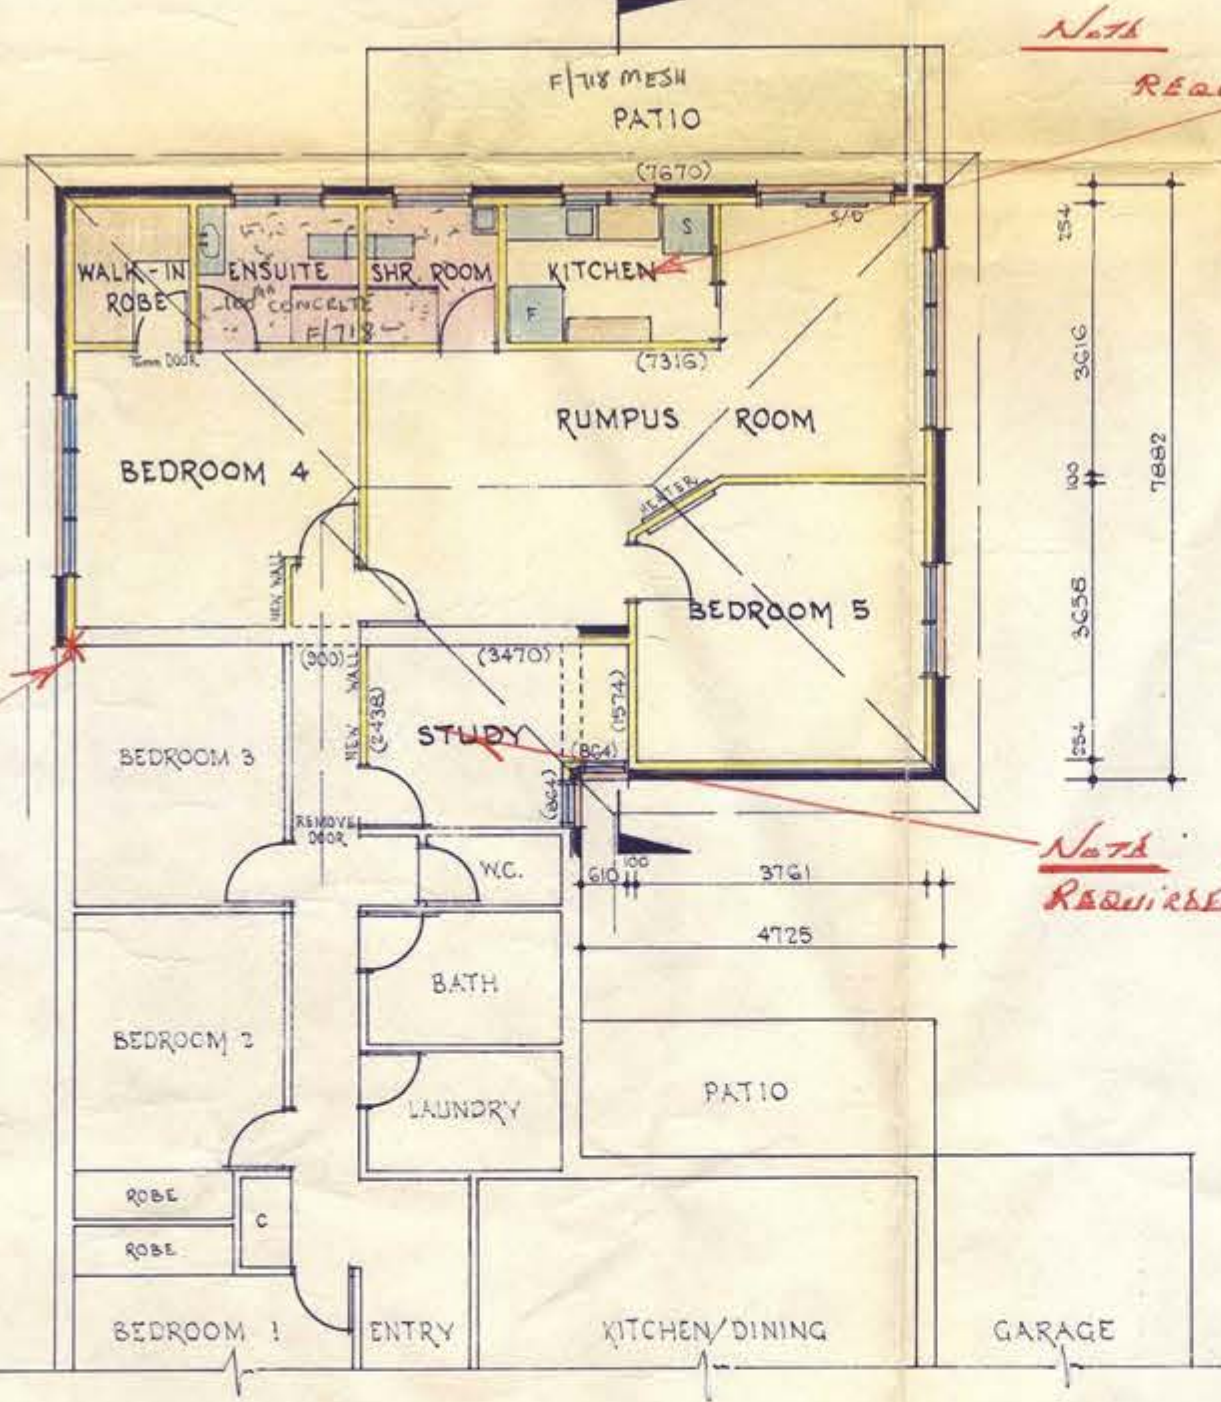
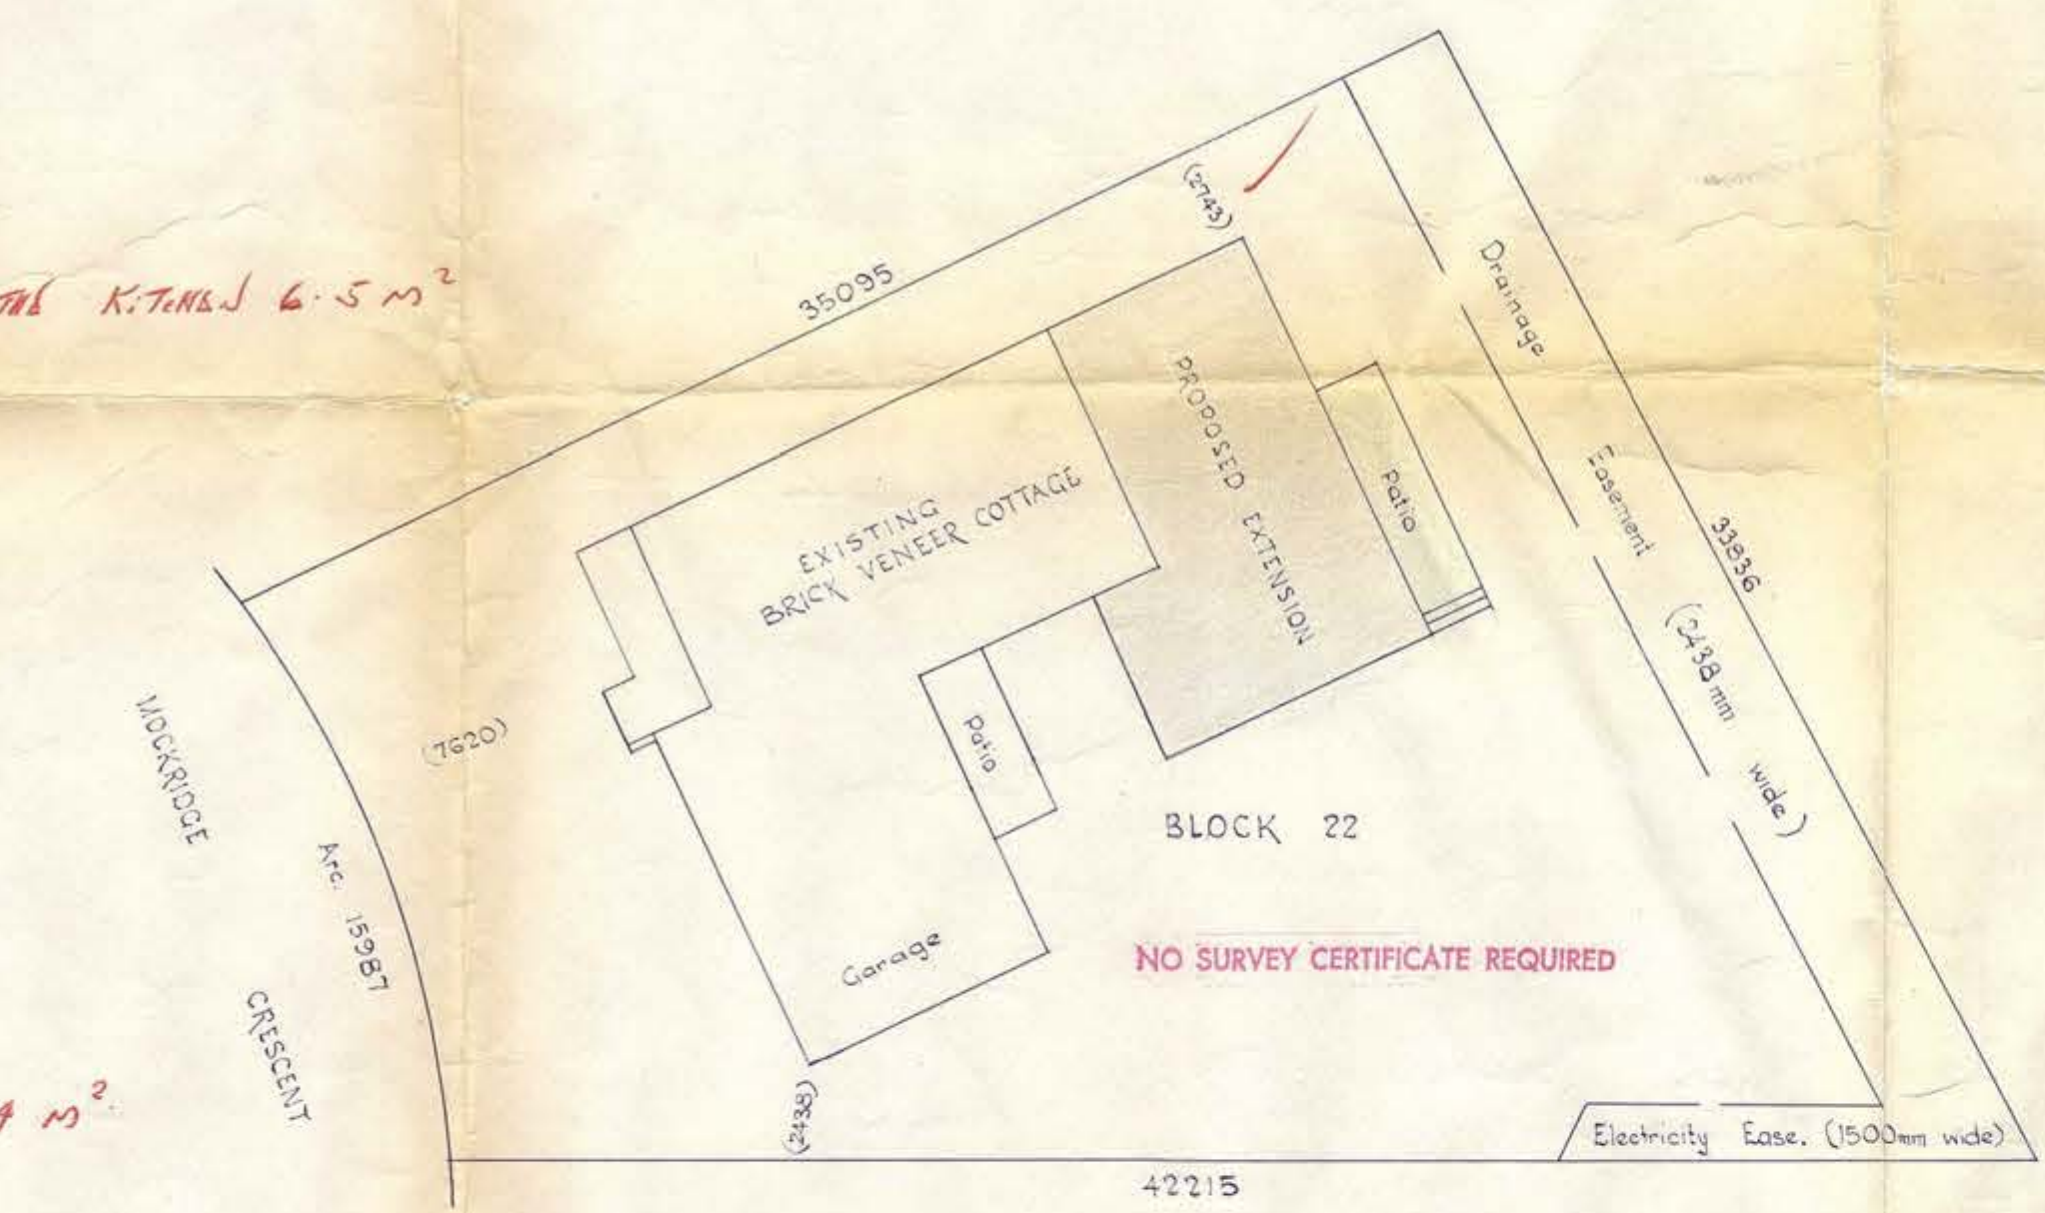
SITE PLAN (Scale = 1:200)

Note REQUIRED FLOOR AREA OF THE KITCHEN 6.5 M²

Note FLOOR AREA OF STUDY 8.4 M²
 REQUIRED FLOOR AREA OF STUDY 8.4 M²

DEPARTMENT OF CONSTRUCTION
 DEPARTMENTAL RECORDS INDICATE THAT PORTION OF THE EXISTING SANITARY DRAINAGE SERVICE WILL BE UNDER THE PROPOSED STRUCTURE. AN APPROVED SANITARY DRAINAGE PLAN SHOWING WHAT ACTION IS TO BE TAKEN TO PROTECT OR RELOCATE DRAINS UNDER THE PROPOSED STRUCTURE, AND ANY OTHER ALTERATIONS OR ADDITIONS TO SEWER DRAINAGE NECESSARY MUST BE OBTAINED AND FORM PART OF THE WORK CONNECTED WITH THIS PROJECT.

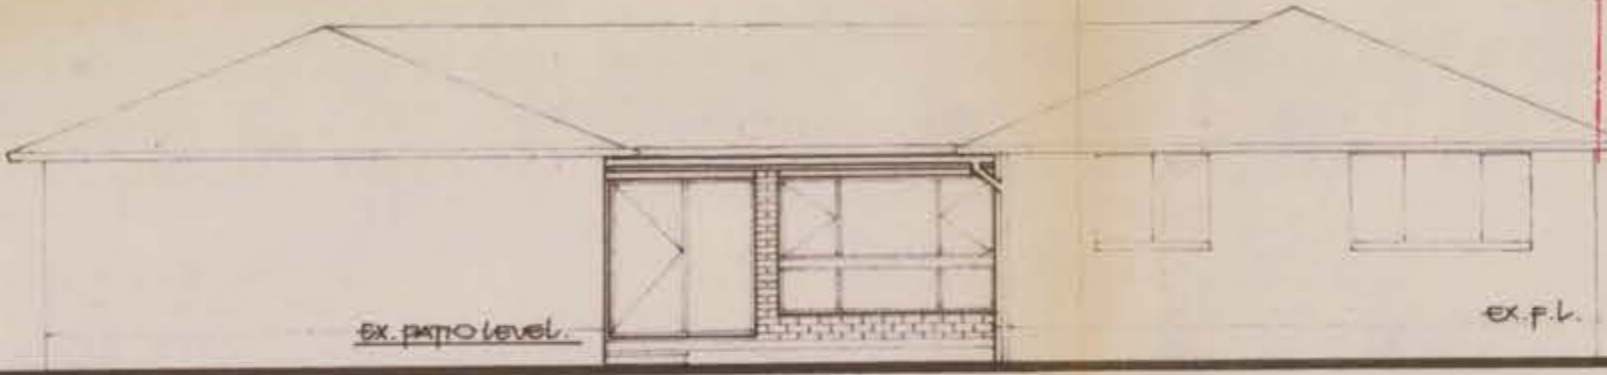
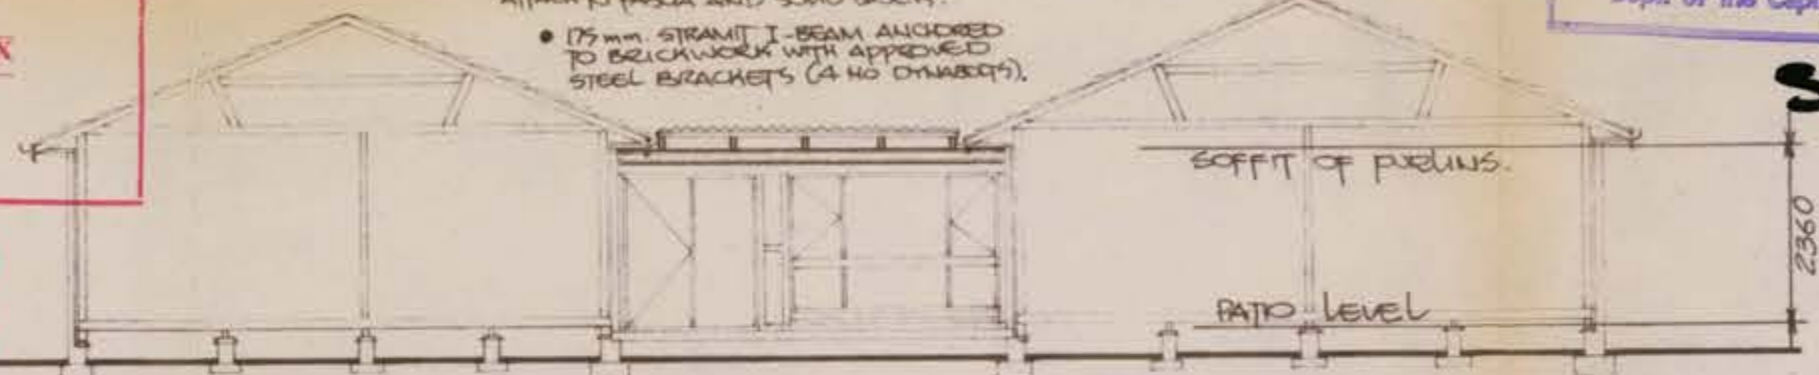
side elevation

INSTALL TO MANUFACTURERS
SPECIFICATION

- LIGHT BEAM ALUMINITE FIBERGLASS CLADDING OVER GRADED BATTENS GIVING 20mm FALL TO ROOF. FLASH AS NECESSARY TO EXCLUDE WATER.
- 90x45 PURLINS AT AV. 1000 CTS. ATTACH TO FASCIA AND SOLID BLOCK.
- 175 mm STRAMIT I-BEAM ANCHORED TO BRICKWORK WITH APPROVED STEEL BRACKETS (4 NO OVERBAYS).

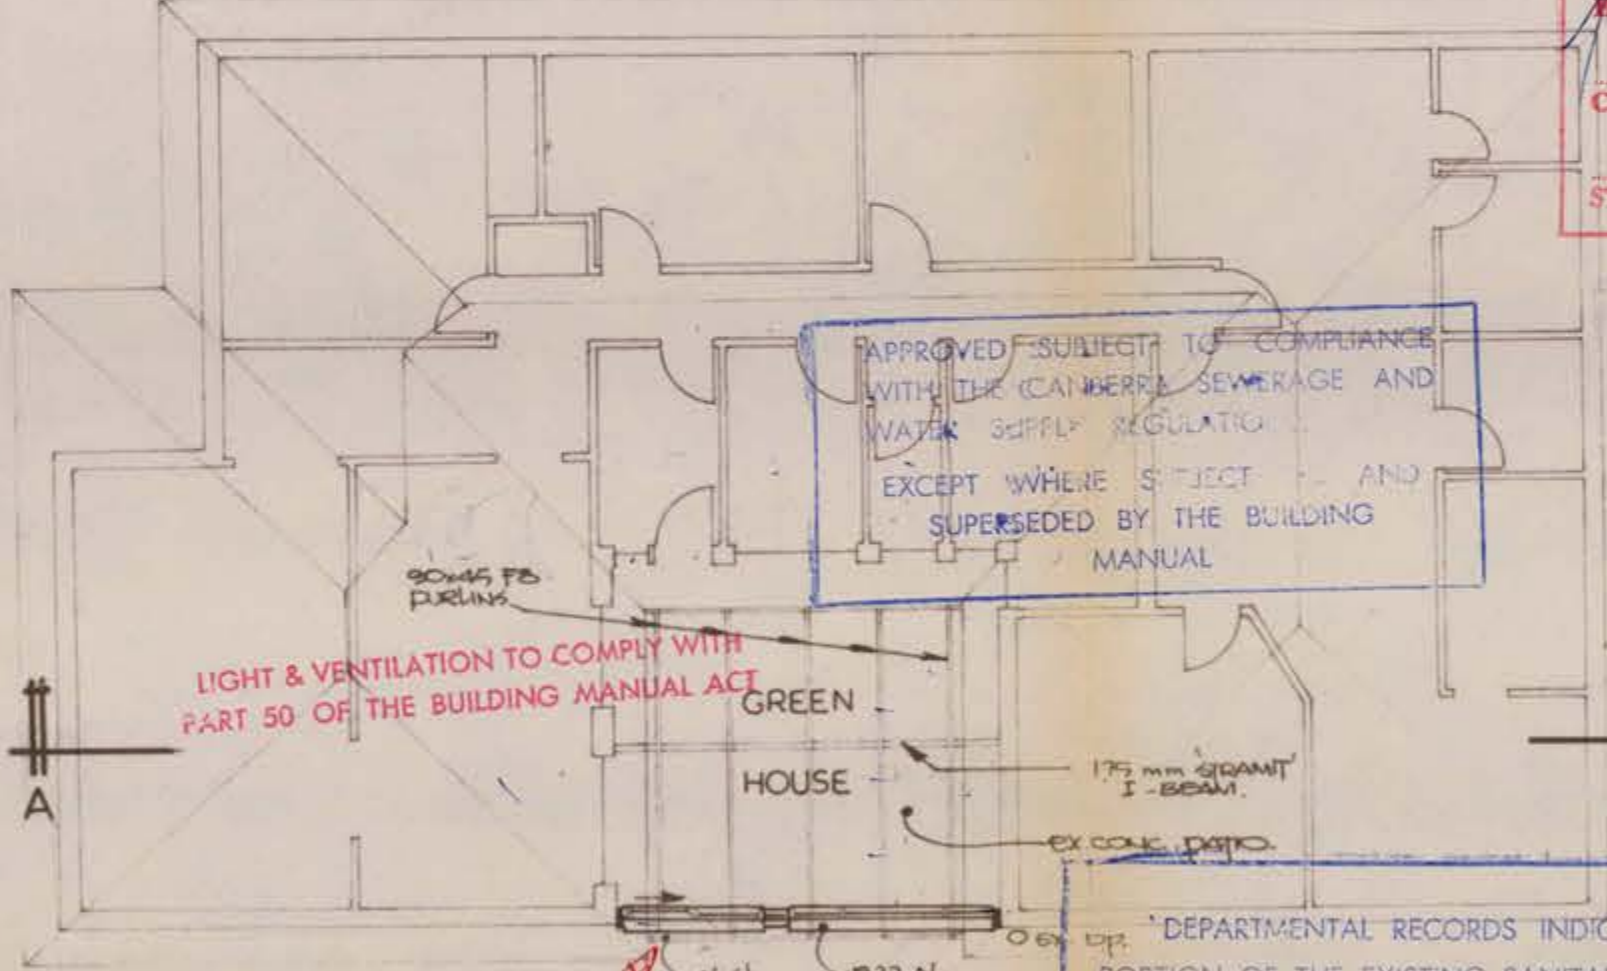
floor plan 1:100

section A-A

LIGHT & VENTILATION TO COMPLY WITH PART 50 OF THE BUILDING MANUAL ACT

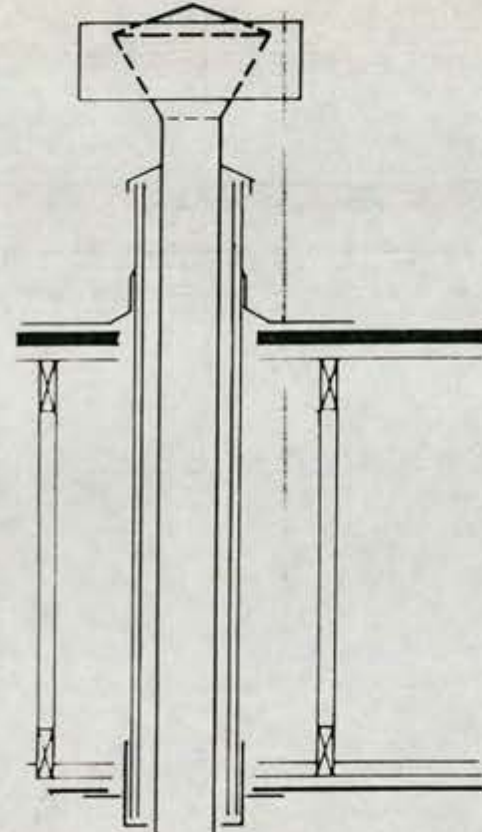
STANDARD ROOF KIT

RAIN CAP SLEEVE USED TO TERMINATE SECOND AND THIRD SKIN OF FLUE

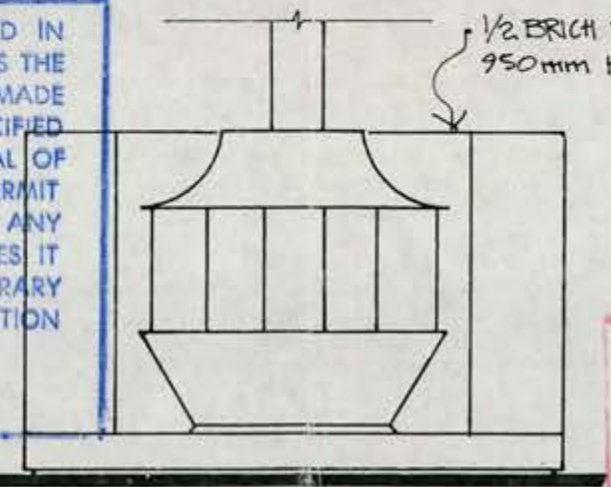
ELEVATION

1/2 BRICK WALL 950 mm HIGH

BRICK HEARTH
12 mm A.C. SHEET
EXISTING TIMBER FLOOR

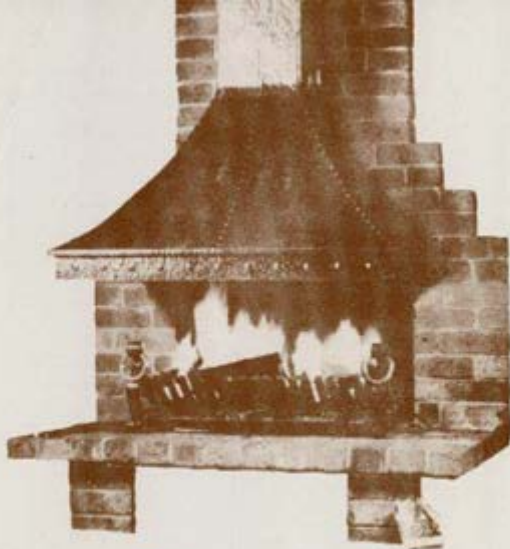
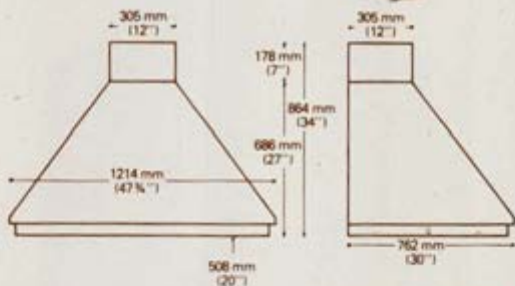
SPECIFICATIONS for Spin 'A' Fire.

MODEL	A	B	C	D	E	F	G	H	I	J	K	L
Spin 'A' Fire	1320	915	406	1270	1473	813	242	330	306	889	749	680
	52"	36"	16"	50"	58"	32"	9 1/4"	13"	12"	35"	29 1/4"	26 1/4"

Standard height from floor to ceiling (including hearth as illustrated)
 2740 mm (9' 0")

Dimensions of Brick Hearth approx:- 1680mm x 940mm
 (66" x 37")

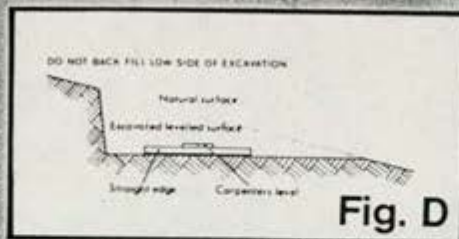
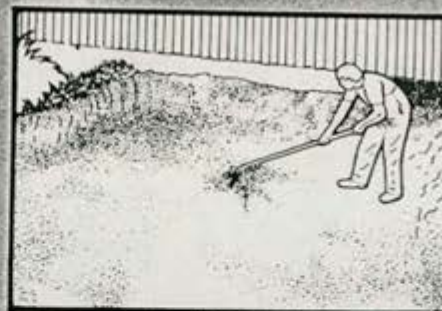
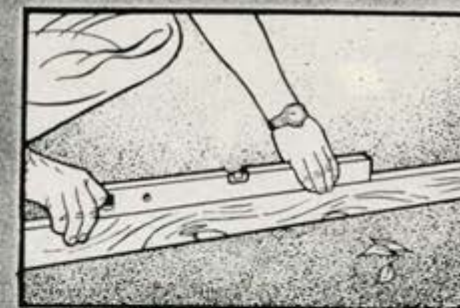
Preparation of Site

8. Preparation of site

The ground upon which your pool is to be erected must be firm and level within 25mm. Mark out the required area (Fig. C). If necessary dig out the high side, check with carpenter's level and straight edge (Fig. D). The success of your installation depends entirely on how well the levelling is performed.

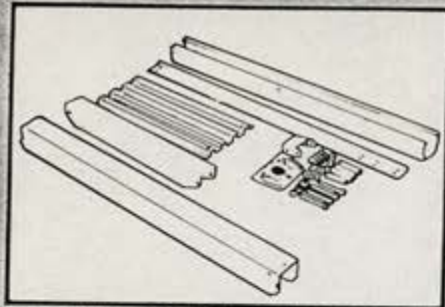
9. Preassembly of side support frame (Fig. A).

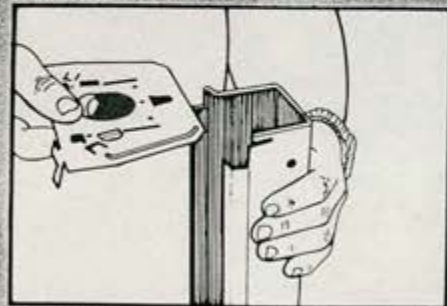
10. Fit connector plate (21) onto the bottom of vertical support (23).

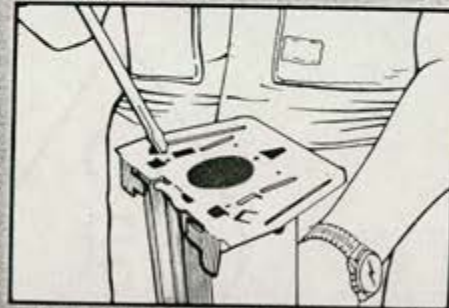
11. Push tabs to hold connector plate in position.

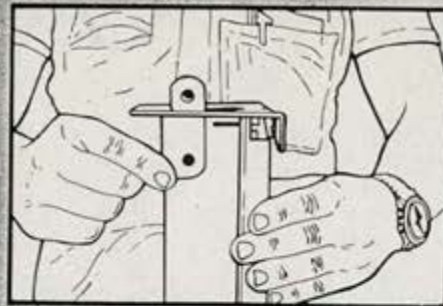
12. Push base channel connector (20) down through connector plate.

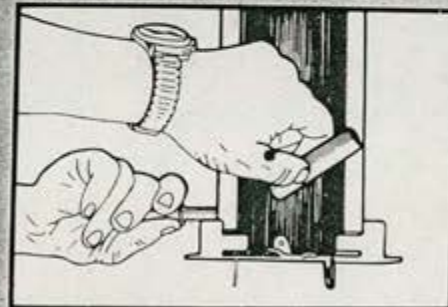
13. Place spacer (19) inside vertical support.

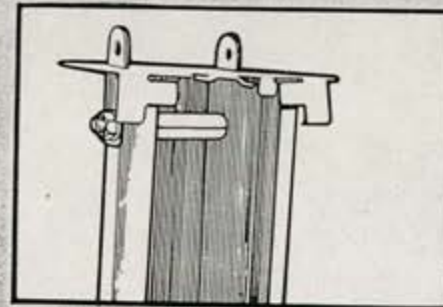
14. Secure connector and vertical with long bolt (13) making sure that the bolt goes through the spacer. Loosely tighten with nut and washer (16 and 17).

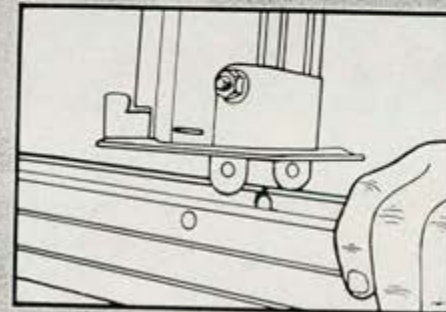
15. Push vertical and connector onto base channel (14).

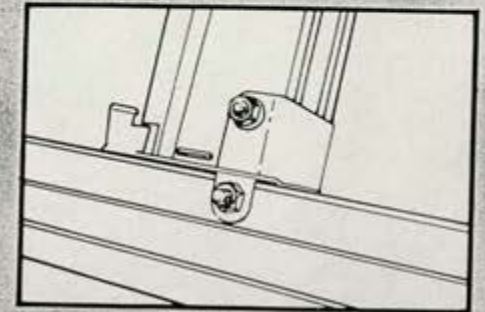
16. Fasten loosely with bolt, spacer, nut and washer.

Note: Make sure that open side of vertical is facing the 4 small holes in base channel.

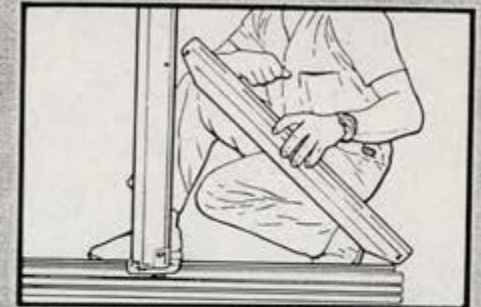
17. Connect diagonal brace (30) onto vertical and base channel using long bolts, spacer, nuts and washers.

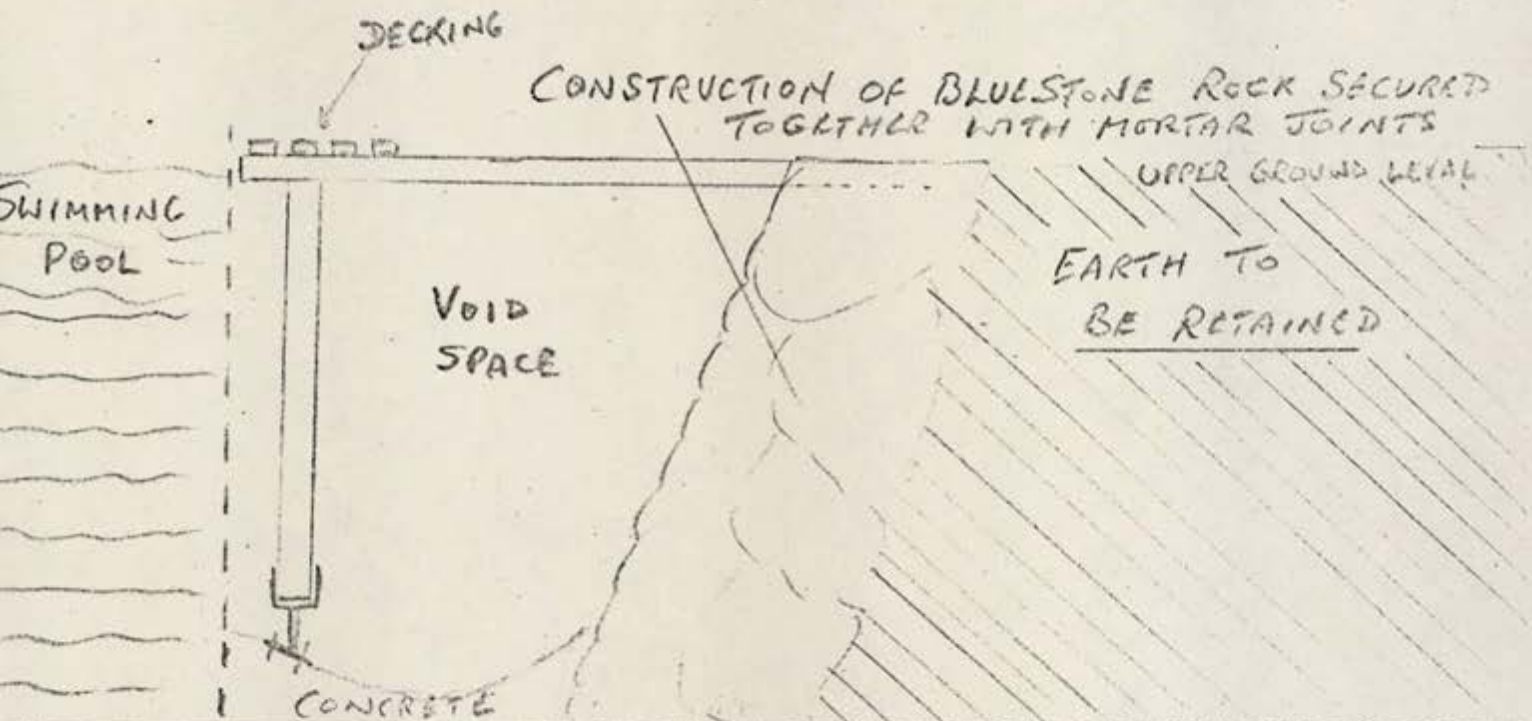
(ALL RETAINING WALLS SIMILAR IN
CONSTRUCTION)

AVERAGE HEIGHT
800 MM

LOWER GROUND LEVEL

READY MIX
CONCRETE

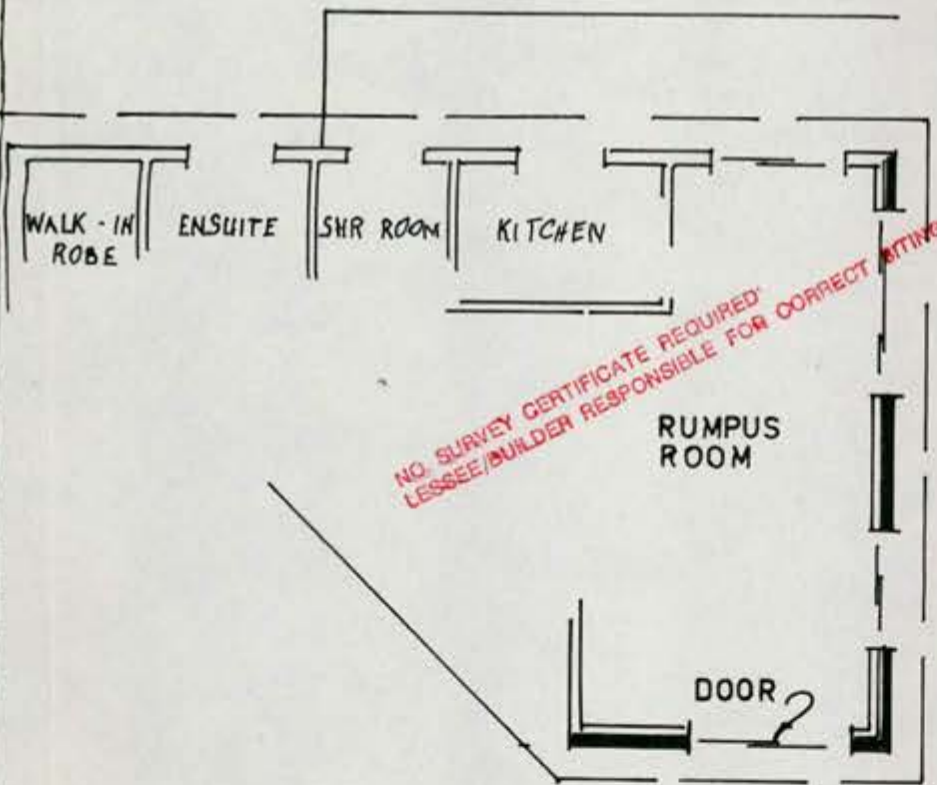
PLAN & CROSS SECTION
ALUMINIUM SLIDING DOOR
BLOCK 22
SECTION 25
HOLT
AS IS CONSTRUCTED
