Report

Building Report

CONCLUSION AND SUMMARY

Property Address: 33 Mockridge Crescent, Holt ACT 2615
Client: Deacon
Inspection Date: Friday, May 1st 2026
Inspection carried out by: Dylan Mitchell

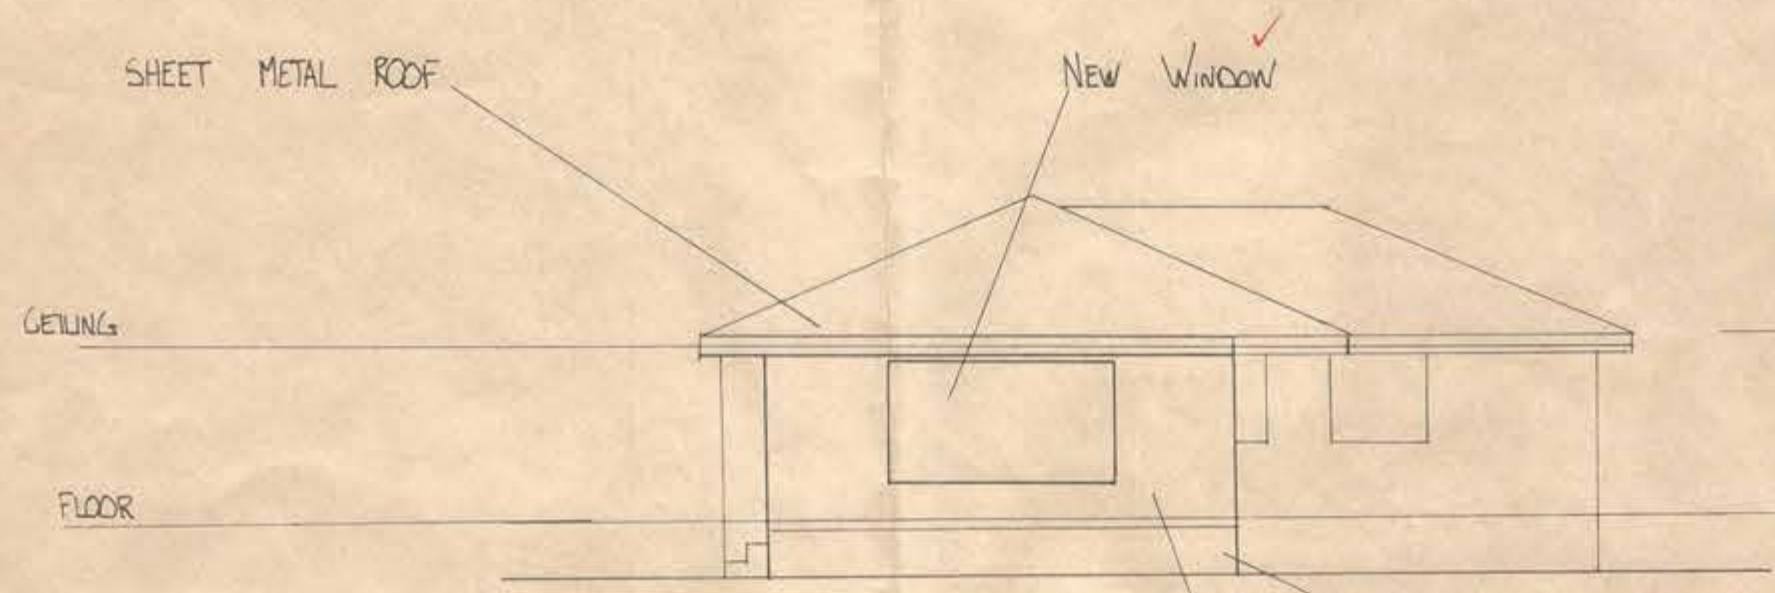
EAST ELEVATION
 1:100
 EXISTING LANDING
 HARDI-FLEX CLADDING

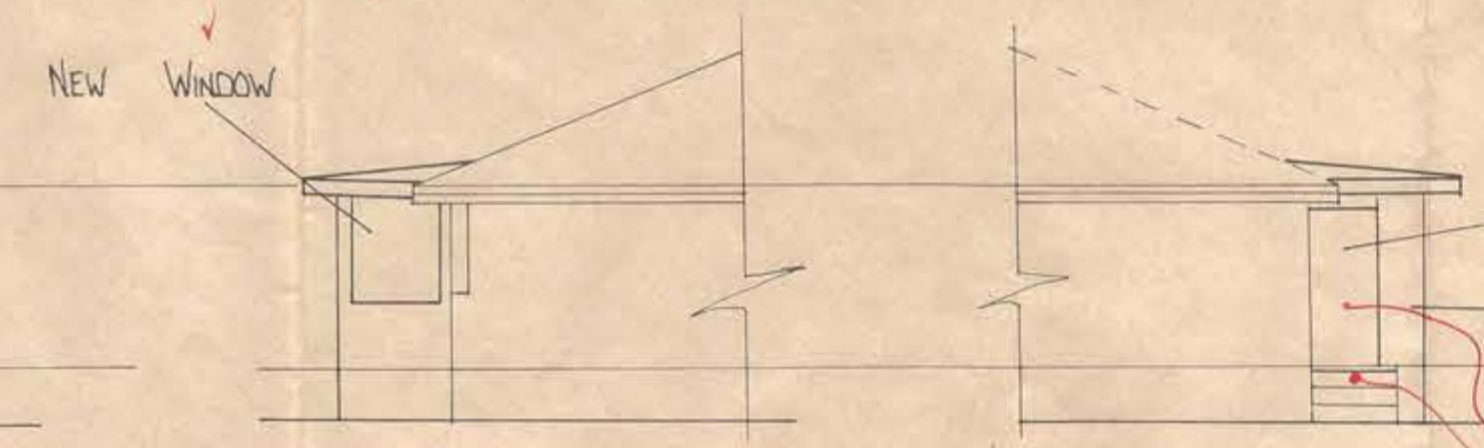
NORTH ELEVATION
 1:100
 SOUTH ELEVATION
 1:100

*if door opens out.
 provide landing.*

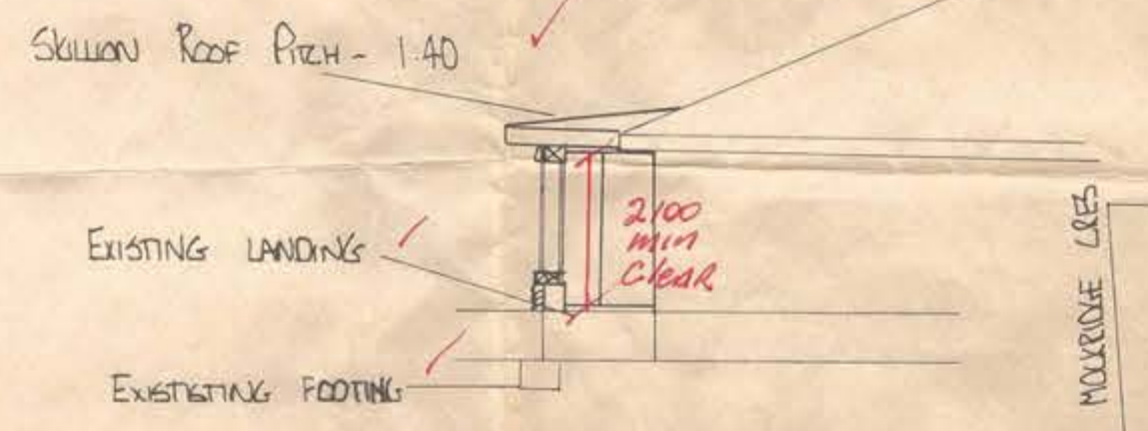
SECTION A-A

WALL FRAME TO BE F5 PINUS RADIATA
 90x45 STUDS AT 450 & 90x45 BOTTOM
 PLATE, NOGS. AND TOP PLATE
 25x16 GAL STEEL DIAGONAL BRACING

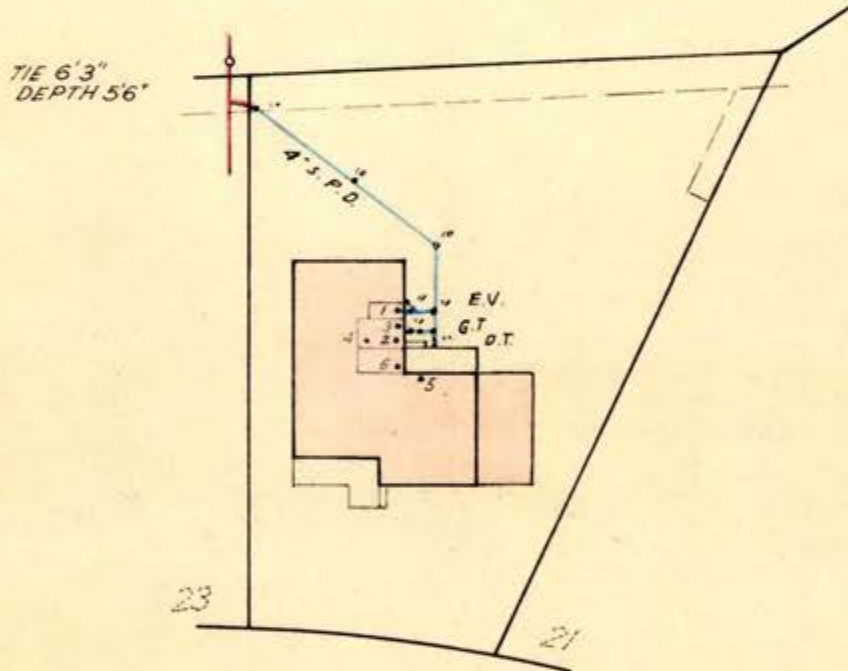
NOTES — DRAINS TO BE LAID ARE SHOWN IN BLUE LINES.
 THIS PLAN TO BE READ IN CONJUNCTION WITH APPROVED ARCHITECTURAL DRAWINGS AND SPECIFICATIONS.
 DRAINS TO BE DELETED SHOWN BY RED — X.
 EXISTING DRAINS SHOWN IN GREEN LINES.
 POSITION OF BRANCH TO BE LOCATED BEFORE ANY WORK IS COMMENCED.

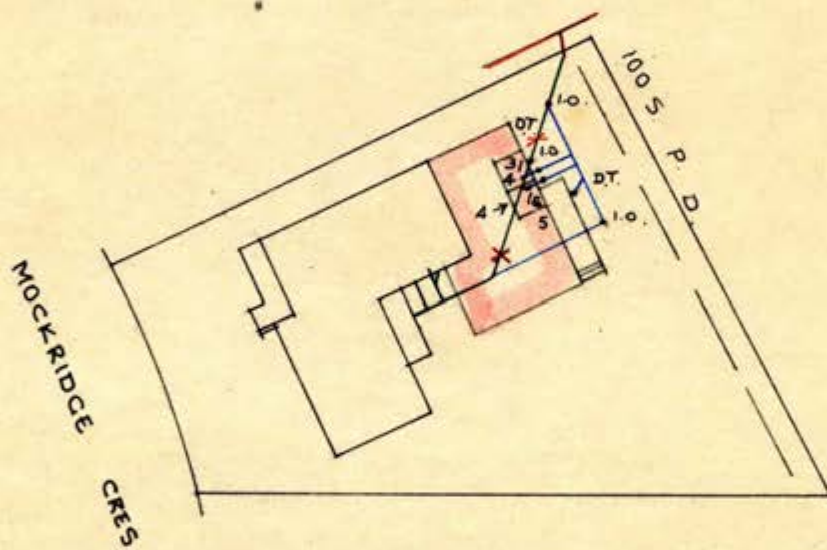
- DRAINS TO BE LAID ARE SHOWN IN BLUE LINES. THIS PLAN TO BE READ IN CONJUNCTION WITH APPROVED ARCHITECTURAL PLANS AND SPECIFICATIONS.
- DRAINS TO BE DELETED SHOWN BY RED X. EXISTING DRAINS SHOWN IN GREEN LINES.
- POSITION OF BRANCH TO BE LOCATED BEFORE ANY WORK IS COMMENCED.
- ~~DRAINS TO BE LAID IN U.P.V.C. UNPLASTICISED POLYVINYL CHLORIDE IN ACCORDANCE WITH A.S.A. GA 67-1972 AND CANBERRA CODE OF PRACTICE ISSUE 1 JULY 1974.~~
- DRAINS BELOW BUILDINGS MUST BE RETESTED. DRAINS HAVING CEMENT JOINTS MUST BE TOTALLY SURROUNDED BY CEMENT CONCRETE 150 mm THICK.
