Report

Building Report

CONCLUSION AND SUMMARY

Property Address: 10 Elliott St, Campbell ACT 2612
Client: McCormack & Wright
Inspection Date: Friday, April 10th 2026
Inspection carried out by: Duncan Clark

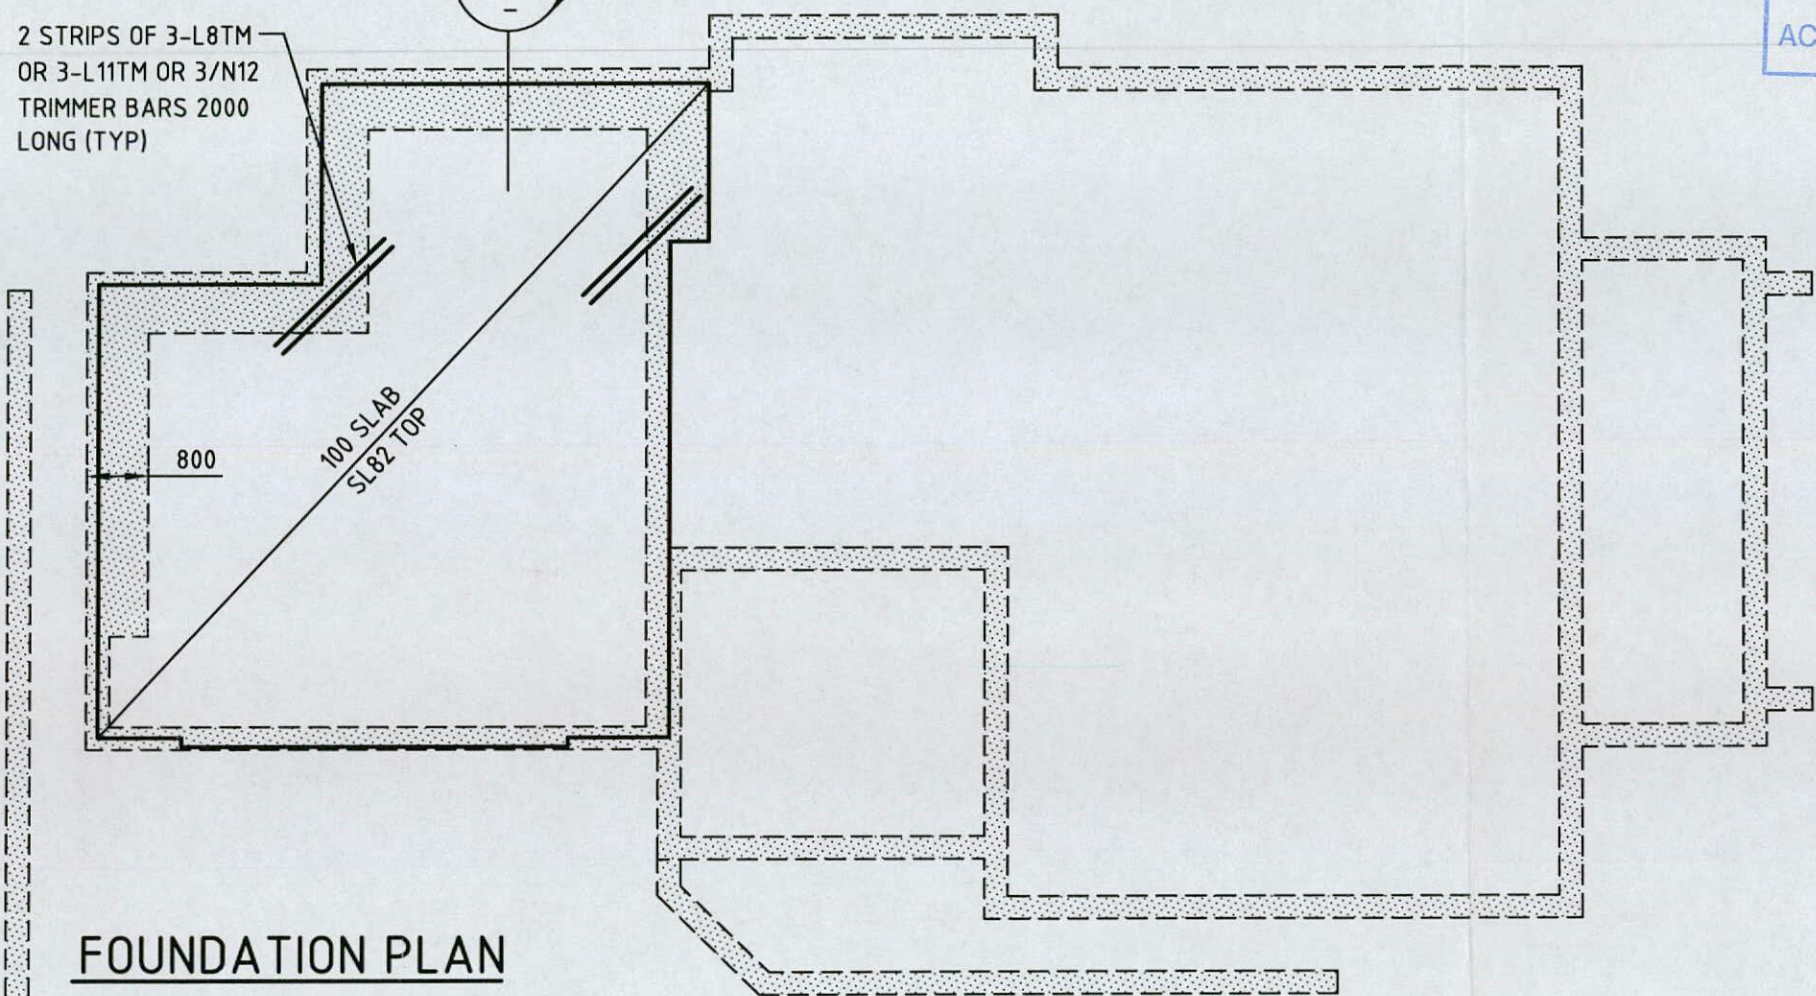
FOUNDATION PLAN

SLAB THICKNESS 100 UNO
 SLAB REINFORCEMENT SL82 TOP UNO
 PROVIDE VAPOUR BARRIER UNDER SLAB
 REFER TO ARCHITECTS DRAWINGS FOR SLAB RL'S
 ALL FOOTINGS 300 WIDE x 500 DEEP UNO

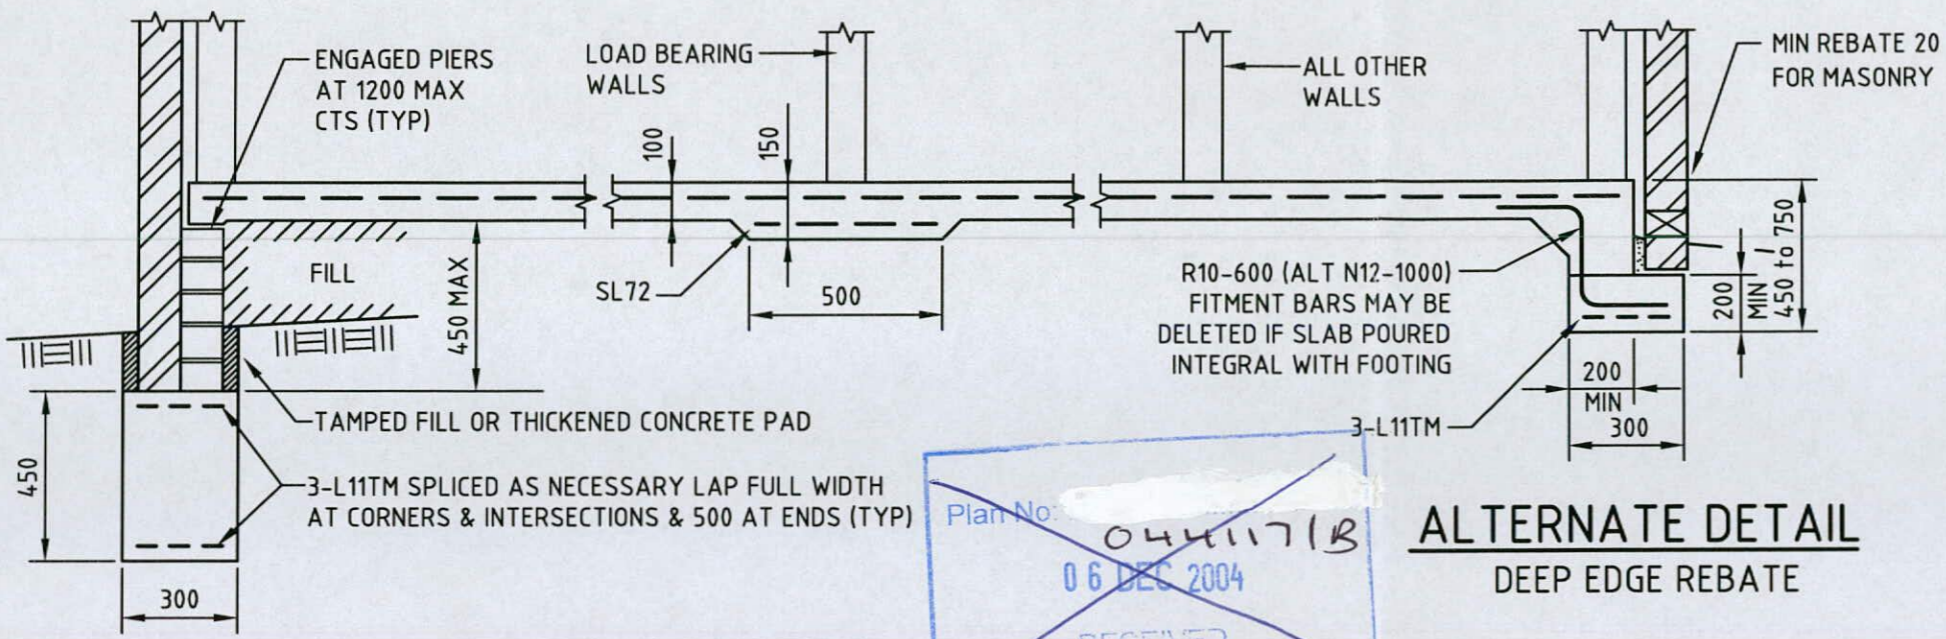
FOOTING SYSTEM

ARTICULATED MASONRY VENEER
 SLAB FABRIC SL72 TOP FOR SLAB LENGTH <18m
 SLAB FABRIC SL82 TOP FOR SLAB LENGTH ≥18m & <25m
 SLAB FABRIC SL92 TOP FOR SLAB LENGTH ≥25m & <30m

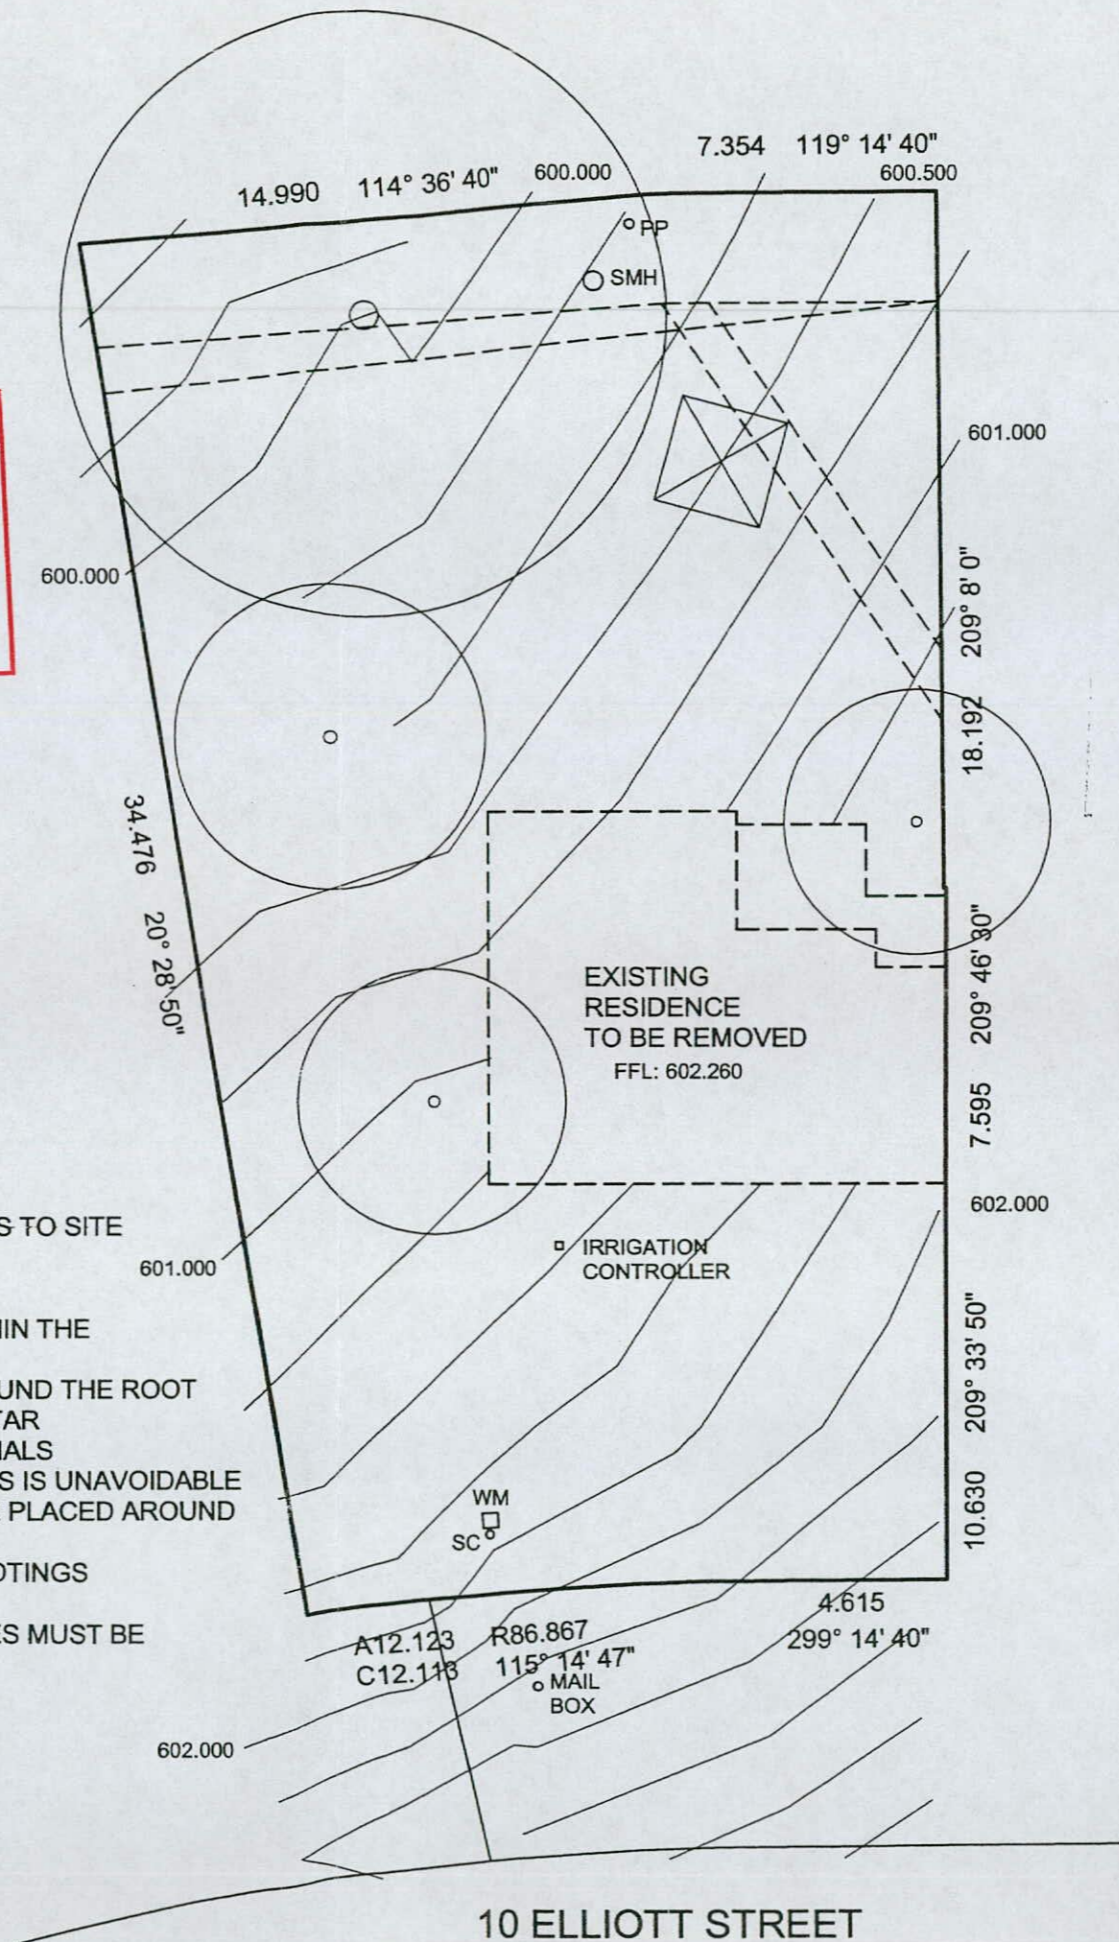
DEMOLITION PLAN

- 1 NO SITE SHEDS, BUILDINGS OR VEHICULAR PARKING WITHIN THE ROOT ZONE (DRIP ZONE + 2m)
- 2 TEMPORARY PROTECTIVE ENCLOSURE IS REQUIRED AROUND THE ROOT ZONE OF THE TREE GROUPS AND SHOULD CONSIST OF STAR PICKETS WITH ORANGE PLASTIC WOVEN FENCING MATERIALS
- 3 WHERE PLANT OPERATION IN CLOSE PROXIMITY TO TREES IS UNAVOIDABLE PROTECTIVE LASHING WITH TIMBER BATTENS SHOULD BE PLACED AROUND TRUNK OF TREES
- 4 THERE SHOULD BE NO EXCAVATION OF SERVICES OR FOOTINGS WITHIN 3m OF THE TREE TRUNK
- 5 EXCAVATION REQUIRED WITHIN THE DROP ZONE OF TREES MUST BE DONE BY HAND

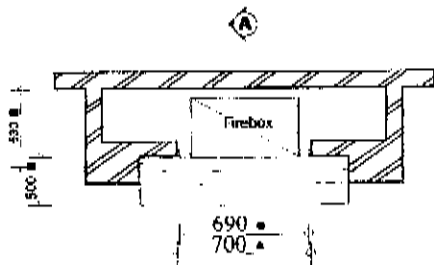
PLAN

Before building base confirm with cheminee

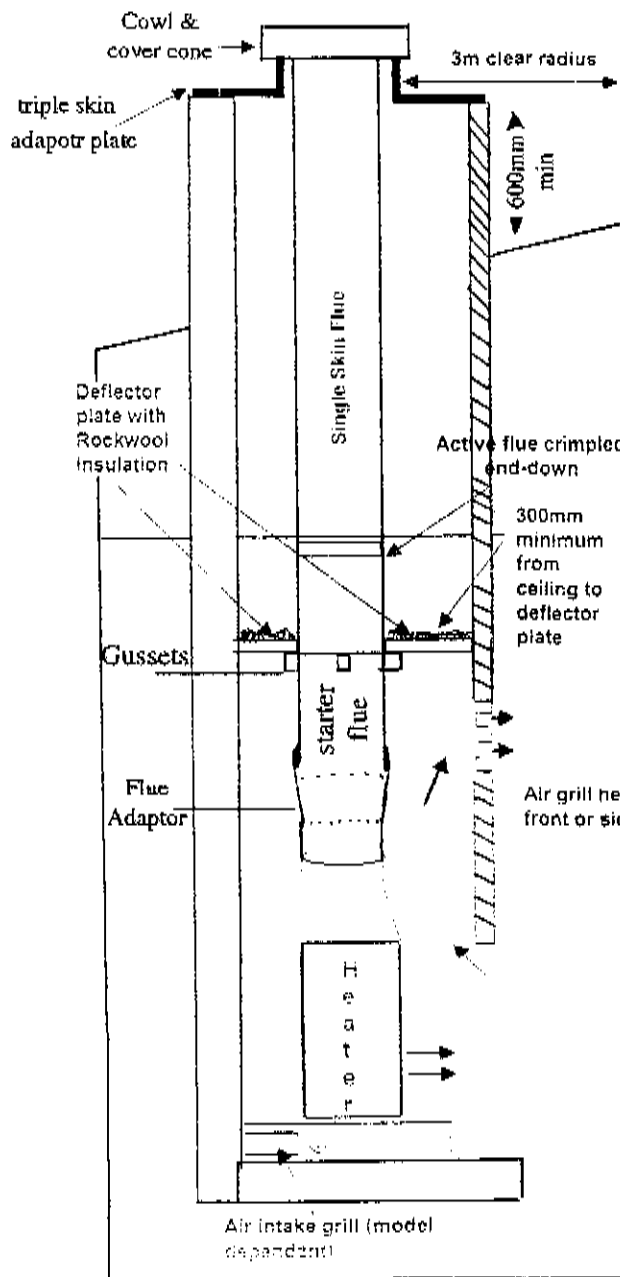
1. Place flue adaptor inside cast iron spigot tap down gently and pop rivet
2. crimped end of st/st flue to face downwards, the starter flue with gussets has no crimp.
3. Deflector plate to installed at 1800mm above the base of the firebox.
4. Deflector (steel gal supplied with Rockwool panels) to be set into course of brickwork by approx 30mm to ensure a good seal.
5. Any part of the brickwork forming part of an outside wall to be double brick construction with a cavity to avoid heat loss.
6. All flues to secured with 3 st/st rivets.

Air grill heat release can be on the front or side of chimney breast.

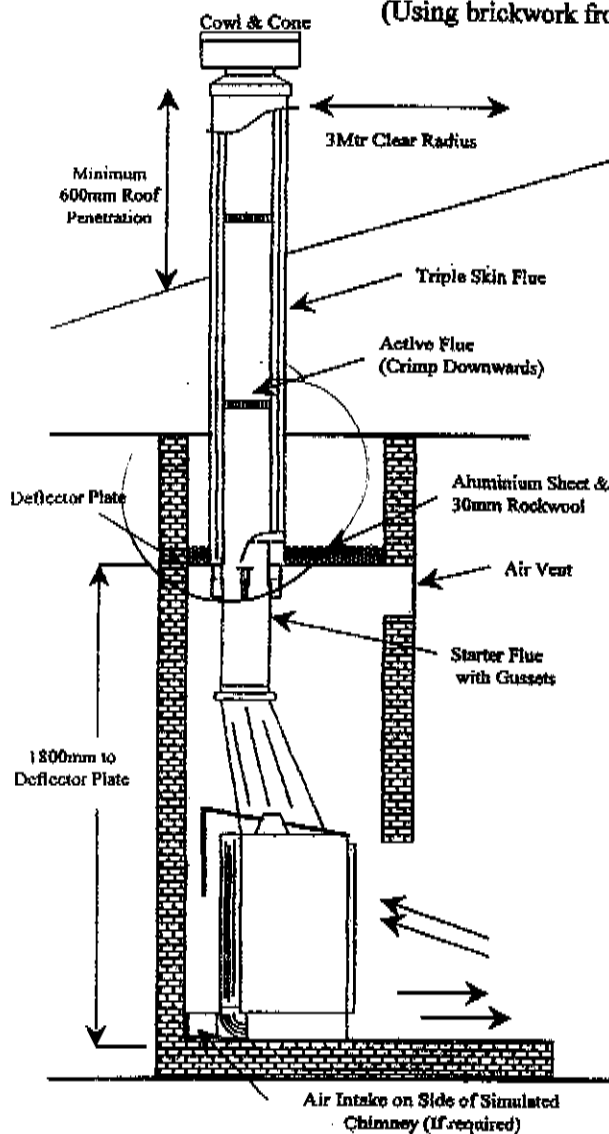
Flue Installation for Cheminees Phillippe Fireplaces

(Using brickwork from floor to ceiling)

1. Determine height of deflector assy and cut starter flue to achieve setup as per drawing. Ventilation slots of triple flue must be approx 30mm above top of Rockwool insulation

2. Fit starter flue (with Gussets) over outside of cast iron collar of firebox. Drill thru collar and secure with stainless steel screws or rivets (x3) Gussets to under side deflector

3. All stainless steel inner flues must be joined using stainless steel pop rivets
4. Set deflector plate into course of brickwork by 30mm to ensure a good seal

6. 50mm clearance is required from outer casing to timbers and other combustible material
7. Pick up weight off outer casing in roof space
8. At the termination height of the triple flue the active stainless steel inner must be 30mm higher than the middle and outer gal casing. The stainless steel skirt is screwed to the crimp of the outer casing the stainless steel cowl slides into the neck of the skirt and must locate inside the active flue below.

*Sketch Example of a Cheminees Phillippe
Simulated Chimney Installation*

- 16- Triple skin flue with stainless steel active flue (modular air flow type) shall be used when the masonry fireplace structure terminates at ceiling level 9" -13" flues to be riveted with stainless steel rivets.

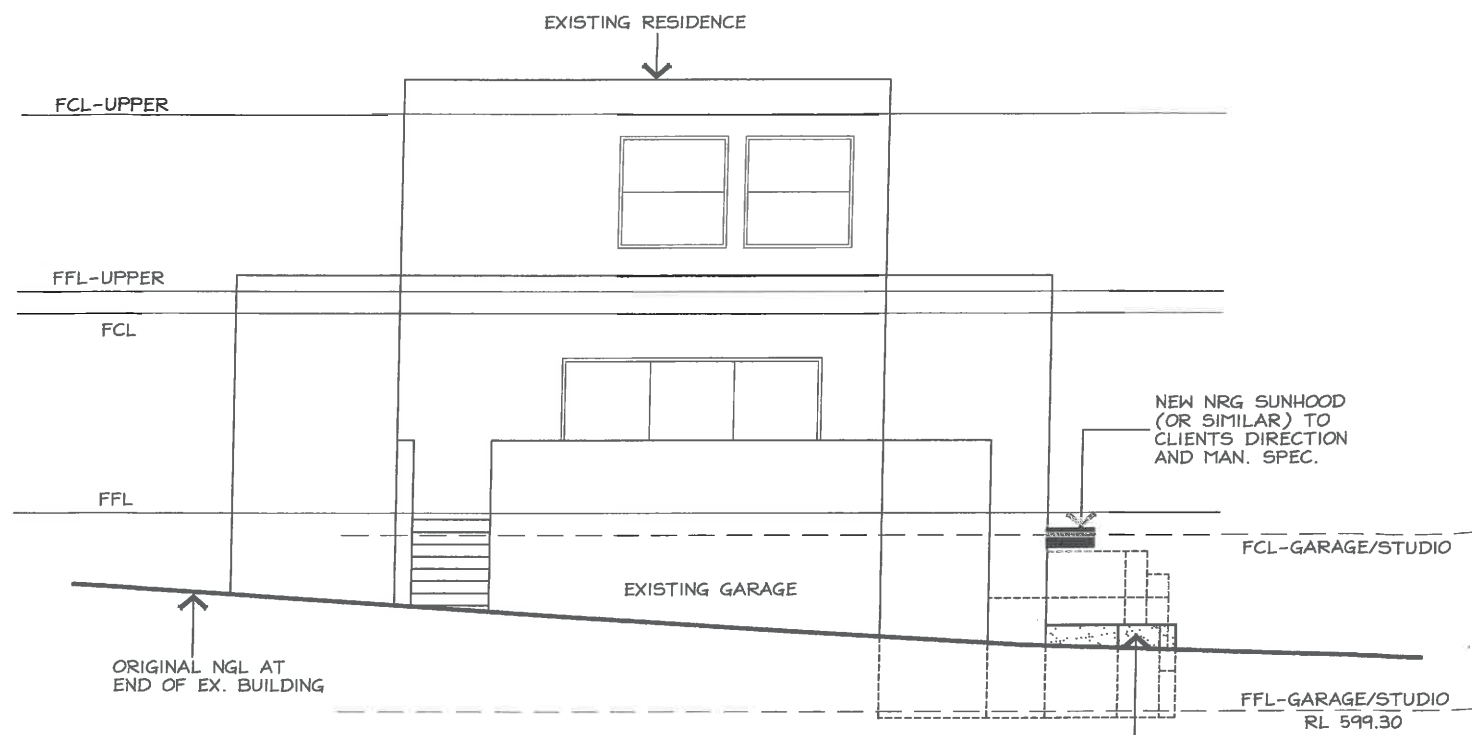
NORTH-EAST ELEVATION

NEW RETAINING WALL TO SUIT NEW STUDIO TO CLIENTS DIRECTION AND ENGINEER'S SPEC. WITH 1m MIN. HIGH FENCE ON TOP

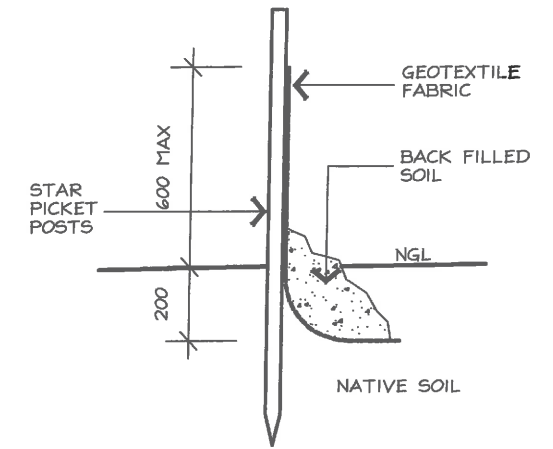
SEDIMENT CONTROL DETAIL

INSTALL A SEDIMENT CONTROL BARRIER OF GEOTEXTILE FABRIC ON THE LOW SIDE/S OF THE BLOCK (AS NOTED ON THE SITE PLAN AND AS PER DETAIL)

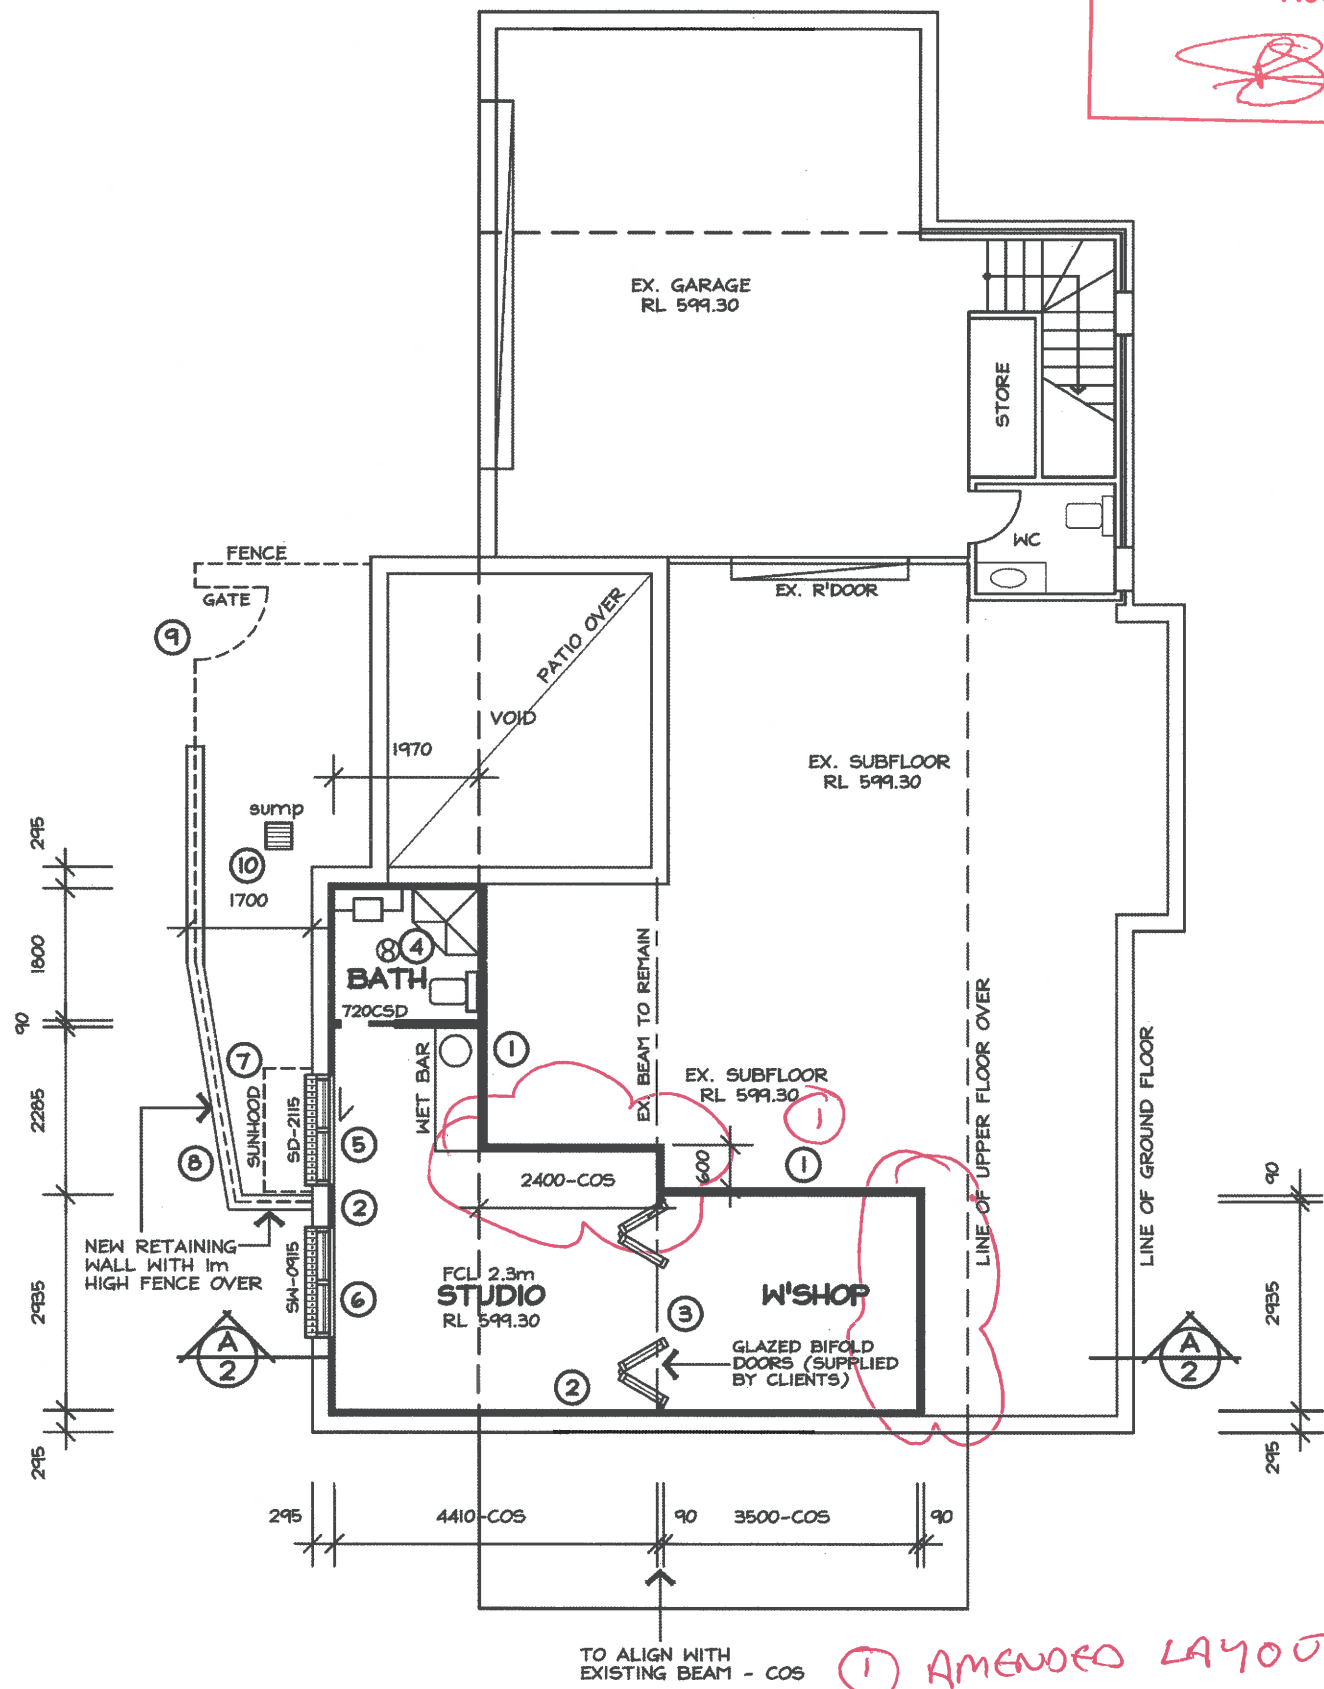
GARAGE FLOOR PLAN

① AMENDED LAYOUT

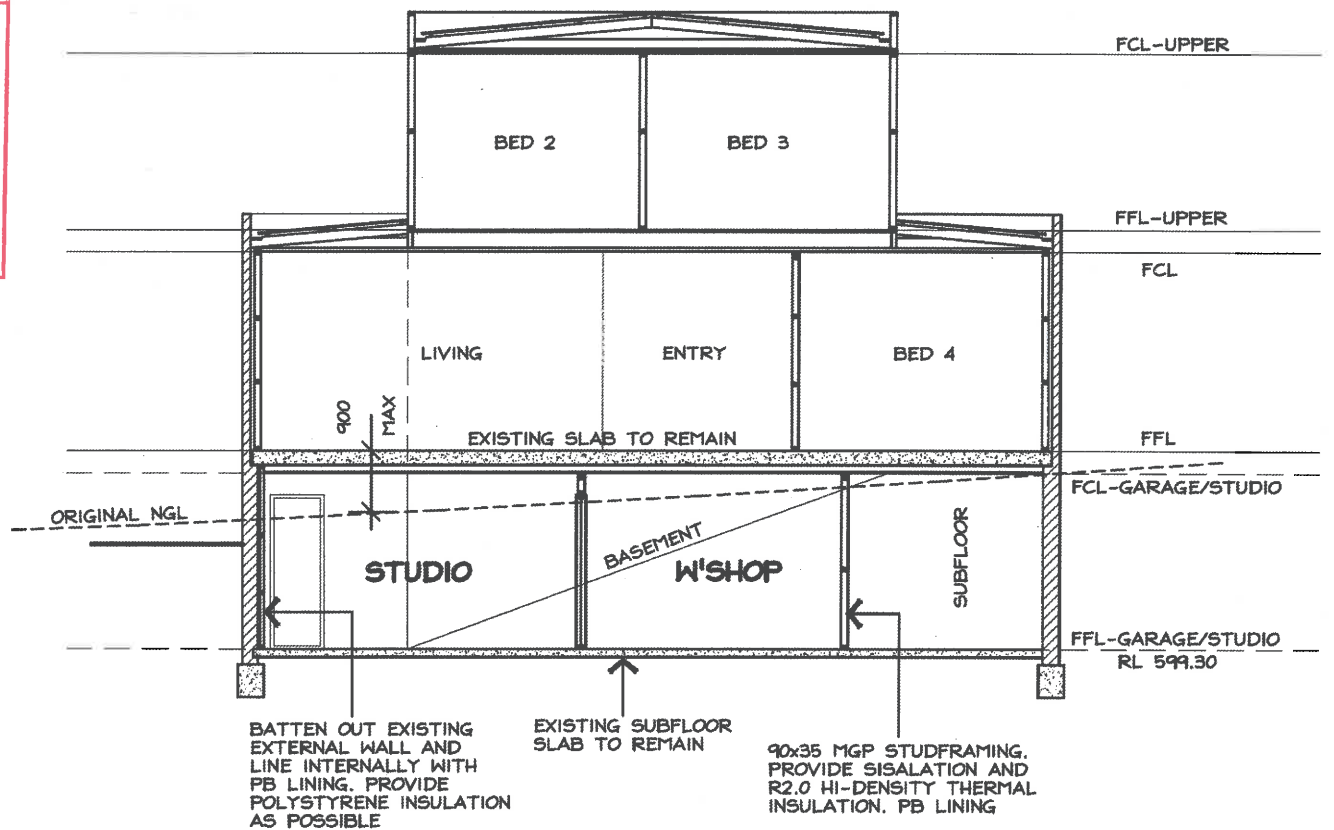
SECTION A-A

BATTEN OUT EXISTING EXTERNAL WALL AND LINE INTERNALLY WITH PB LINING. PROVIDE POLYSTYRENE INSULATION AS POSSIBLE
 EXISTING SUBFLOOR SLAB TO REMAIN
 90x35 MGP STUDFRAMING. PROVIDE SISALATION AND R2.0 HI-DENSITY THERMAL INSULATION. PB LINING

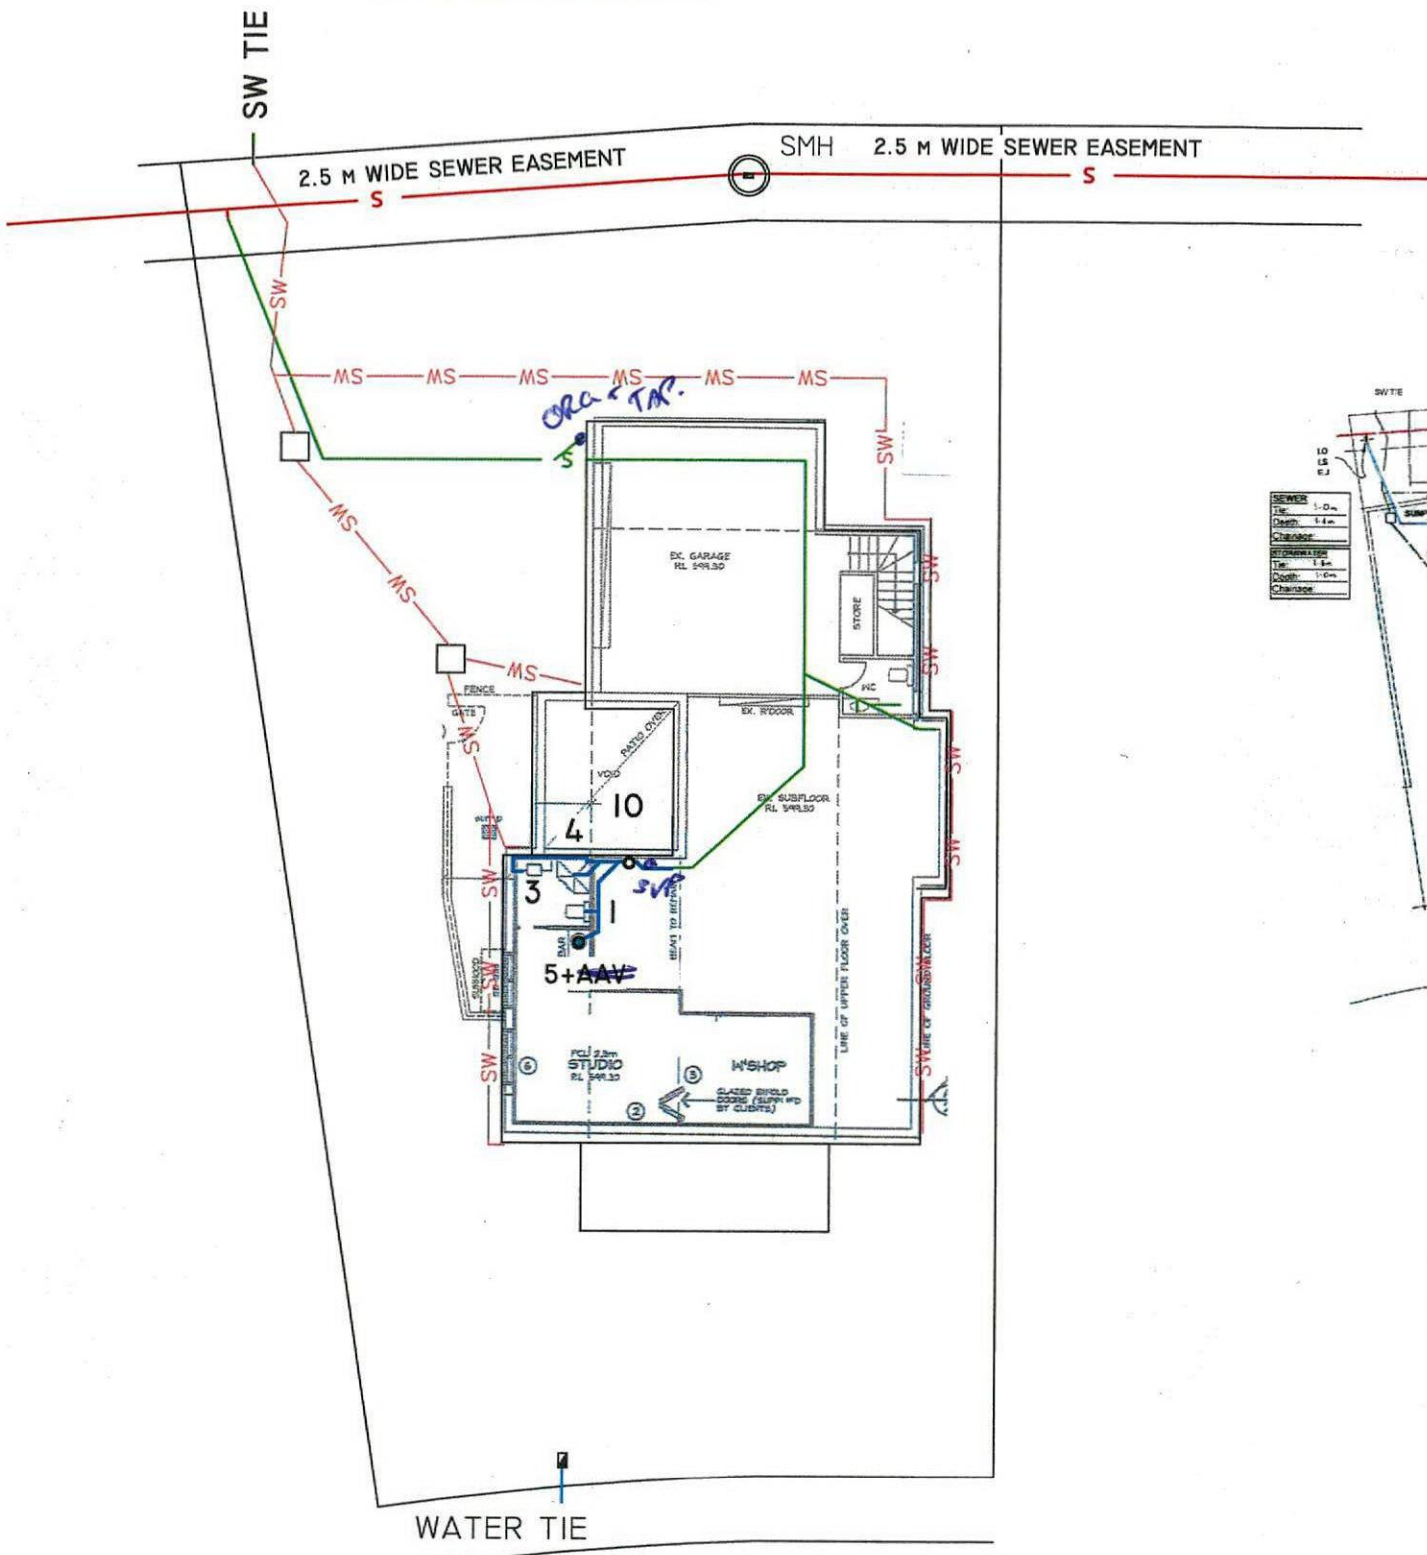
NOTES 1. ALL NEW SEWER DRAINS ARE 100Ø UPVC UNLESS NOTED OTHERWISE.
2. ALL NEW SW IS 90Ø PVC EXCEPT 100Ø LINE FROM TIE TO FIRST JUNCTION & UNDER SLABS.

PLEASE NOTE: ON THE TIE IMAGE, RED LINES INDICATE SEWERAGE, GREEN LINES INDICATE STORM WATER AND BLUE LINES INDICATE WATER SUPPLY.
