# Report

# Building Report

## COMPLIANCE REPORT

Project  
Residential Alterations and Additions

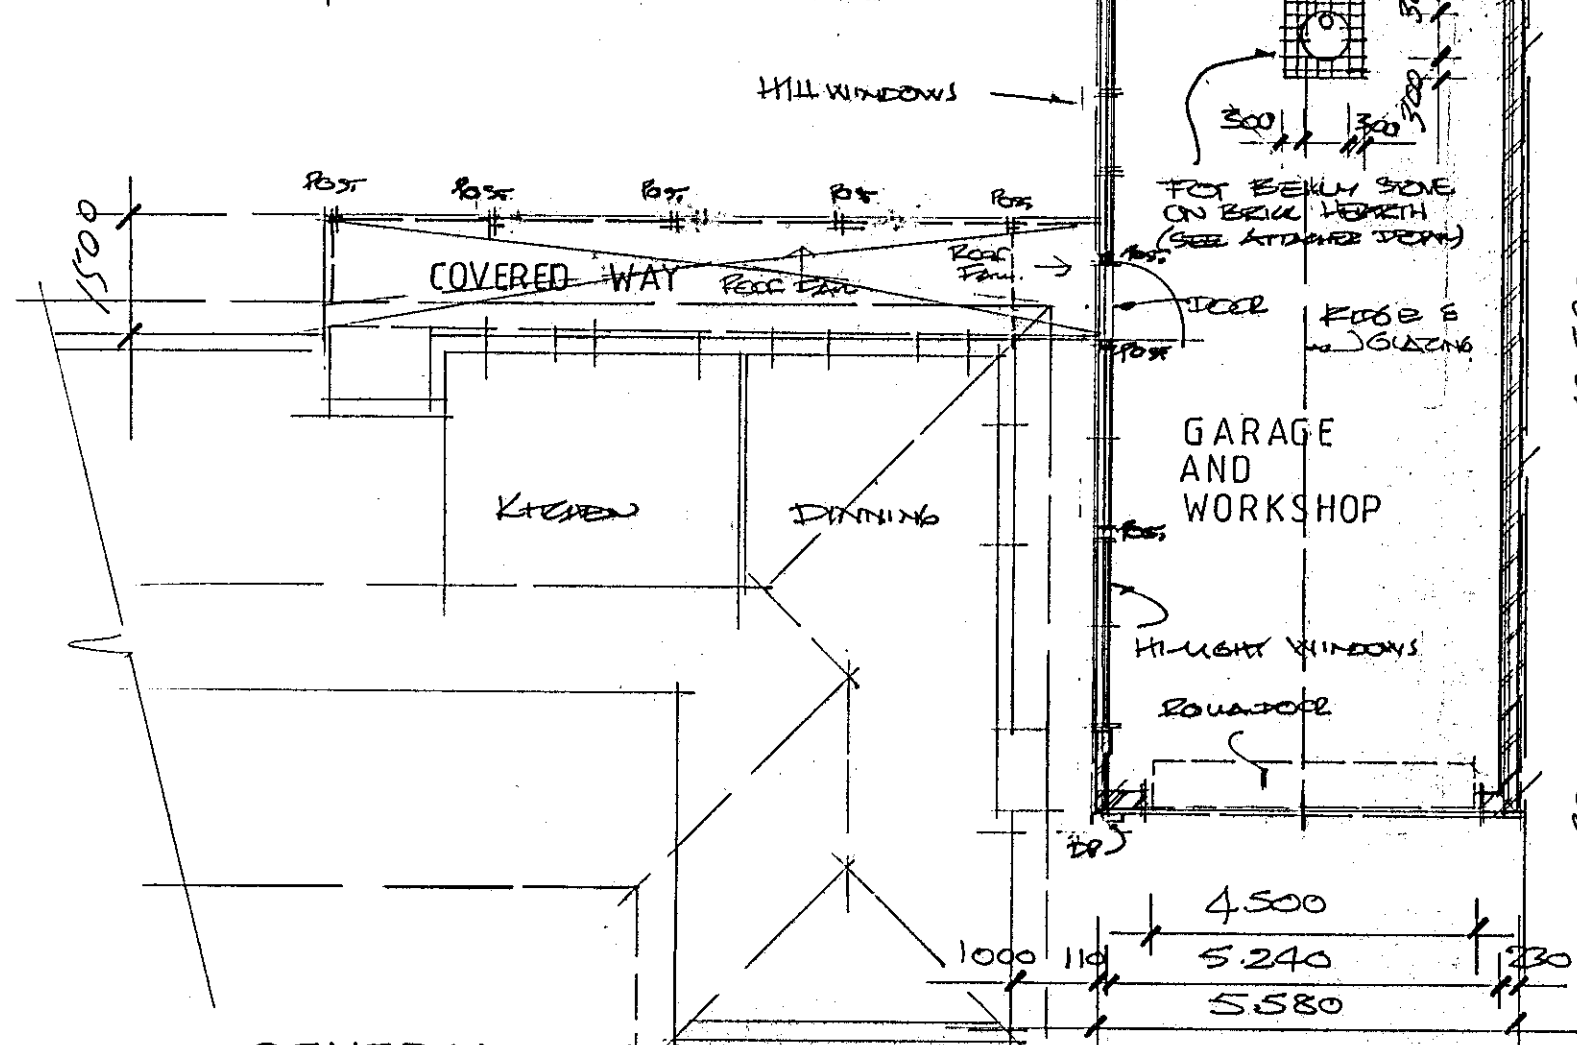
GENERAL FLOOR PLAN 1:100

ALL FOOTINGS TO BE TAKEN DOWN TO SOLID GLAND.  
DEMOLISH OLD GARAGE.  
DOUBLE CHECK AND VERIFY ALL DIMENSIONS ON SITE.  
ELECTRICAL LAYOUT AS REQUIRED.  
LIME SIZES AS NOTED CLAS PER TRUSS MANUFACT-  
CHARTS.  
TERRAIN CATEGORY 3, AS PER A.S.1170 - WIND  
LOADING CODE.  
REFER TO A.S. 1684-1979 - TIMBER FRAMING CODE.  
ALL FINISHES AS NOTED.  
REFER TO CONFORM TO PT 25 OF B.M.  
AREA OF GARAGE - 61.38 M2  
GROUND LINES ARE AS SHOWN.

AMENDMENTS: 24/8/88  
(1) GARAGE ROOF CHANGED TO NORTH LIGHT GABLE.  
(2) COVERED WAY HEIGHT REDUCED & FINED TO WALL IN LIEU OF FINES LINE.  
(3) Fire place details as requested.

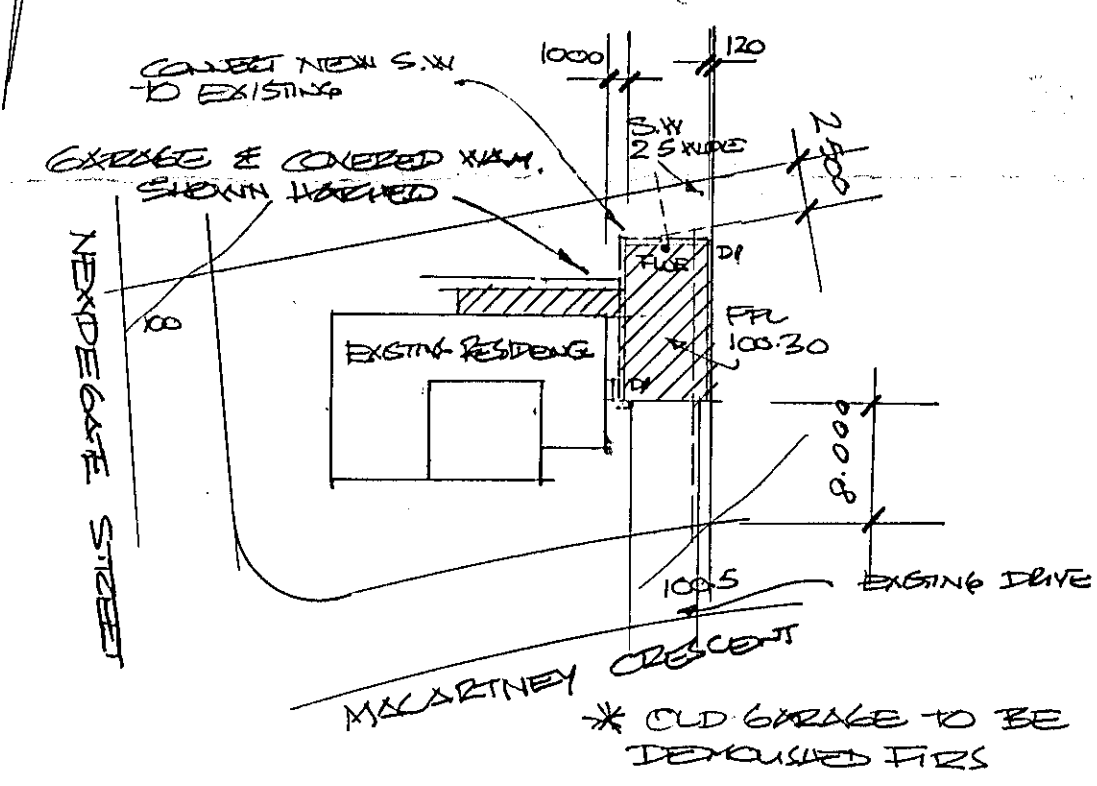
SITE PLAN 1:500

BLOCK AREA - 670.55 M2  
HOUSE - 162.57  
GARAGE - 61.38  
WALLWAY - 15.00  
TOTAL 238.95 M2  
P.R 35% = 237.84 M2  
PERCENTAGE USED - 35.1% (APPROX)

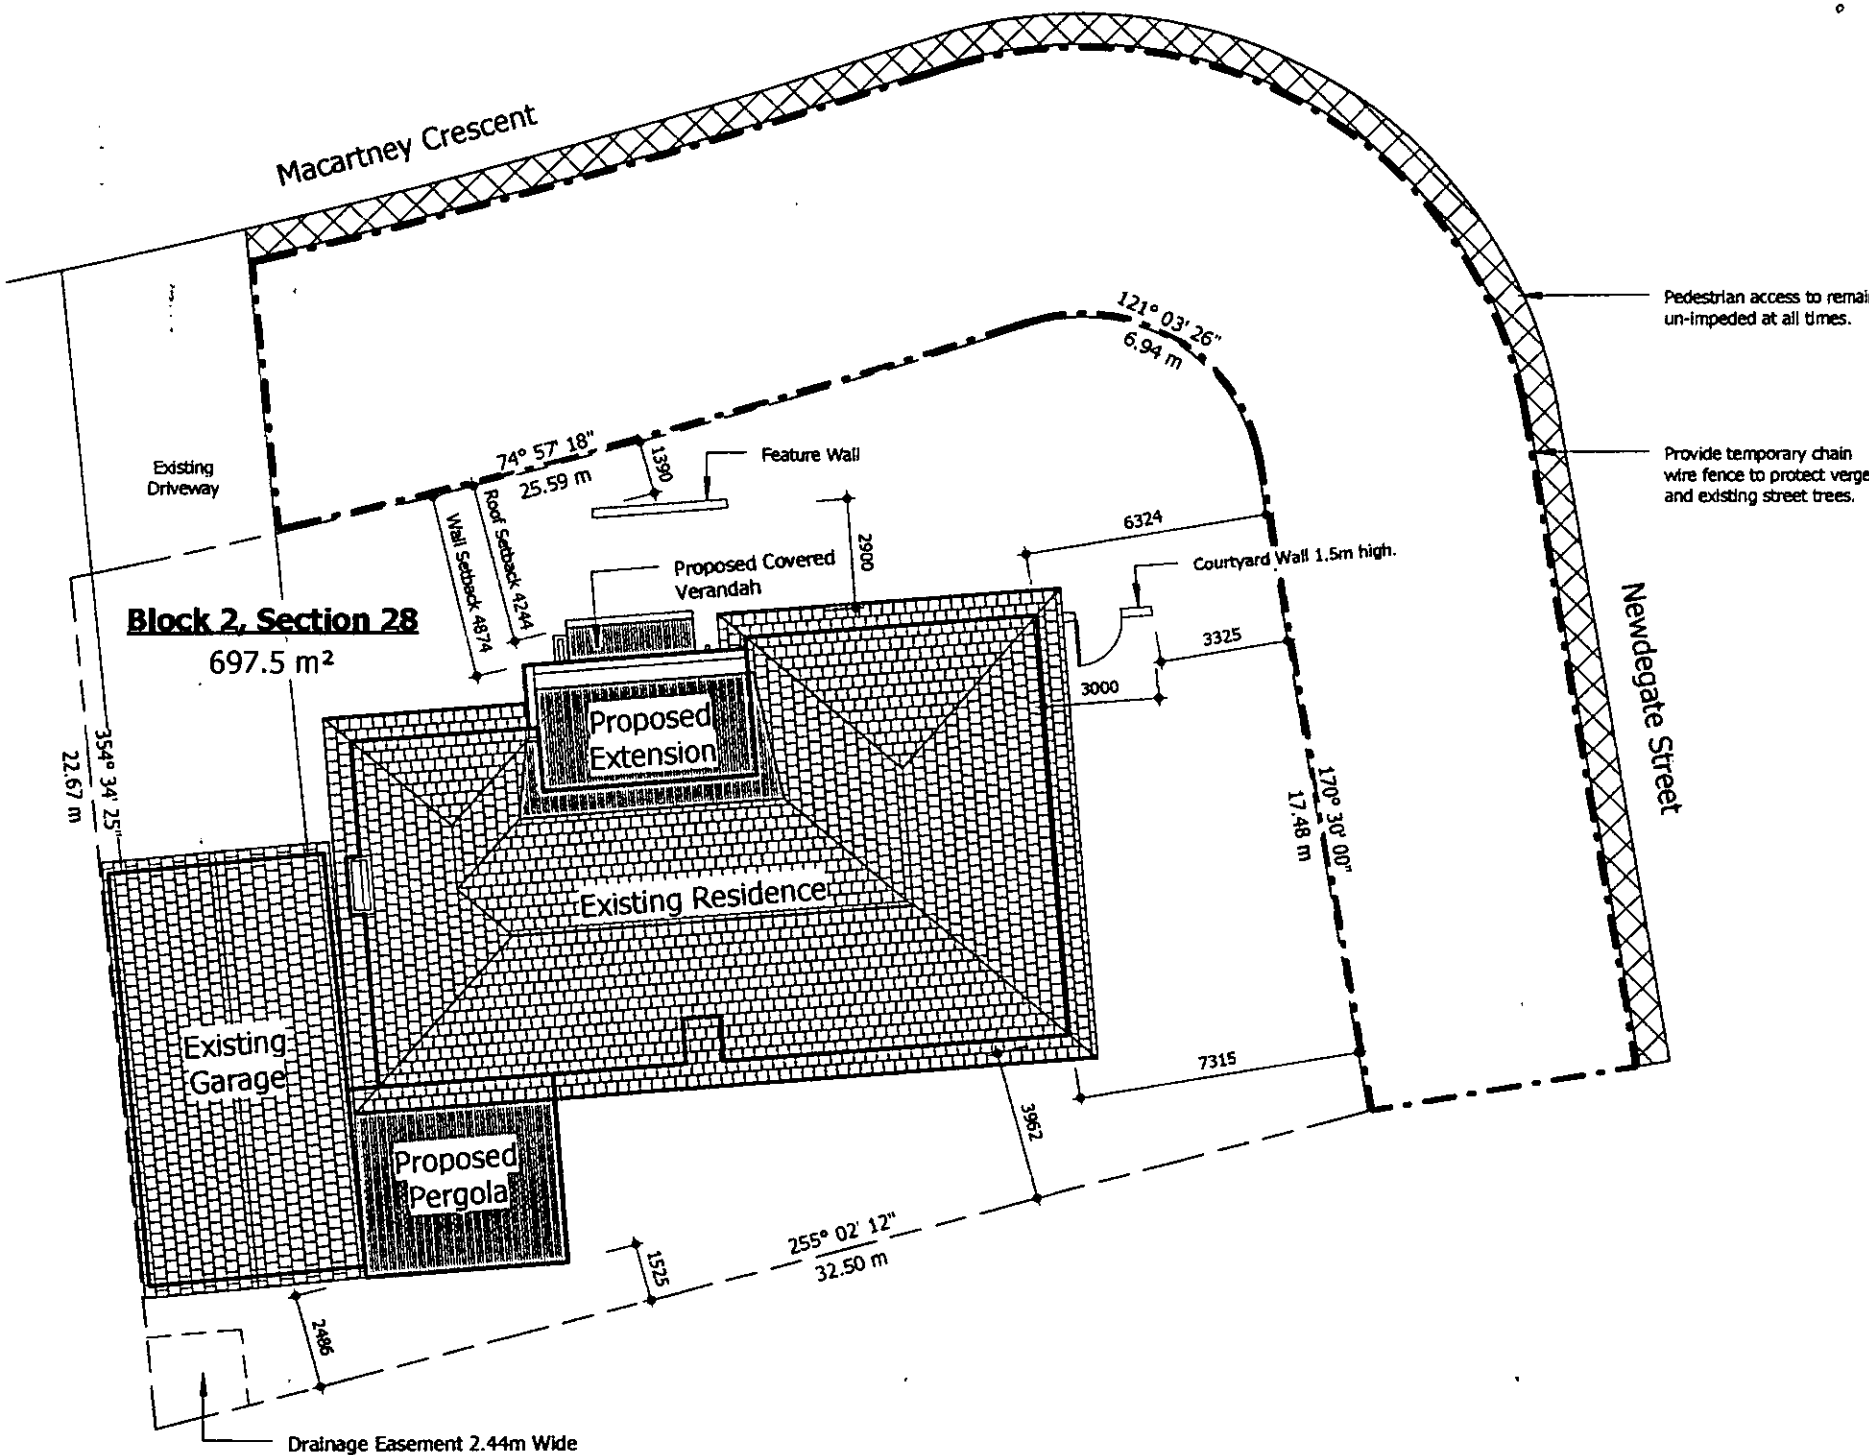
**1 Landscape Management and Protection Plan**  
1 : 200

All, if any, street trees are to be retained and kept  
undamaged.  
Existing crown clearance is not to be altered.  
Ensure construction equipment can pass beneath lowest  
limb, through driveway access.  
Crowns and apex of canopies are not to be altered or  
reduced.  
Ensure lifting equipment and load can clear height and  
width of tree crown without damage to crown.

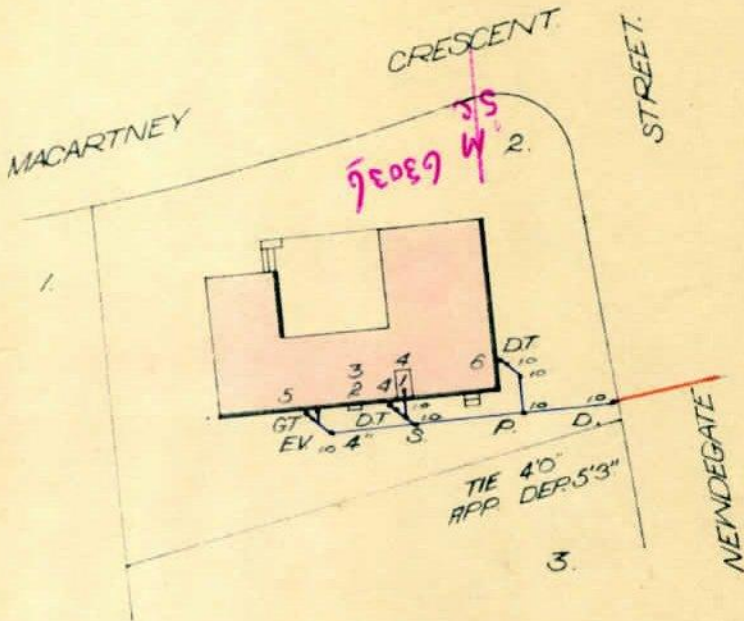
NOTE  
Drains to be laid shown in blue lines.

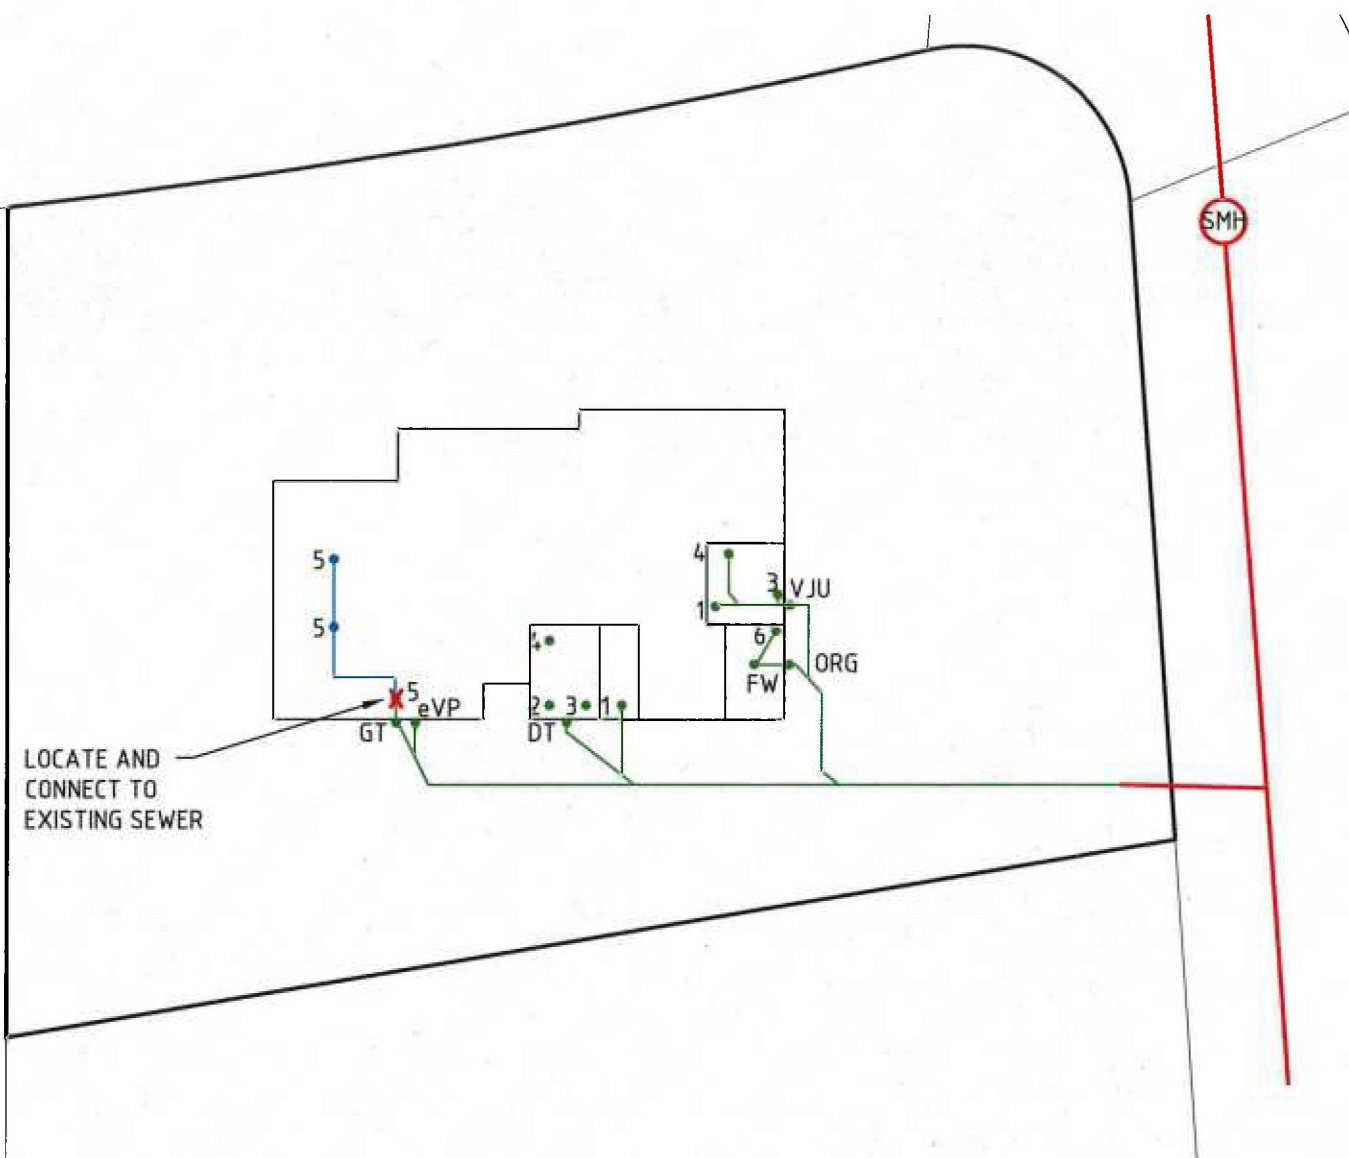
S TIE  
T 1.21m  
D 1.60m

# WORK AS EXECUTED
