# Report

# Building Report

# Compliance Report

ALTERATIONS TO EXISTING RESIDENCE  
FOR MR+MRS CONWAY  
BLOCK 30 , SECTION 40 , DOWNER

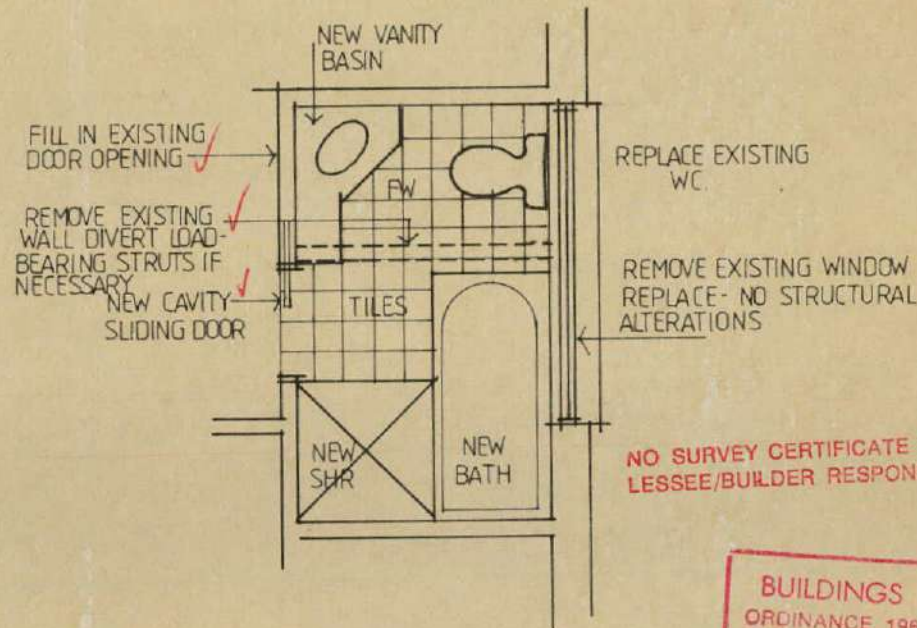
DETAIL PLAN SCALE 1:50

*Buttress* TO COMPLY WITH  
PART 46 & 47 OF THE BUILDING MANUAL

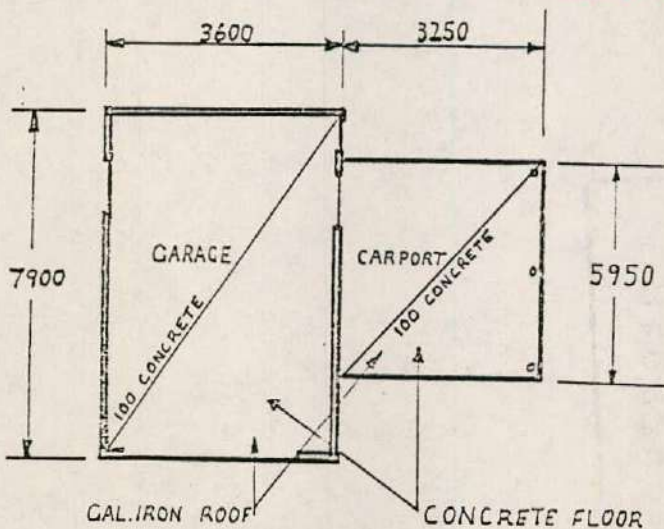
FLOOR PLAN

SUB BASE SUPPORTING CONCRETE  
FLOORS TO BE COMPACTED. FILL  
DEPTH NOT TO EXCEED 400mm WITH-  
OUT APPROVAL.

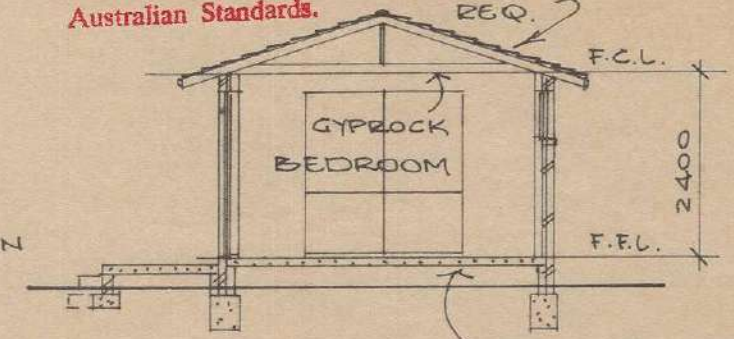
SECTION A-A

CONSTRUCTION MUST COMPLY WITH A.S. 1684-1979  
TIMBER FRAMING CODE  
AND RELEVANT SUPPLIMENTS  
TAKE FOOTINGS DOWN TO SOLID GROUND.  
MAX. FILL BELOW SLAB NOT TO EXCEED 400mm.  
FOOTINGS TO COMPLY WITH AS2870.

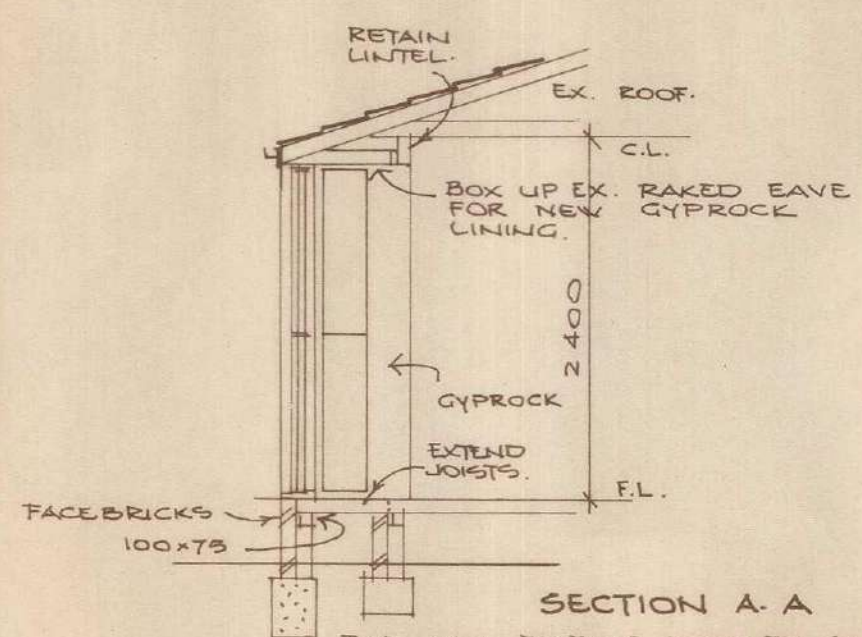
SECTION A-A

TAKE NEW FOOTING DOWN TO SOLID GROUND.  
 FOOTING TO COMPLY WITH AS2870.

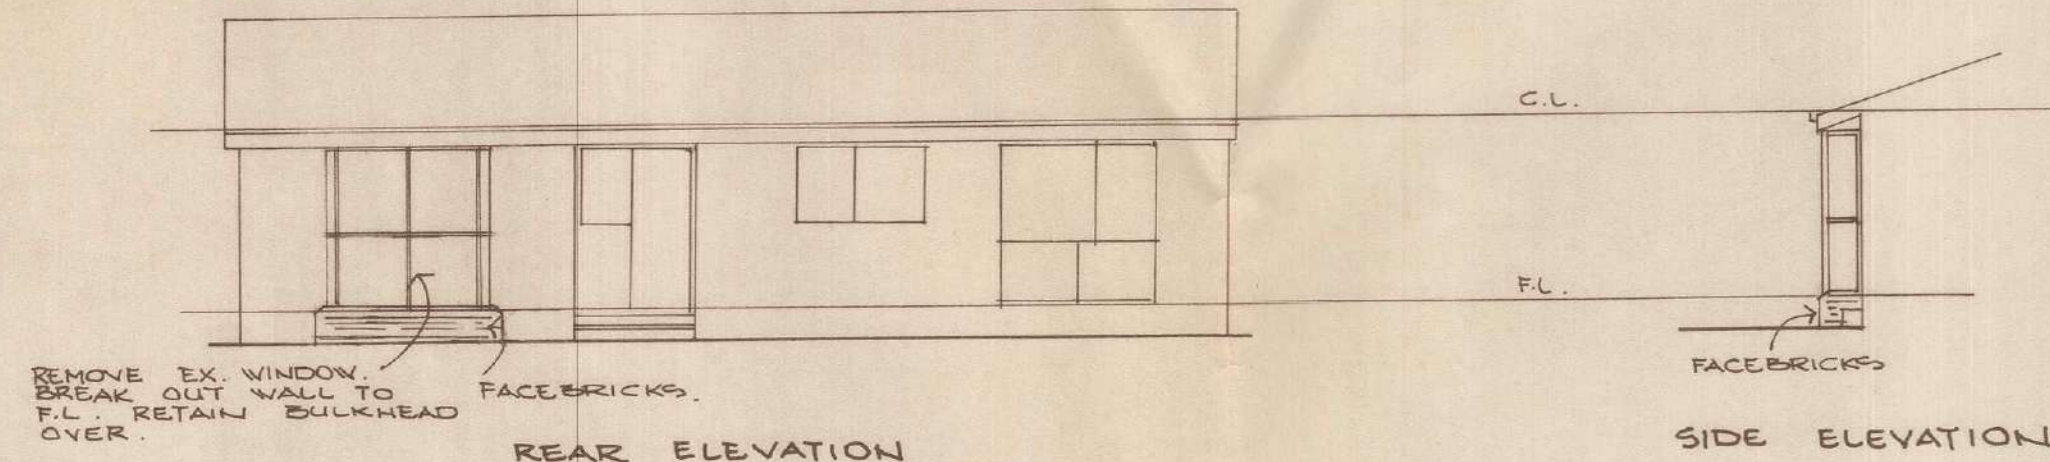
REAR ELEVATION

REMOVE EX. WINDOW.  
BREAK OUT WALL TO  
F.L. RETAIN BULKHEAD  
OVER.

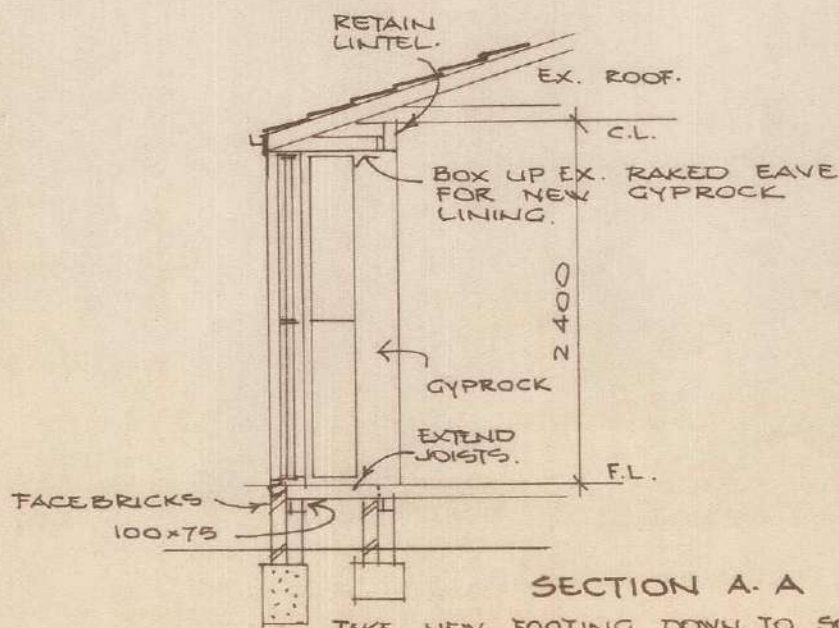
SECTION A-A

TAKE NEW FOOTING DOWN TO SOLID GROUND.  
FOOTING TO COMPLY WITH AS2870.

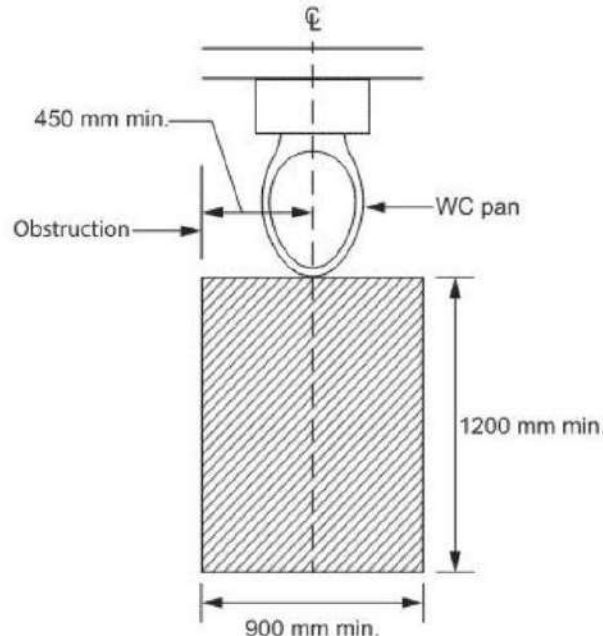
Figure 4.2:

Circulation space for a toilet pan

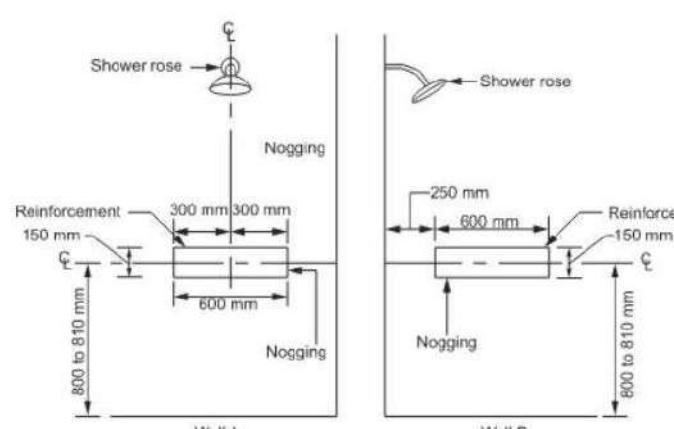
Location of noggings for shower walls

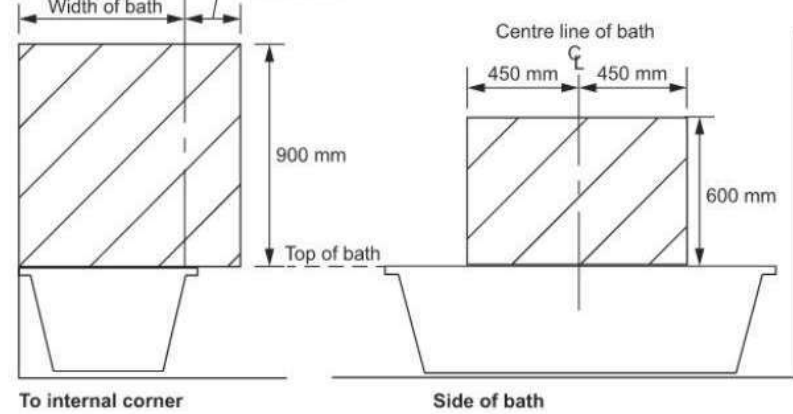
Figure 6.2b:

Location of sheeting for walls surrounding a bath

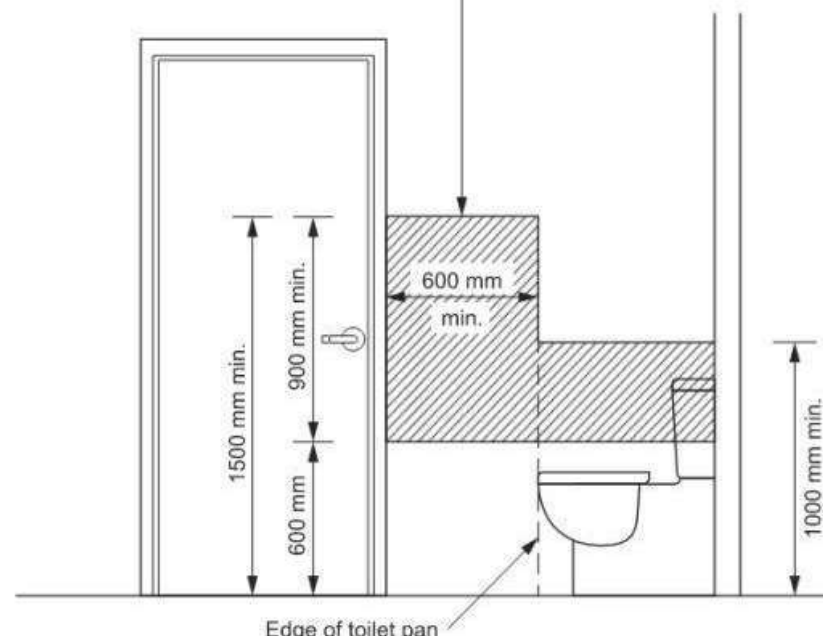
Figure 6.2e:

Minimum extent of sheeting for wall adjacent to a toilet pan

Minimum extent of structural sheeting clear of any door frame, window frame or wall opening

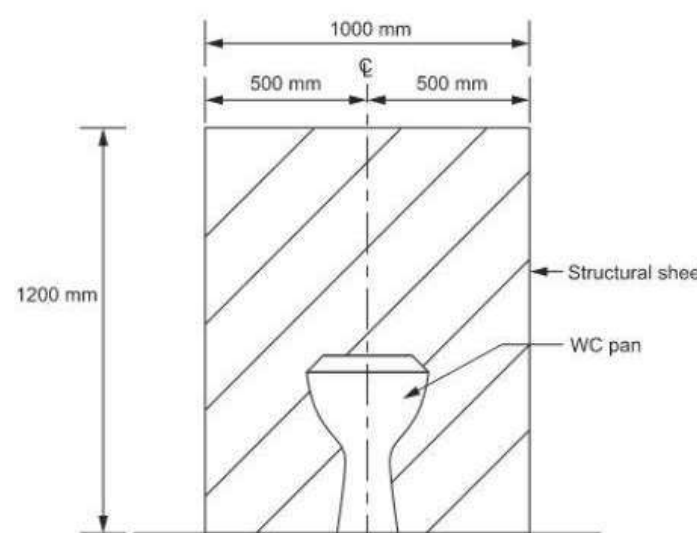
Figure 6.2g:

Location of sheeting for a wall behind a toilet pan

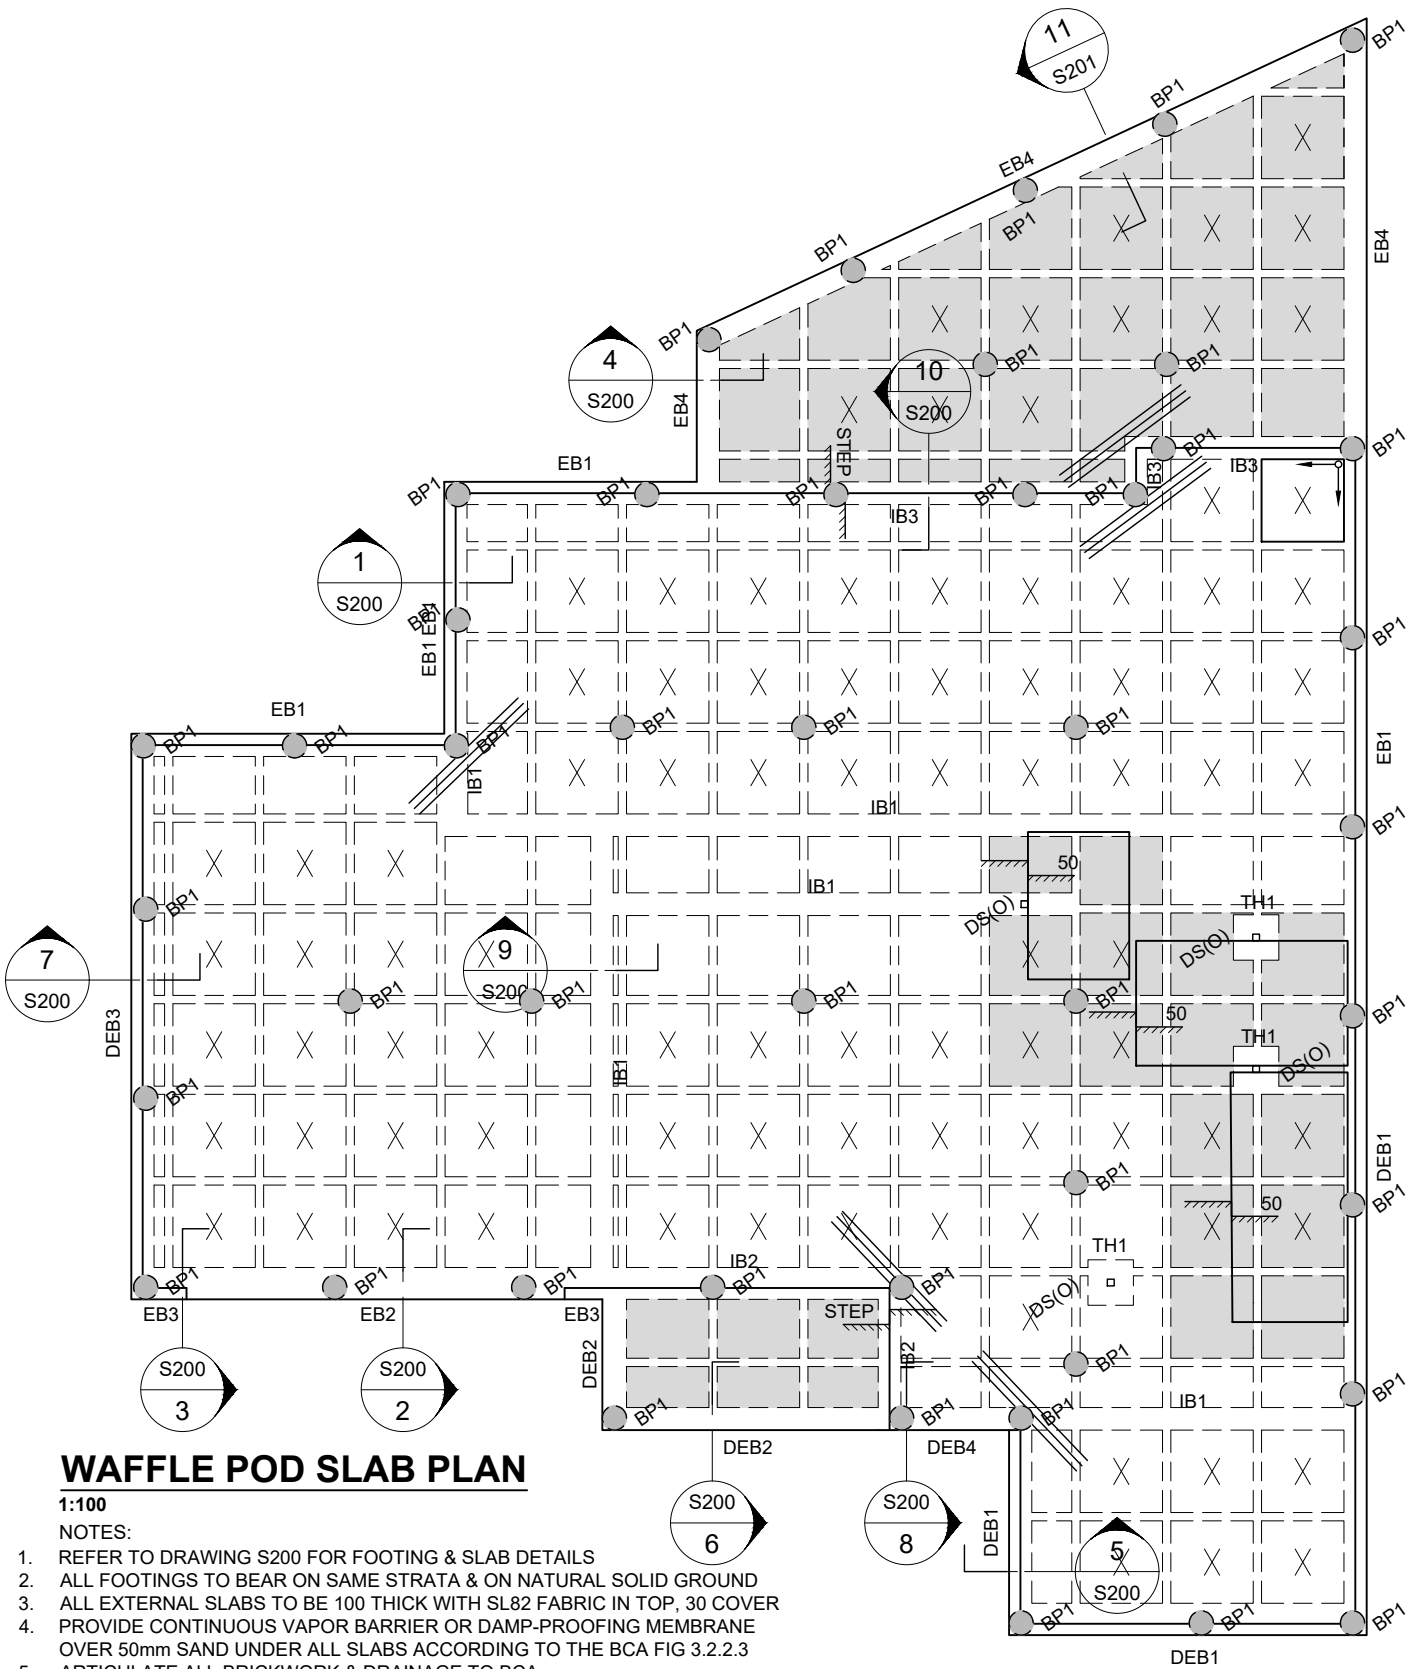
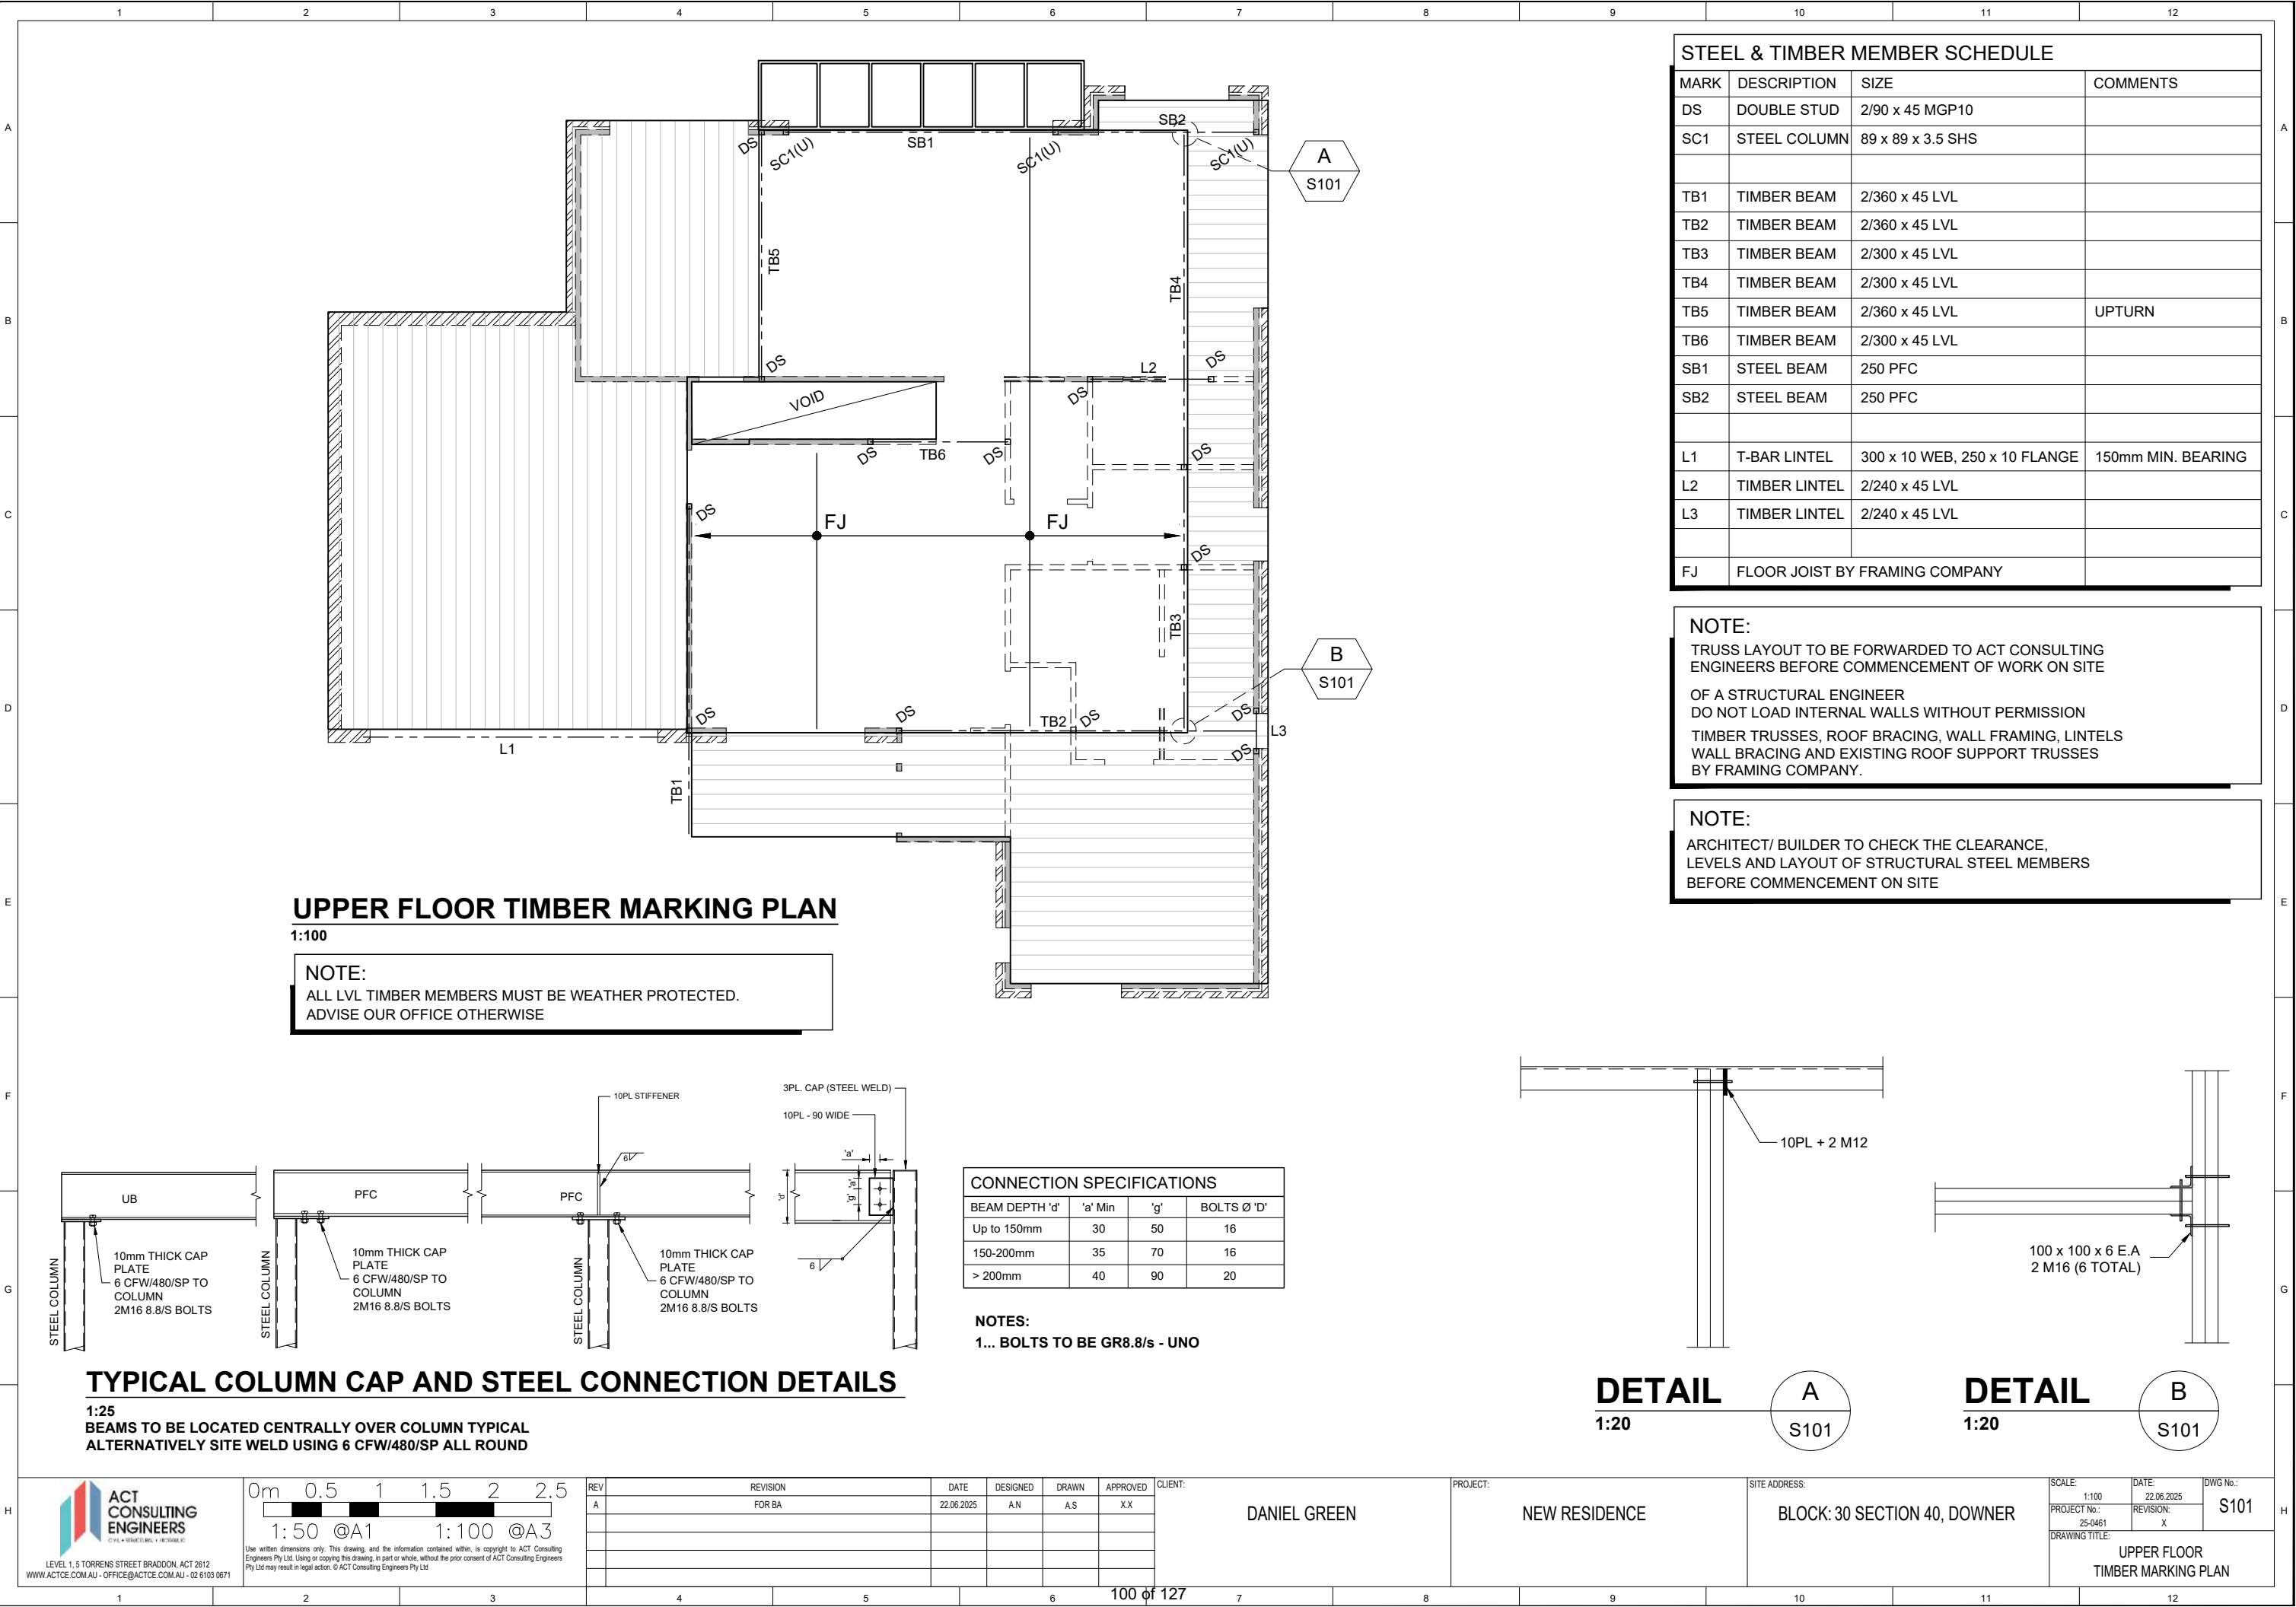
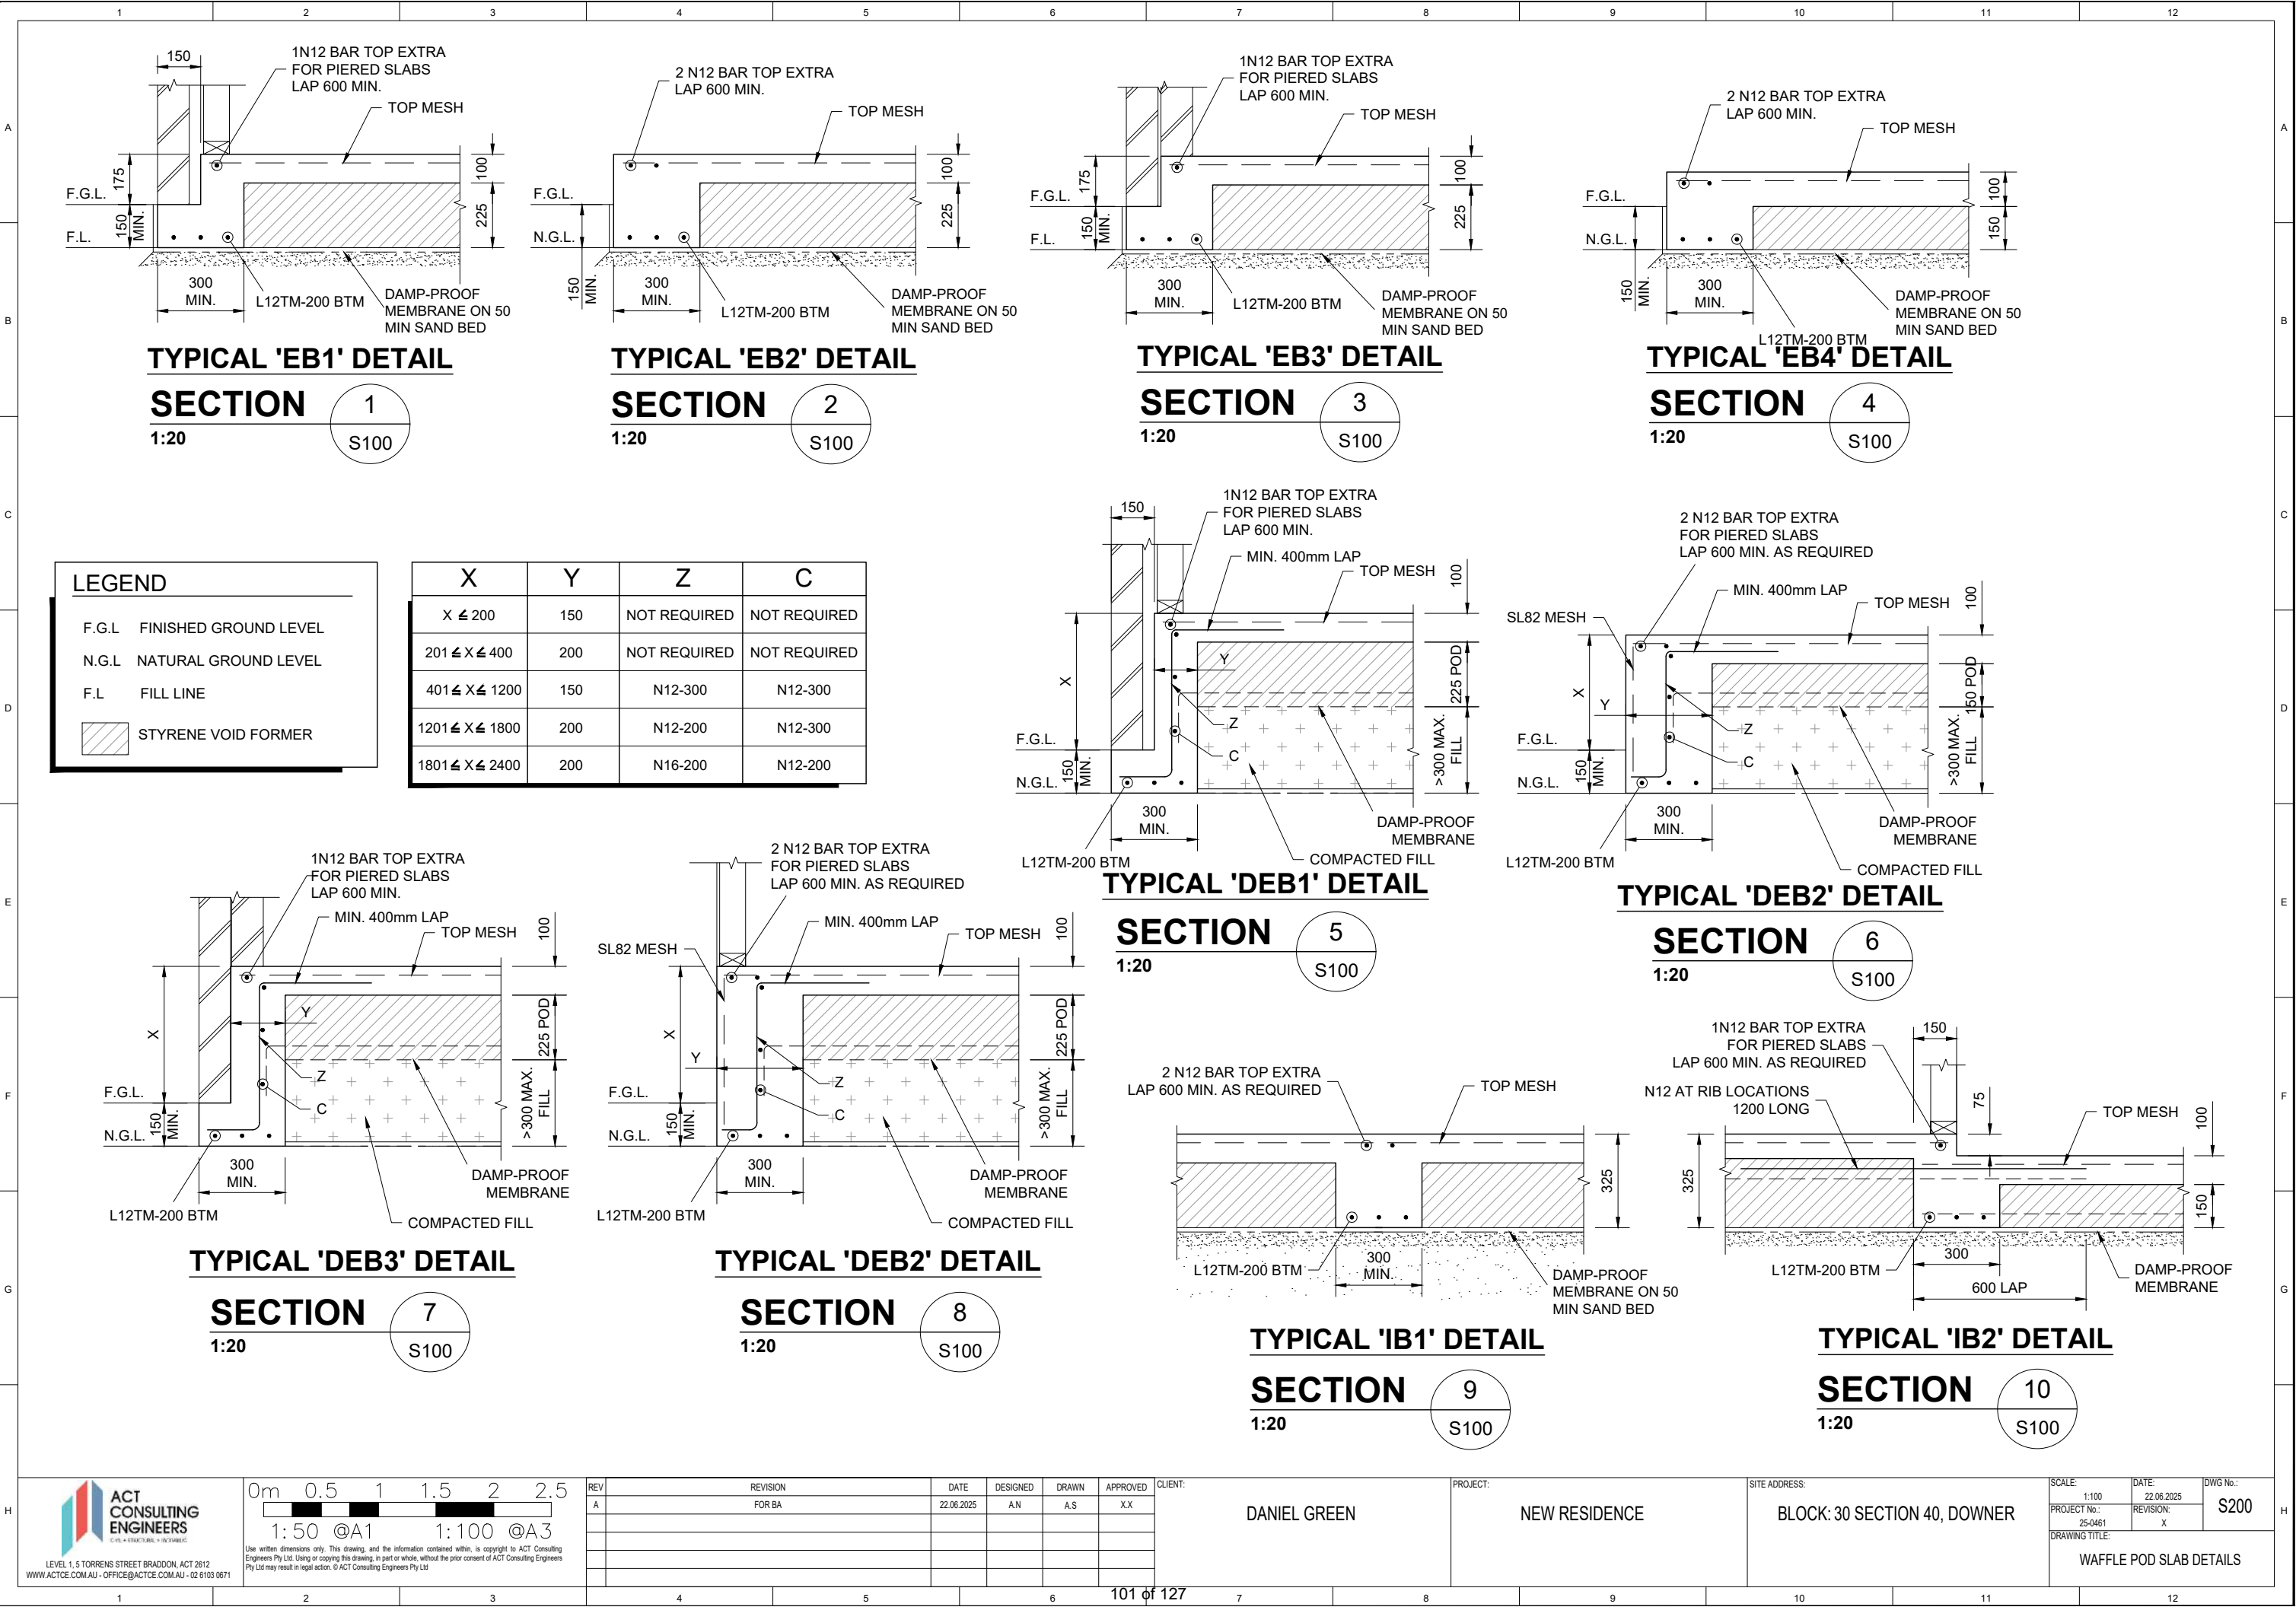
- REFER TO DRAWING S200 FOR FOOTING & SLAB DETAILS
- ALL FOOTINGS TO BEAR ON SAME STRATA & ON NATURAL SOLID GROUND
- ALL EXTERNAL SLABS TO BE 100 THICK WITH SL82 FABRIC IN TOP, 30 COVER
- PROVIDE CONTINUOUS VAPOR BARRIER OR DAMP-PROOFING MEMBRANE  
OVER 50mm SAND UNDER ALL SLABS ACCORDING TO THE BCA FIG 3.2.2.3
- ARTICULATE ALL BRICKWORK & DRAINAGE TO BCA
- BUILDER TO REPORT SITE CONDITION TO STRUCTURAL ENGINEER AFTER  
THE SITE CUT & FILL IS COMPLETE
- WHERE ADDITIONAL FILL IS REQUIRED TO THE UNDERSIDE OF SLABS ON  
GROUND, NON COHESIVE MATERIAL SUCH AS SAND AND GRAVEL DUST  
SHALL BE PLACED BY "CONTROLLED" COMPACTION IN HORIZONTAL LAYERS  
OF 200mm (loose) MAXIMUM DEPTH. THIS FILL SHALL BE COMPACTED TO AT  
LEAST 95% OF STANDARD MAXIMUM DRY DENSITY (SMDD).

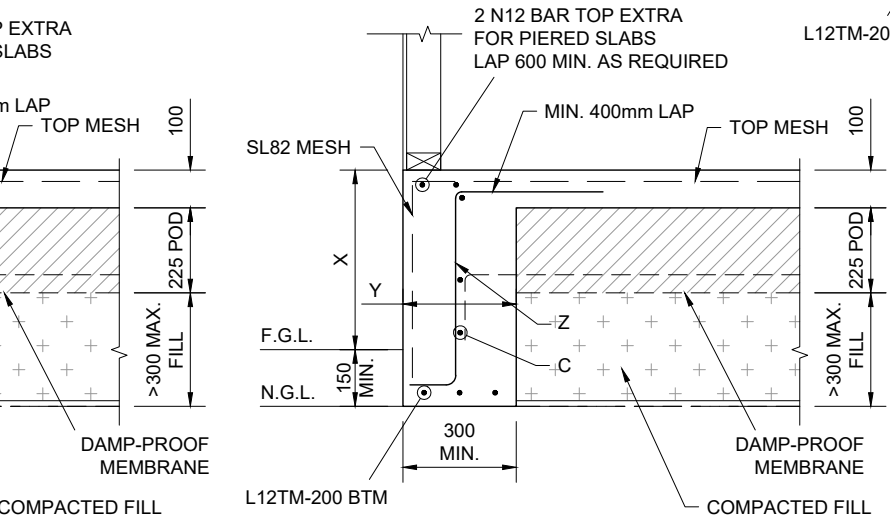
TYPICAL 'DEB3' DETAIL

SECTION 7  
1:20  
S100

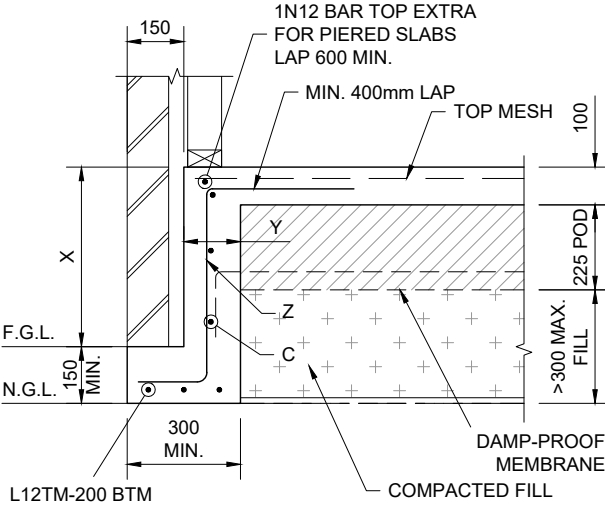
TYPICAL 'DEB1' DETAIL

SECTION 5  
1:20  
S100

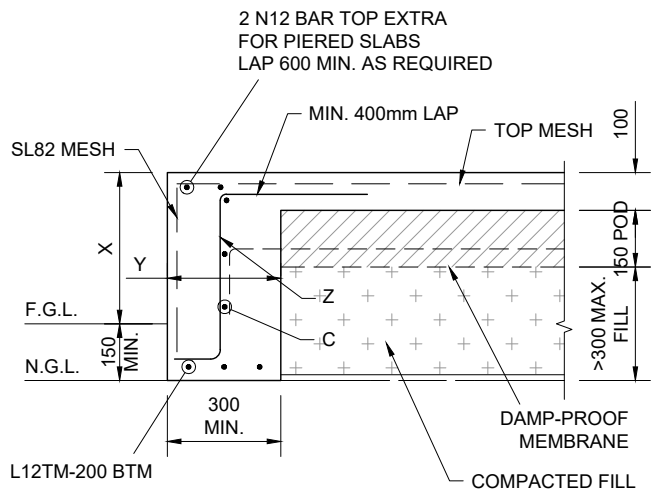
TYPICAL 'DEB2' DETAIL

SECTION 6  
1:20  
S100

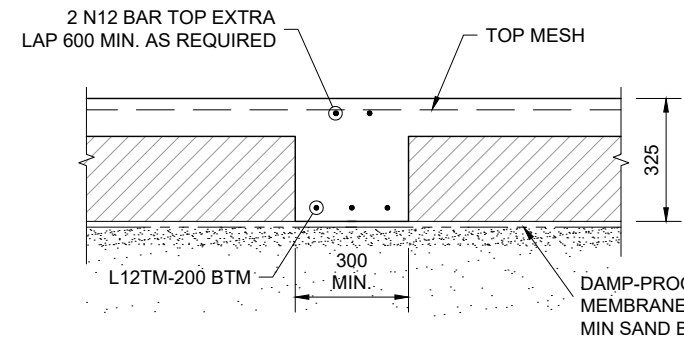
TYPICAL 'IB1' DETAIL

SECTION 9  
1:20  
S100

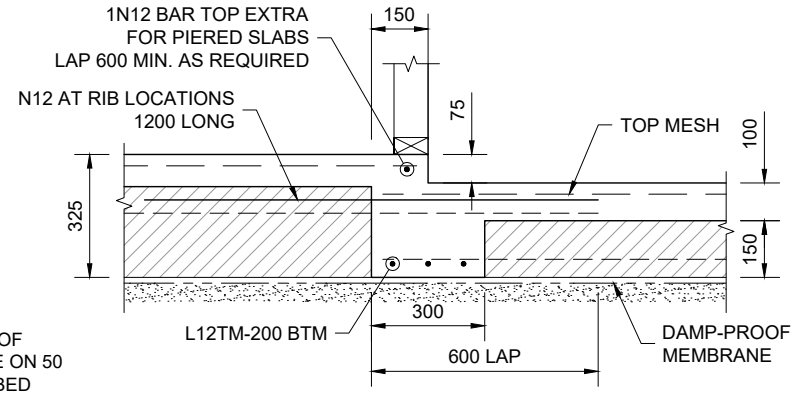
TYPICAL 'IB2' DETAIL

SECTION 10  
1:20  
S100

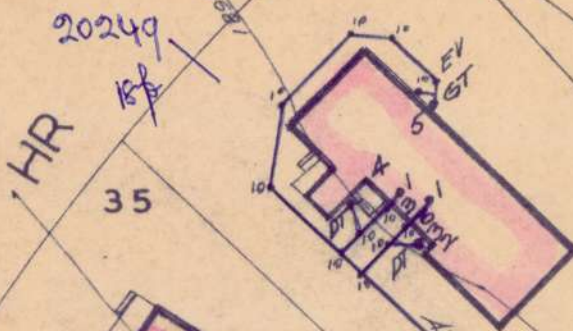
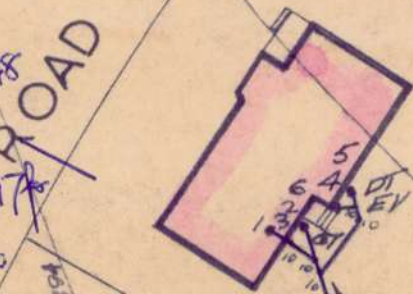
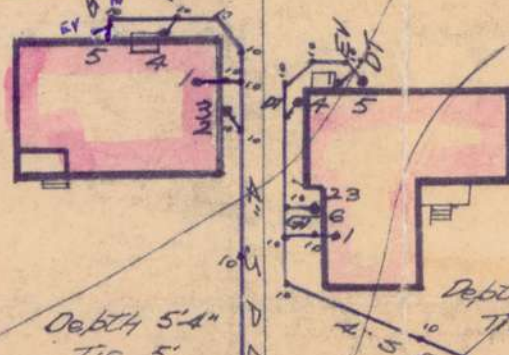
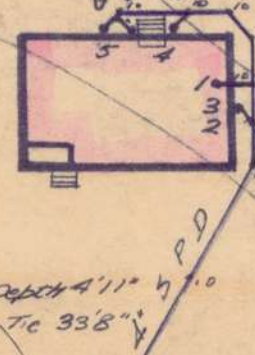
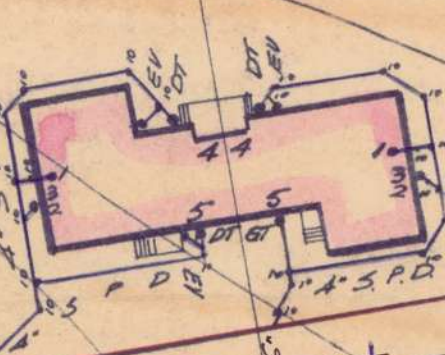
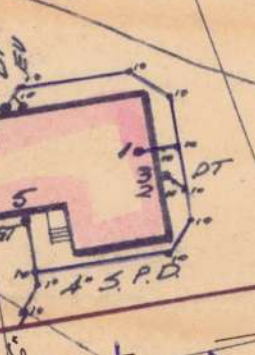
Depth 4'10"  
Tie 4'

Depth 4'8"  
Tie 11H.

Depth 5'10"  
Tie 4'1"

Depth 5'4"  
Tie 5'

Depth 4'11"  
Tie 33'8"

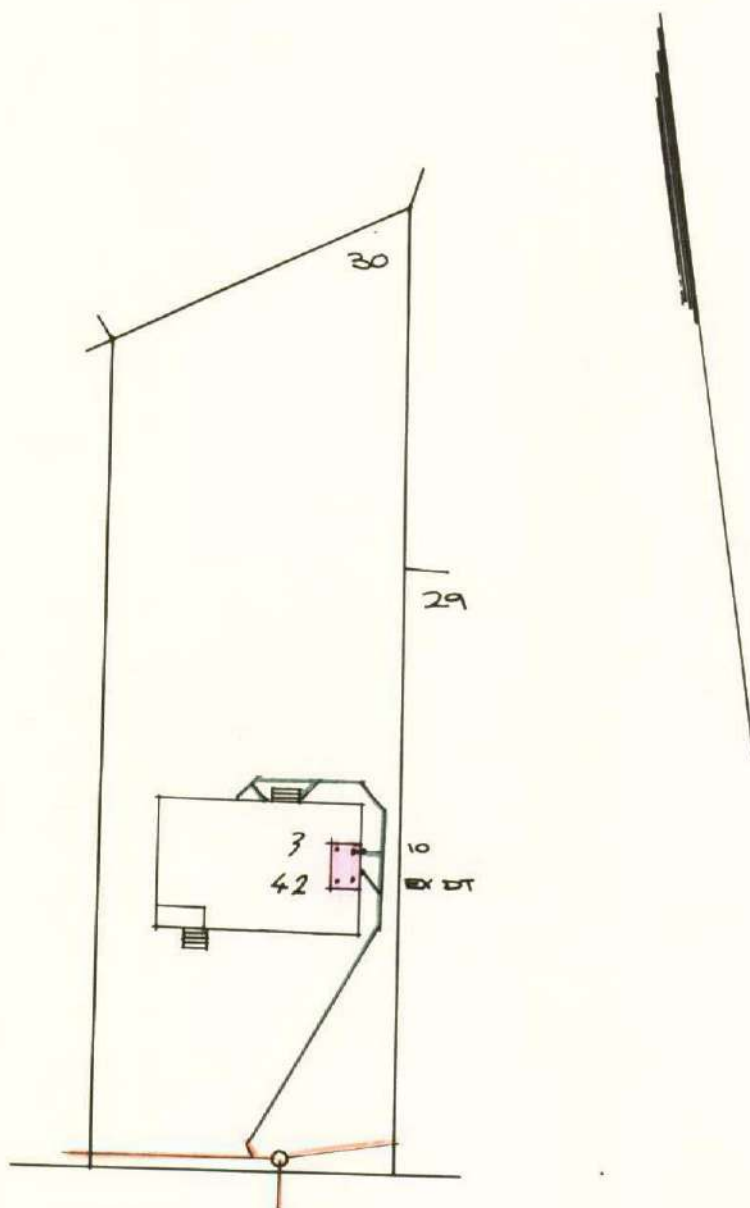
Block 30 Section 40 DOWNER  
 Scale 1:500 **ADDITIONAL WORK**

All work must be carried out in conformity with the  
 Canberra Sewerage and Water Supply Regulations.
