Building Report  
Timber Pest Inspection Report  
Compliance Report  
Conveyancing Report  
Energy Efficiency Rating  
Insurance Certificates  
Tax Invoice

# Building Report

## CONCLUSION AND SUMMARY

The purpose of the Inspection is to identify the major defects and safety hazards associated with the property at the time of the Inspection. The Inspection and reporting are limited to a visual assessment of the Building Members in accord with Appendix C AS4349.1-2007.

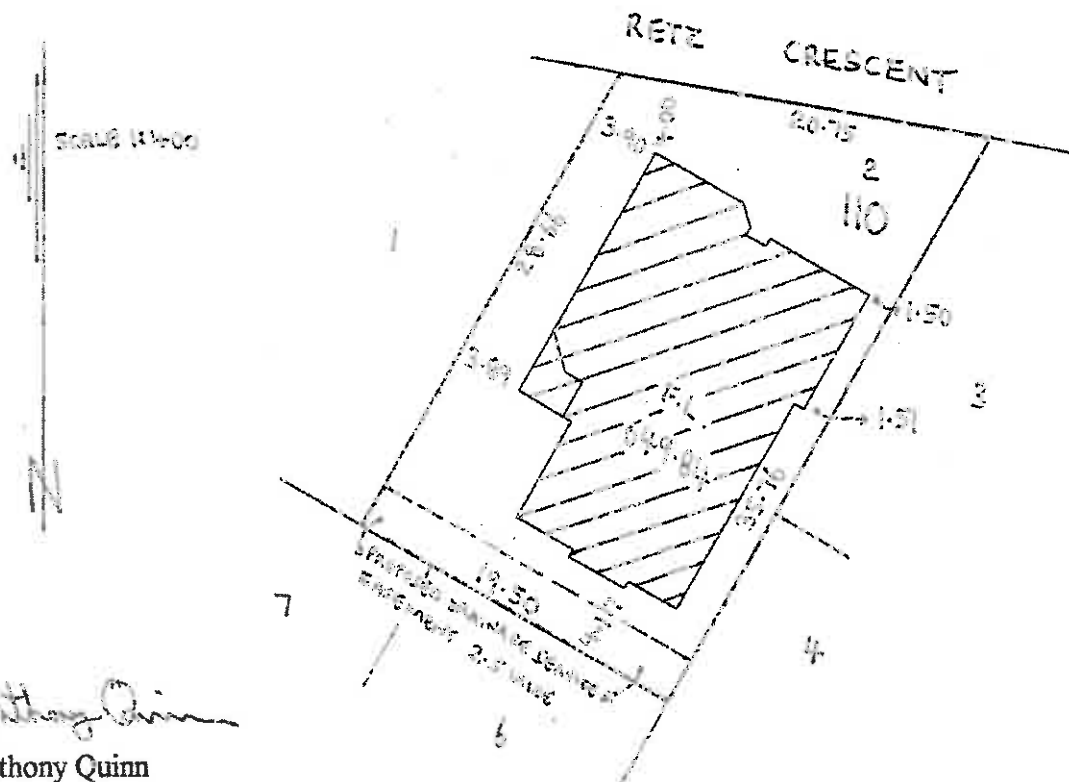
The brick house to floor level stands entirely within the boundaries of the subject land.

Relevant offsets and levels are shown on the sketch.

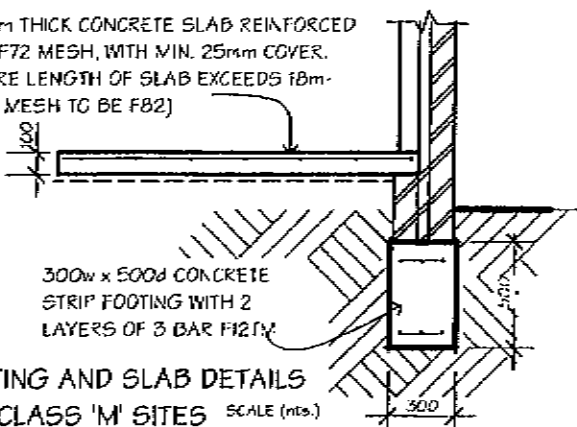
FOOTING AND SLAB DETAILS  
FOR CLASS 'M' SITES SCALE (nbs.)  
(44-SONEY VENEER CONSTRUCTION)

100mm THICK CONCRETE SLAB REINFORCED  
WITH F72 MESH, WITH MIN. 25mm COVER.  
(WHERE LENGTH OF SLAB EXCEEDS 18m-  
SLAB MESH TO BE F82)

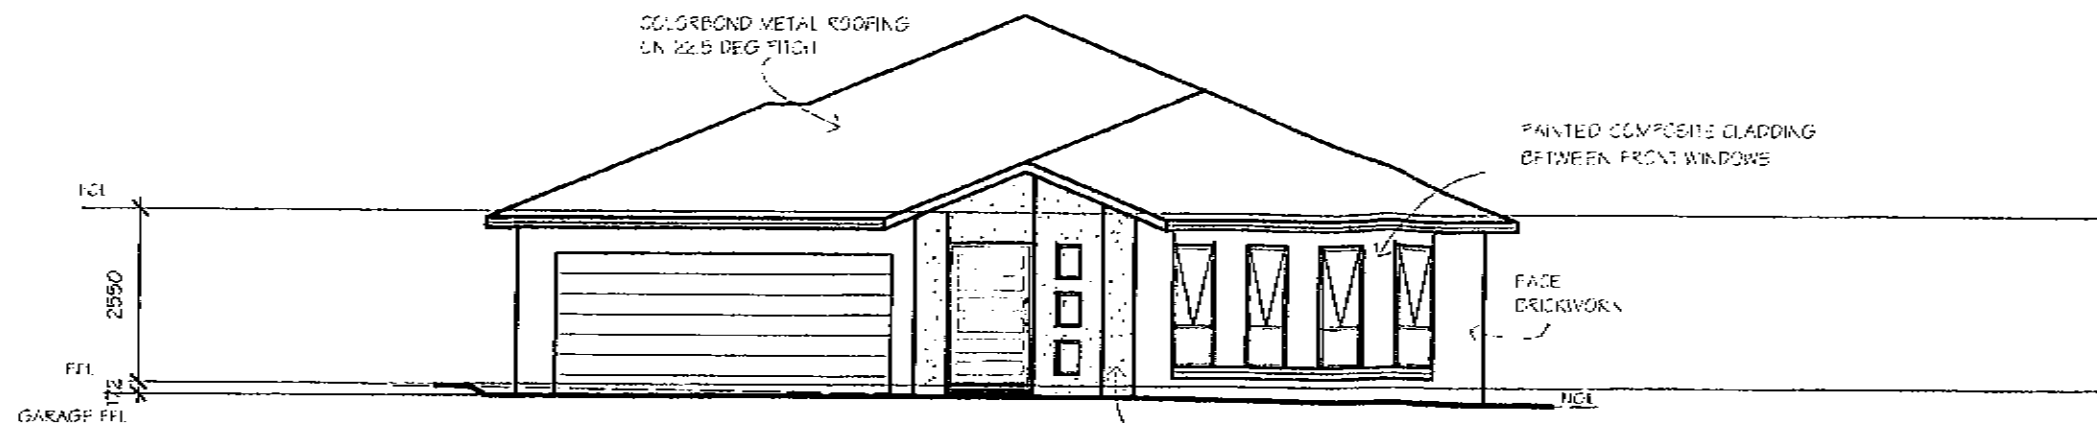
FRONT ELEVATION

BUSIFIRE MITIGATION MEASURES APPLY:

- CONSTRUCTION TO MEET BAL 12.5
- LOW FLAMMABILITY GARDENS WITHIN 5.0m OF THE RESIDENCE

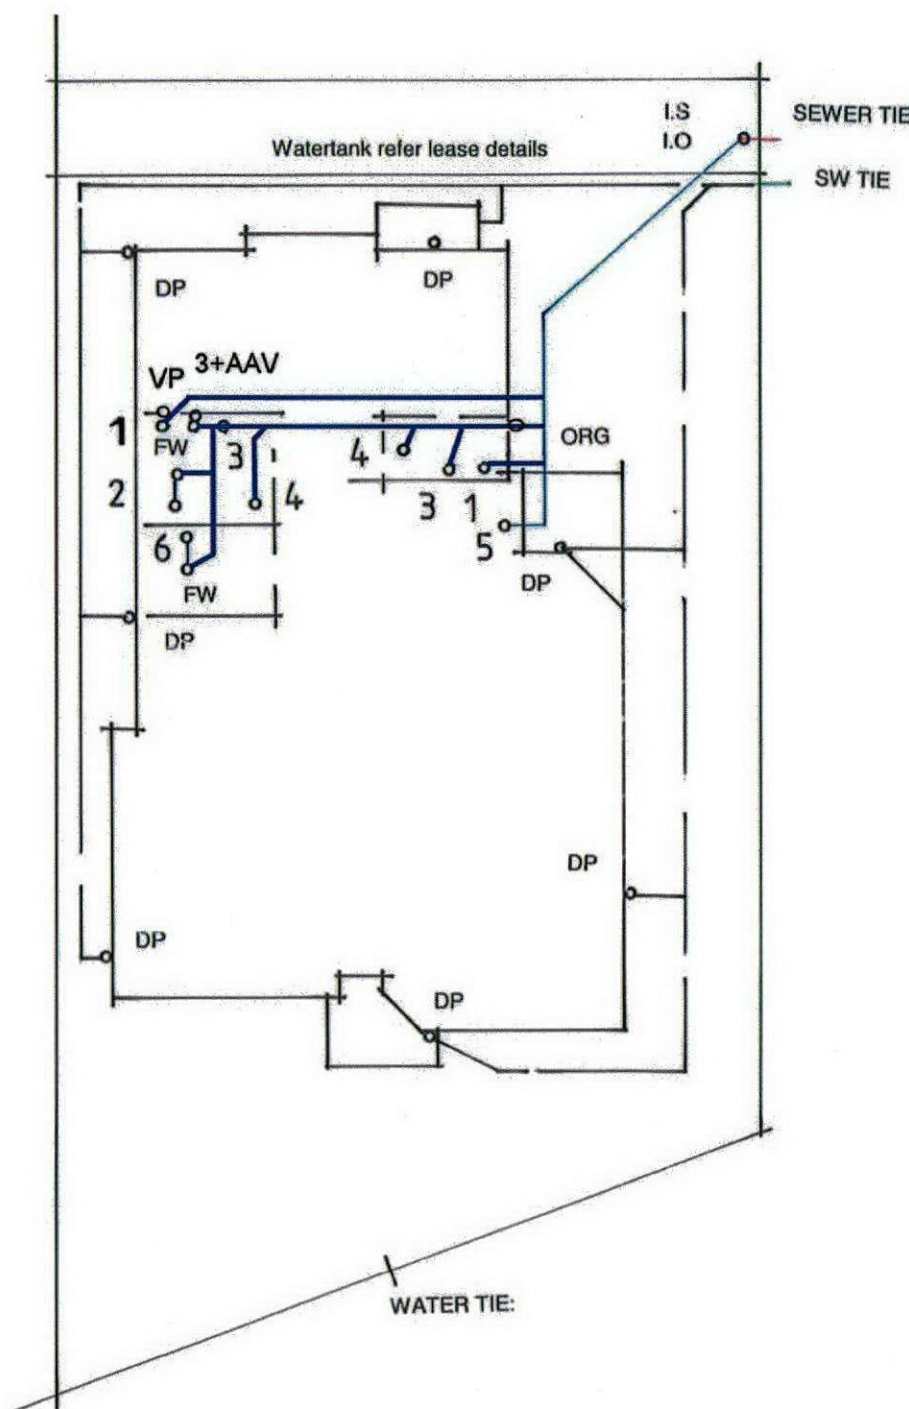
## PLAN OF HYDRAULIC SERVICES

ALL WORK TO BE IN ACCORDANCE WITH THE CANBERRA SEWERAGE AND WATER SUPPLY REGULATIONS. THIS PLAN TO BE READ IN CONJUNCTION WITH APPROVED ARCHITECTURAL PLANS. THIS PLAN HAS BEEN DESIGNED IN ACCORDANCE WITH A.S 3500, NATIONAL PLUMBING AND DRAINAGE CODE. ORG TO BE A HEIGHT OF 150mm BELOW LOWEST FIXTURE TO BE DRAINED & A MINIMUM 75mm ABOVE F.G.L.(50mm IN PAVED AREAS, GRADED FROM O.R.G.)

- NOTES
1. ALL NEW SEWER DRAINS ARE 1000 UPVC UNLESS NOTED.
  2. ALL NEW SW IS 900 PVC EXCEPT 1000 LINE FROM TIE TO FIRST JUNCTION & UNDER SLABS.
  3. PORTION OF DRAIN MARKED 'X' NOT TO BE LAID UNTIL CONFIRMATION FROM ACTEW THAT MAIN IS AVAILABLE FOR CONNECTION.

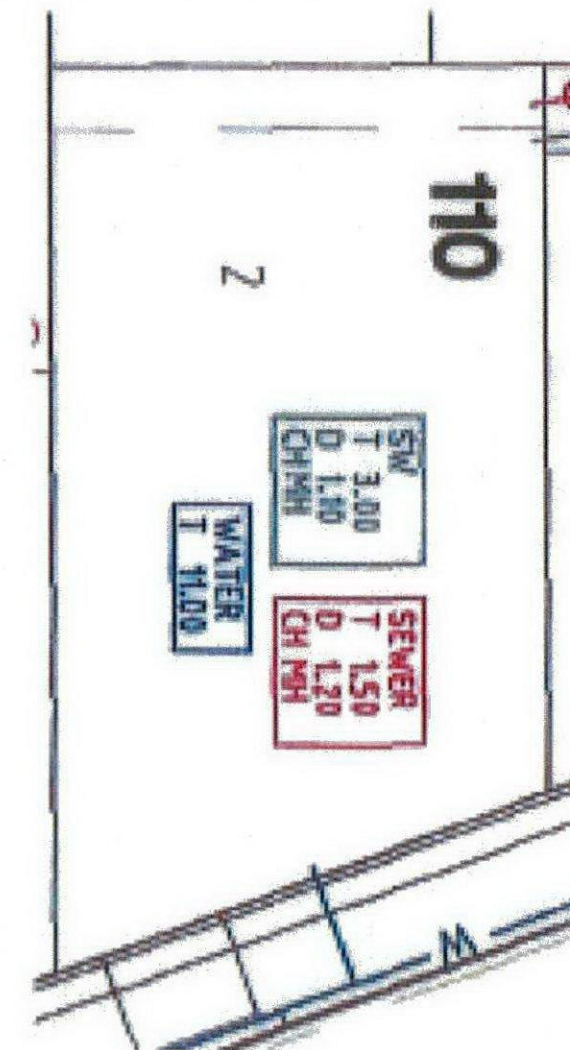
SW NOTE: PROVIDE 100 DIAMETER PIPE TO THE FIRST JUNCTION AND UNDER BUILDINGS UNLESS NOTED OTHERWISE. GREASE LINES SHOWN IN ORANGE LINES. PROPOSED WASTE PLUMBING SHOWN IN YELLOW LINES. PROPOSED SOIL AND DRAINS TO BE LAID SHOWN IN BLUE LINES. DRAINS DELETED SHOWN BY RED 'X'. EXISTING DRAINS SHOWN IN GREEN LINES. PROVIDE INSPECTION OPENINGS ON EACH WC BRANCH OF INTERVALS OF NOT MORE THAN 30m SPACED EQUIDISTANT IMMEDIATELY UP & DOWNSTREAM OF ALL JUMP UPS. VITRIFIED CLAY PIPES TO BE IN ACCORDANCE WITH AS1693 & AS A164. UPVC PIPES TO BE IN ACCORDANCE WITH AS1260. PROVIDE FIRE STOP COLLARS TO ALL UPVC PENETRATIONS OF FIRE RATED FLOORS AND WALLS. THIS BASE DRAINAGE PLAN REMAINS THE PROPERTY OF THE ARCHITECTURAL DESIGN STUDIO & IS NOT TO BE COPIED WITHOUT THE EXPRESS WRITTEN PERMISSION OF ANTHONY BURR. WHILST EVERY PRECAUTION IS TAKEN TO ENSURE THE ACCURACY OF THE NOTES &/OR DRAWINGS NO RESPONSIBILITY &/OR LIABILITY WILL BE ACCEPTED FOR ANY ERRORS &/OR OMISSIONS IN THE TEXT &/OR DRAWINGS. IT IS THE CONTRACTORS RESPONSIBILITY TO ESTABLISH THE LOCATION OF ALL EXISTING SERVICES & THE SUITABILITY OF THE DESIGN PRIOR TO COMMENCING CONSTRUCTION. CHECK POSITION OF TIE PRIOR TO COMMENCING CONSTRUCTION. INSPECTION SHAFT TO BE LOCATED AT THE PROPERTY BOUNDARY IS TO BE RAISED TO GROUND LEVEL IN ACCORDANCE WITH PLUMBING NOTE 3.
