Building Report  
Timber Pest Inspection Report  
Compliance Report  
Conveyancing Report  
Energy Efficiency Rating  
Insurance Certificates  
Tax Invoice

# Building Report

## CONCLUSION AND SUMMARY

# PLAN OF HYDRAULIC SERVICES

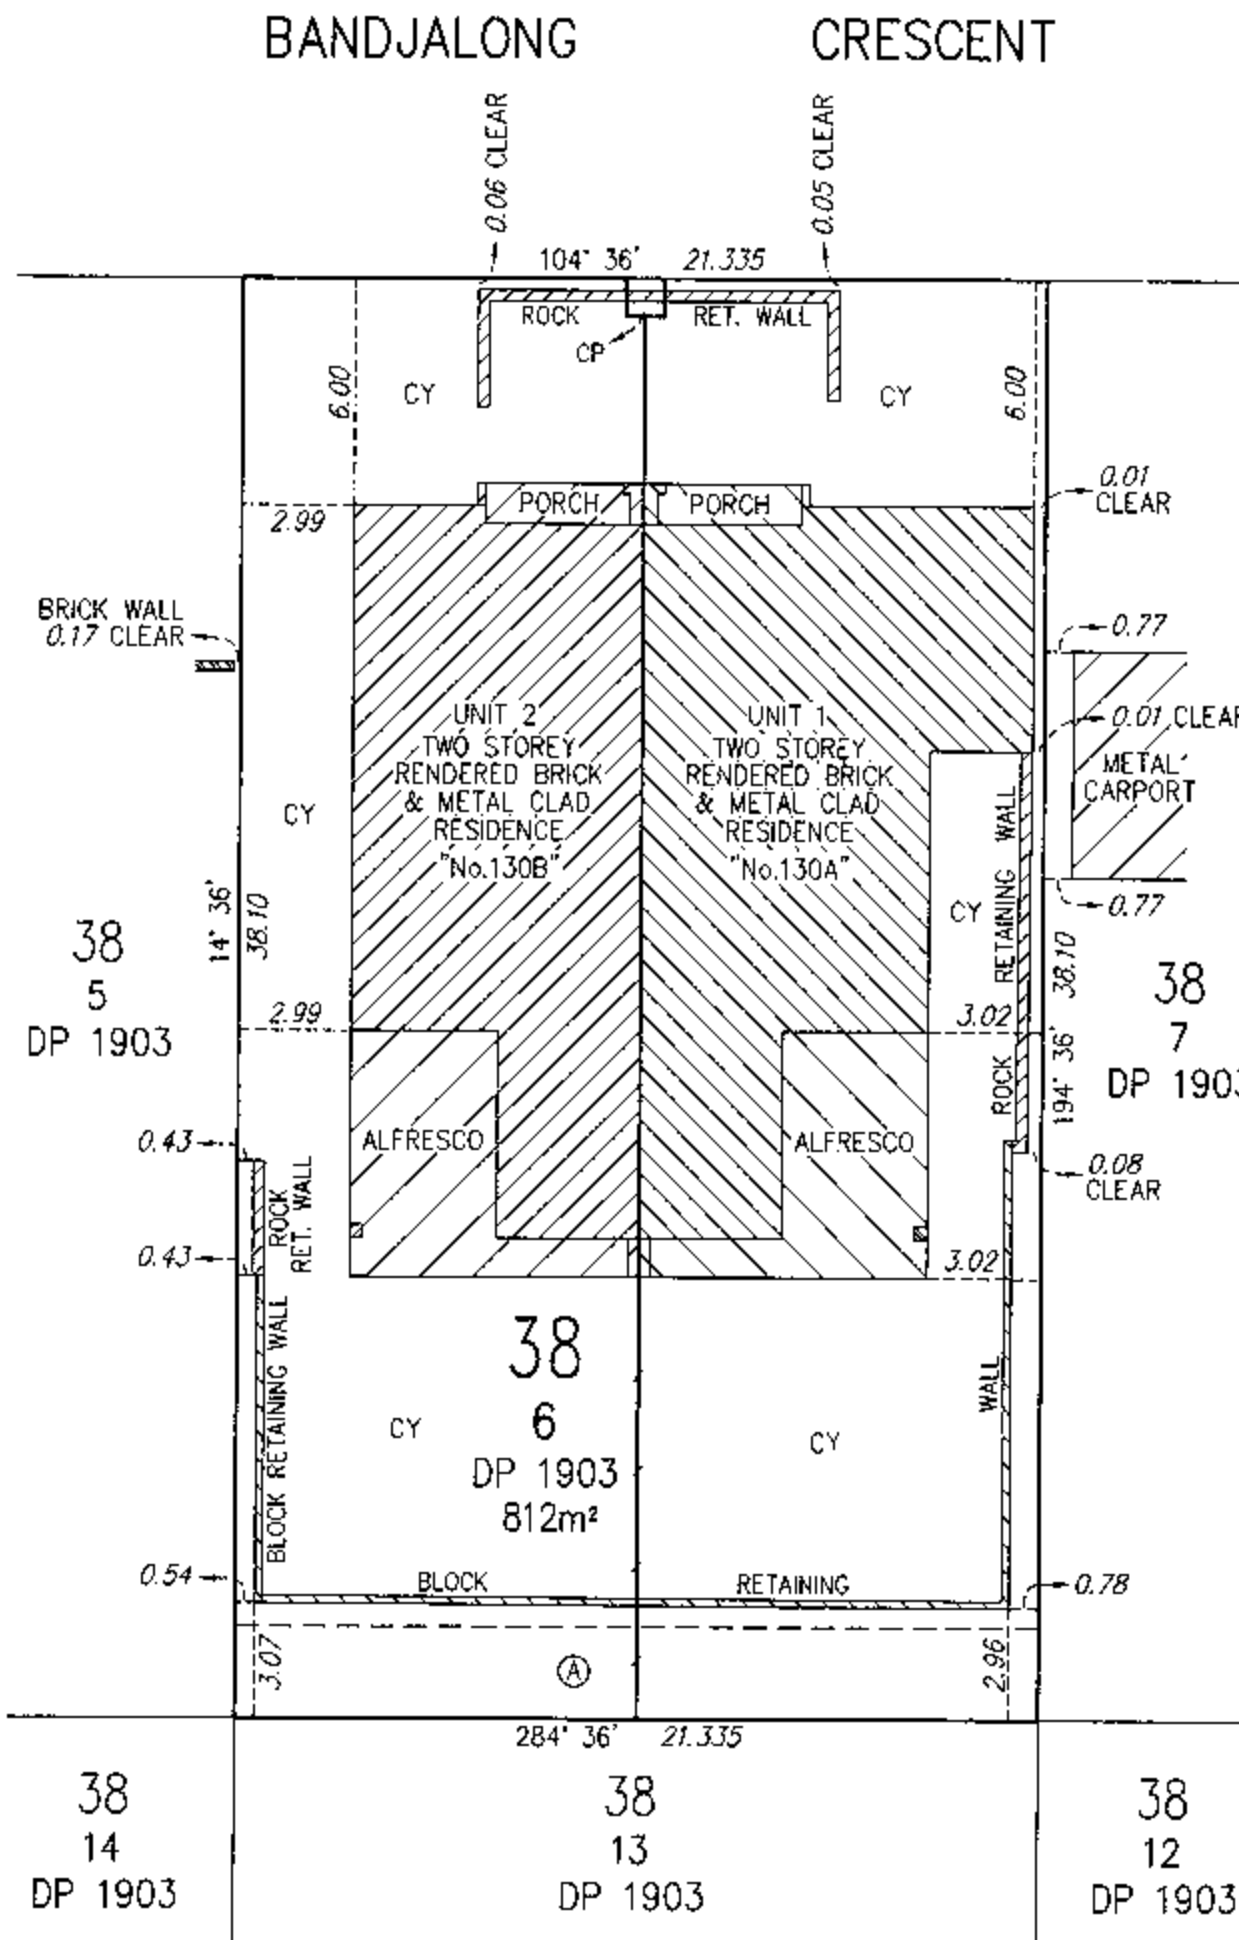
CP DENOTES COMMON PROPERTY  
CY DENOTES COURTYARD  
Ⓐ DENOTES PROPOSED DRAINAGE & ELECTRIC SUPPLY SERVICE EASEMENT 2.44 WIDE (DP 1903)

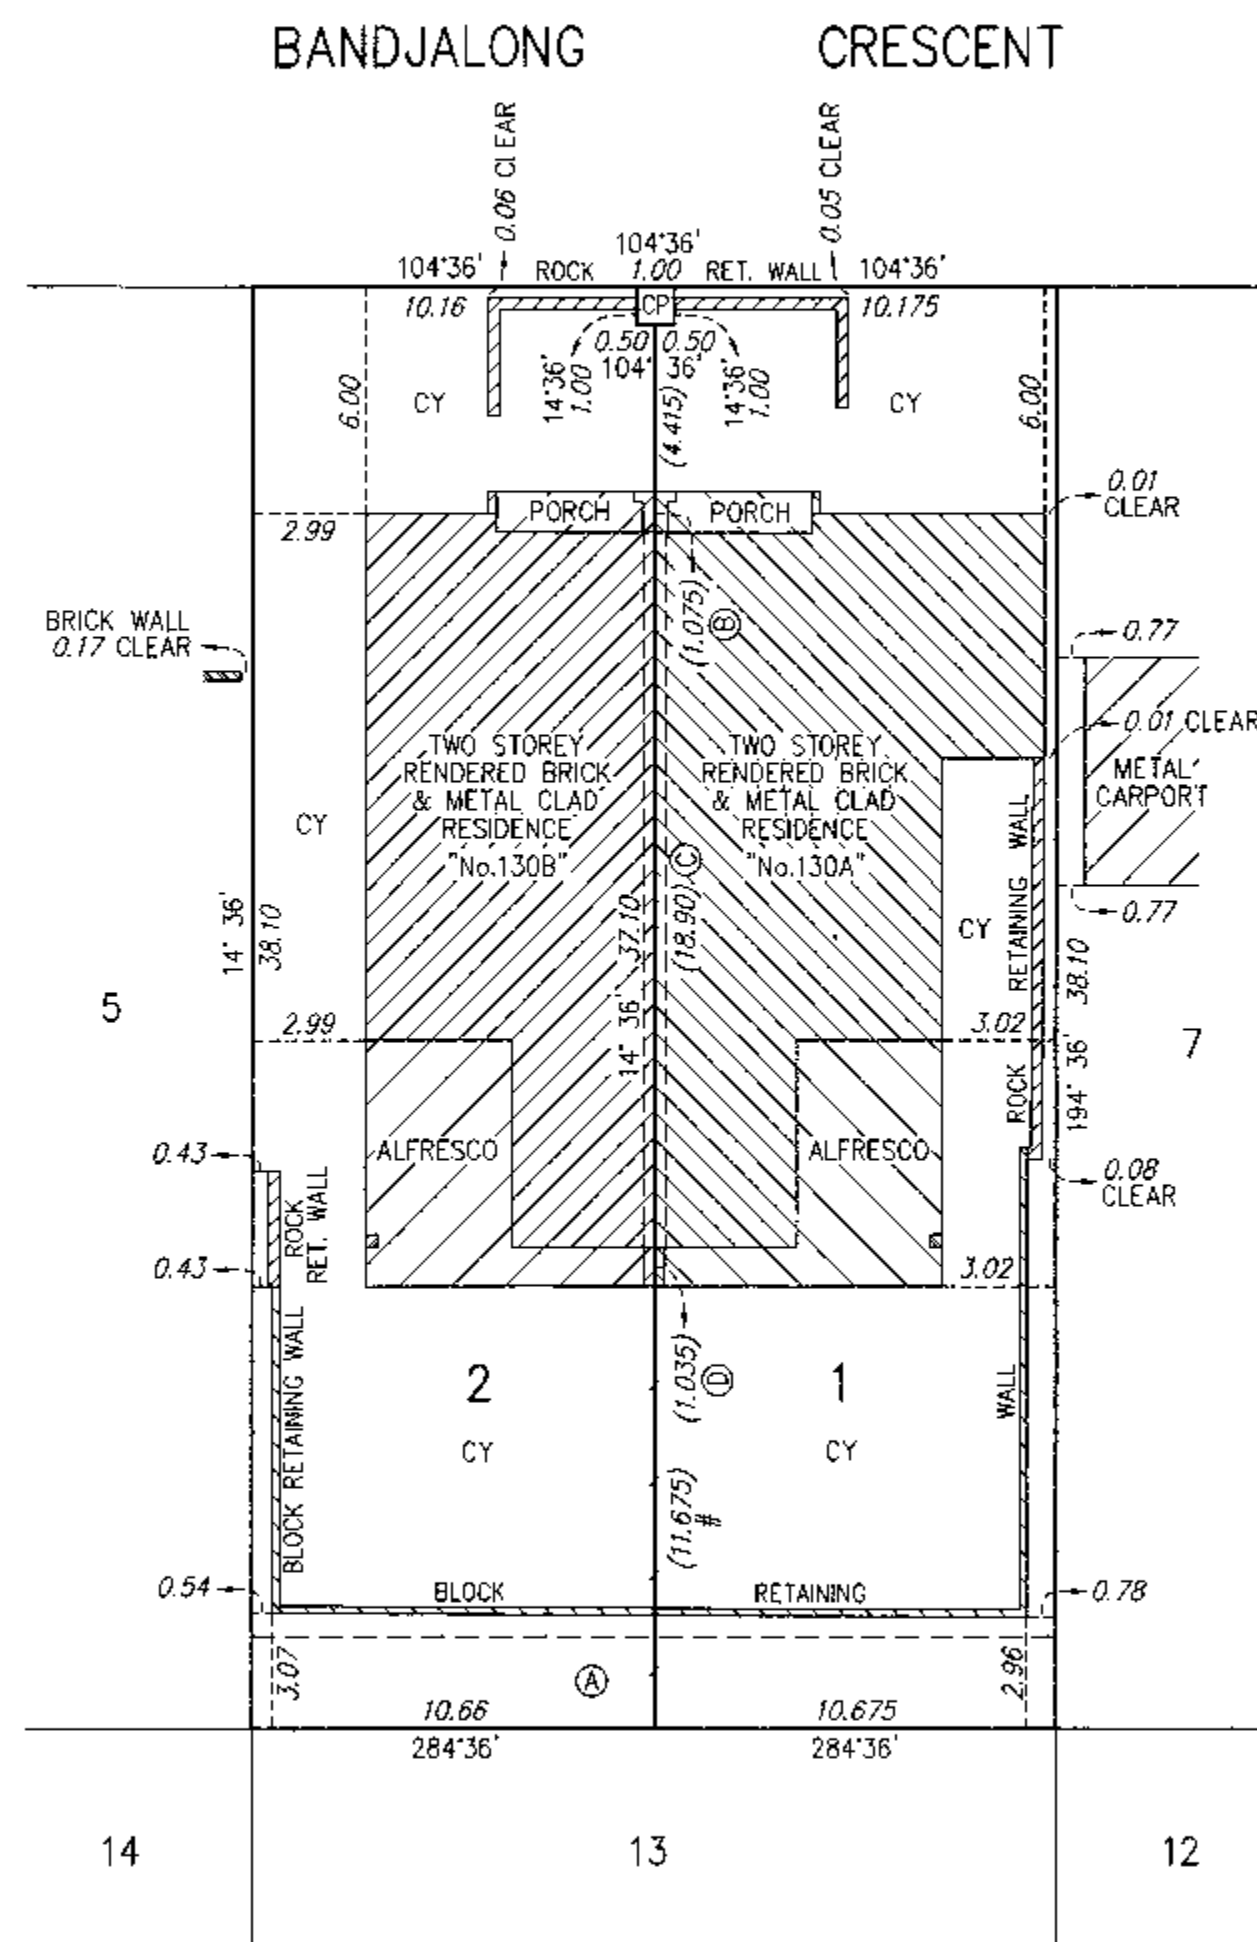
CP DENOTES COMMON PROPERTY  
CY DENOTES COURTYARD  
# DENOTES METAL FENCE ON BOUNDARY  
(A) DENOTES PROPOSED DRAINAGE & ELECTRIC SUPPLY SERVICE EASEMENT 2.44 WIDE (DP 1903)  
(B) DENOTES CENTRE OF 0.44 WIDE WALL IS BOUNDARY  
(C) DENOTES CENTRE OF 0.28 WIDE WALL IS BOUNDARY  
(D) DENOTES CENTRE OF 0.23 WIDE WALL IS BOUNDARY

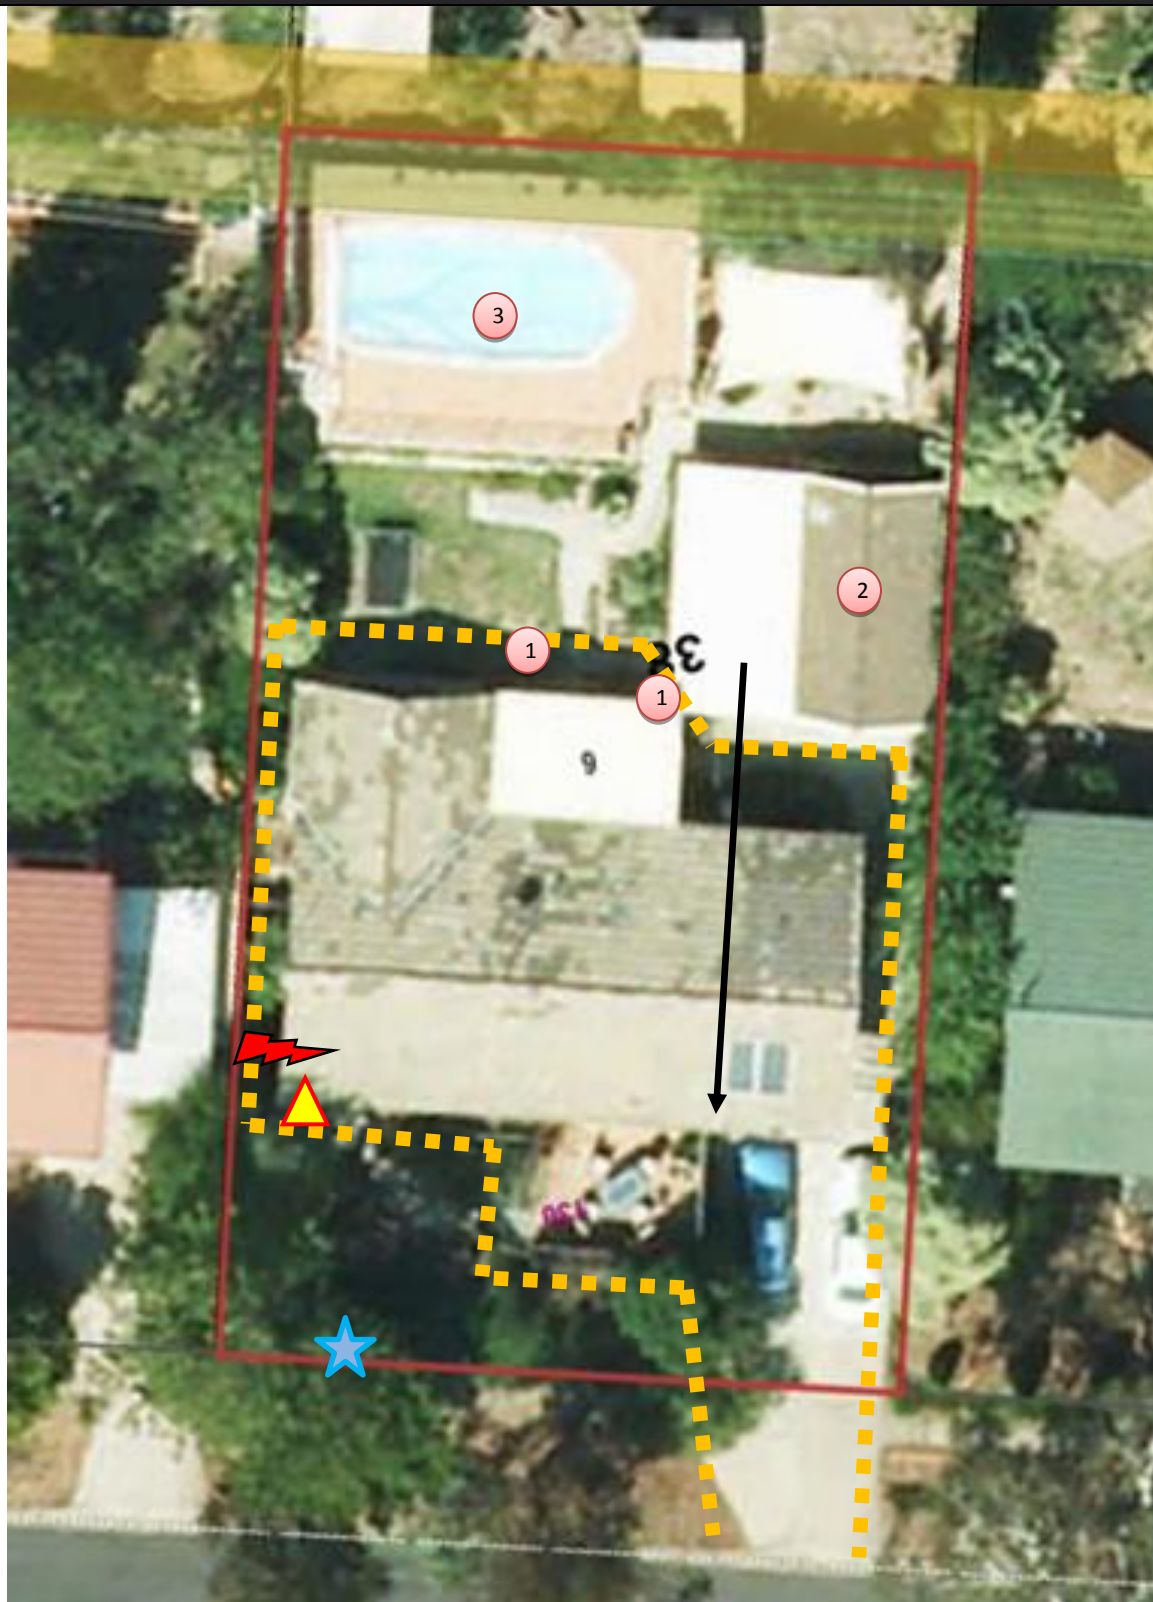
**PLAN**

Street num: 130 Street name: Bandjalong Cres Suburb: Aranda  
Block: 6 Section: 38 Block area: 812m<sup>2</sup>

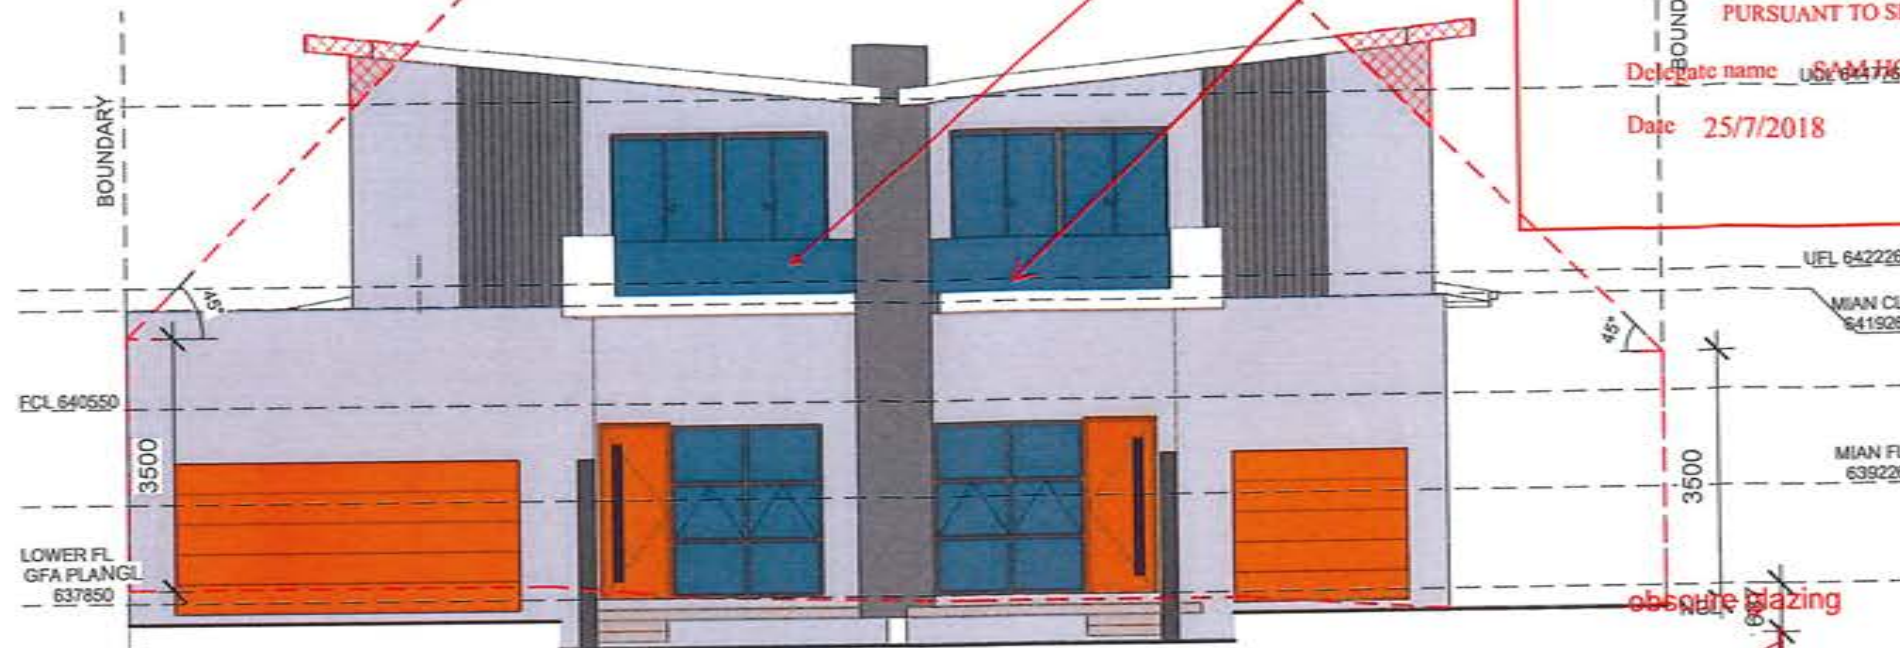
1

**ELEVATION 1:100**

North Elevation

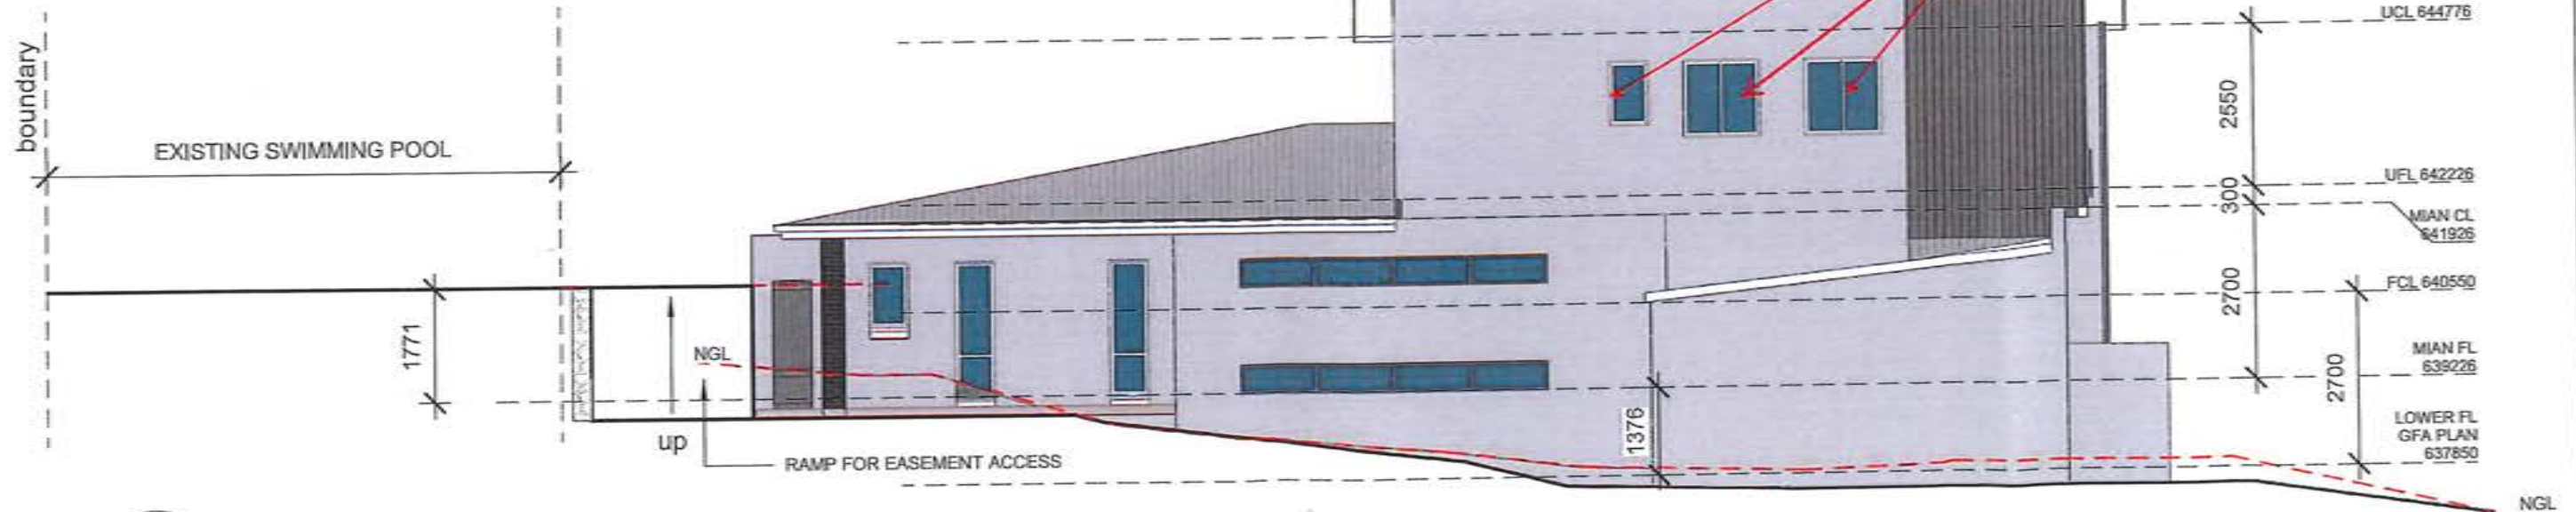
2

**ELEVATION 1:100**

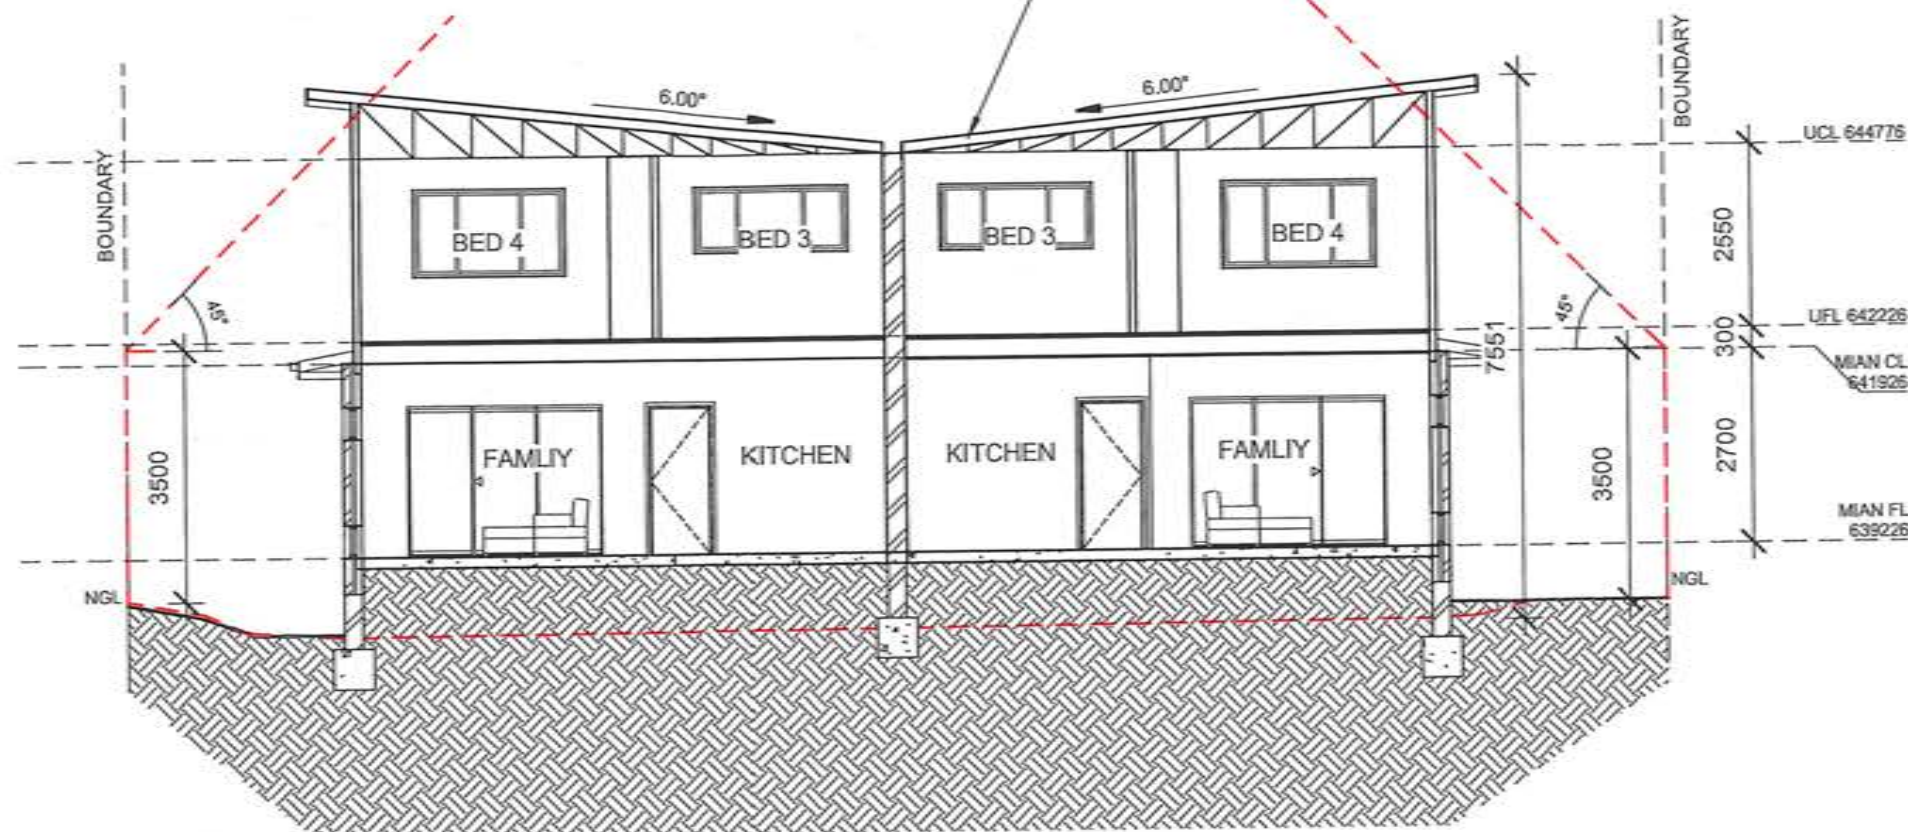
SECTION A-A

R4.0 CEILING INSULATION  
R2.0 WALL INSULATION

WEATHER STRIPS TO EXTERNAL DOORS

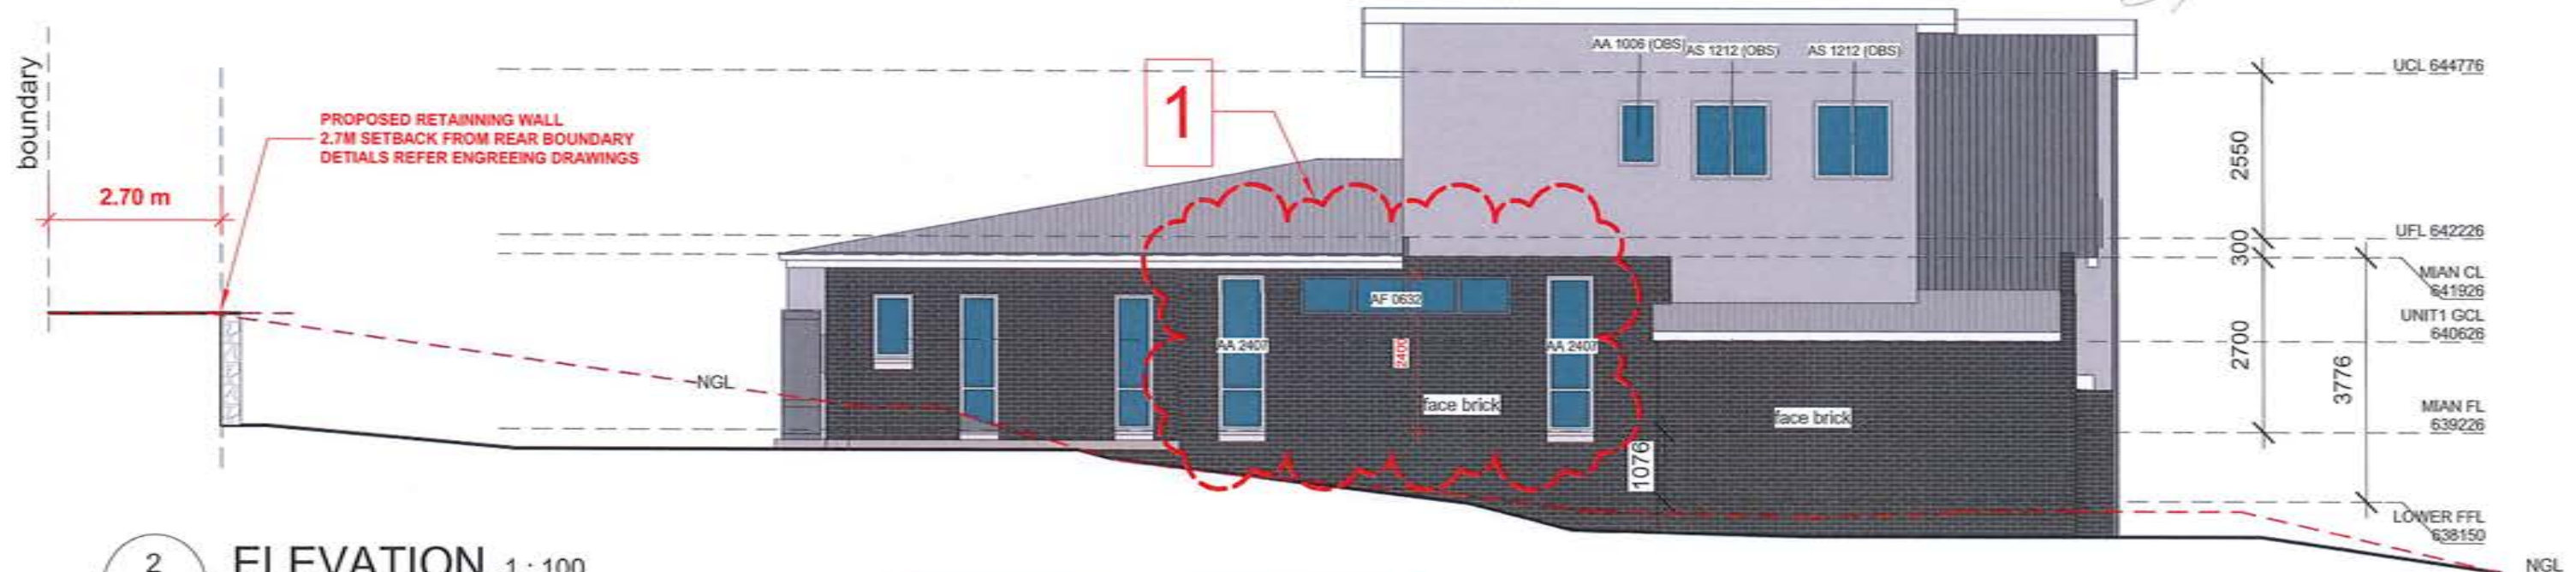
2 **ELEVATION** 1 : 100  
East Elevation

- 1.changed window size from AA0448 to AF 0632, removed window AF0448, add 2 x AA 2107 windows in for unit 1 East elevation and unit 2 West elevation.
- 2.removed ex-swimming pool and ramp, proposed retaining wall 2.7m setback from rear boundary.
- 3.changed garage's the roof of the unit 1 slope direction.
4. add sky light in staircase area for unit 1 and unit 2.

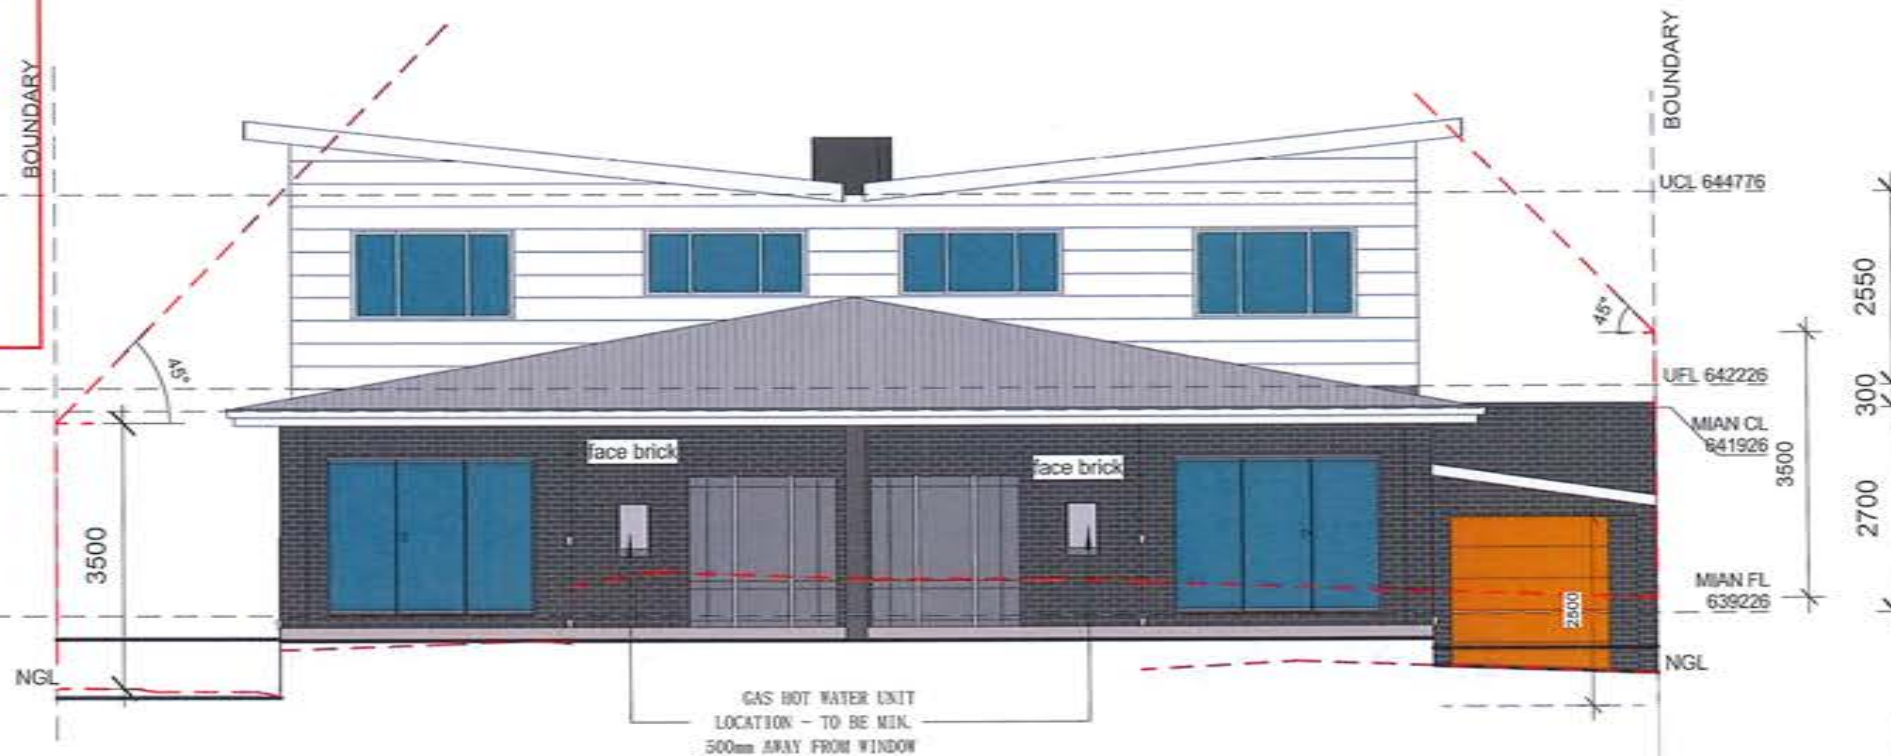
1

**ELEVATION 1:100**

South Elevation

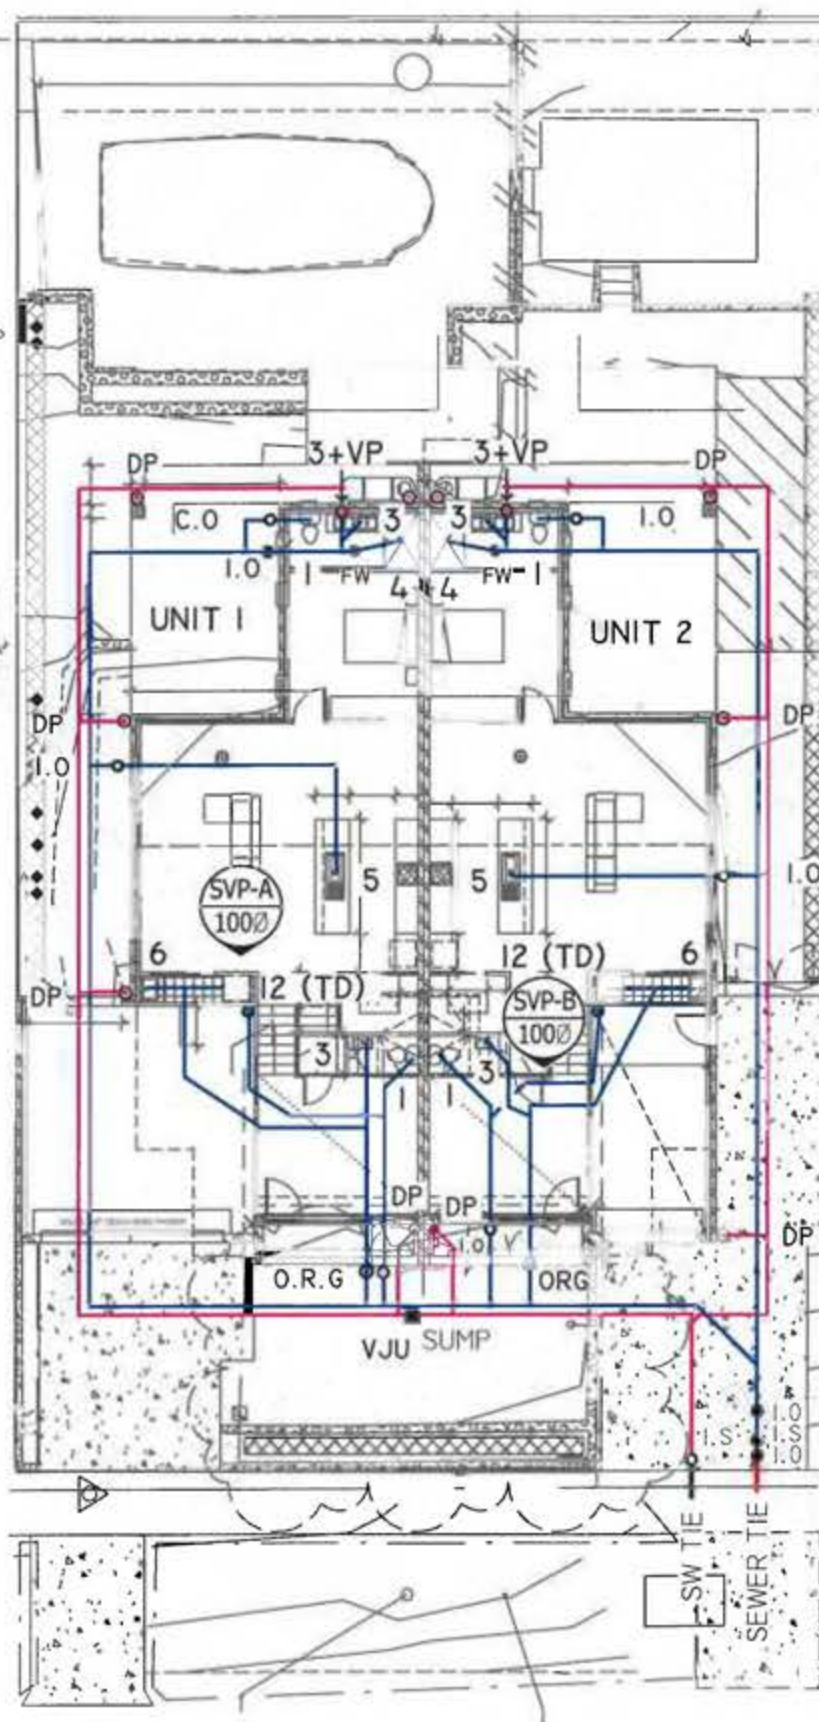
- NOTES**
1. ALL NEW SEWER DRAINS ARE 100Ø UPVC UNLESS NOTED OTHERWISE.
  2. ALL NEW SW IS A MINIMUM 90Ø PVC. MINIMUM 100Ø LINE FROM TIE TO FIRST JUNCTION & UNDER SLABS.
