Report

Building Report

Property Address: 130A Bandjalong Crescent, Aranda ACT 2614
Client: Akay & Ong
Inspection Date: Thursday, May 21st 2026
Inspection carried out by: Tom Strickland

Compliance Report

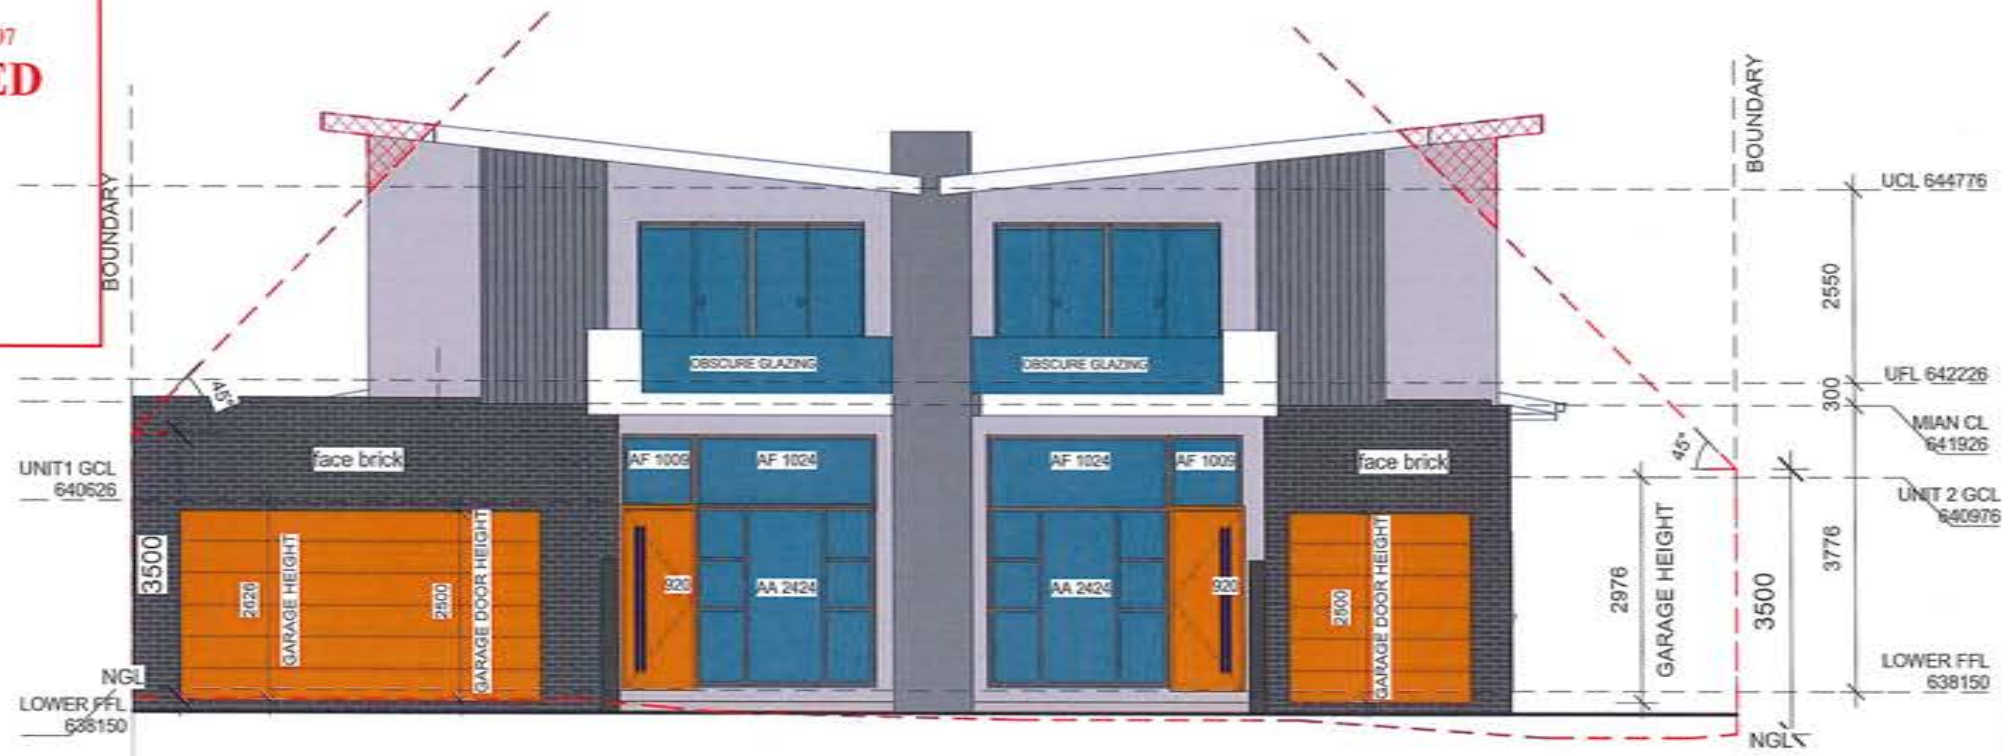
1 **ELEVATION** 1 : 100
 North Elevation

AMENDMENT 18/7/19
 1. changed window size from AA0448 to AF 0632,
 removed window AF0448. add 2 x AA 2107 windows in
 for unit 1 East elevation and unit 2 West elevation.
 2. removed ex-swimming pool and ramp. proposed retaining
 wall 2.7 setback from rear boundary.
 3. changed garage's the roof of the unit 1 slope direction .
 4. add sky light in staircase area for unit 1 and unit 2.
