Report

Building Report

CONCLUSION AND SUMMARY

Compliance Report

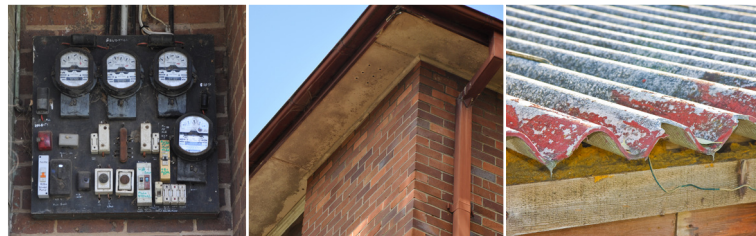
1. Exterior
roof sheeting, gutters, downpipes,
ridge capping, eaves, cladding,
electrical switchboards

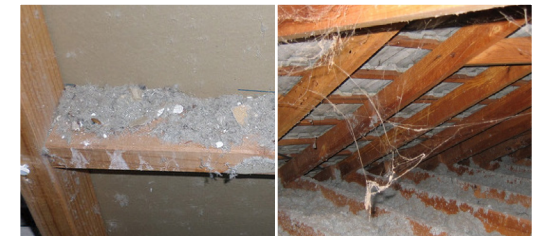
5. Building cavities
A small number of homes may still contain
loose fill asbestos insulation in the roof
cavity, wall cavities or sub-floor space
