# Report

# Building Report

## CONCLUSION AND SUMMARY

SUBURB: **FRASER** SECTION: **39** BLOCK: **6** UNIT: **2** EX GOV: **NO**

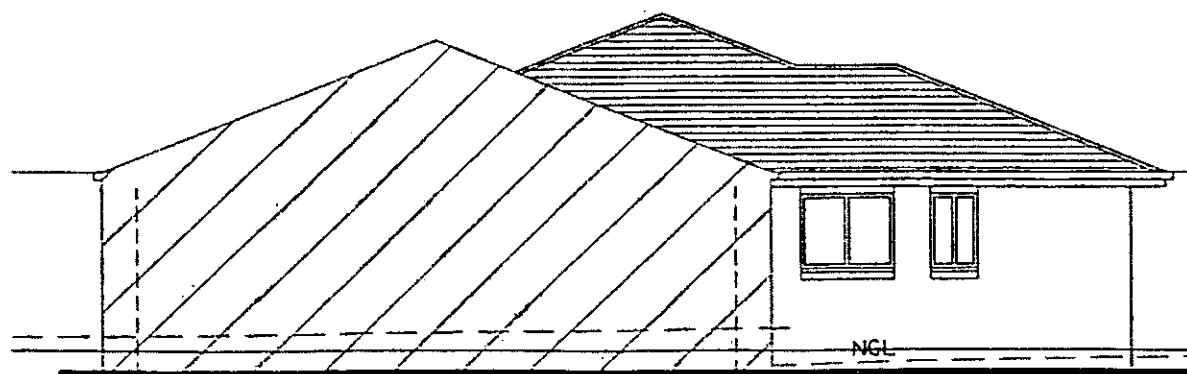
ELEVATION 4

90x35 PINE PLATES AND NOGGINGS  
 90x35 PINE STUDS AT 450CTRS TO LOAD  
 BEARING WALLS AND AT 600CTRS TO  
 NON-LOAD BEARING WALLS  
 PLASTERBOARD INTERNAL WALL AND CEILING  
 LINING  
 CEMENT SHEET LINING TO WET AREAS  
 FINISHES AS SELECTED.

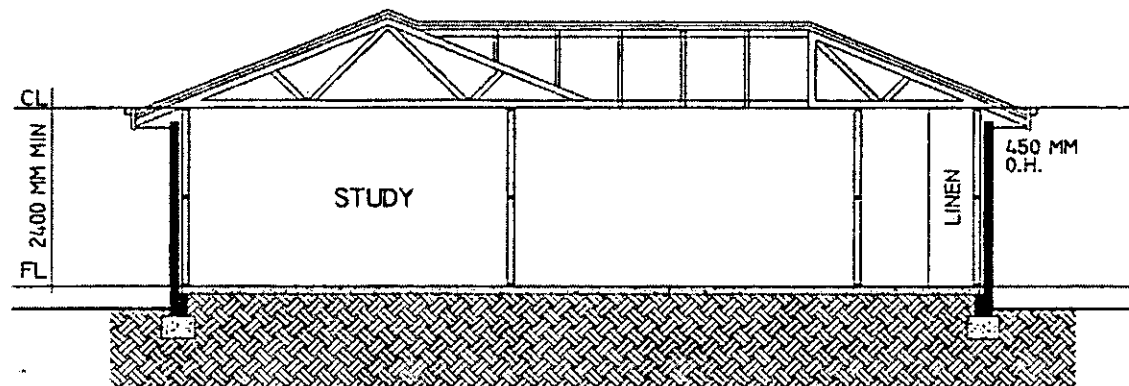
SECTION A - A

ALL CONCRETE FOOTINGS AND SLABS TO BE IN  
 ACCORDANCE WITH ENGINEERS DETAILS  
 PROVIDE CONTINUOUS DAMPROOF  
 MEMBRANE UNDER SLAB.

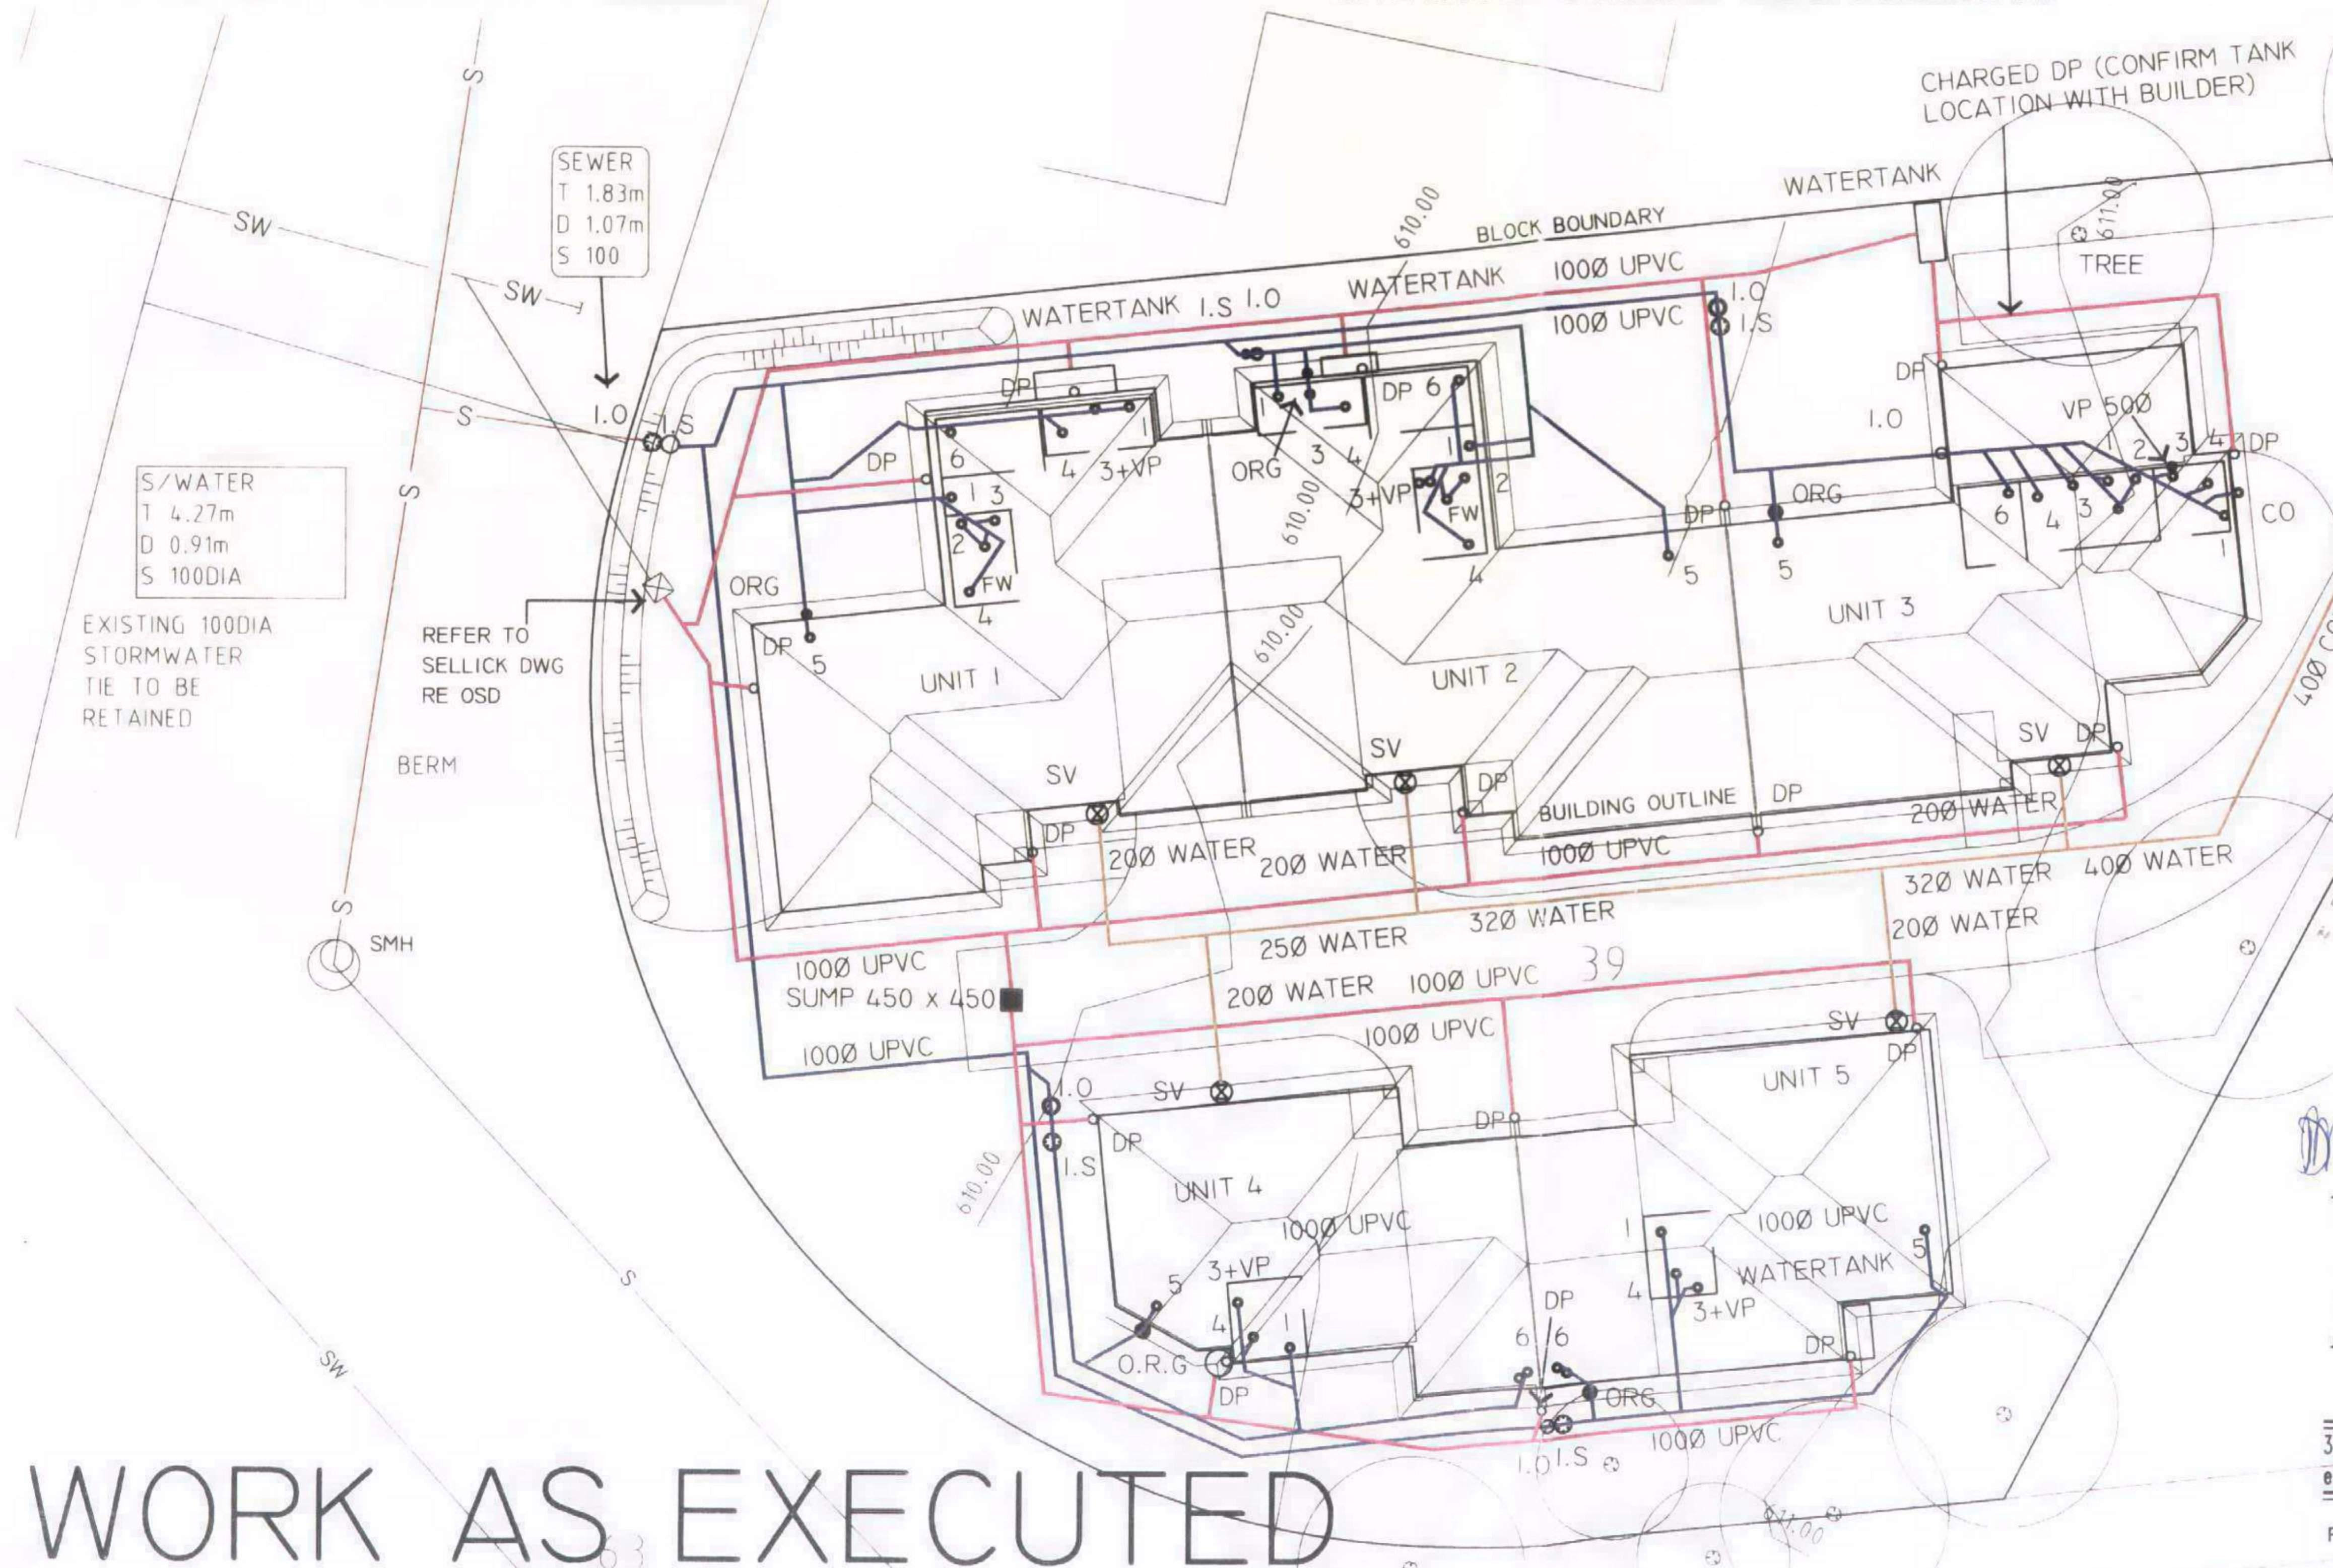
SHEET 1 OF 2

ALL WORK TO BE IN ACCORDANCE WITH THE CANBERRA SEWERAGE AND WATER SUPPLY REGULATIONS. THIS PLAN TO BE READ IN CONJUNCTION WITH APPROVED ARCHITECTURAL PLANS. THIS PLAN HAS BEEN DESIGNED IN ACCORDANCE WITH A.S 3500, NATIONAL PLUMBING AND DRAINAGE CODE. ORG TO BE A HEIGHT OF 150mm BELOW LOWEST FIXTURE TO BE DRAINED & A MINIMUM 75mm ABOVE F.G.L.(50mm IN PAVED AREAS, GRADED FROM O.R.G.)

DISCONNECT EXISTING 200 WATER SERVICE, BY ACTEWAGL AT CONTRACTORS EXPENSE.  
EXISTING WATER METER NUMBER 127569 TO BE REMOVED BY ACTEWAGL AT TIME OF DISCONNECTION

*28/7/10*  
ALL SW AND SEWER IS 1000 UPVC UNLESS NOTED OTHERWISE  
*1988/4767 11-03 10*
