# Building Report

## CONCLUSION AND SUMMARY

## COMPLIANCE REPORT

**UPPER FLOOR PLAN**  
 SCALE 1:100 @ A3

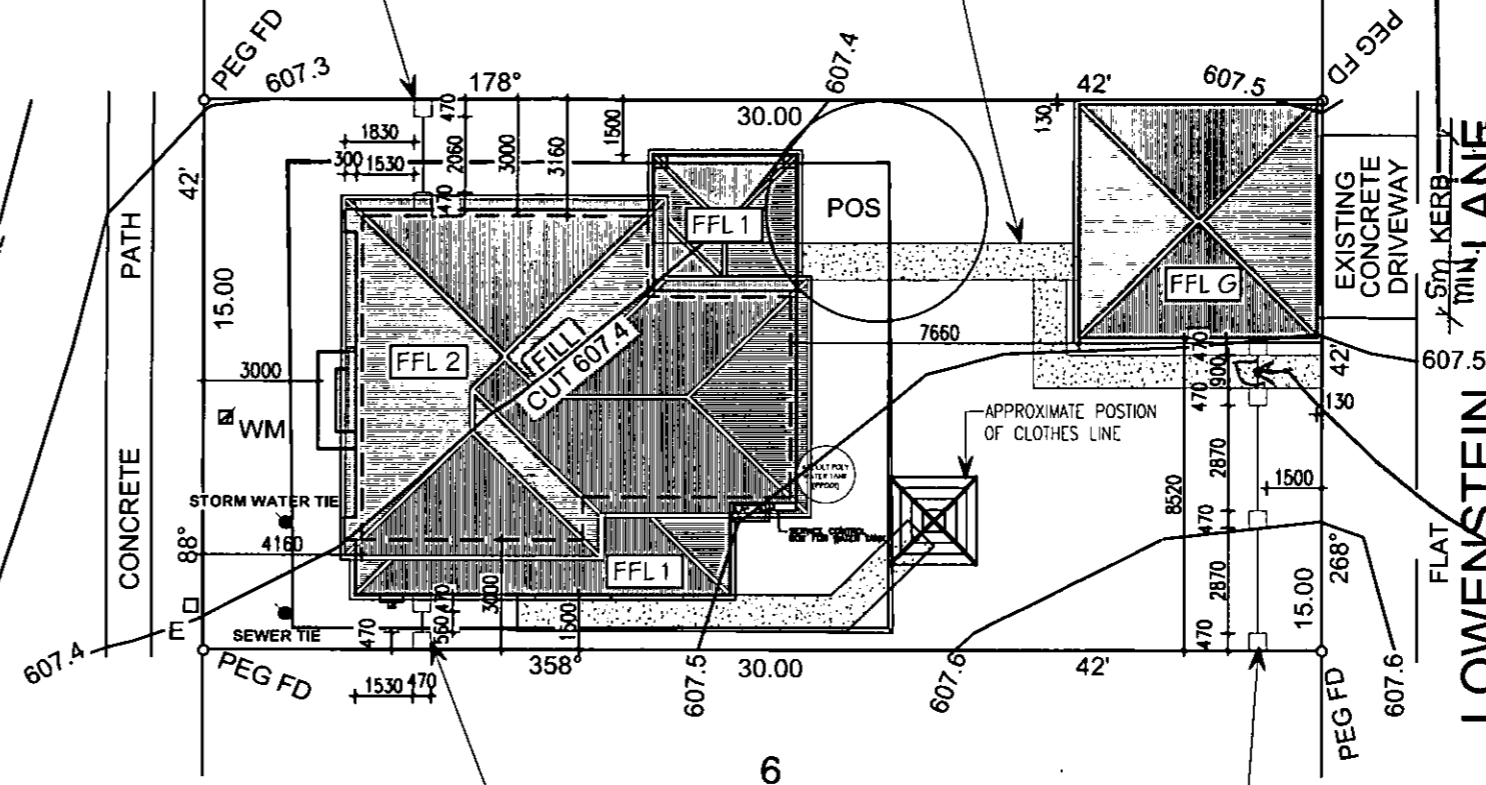
OODGEROO AVENUE  
&  
LOWENSTEIN FLAT

FENCE TYPE F1 MANDATORY AS PER LEASE AND DEVELOPMENT CONDITIONS. 470 x 470 BRICK PIERS 1200mm HIGH WITH 350mm LINKING HOB. INFILL TO BE BLACK POWDER COATED 'CYCLONE'; FENCE. BRICK RENDERED AND PAINTED TO MATCH HOUSE.

FENCE TYPE F2 PLUS PEDESTAL GATE MANDATORY AS PER L&D CONDITIONS. 470x 470 BRICK PIERS 1800 HIGH WITH CAPPING IF DESIRED. INFILL WITH 100 x 25 NATIVE PLANTATION HARDWOOD TIMBER PALINGS, 50mm GAP. PIERS LOCATED AT BLOCK CORNERS AND PEDESTRIAN ACCESS LOCATIONS. BRICK RENDERED AND PAINTED TO MATCH HOUSE.

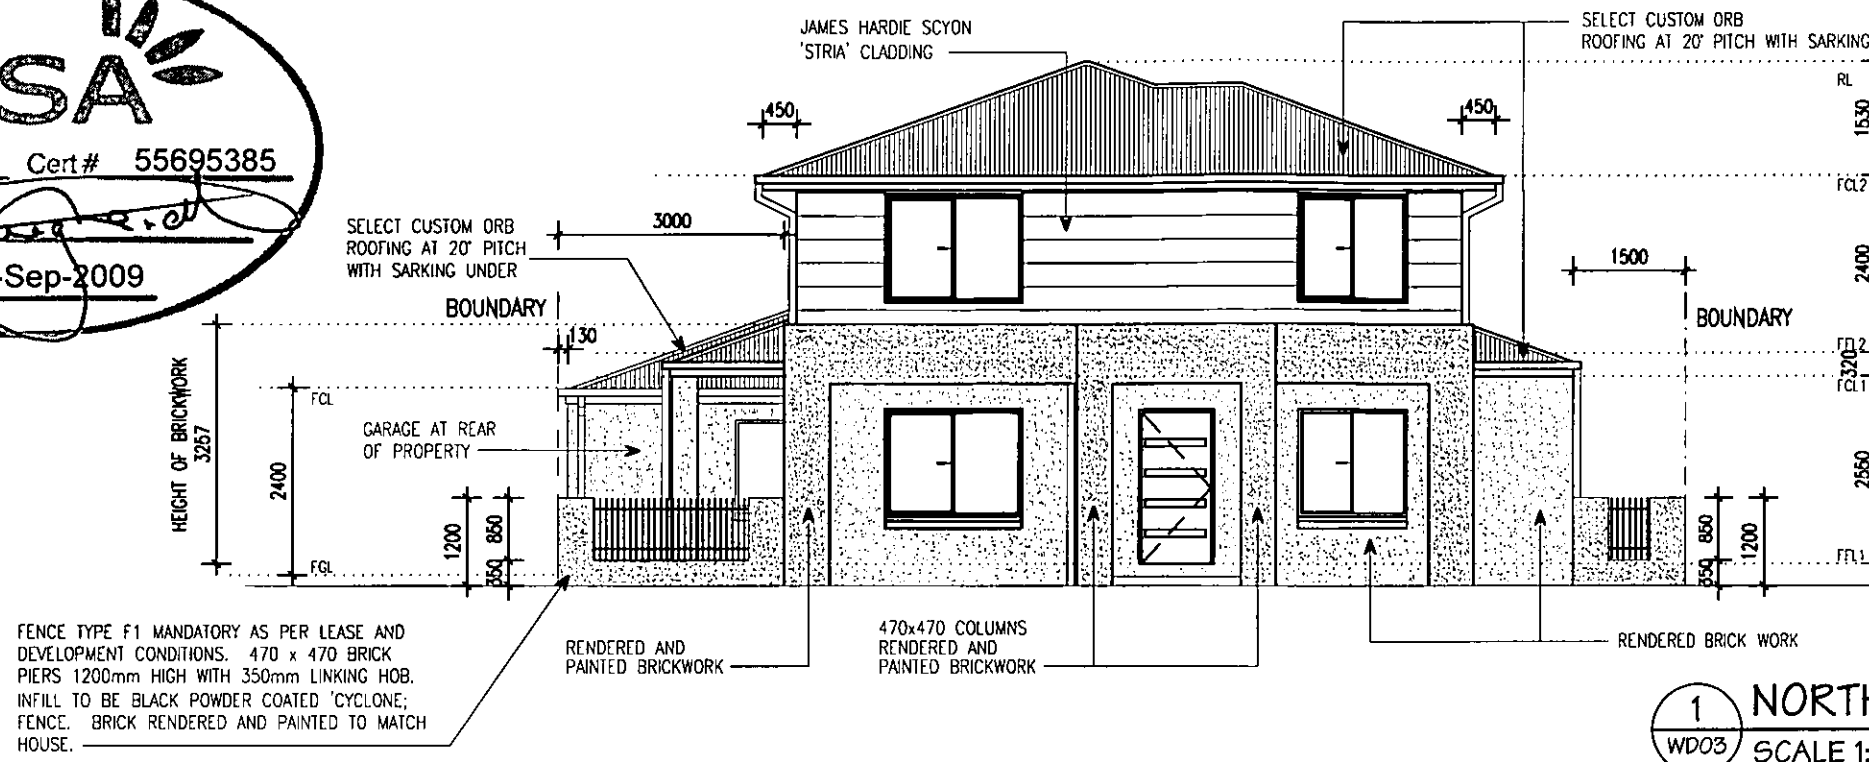
1 NORTH ELEVATION  
WD03 SCALE 1:100 @ A3

NOTE:  
 • WINDOWS TO BE POSITIONED AT HEAD HEIGHT : 2143 OR DIRECTLY UNDER EAVES WHERE APPLICABLE  
 • GARAGE DOOR HEAD HEIGHT : 2143

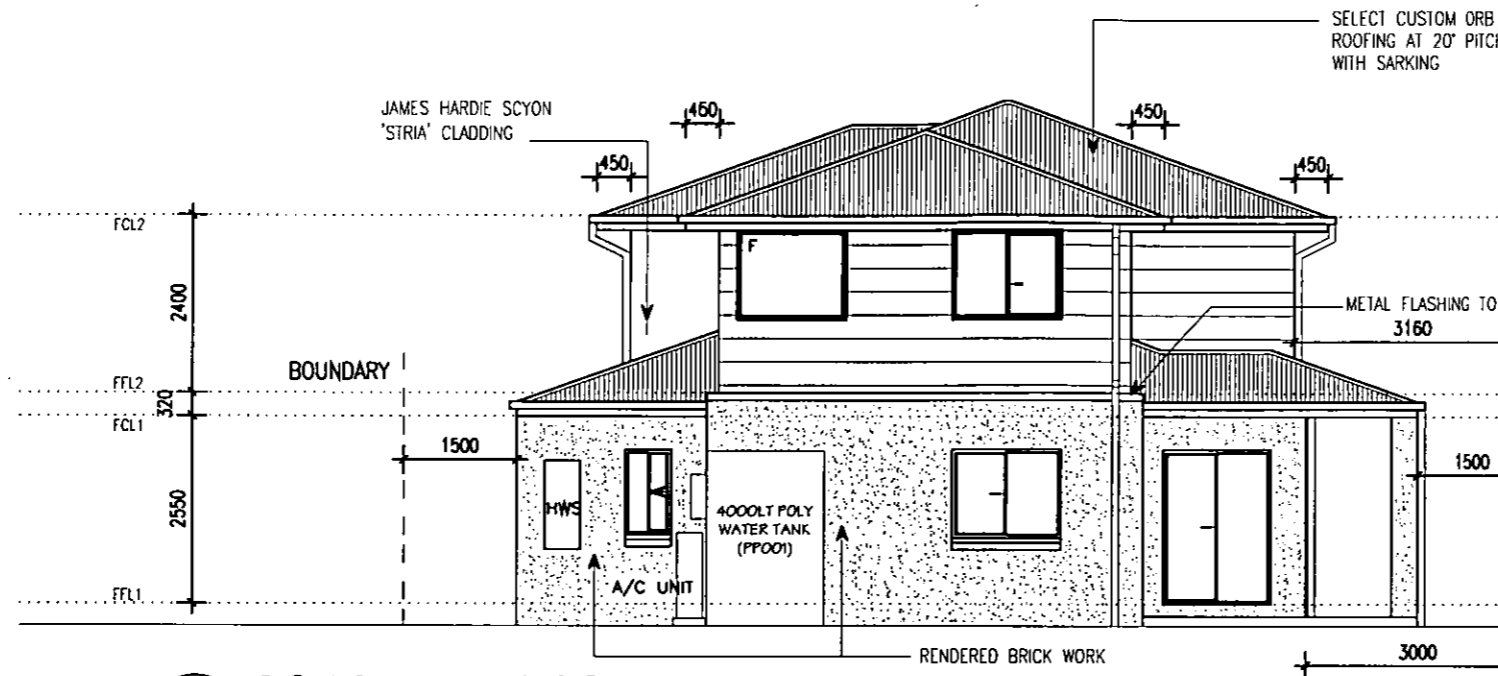
**3 SOUTH ELEVATION**  
 WDO3 SCALE 1:100 @ A3

NOTE:  
 • WINDOWS TO BE POSITIONED AT HEAD HEIGHT : 2143 OR DIRECTLY UNDER EAVES WHERE APPLICABLE  
 • GARAGE DOOR HEAD HEIGHT : 2143

PROVIDE LEVEL 1 BUILDING CONSTRUCTION TO HOME AS PER AS3959 - 1999

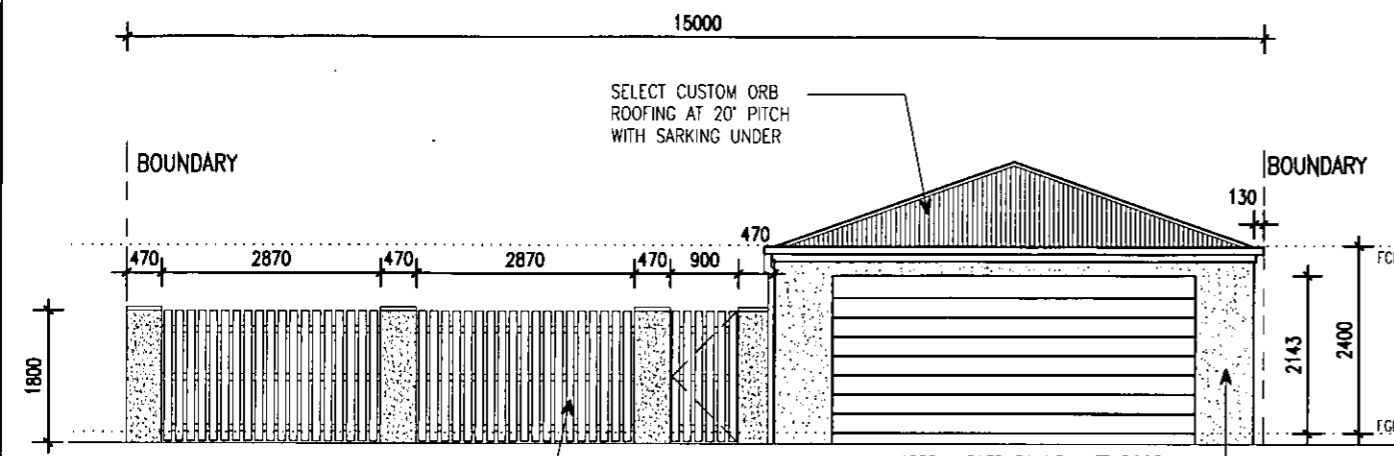
**3 SOUTH ELEVATION**  
 WDO3 SCALE 1:100 @ A3

CONNECT MAIN HOUSE 100% OF ROOF GUTTERS TO TOILET FLUSHING AND LAUNDRY COLD TAPS

PROVIDE LEVEL 1 BUILDING CONSTRUCTION TO HOME AS PER AS3959 - 1999

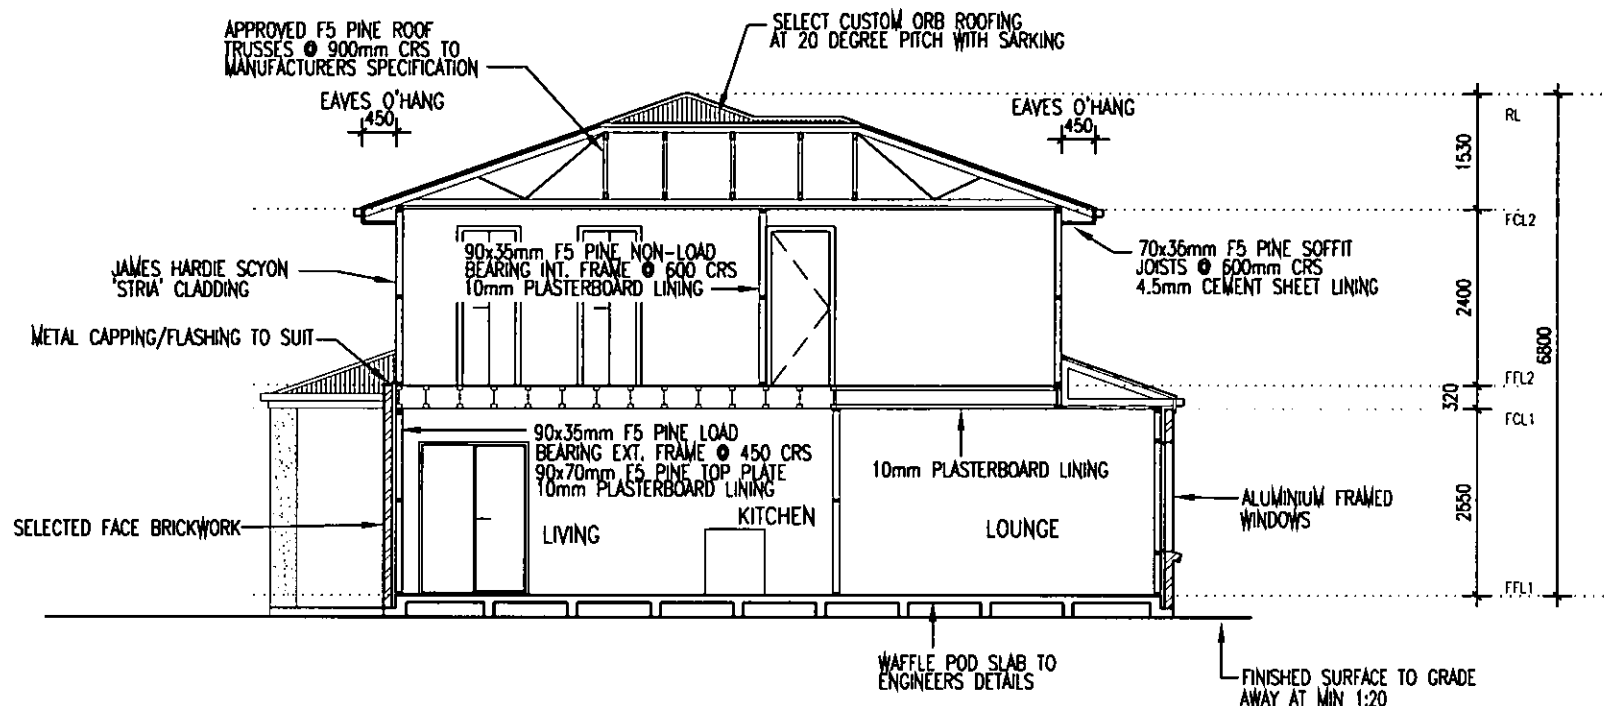
AA SECTIONAL DETAIL  
03-04 SCALE 1:100 @ A3

PROVIDE LEVEL 1 BUILDING CONSTRUCTION TO HOME AS PER AS3959 - 1999

**INSULATION NOTE:**  
R3.5 BULK INSULATION BATTS TO LIVING AREA CEILINGS  
R2.0 INSULATION TO EXTERNAL WALLS  
SARKING TO UNDERSIDE OF ROOF

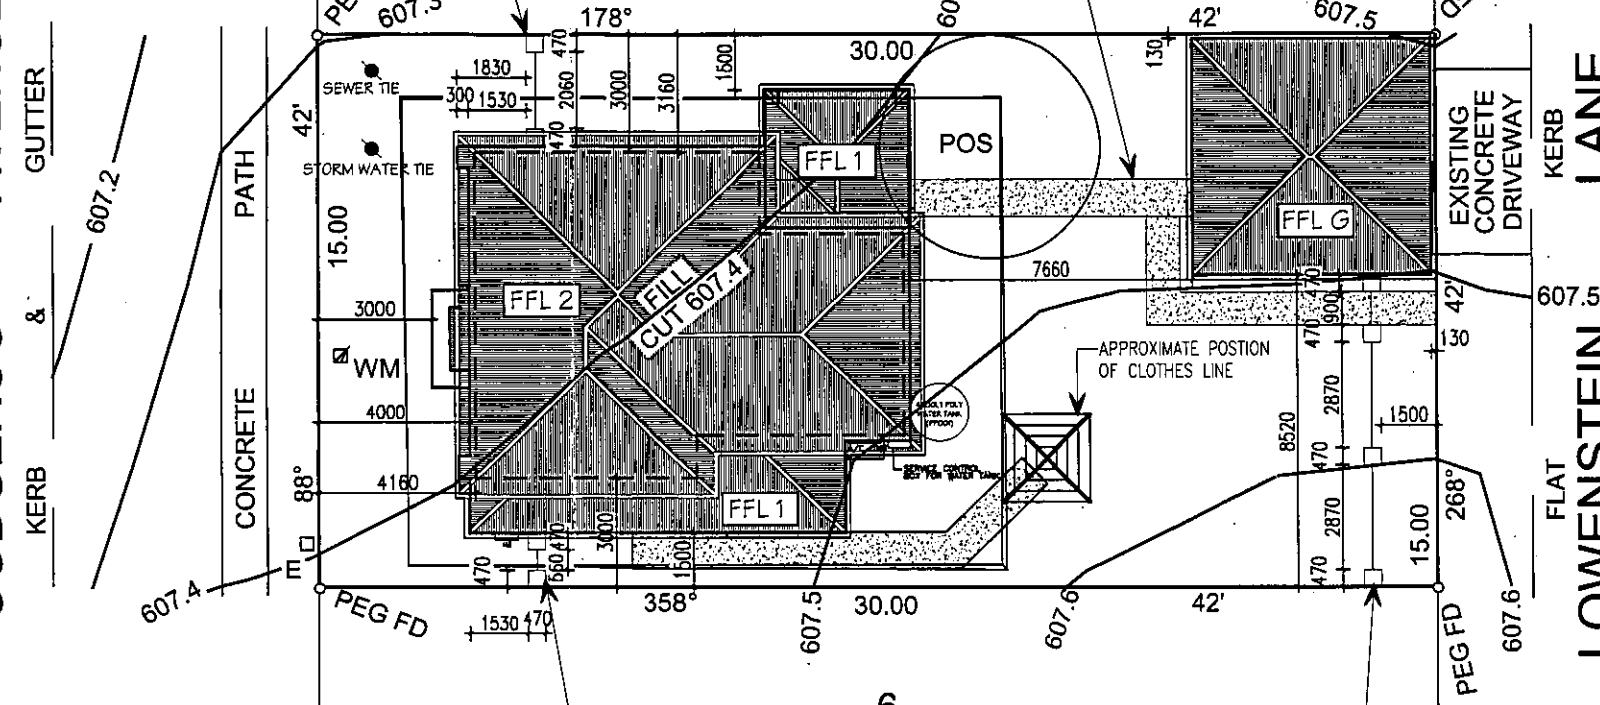
APPROXIMATE POSITION/LOCATION OF CONCRETE PATHS, TOTAL 30m<sup>2</sup>

FENCE TYPE F1 MANDATORY AS PER LEASE AND DEVELOPMENT CONDITIONS. 470 x 470 BRICK PIERS 1200mm HIGH WITH 350mm LINKING HOB. INFILL TO BE BLACK POWDER COATED 'CYCLONE' FENCE. BRICK RENDERED AND PAINTED TO MATCH HOUSE.

FENCE TYPE F2 PLUS PREDESTIAN GATE MANDATORY AS PER L&D CONDITIONS. 470x 470 BRICK PIERS 1800 HIGH WITH CAPPING IF DESIRED. INFILL WITH 100 x 25 NATIVE PLANTATION HARDWOOD TIMBER PALINGS, 50mm GAP. PIERS LOCATED AT BLOCK CORNERS AND PEDESTRIAN ACCESS LOCATIONS. BRICK RENDERED AND PAINTED TO MATCH HOUSE.
