## PRESALE REPORT

**33 Mackennal Street**

Lyneham

ADDRESS	33 Mackennal Street Lyneham	
CLIENT	Angela Lenn & Travis Thurston	
OCCUPANCY STATUS	unoccupied - the dwelling was unfurnished at the time of the inspection	
INSPECTOR - Mick Ffrench	INSPECTION DATE - 18 May 2026	WEATHER CONDITIONS - Raining
JOB REFERENCE - 46579	BLOCK - 21	SECTION - 34

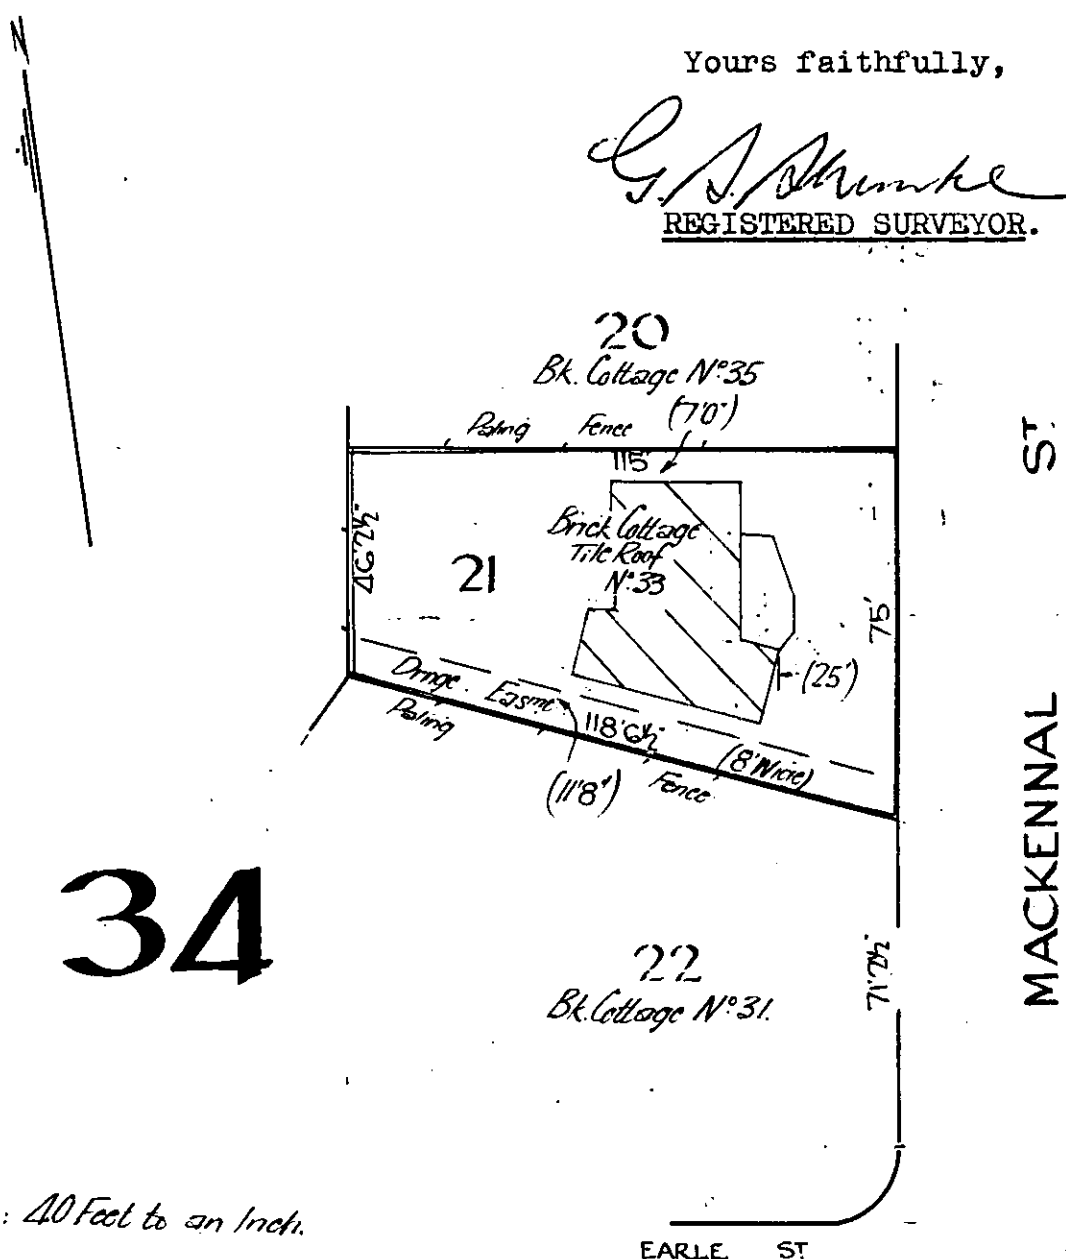
Scale: 40 Feet to an Inch.

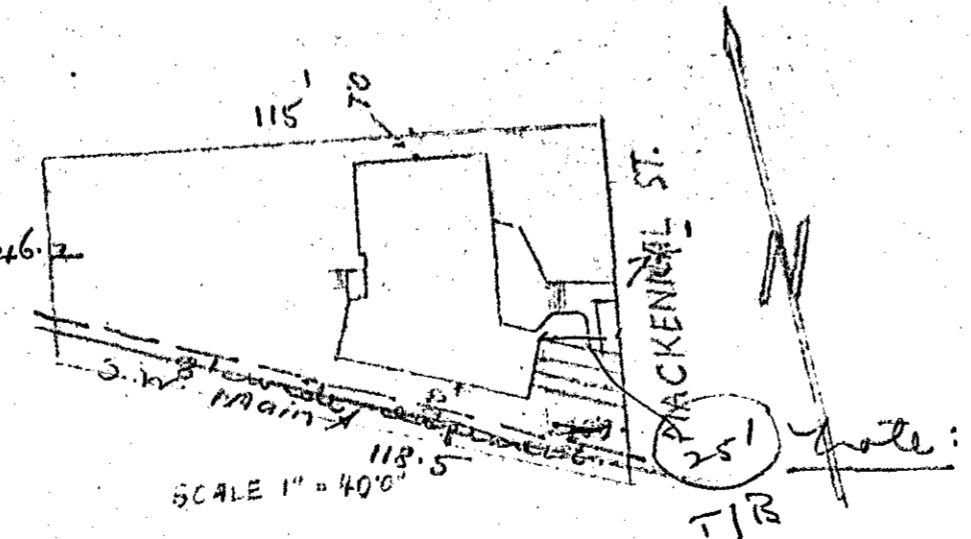
PLAN FOR PROPOSED  
 RESIDENCE IN BRICK AREA 1265 SQ.FT.  
 ON BLOCK 21 SECTION 34  
 LYNHAM A.C.T. FOR A. NIEDERMEIER  
 SCALE 1/8" = 10"
