Report

Building Report

Property Address: 49 Coranderrk Street, Reid ACT 2612
Client: Papas Developments Pty Ltd
Inspection Date: Wednesday, May 13th 2026
Inspection carried out by: Ben Halse

49 CORANDERRK STREET
REID: Block 10, Section 15
(ACT MAPI - ID 104049)
PAPAS
BASEMENT PLAN

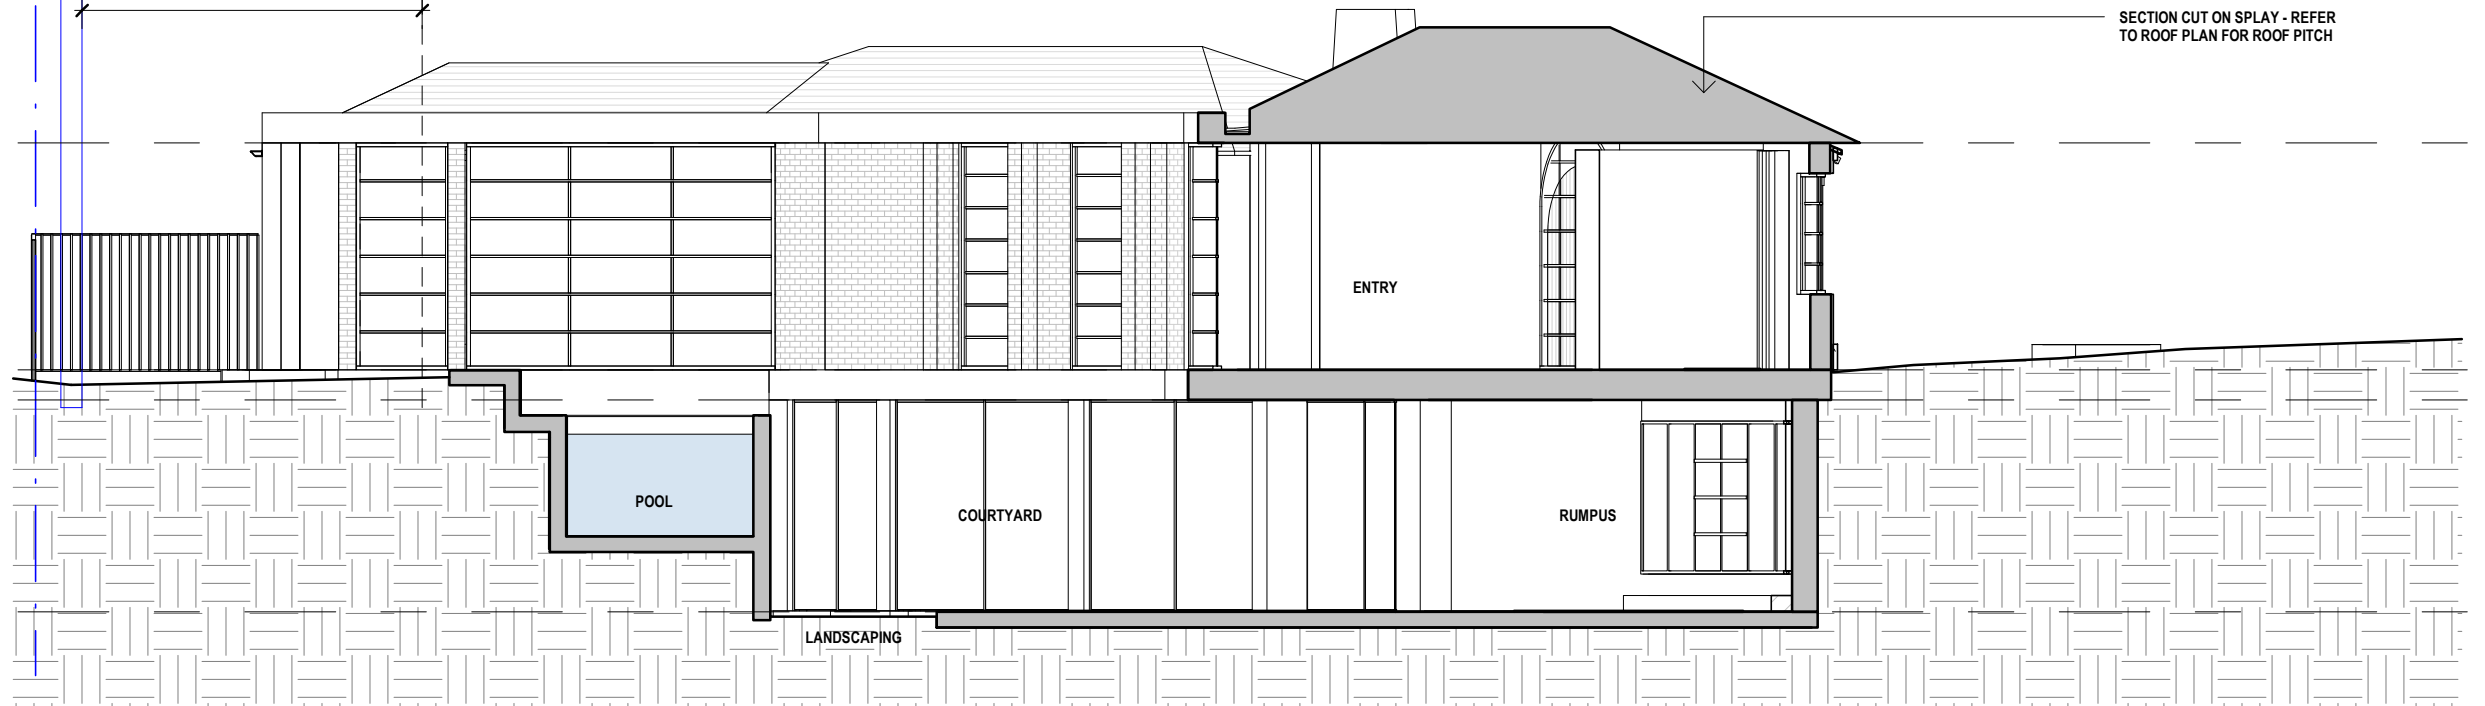
49 CORANDERRK STREET
 REID: Block 10, Section 15
 (ACT MAPI - ID 104049)
 PAPAN
**SECTION 3 - POOL &
 COURTYARD**
 1:100 @ A3
A113

1 Section 3 - Pool and LGF Courtyard
 1:100
