PRESALE REPORT

58 Savige Street

Campbell

SITE RECORD

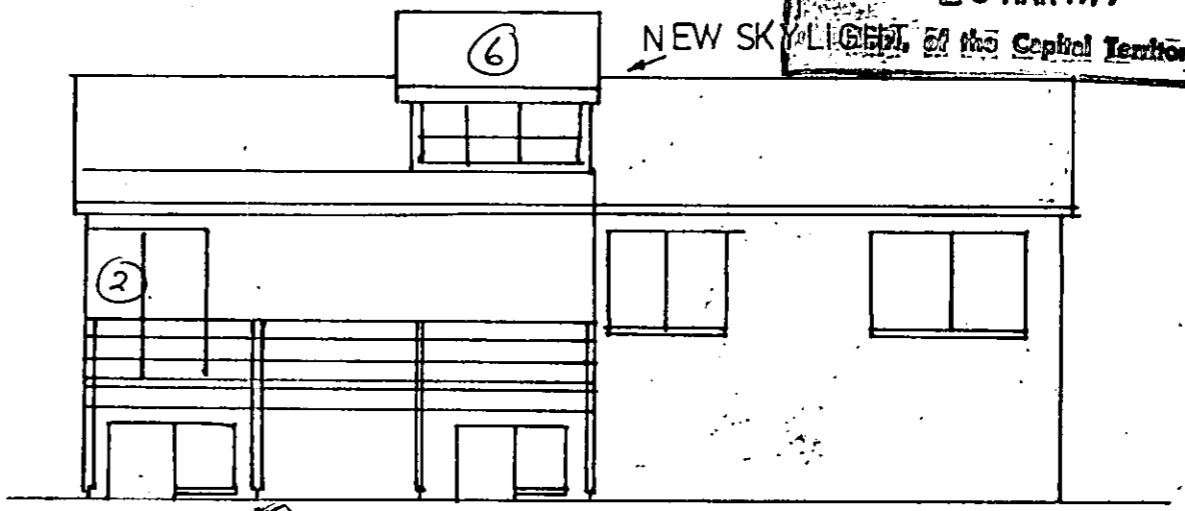
SECTIONS A-A, B-B & C-C

PROPOSED CHANGES TO THE RESIDENCE of
 MR. L. JONES at BLOCK 2 SECTION 20 CAMPBELL
 12-3-1979 scale 1:100 1:500
