# Report

# Building Report

## CONCLUSION AND SUMMARY

## COMPLIANCE REPORT

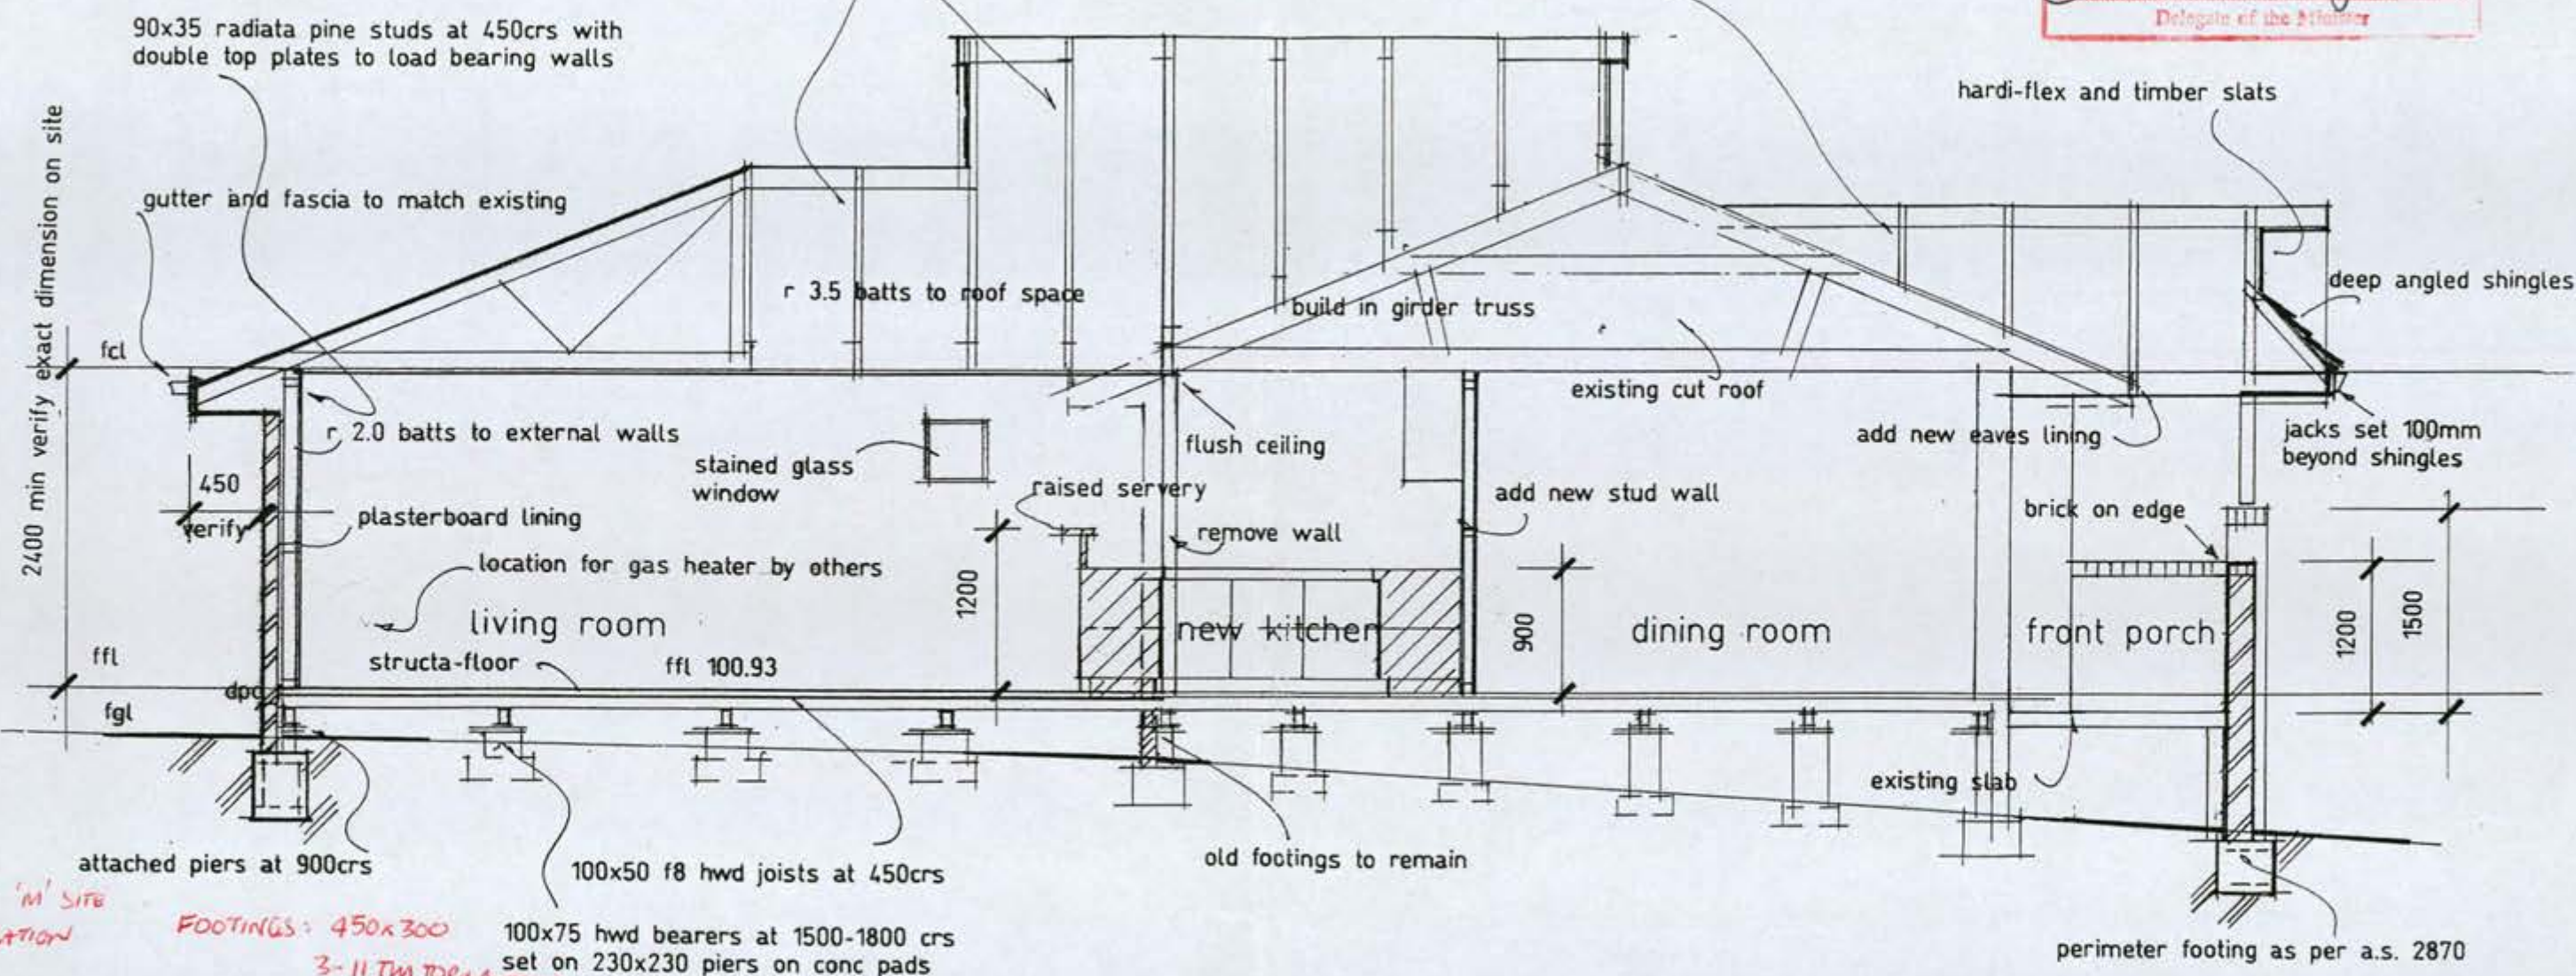
trussed roof installed to manuf spec with 22.5 deg pitch to match existing

ASSUME 'M' SITE CLASSIFICATION

FOOTINGS: 450x300  
 3-11 TM TOP & BOTTOM  
 300 LIGS  
 100x75 hwd bearers at 1500-1800 crs set on 230x230 piers on conc pads

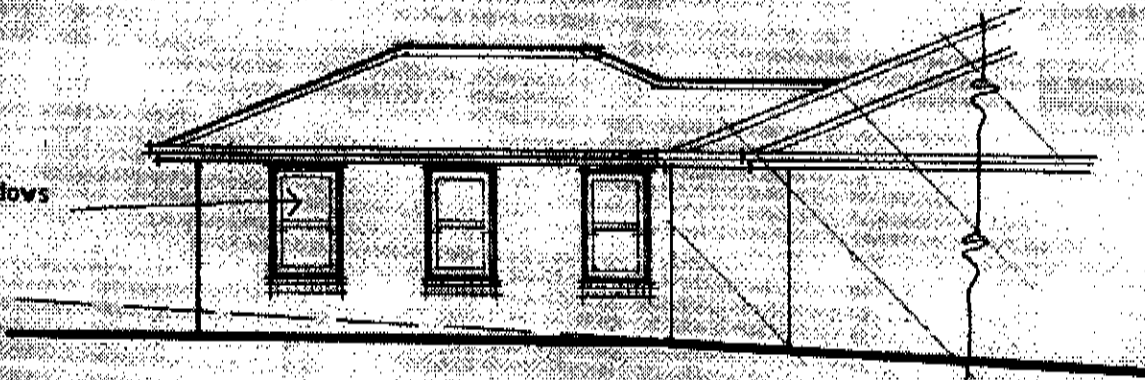
EAST ELEVATION

timber frame windows  
to match existing

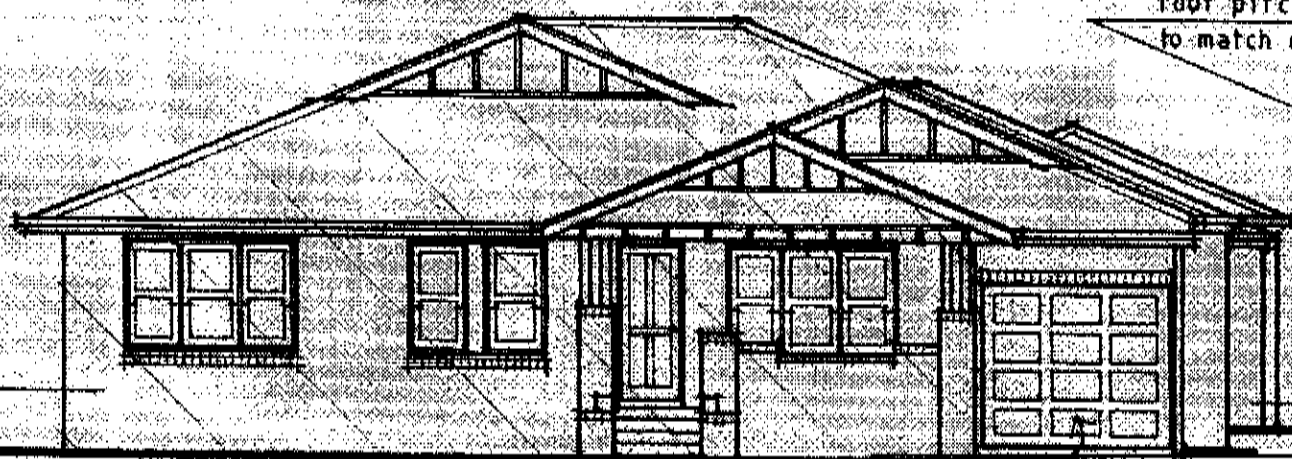
NORTH ELEVATION

roof pitch  
to match existing

ceiling height  
to match existing  
2400  
floor level  
to match existing
