Report

Building Report

Property Address: 97 Fitchett Street, Garran ACT 2605
Client: Hutchinson
Inspection Date: Thursday, May 7th 2026
Inspection carried out by: Ned Strickland

PROPOSED BRICK RESIDENCE AT
 BLOCK 29, SECTION 8, GARRAN,
 FOR:
 MR. & MRS. A.I. KENNER.

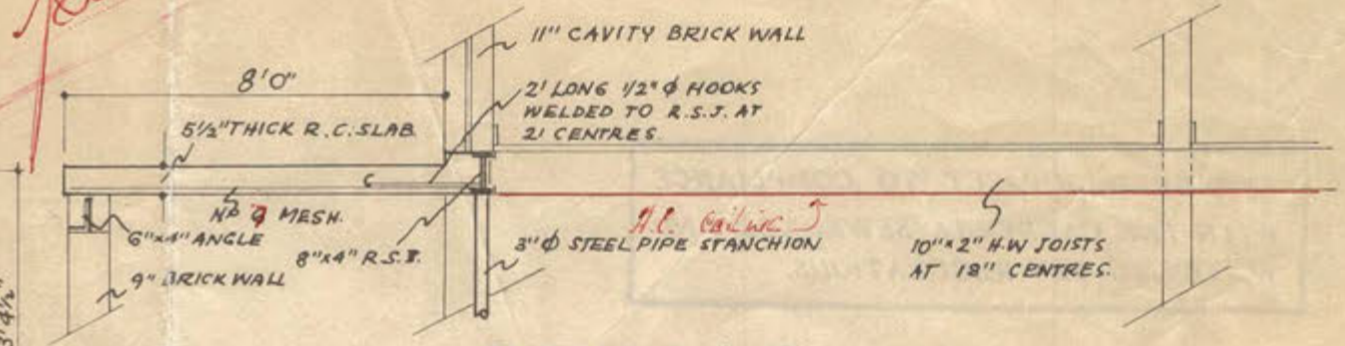
SECTION A-B

TILED ROOF, 22 1/2° PITCH.

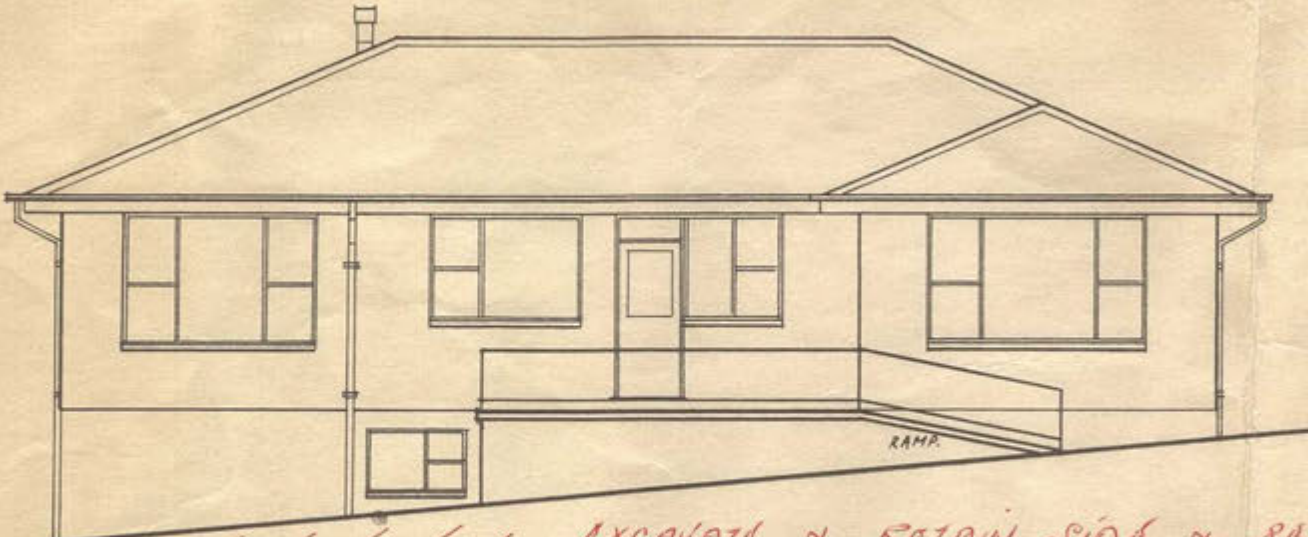
REAR ELEVATION

EXCAVATE & RETAIN SIDE & REAR
AS PER DETAIL.

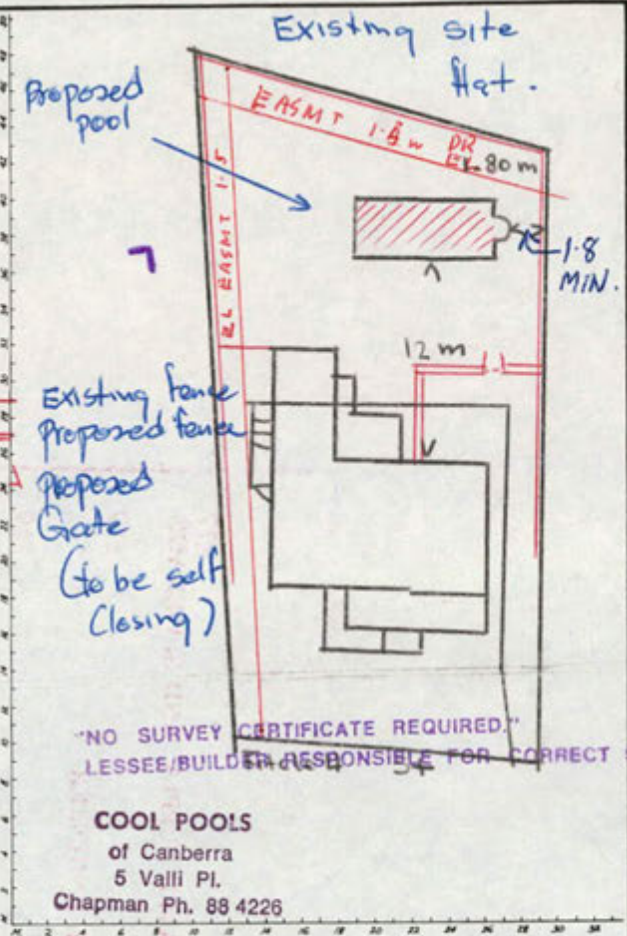
Existing fence
Proposed fence
Proposed Gate
(to be self closing)

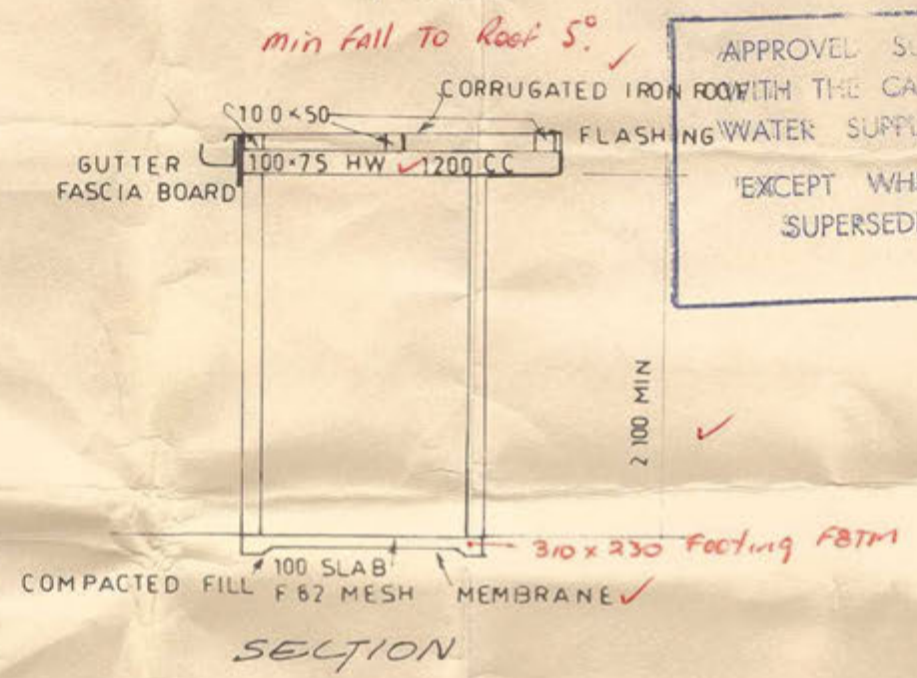
SECTION

FOOTINGS TO BE TAKEN DOWN TO SOLID GROUND

DEPTH OF FILL UNDER SLAB NOT TO EXCEED 400 mm

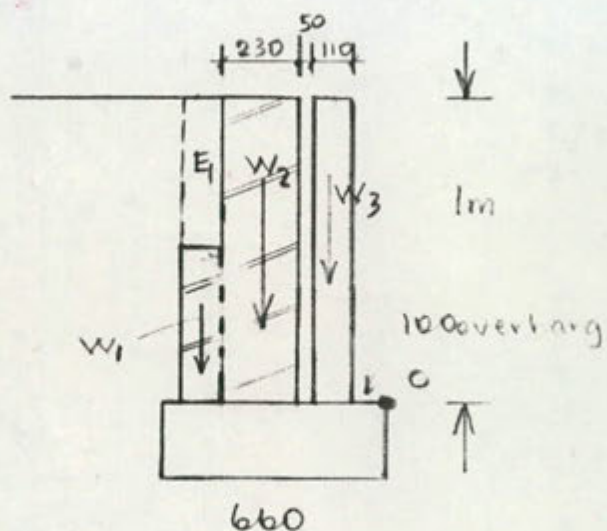
Backfill - Sand

$$\gamma = 20 \text{ kN/m}^3, \phi = 35^\circ$$

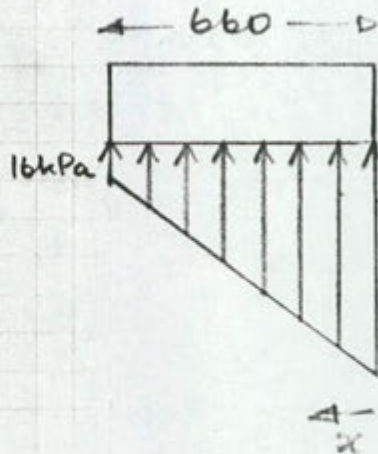
Footing
(designed
for house
loading
as below)

$$q = 164 - 224x$$

$$Q = 164x - \frac{224x^2}{2}$$

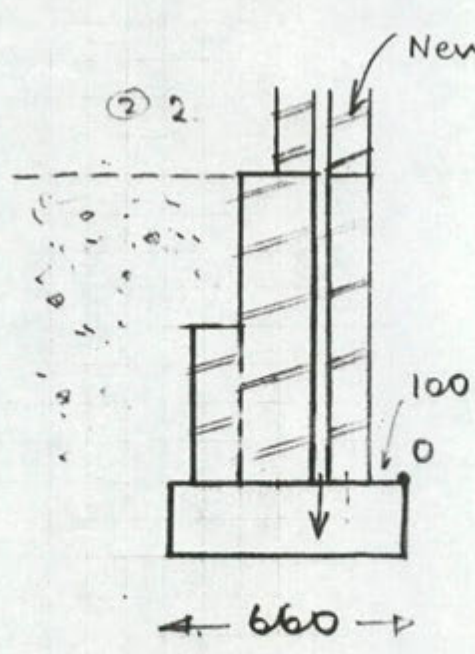
Future House loading - 2 storey

Additional M_r , about 0.

$$51 \times (100 + 110 + 25) = 11.99 \text{ kNm}$$

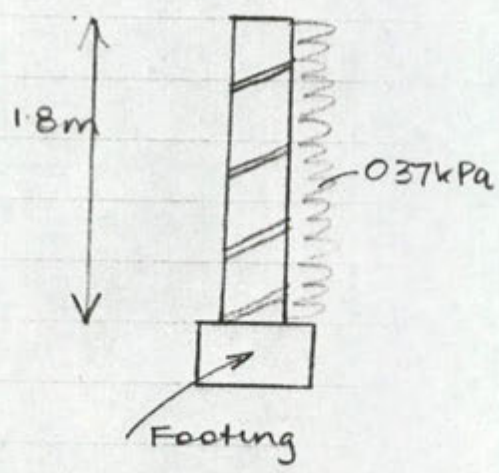
Effective height = $2.0h = 2.0 \times 1.8 = 3.6m$
Effective length = $1.0L = 1.0 \times 1.5 = 1.5m$
Effective thickness = $1.4t = 1.4 \times 110 = 154mm$
Slenderness Ratio = $\frac{1.5}{0.154} = 10 < 27 OK$

Wind $V = 38 m/s$ multiplier = 0.65
 $V' = 0.65 \times 38 = 24.7 m/s$
 $q_3 = 0.6 \times (24.7)^2 \times 10^{-3} = 0.37 kPa$
 $C_D = 1.2$
Area = $1.8 \times 1.5 = 2.7$
 $F = C_D A q_3 = 1.2 \times 2.7 \times 0.37 = 1.2 kN$
 $M = 1.2 \times 0.9 = 1.08 kNm$

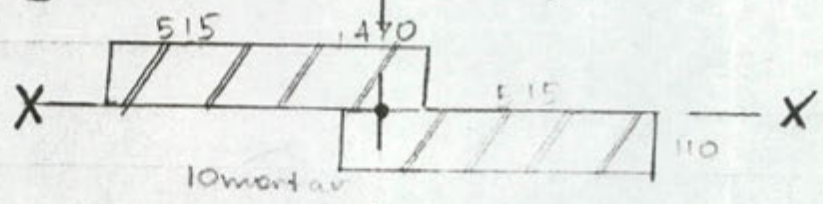
Bending - consider brick panel

$I_{xx} = 2 \left(\frac{110^3 \times 985}{12} + 985 \times 110 \times 60^2 \right)$
 $= 9.99 \times 10^8 mm^4$
 $Z_{xx} = 8.68 \times 10^6 mm^3$

$f_b = \frac{M}{Z_{xx}} = 124 kPa$

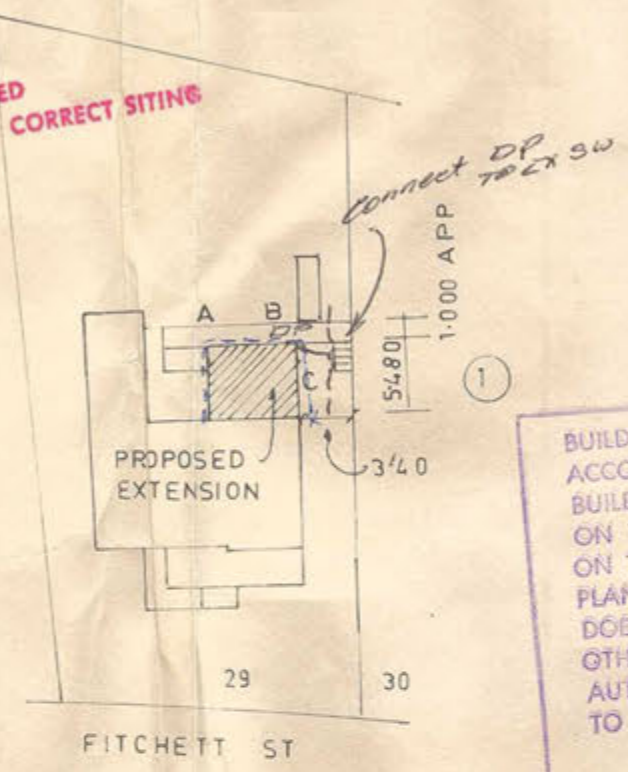
SITE PLAN

UPPER LEVEL	0.0
GL 'A' & 'B'	-4.031
LOWER FL. 'A' & 'B'	-5.331
GL 'C'	-5.381

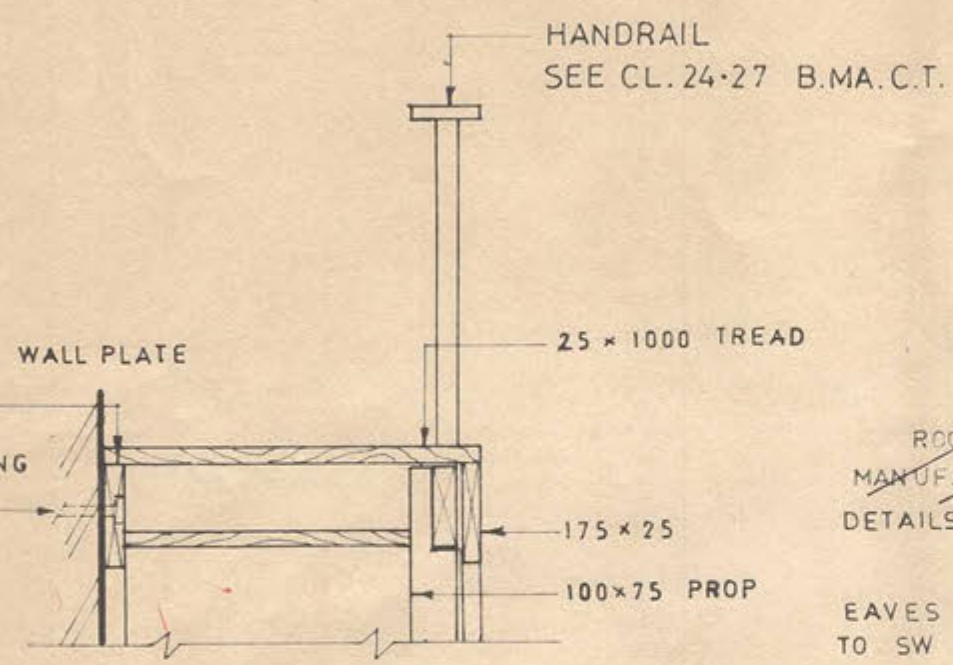
SECTION THROUGH STAIRS 1:2.0

- 5 - ROOF TRUSSES
 RAFTERS: 150 x 50 450 C/C
 C. JOISTS: 150 x 50
~~PROPS: 150 x 50~~
 RIDGE: 200 x 38
 W. PLATES: 100 x 50
 FACIA B. 185 x 32
- CEILING TO MATCH EXIST.
 OREGON FACIA BOARD
 HARDWOOD: REMAINING PARTS.
- 3 - STAIRCASE
 TO BE DONE IN ACCORDANCE WITH THE B.M.A.C.T.

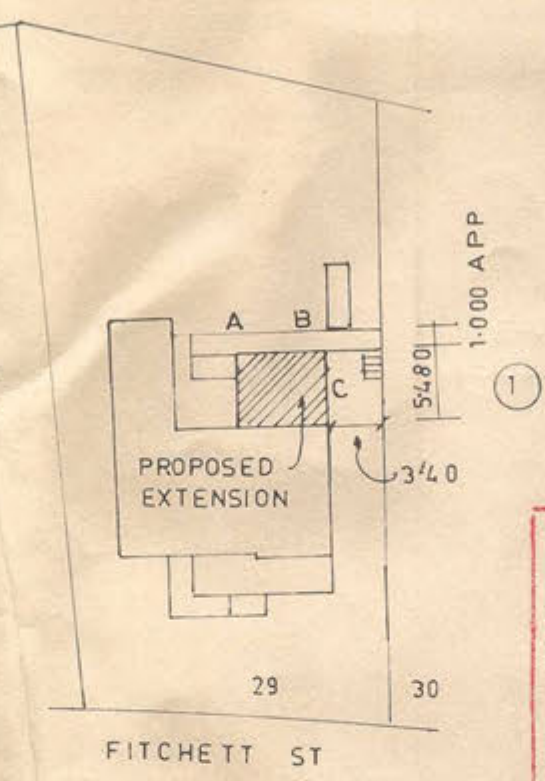
SITE PLAN

UPPER LEVEL	0.0
GL A & B	-4.031
LOWER FL. A & B	-5.331
GL C	-5.381

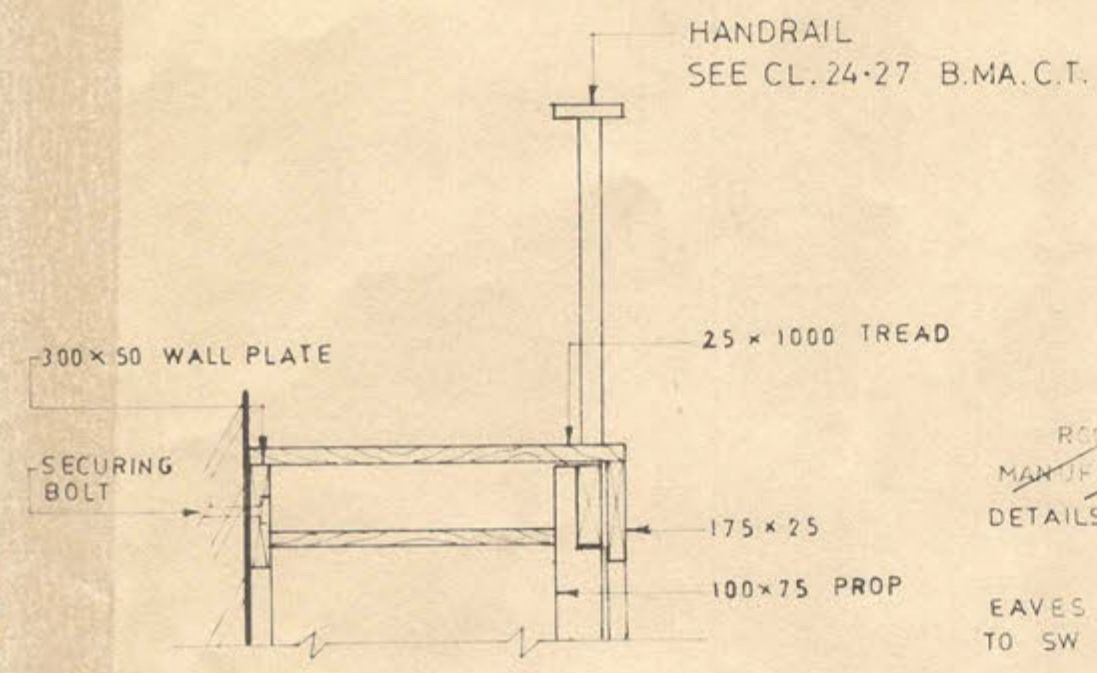
SECTION THROUGH STAIRS 1:2.0

- 5 - ROOF TRUSSES
- RAFTERS: 150 x 50 450 C/C
- C JOISTS: 150 x 50
- PROPS: 150 x 50
- RIDGE: 200 x 38
- W. PLATES: 100 x 50
- FACIA B: 185 x 32

CEILING TO MATCH EXIST.
OREGON FACIA BOARD
HARDWOOD: REMAINING PARTS.

- 3 - STAIRCASE
TO BE DONE IN ACCORDANCE
WITH THE B.M.A.C.T.

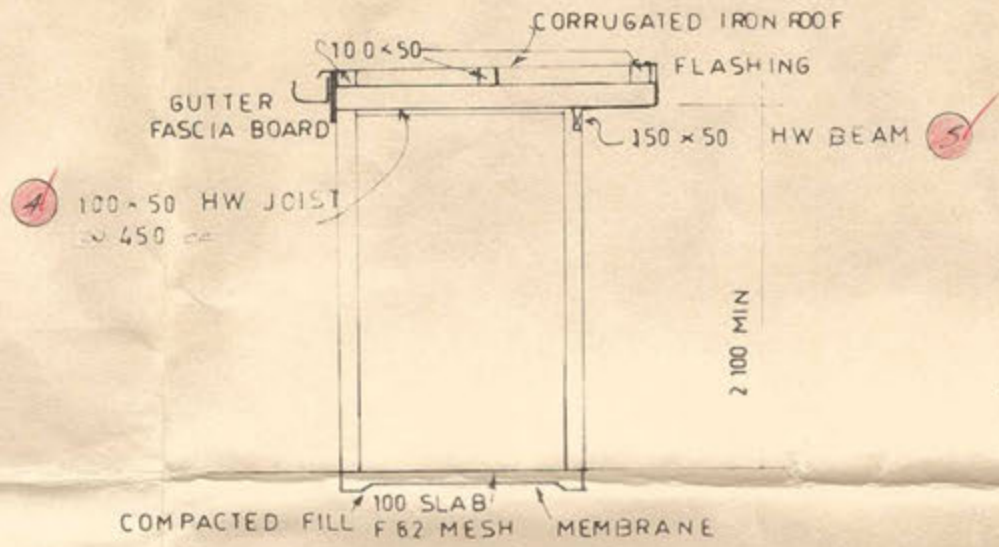
SECTION

- AMENDMENTS 13 10 81
- 1 WINDOW RELOCATED
 - 2 SHOWER AND WC REVERSED
 - 3 EXTEND BBQ AREA
 - 4 100 x 50 HW JOIST @ 450 cc
 - 5 150 x 50 HW BEAM
 - 6 50 Ø PIPE TO TAKE BEAM

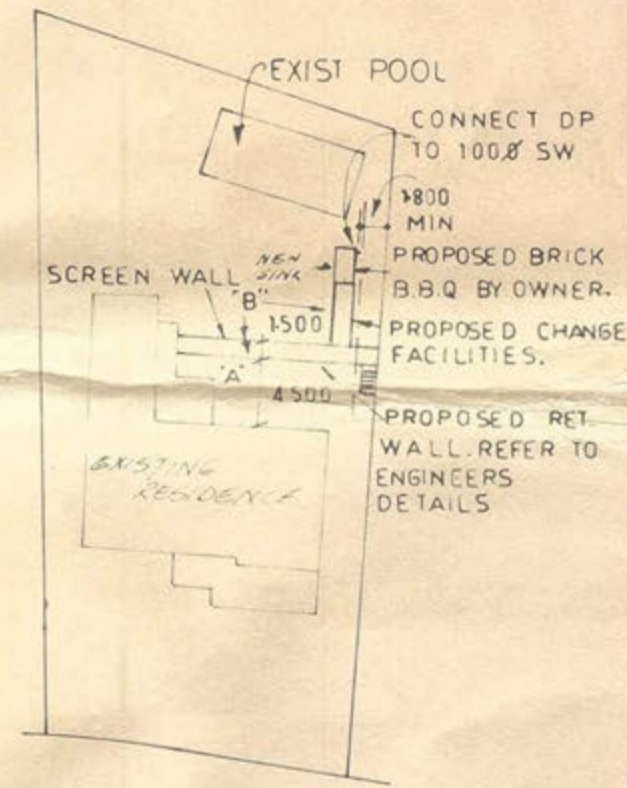
SITE PLAN

RL 'A' 0.00
 RL 'B' 1.00

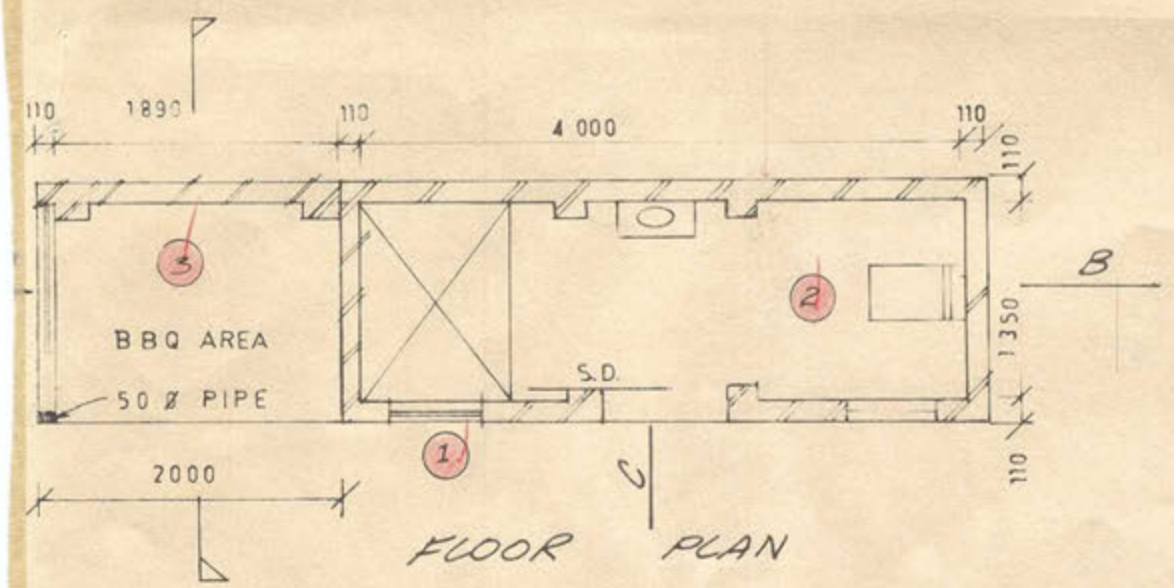
FLOOR PLAN

ALL WORK TO CONFORM TO BMACT AND RELAVENT SAA CODES
 THIS PLAN TO BE READ IN CONJUNCTION WITH ENGINEERING DETAILS FOR SCREEN WALL AND RETAINING WALL.

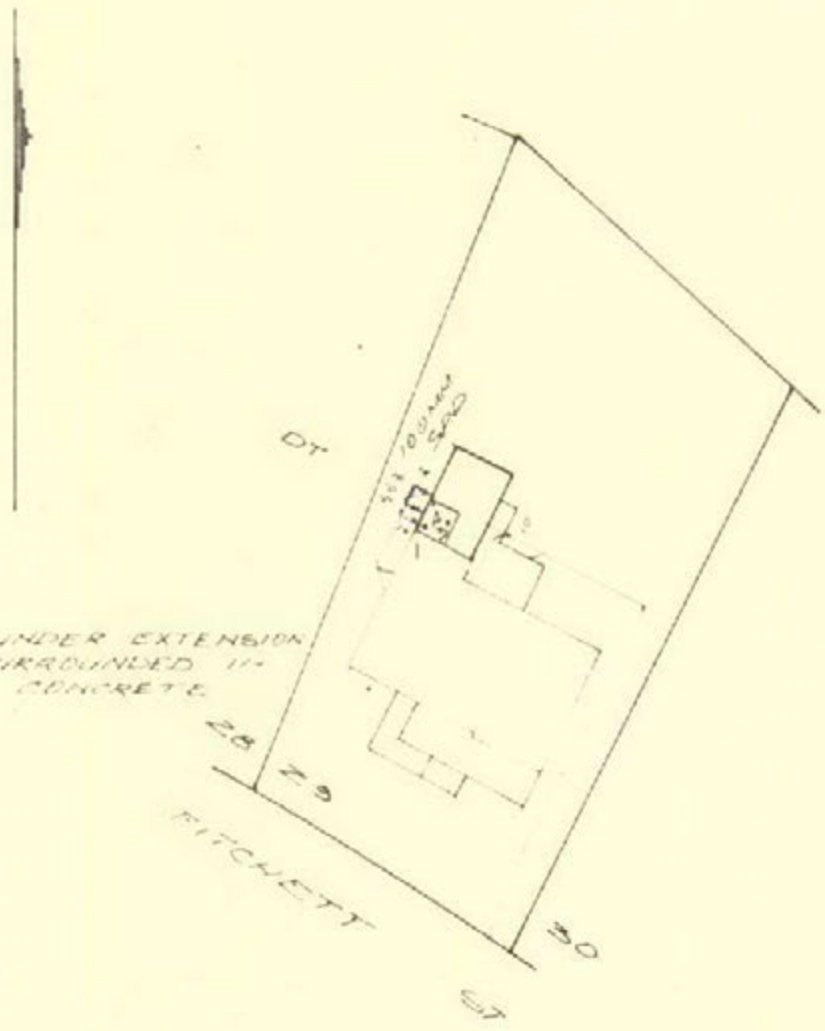
DRAINS UNDER EXTENSION TO BE SURROUNDED 100MM CONCRETE

NOTES DRAINS TO BE LAID ARE SHOWN IN BLUE LINES THIS PLAN TO BE READ IN CONJUNCTION WITH APPROVED ARCHITECTURAL PLANS AND SPECIFICATIONS
 DRAINS TO BE DELETED SHOWN BY RED X EXISTING DRAINS SHOWN IN GREEN LINES
 POSITION OF BRANCH TO BE LOCATED BEFORE ANY WORK IS COMMENCED

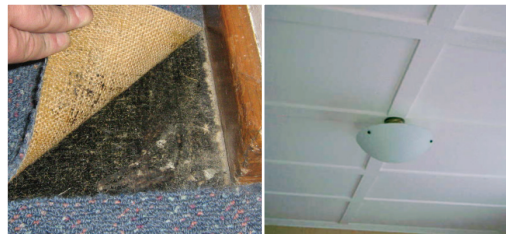
- 3.** Internal areas
wall and ceiling panels, carpet underlay,
textured panels, insulation in domestic
heaters
