# Report

# Building Report

## CONCLUSION AND SUMMARY

PROJECT TITLE PROPOSED DUAL OCCUPANCY 1 ANSTEY STREET BLOCK 27 SECTION 19, PEARCE	TITLE SITE PLAN  CLIENT P & G DRITSAS	SCALES 1 : 200 DRAWN JLG CHECKED JLG DATE 15 JUNE 2018	PROJECT No. 2 17 TORRENS DRAWING No A01 REVISION APPROVAL
ISSUE	DATE	AMENDMENT

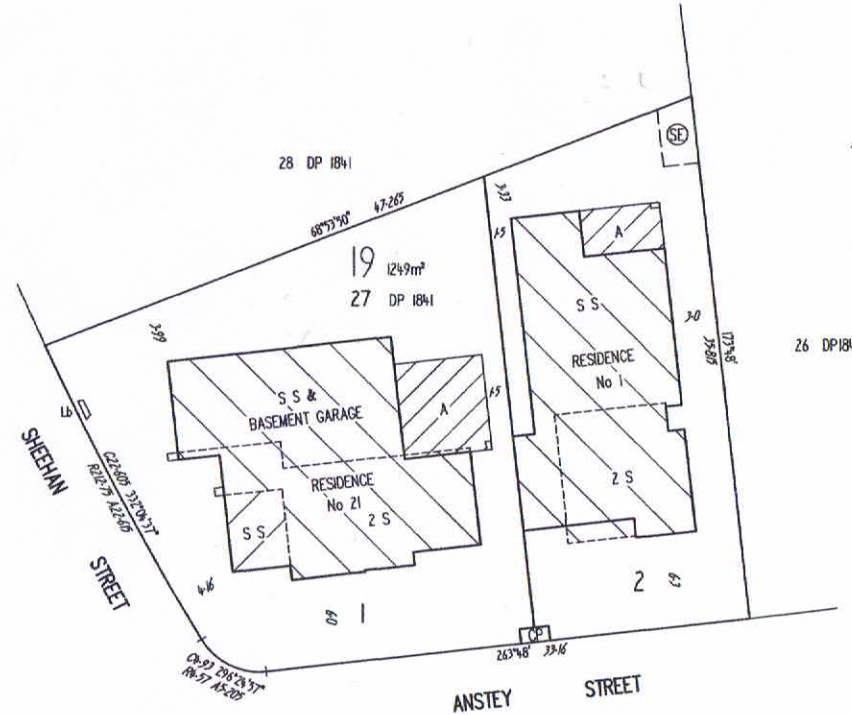
Sheet No. 1 of 13 sheets

The sketch shows the positions of the brick foundations relative to the boundaries and levels of the concrete slab on Australian Height Datum (A.H.D). The land is subject to a Sewerage and Electricity Supply Easement 2.44 metres wide.

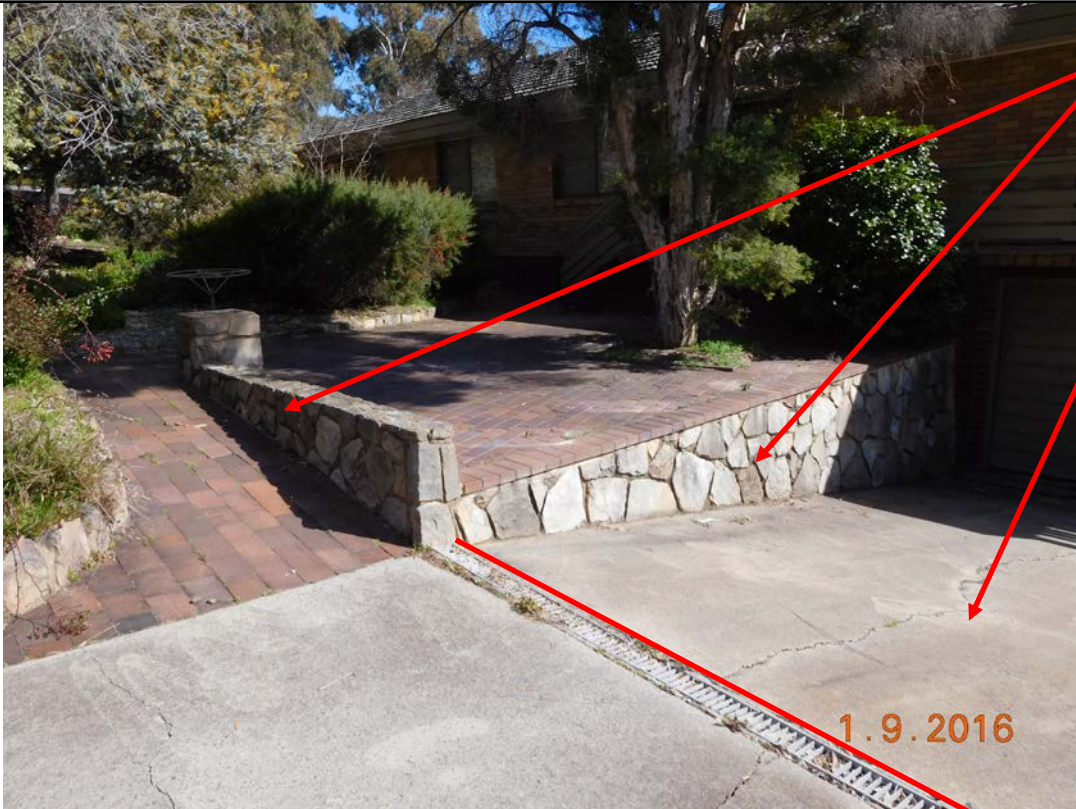
1

Remove retaining wall and batter.

Remove driveway/ hardstand saw cut near drain

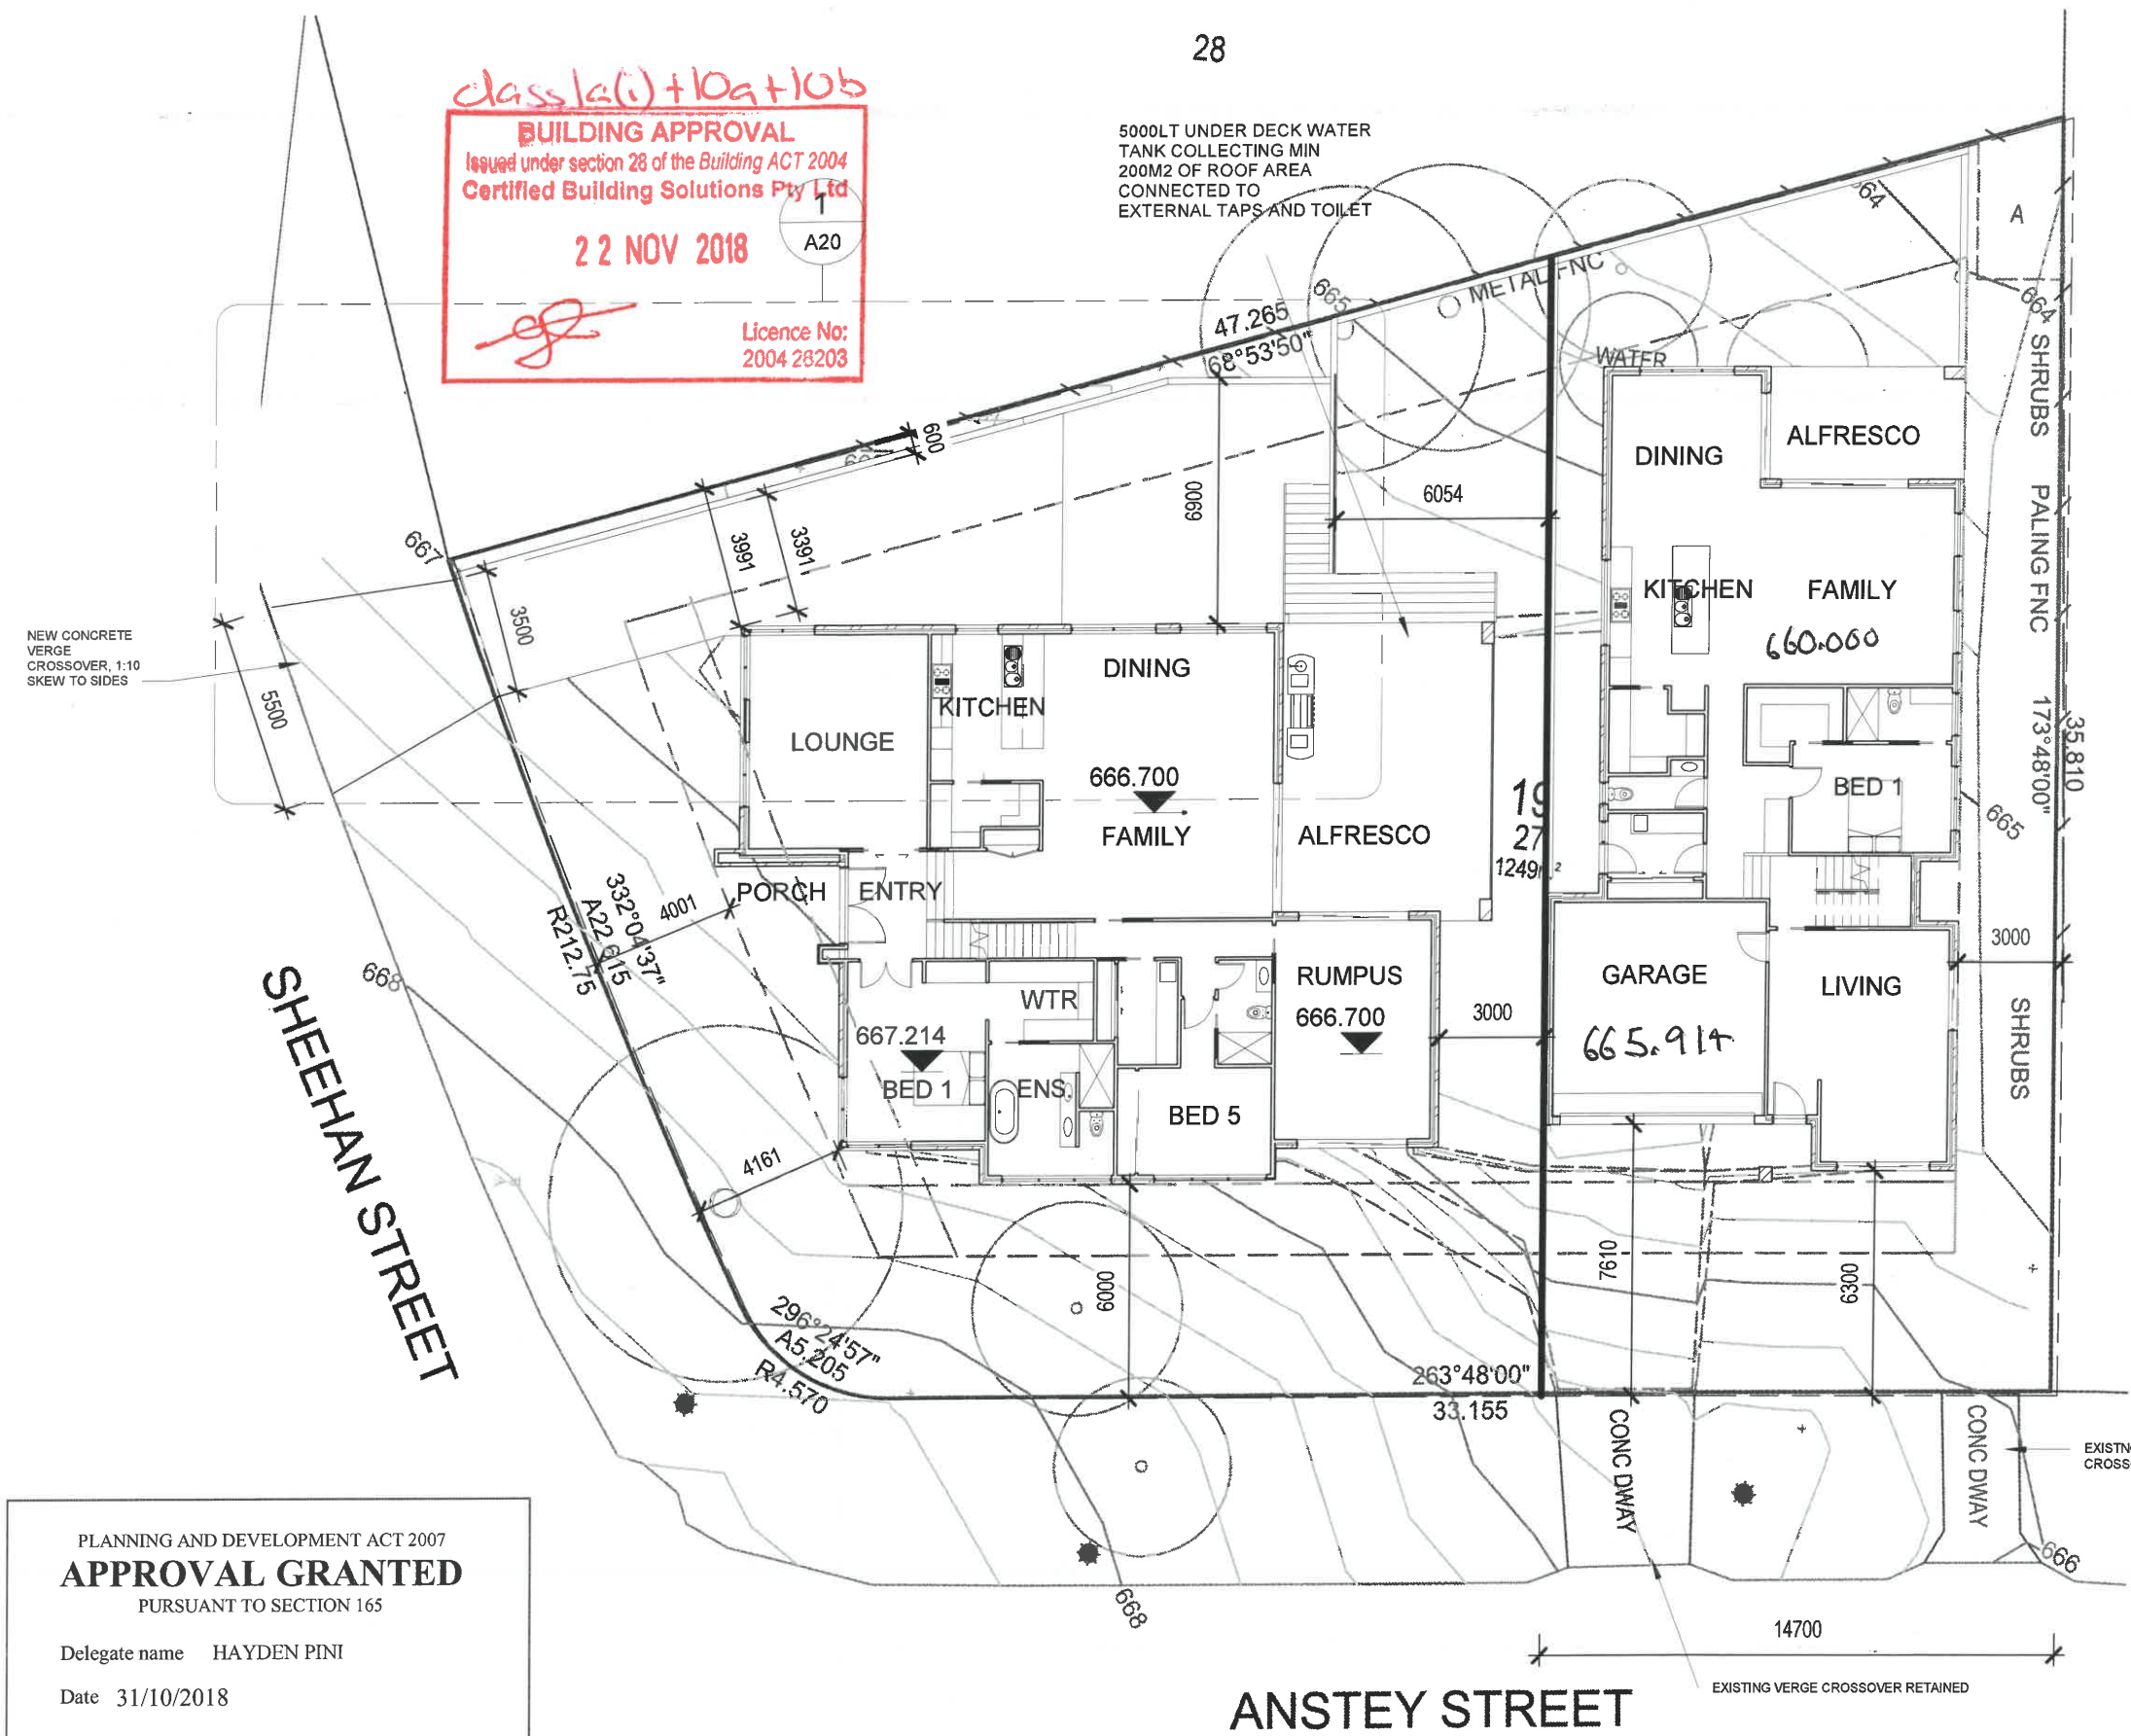
5000LT UNDER DECK WATER  
 TANK COLLECTING MIN  
 200M2 OF ROOF AREA  
 CONNECTED TO  
 EXTERNAL TAPS AND TOILET

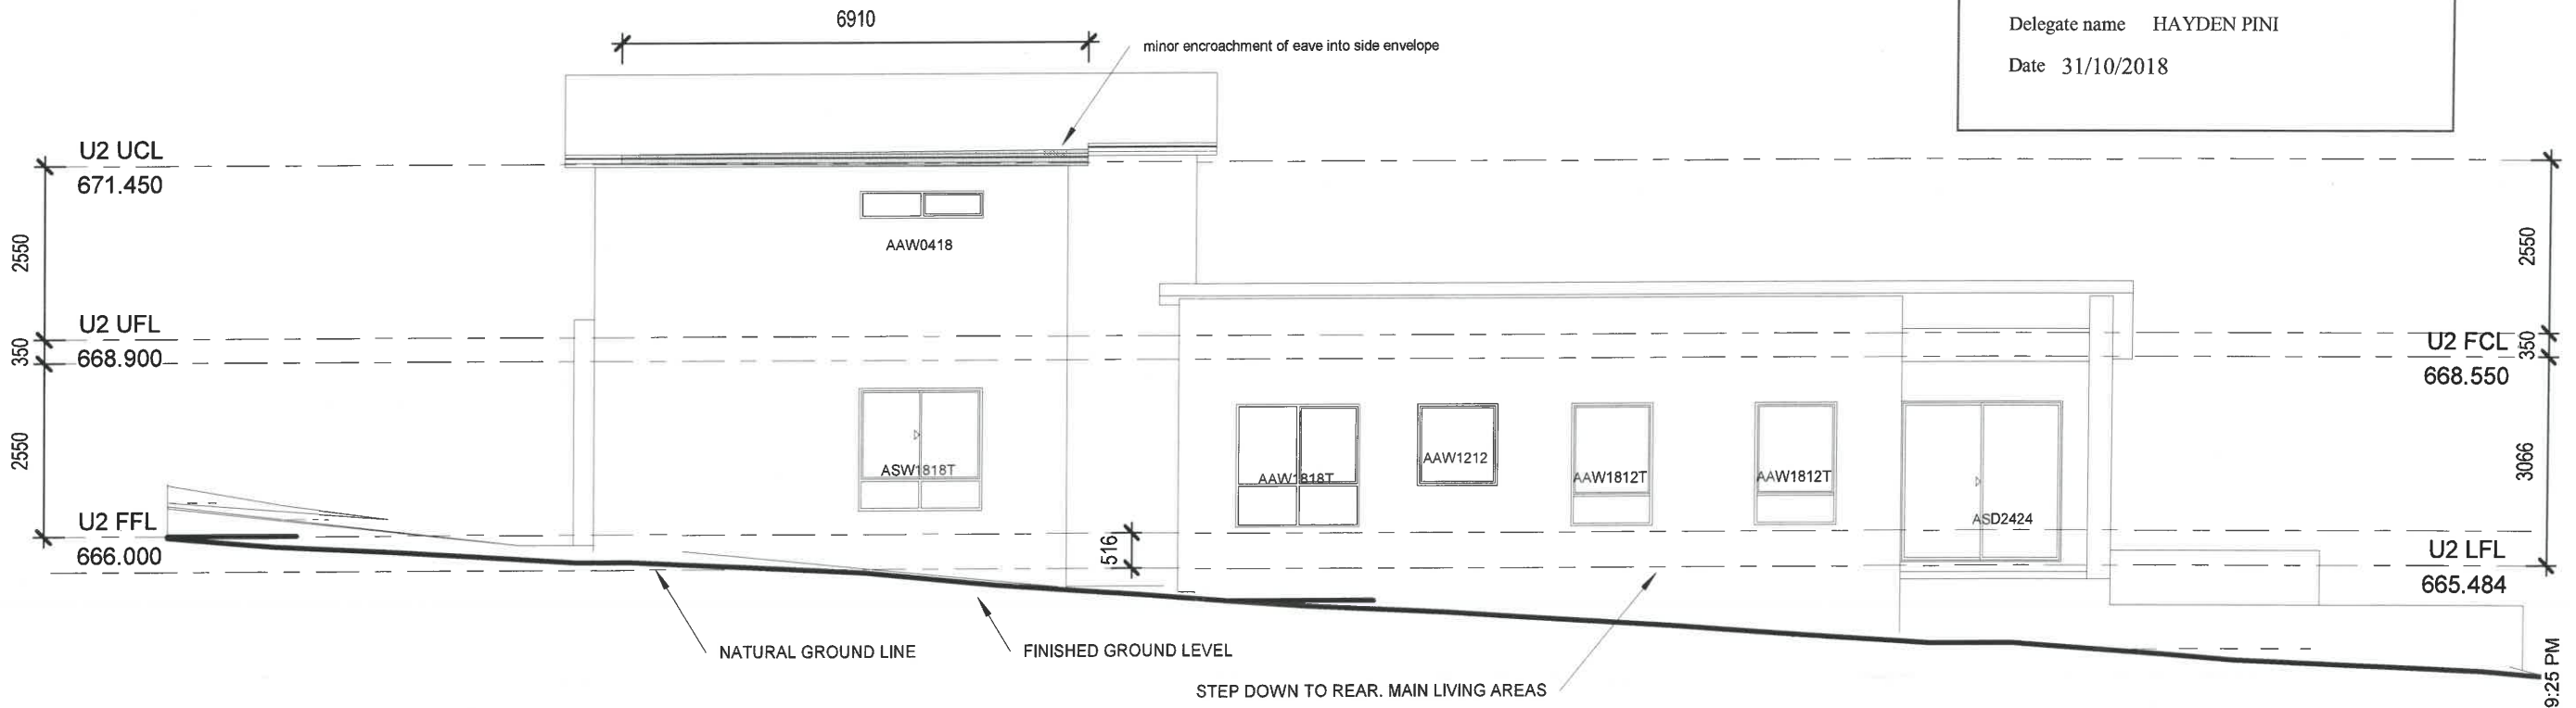
3 U2 EAST  
 A08 1 : 100

PROJECT TITLE PROPOSED DUAL OCCUPANCY 1 ANSTEY STREET BLOCK 27 SECTION 19, PEARCE		TITLE UNIT 2 - ELEVATIONS CLIENT P & G DRITSAS	SCALES 1 : 100 DRAWN JLG CHECKED JLG DATE 15 JUNE 2018	PROJECT No. 27 19 PEARCE DRAWING No REVISION <b>A10</b> APPROVAL
ISSUE	DATE	AMENDMENT	ALL DIMENSIONS ARE IN MILLIMETRES. DO NOT SCALE DRAWING. ALL DIMENSIONS AND LEVELS MUST BE VERIFIED ON SITE BY CONTRACTOR BEFORE THE COMMENCEMENT OF WORK

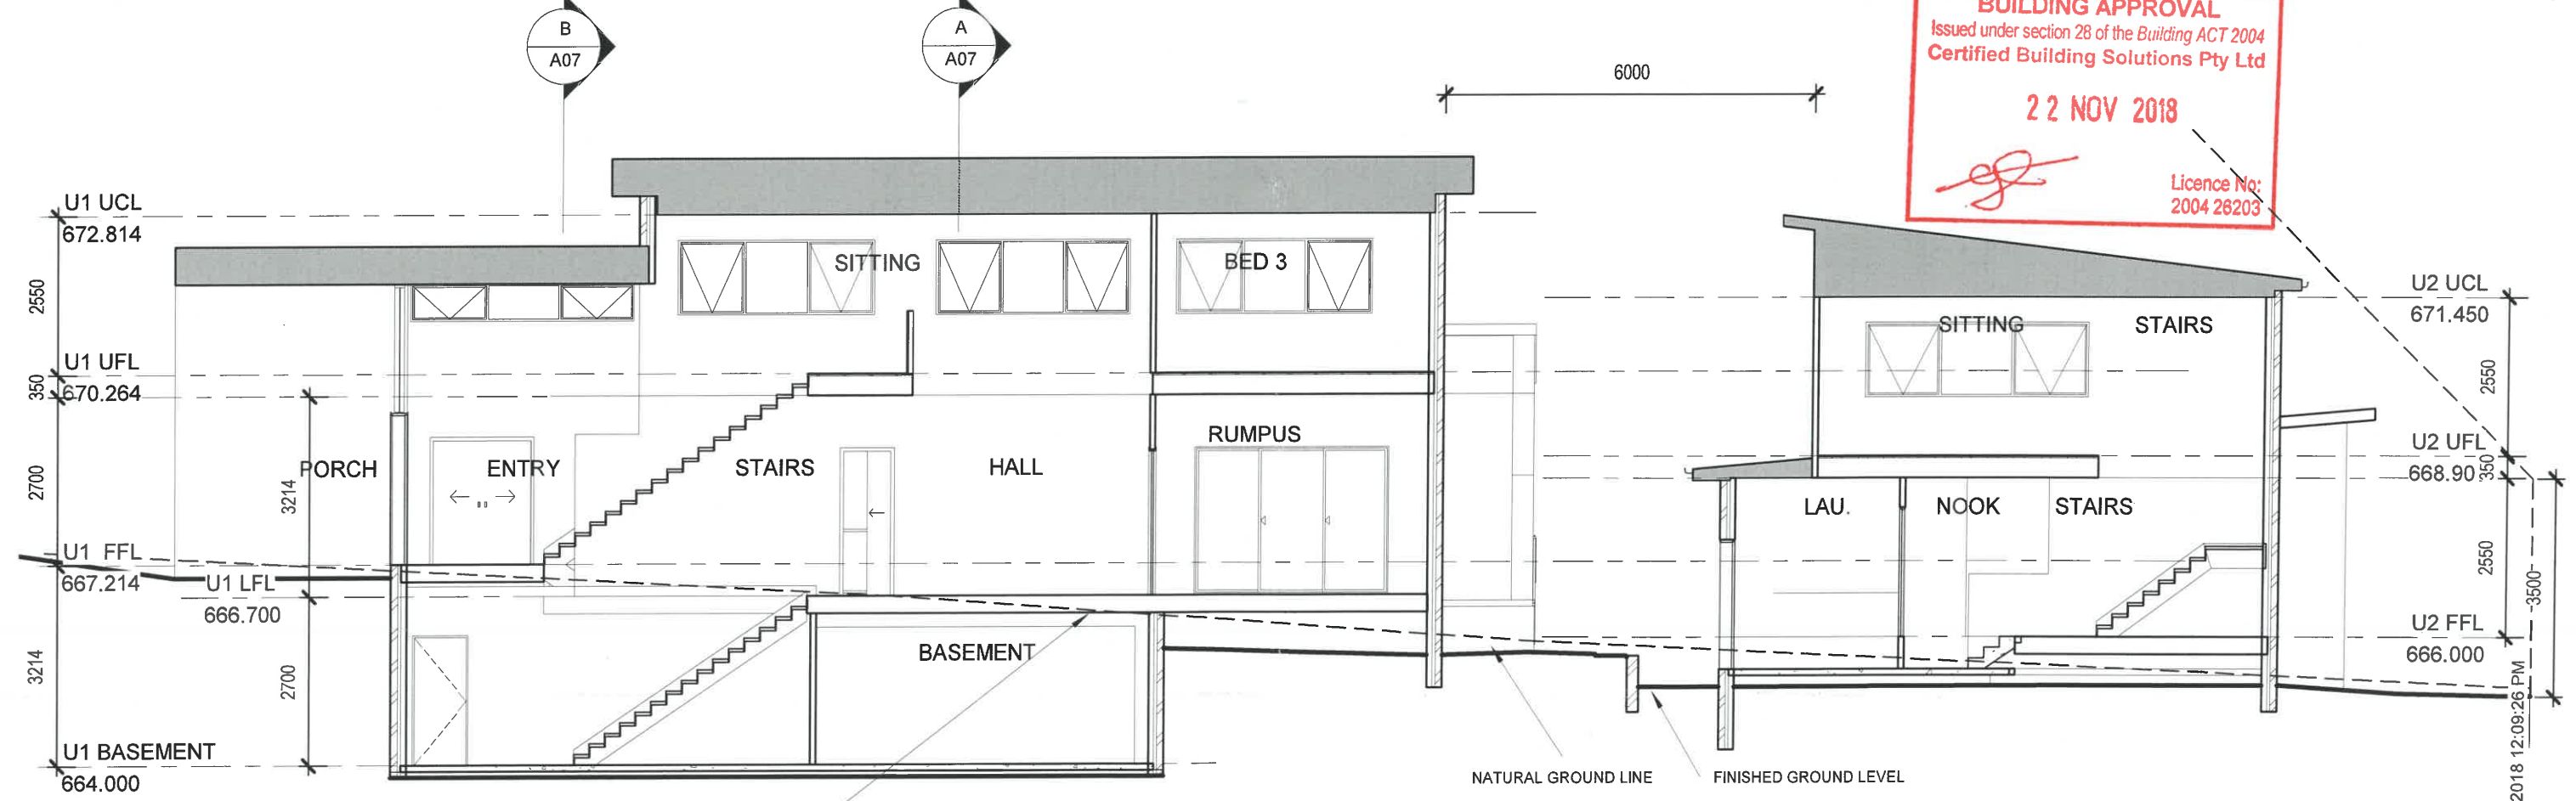
**D Section D**  
 A02 1 : 100

GROUND FLOOR TO BE LESS THAN 1M ABOVE NATURAL GROUND LEVEL AT ANY POINT OVER THE BASEMENT

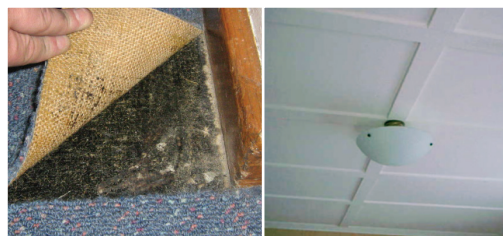
- 3.** Internal areas  
wall and ceiling panels, carpet underlay,  
textured panels, insulation in domestic  
heaters
