Report

Building Report

CONCLUSION AND SUMMARY

Property Address: 111/50 Ellenborough Street, Lyneham ACT 2602
Client: Cooper
Inspection Date: Tuesday, June 16th 2026
Inspection carried out by: Michael Kane

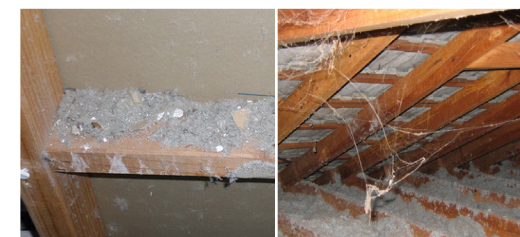
- 5.** Building cavities
A small number of homes may still contain
loose fill asbestos insulation in the roof
cavity, wall cavities or sub-floor space
