# Report

# Building Report

The purpose of the Inspection is to identify the major defects and safety hazards associated with the property at the time of the Inspection. The Inspection and reporting are limited to a visual assessment of the Building Members in accord with Appendix C AS4349.1-2007.

## CONVEYANCING BUILDING FILE INDEX

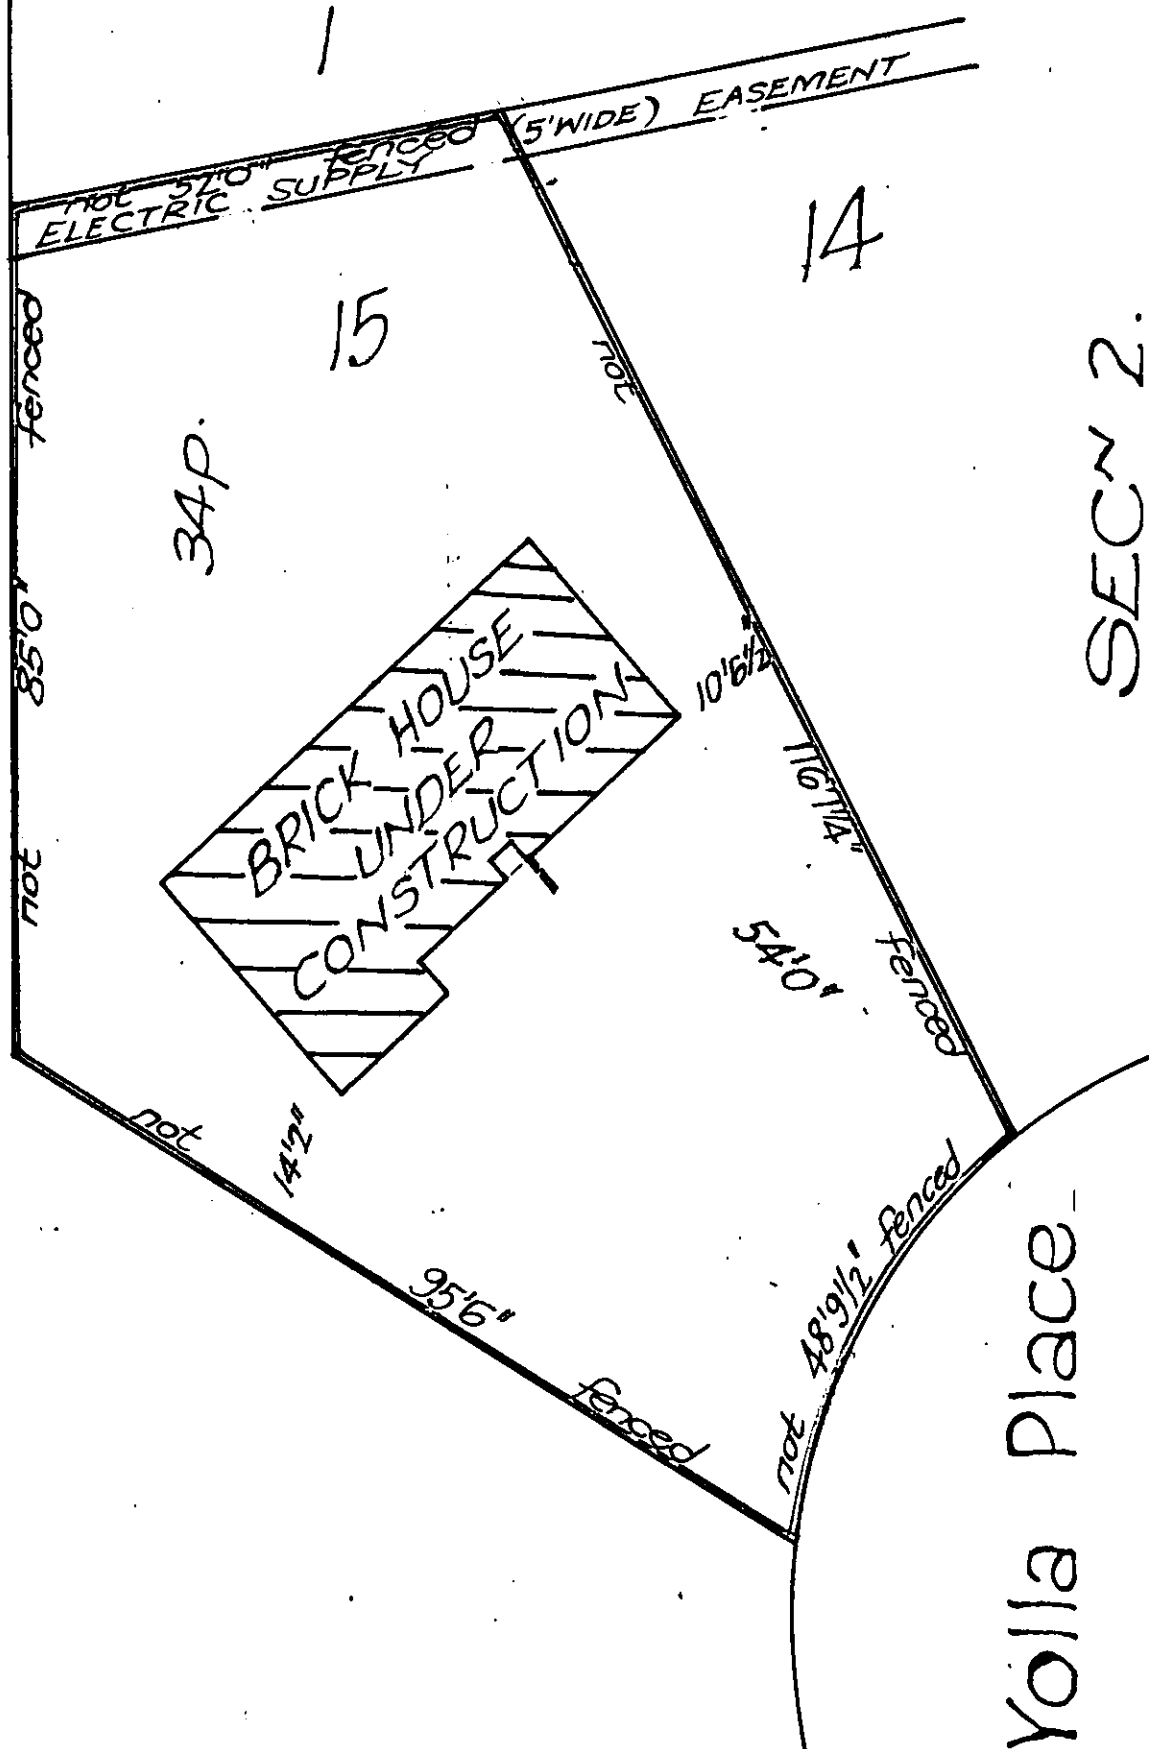
### SKETCH

Scale 20' = 1"

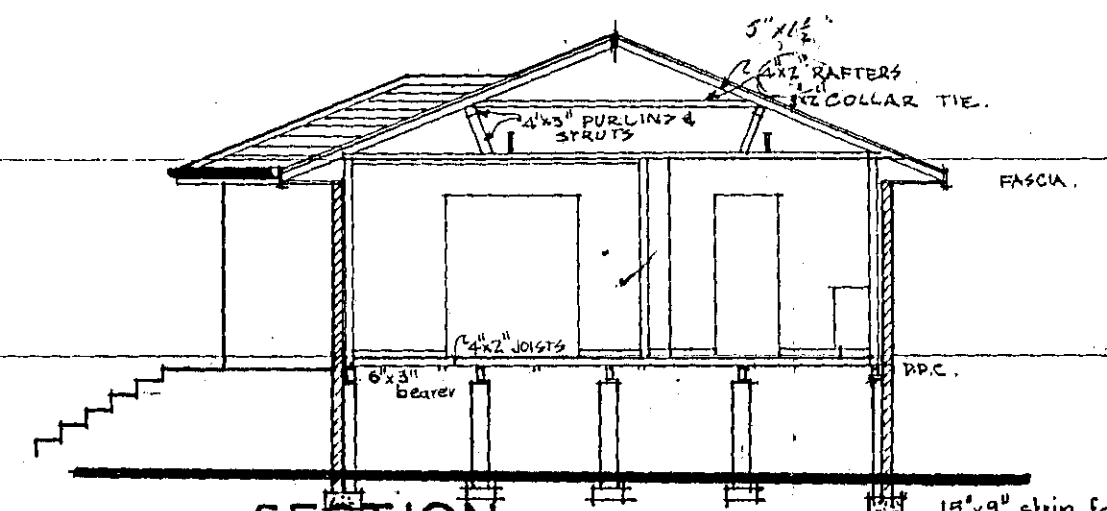
SECTION

15'x9" strip footings with  
one layer No 7 french mesh

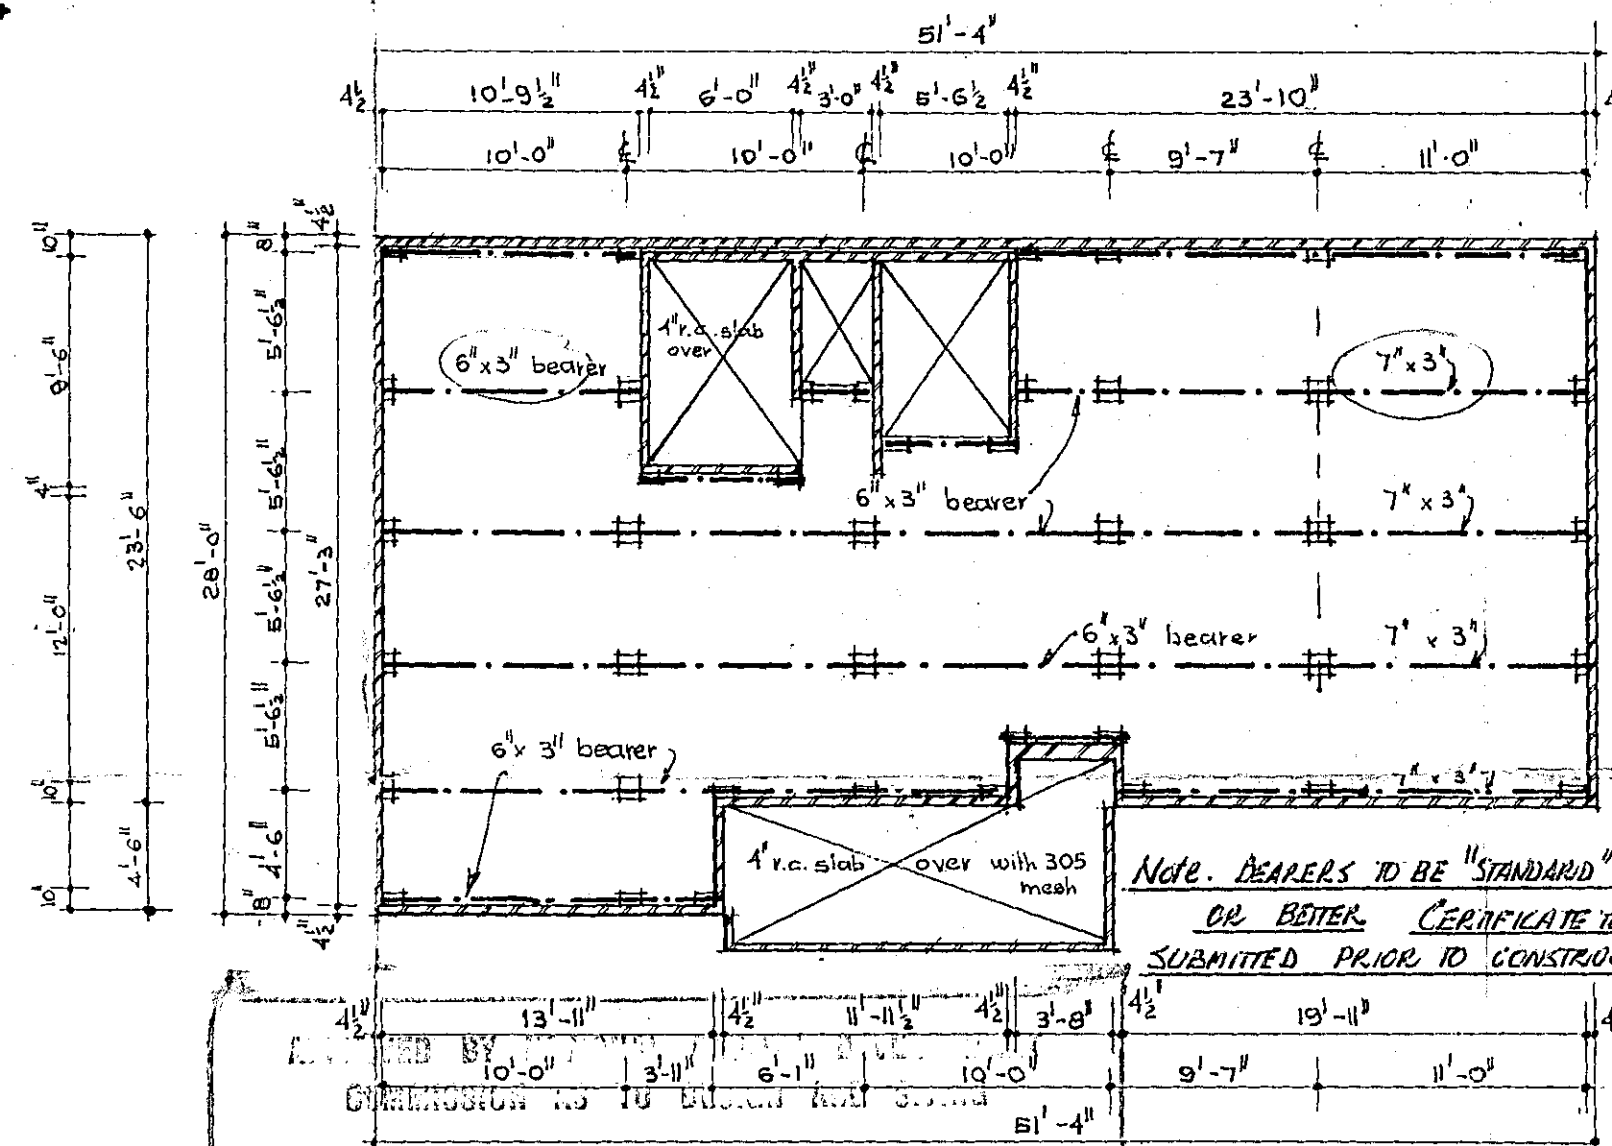
FOUNDATION PLAN

NOTE: BEARERS TO BE "STANDARD" 8" GRADE  
OR BETTER. CERTIFICATE TO BE  
SUBMITTED PRIOR TO CONSTRUCTION.

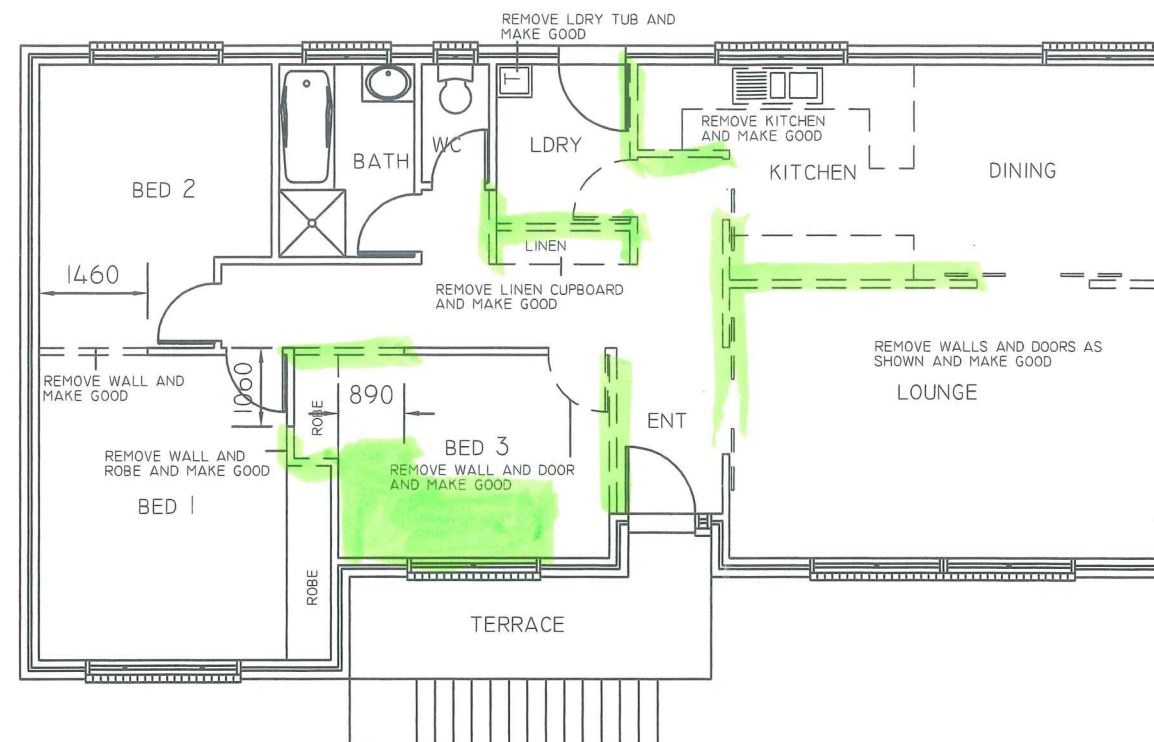
## INTERNAL DEMOLITION

PRIOR TO DEMOLITION OF ANY INTERNAL WALLS  
ENGINEER TO INSPECT PROPERTY AND PROVIDE DETAILS

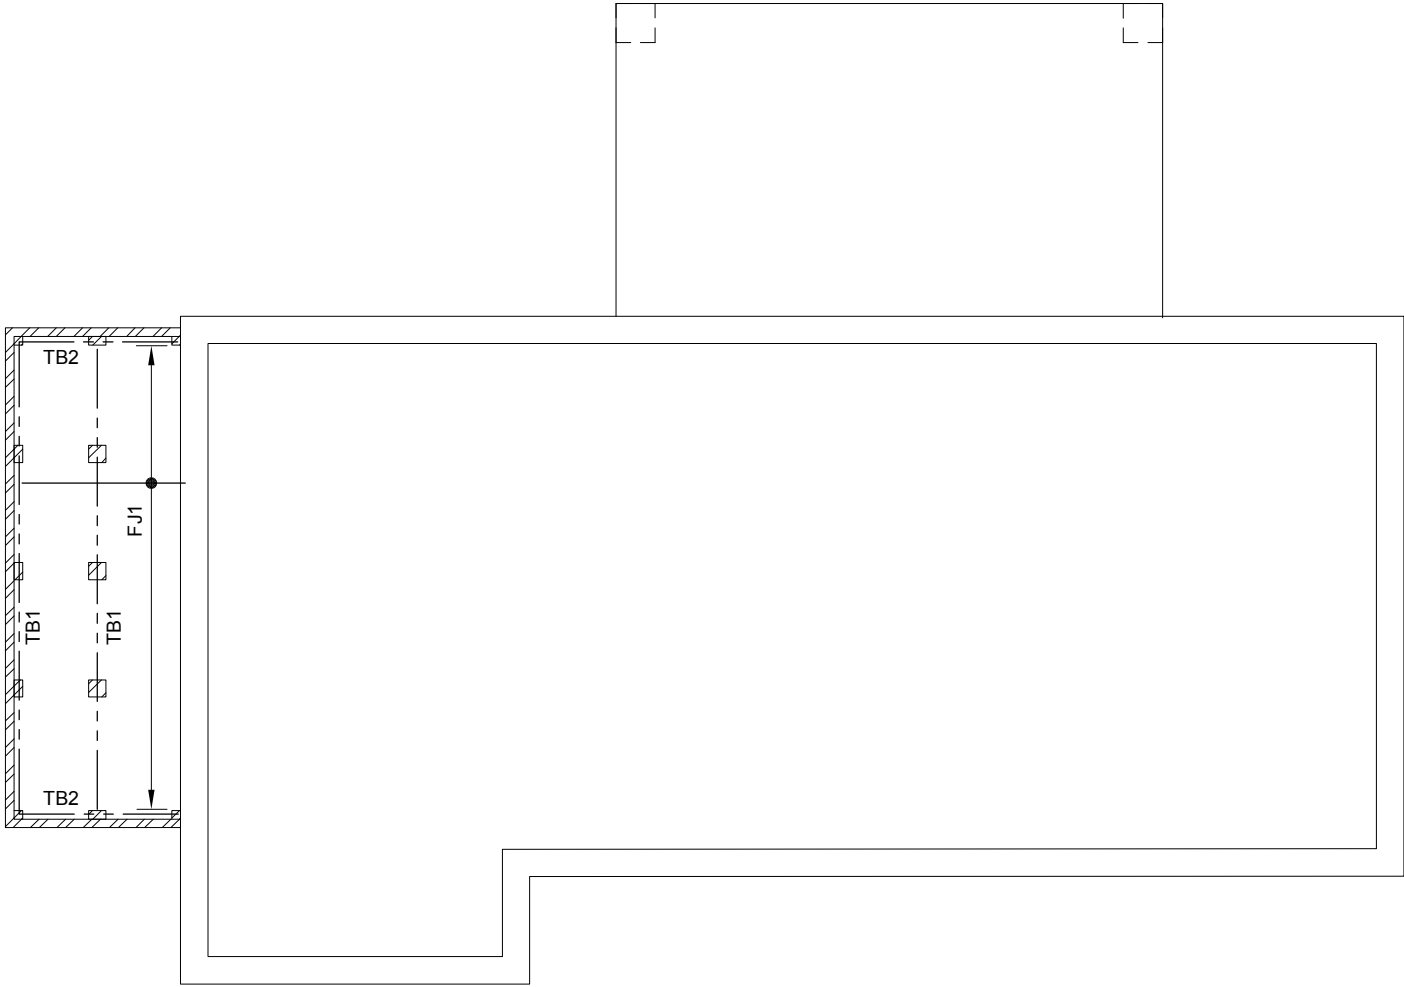
**TIMBER FLOOR MARKING PLAN**  
**1:100**

**NOTE:**  
ALL LVL BEAMS ARE ASSUMED WEATHER PROTECTED.  
ADVISE OUR OFFICE OTHERWISE

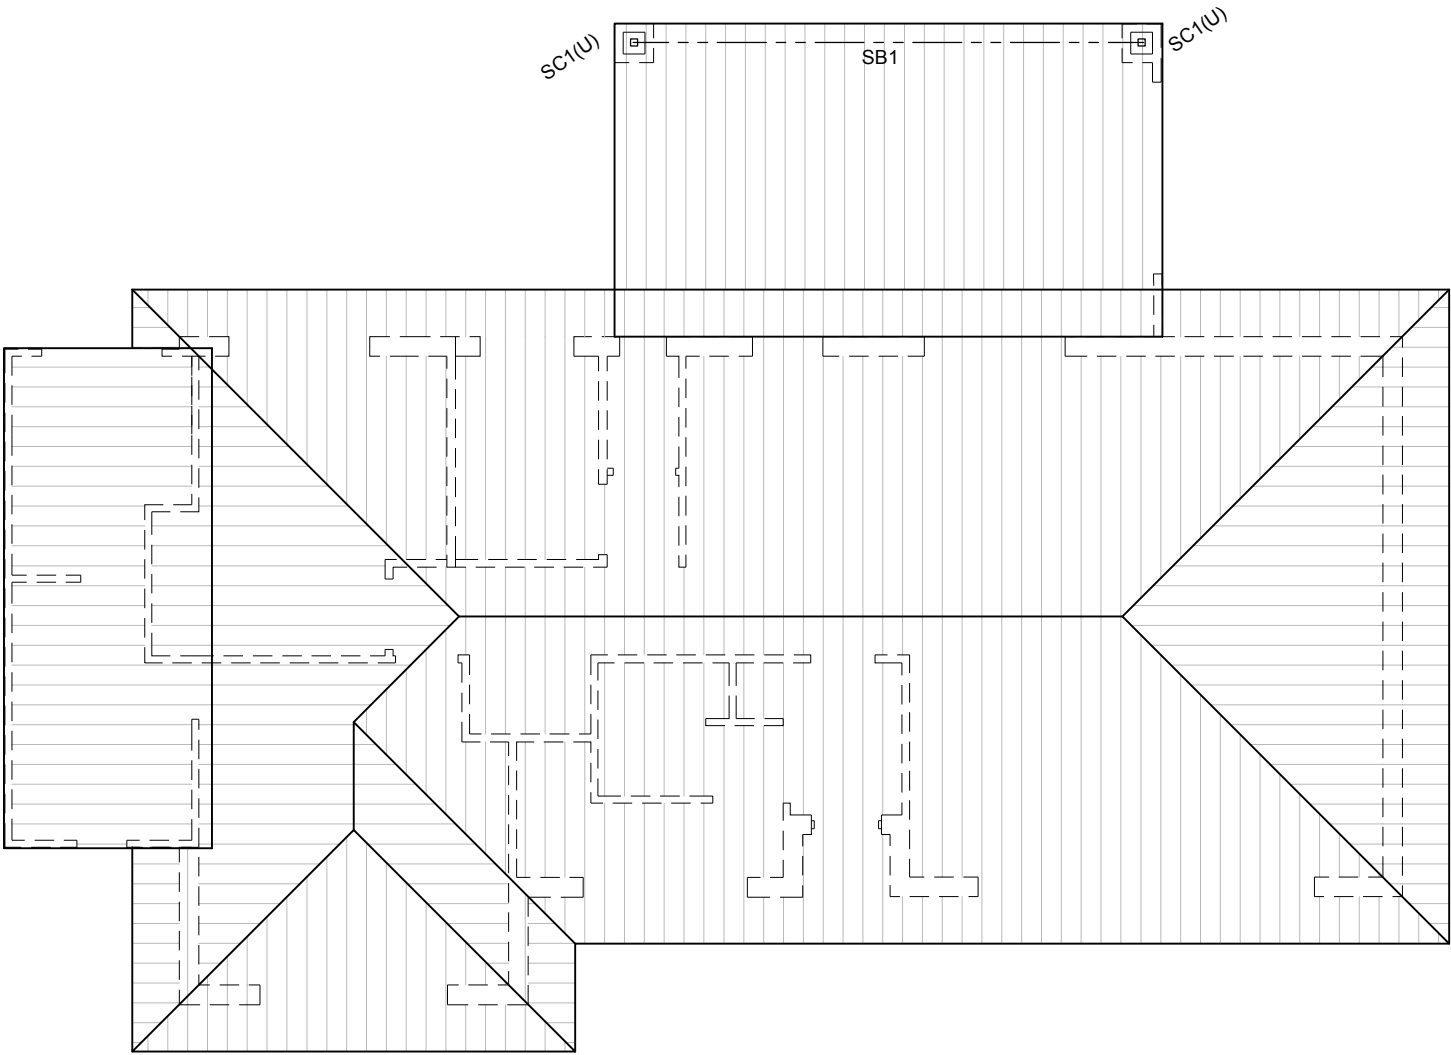
ROOF SUPPORT STRUCTURE

- 1- DO NOT DEMOLISH LOAD BEARING WALLS BEFORE CONTACTING OUR OFFICE.
- 2- BUILDER CAN ENGAGE OUR OFFICE FOR ALTERNATIVE SUPPORT STRUCTURE.

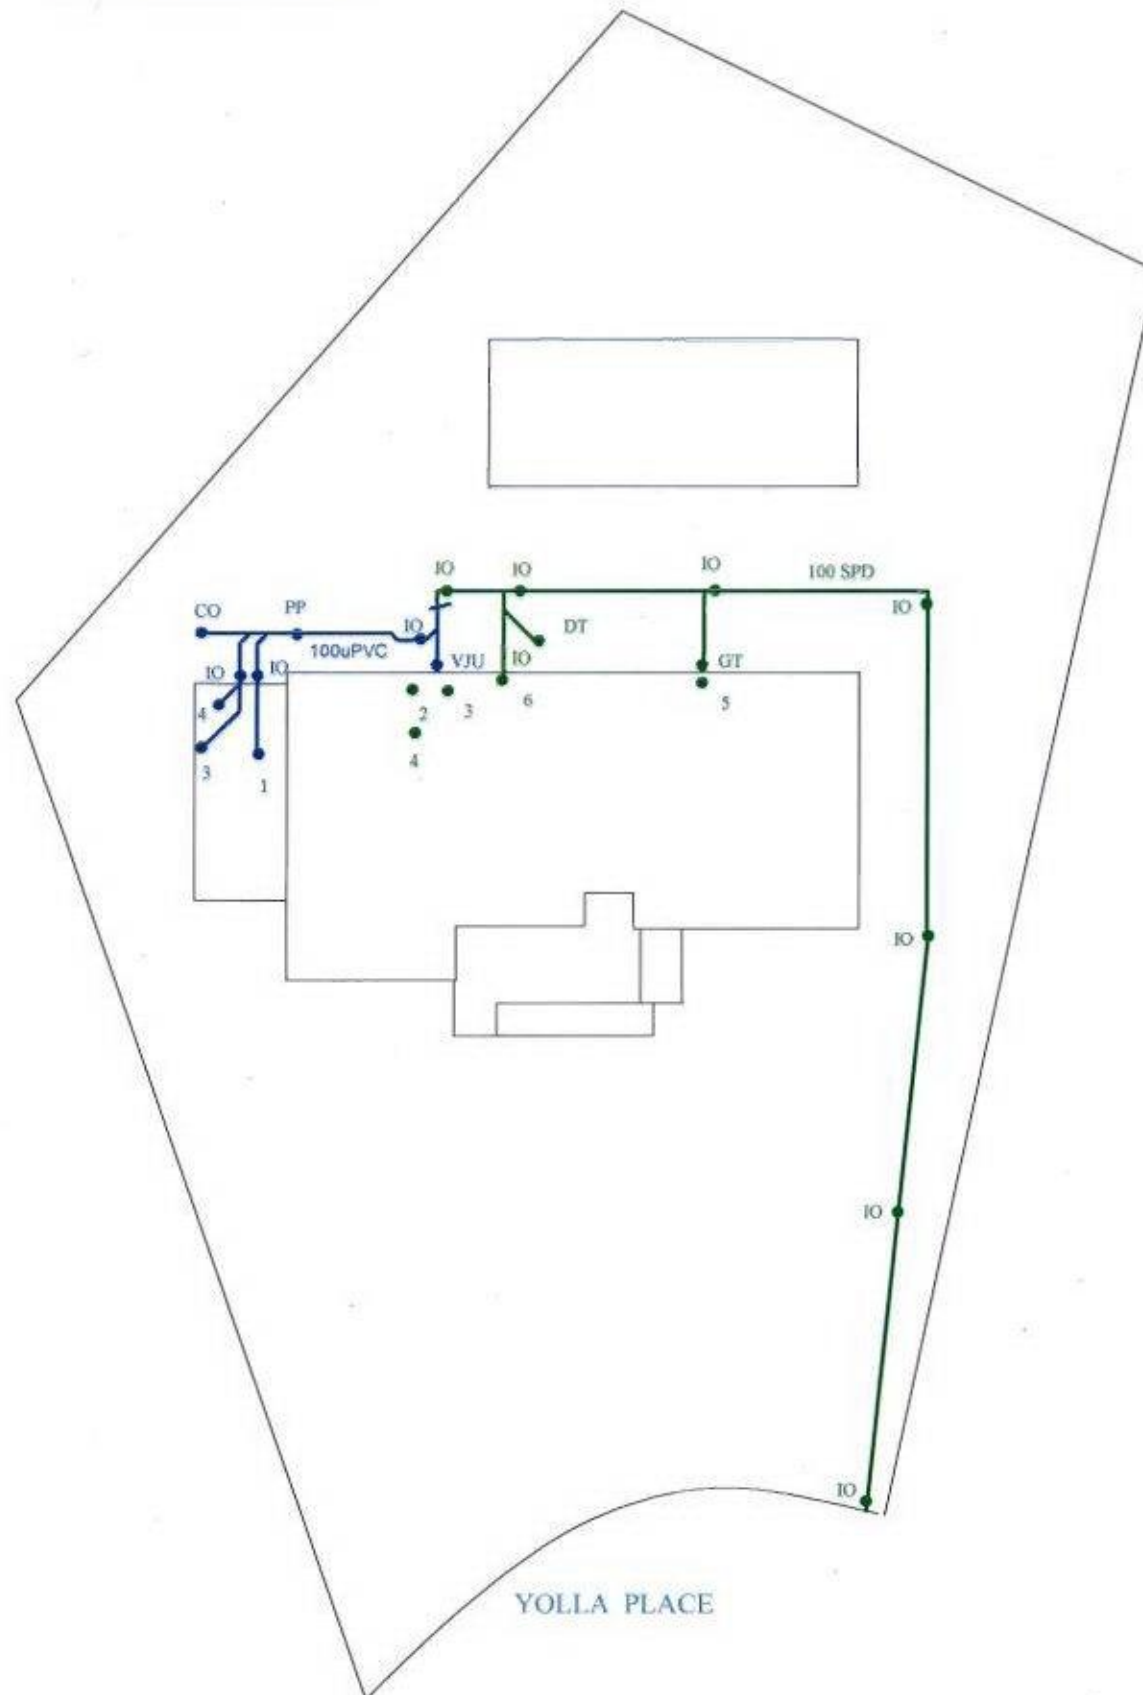
# DRAINAGE PLAN N

WORK AS EXECUTED PLAN.

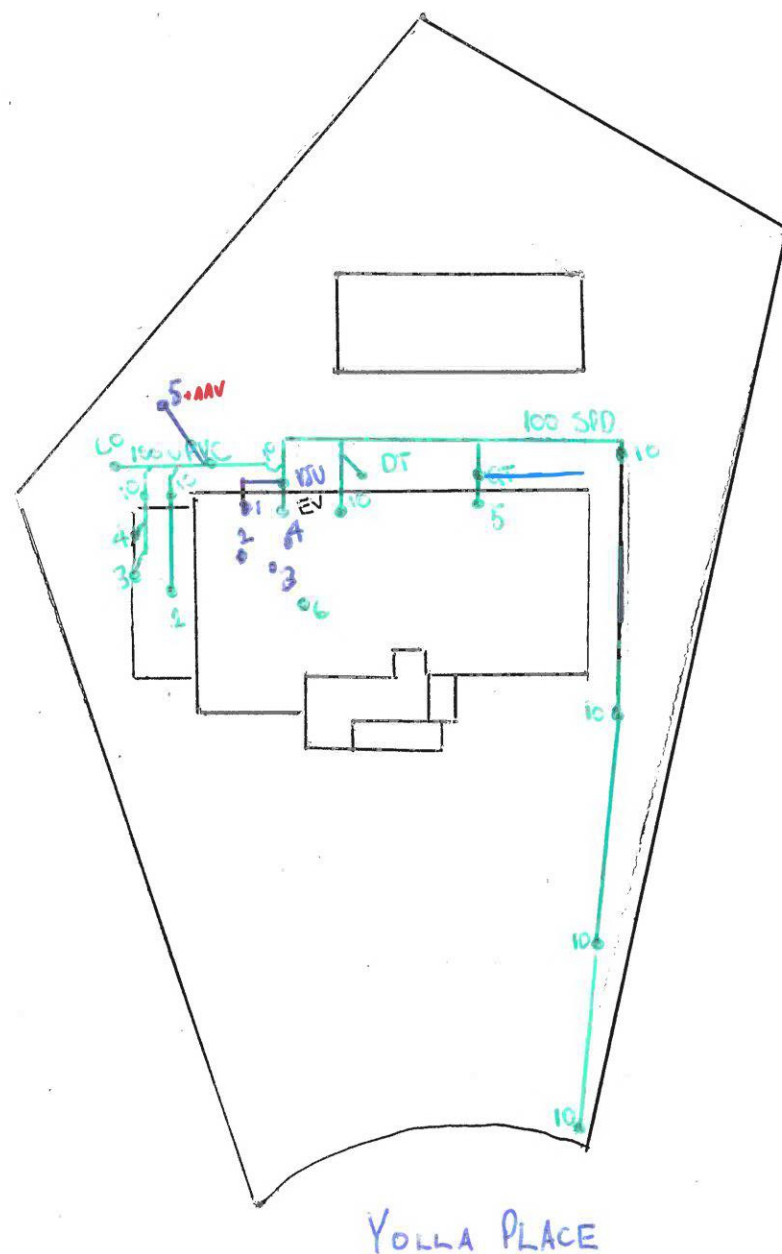
PLAN OF SANITARY DRAINAGE

WORK AS EXECUTED PLAN
