Report

Building Report

CONCLUSION AND SUMMARY

Property Address: 2 Cawthorn Crescent, Evatt ACT 2617
Client: Abel & Kerin
Inspection Date: Friday, June 12th 2026
Inspection carried out by: Duncan Clark

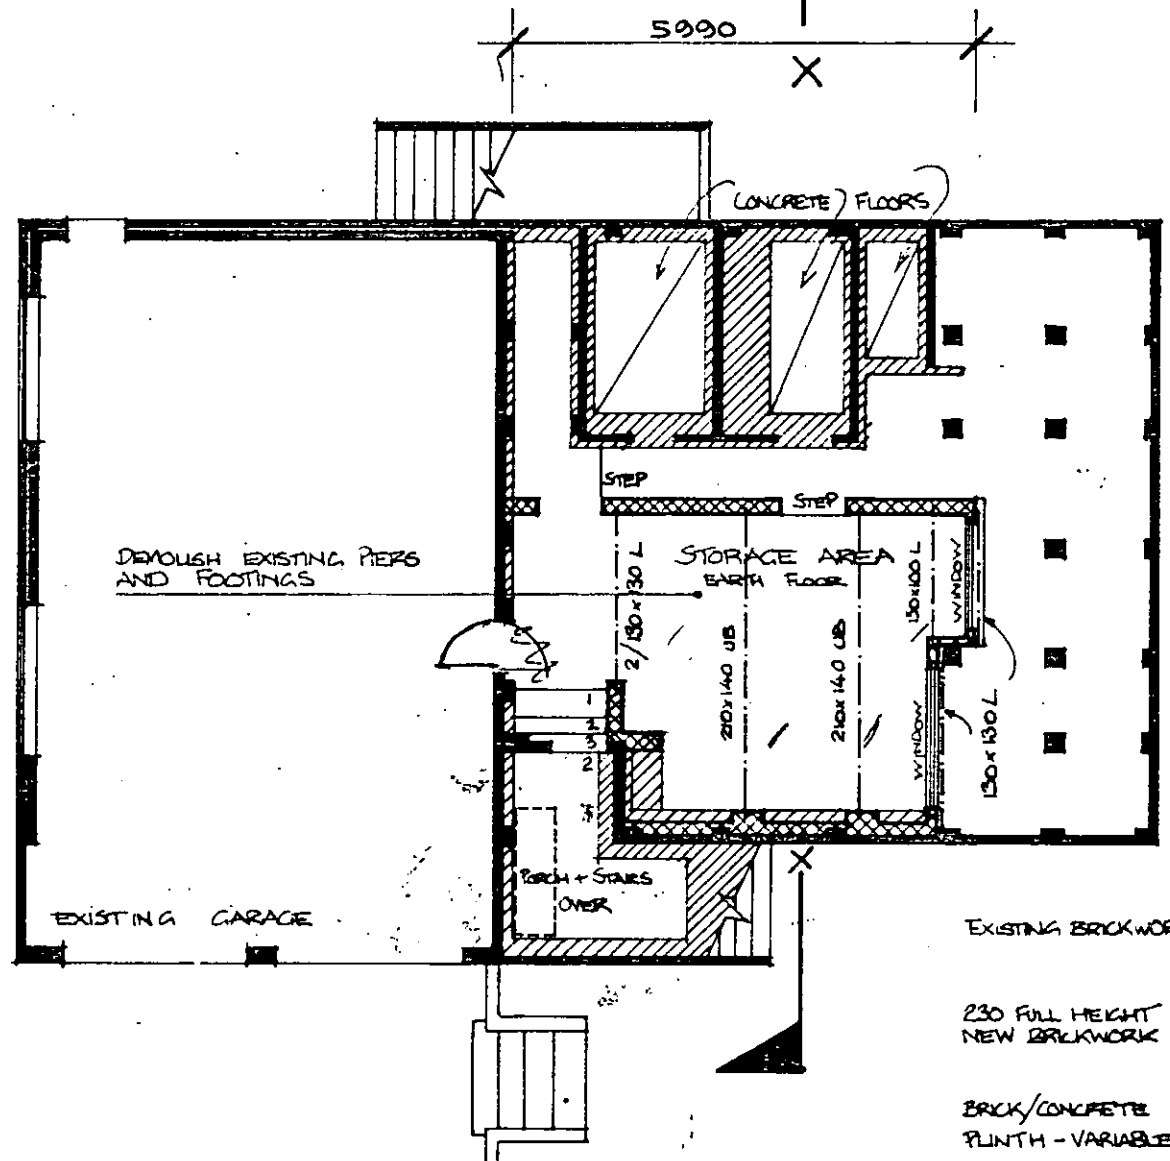
SUB-FLOOR PLAN

NOT TO BE USED FOR HABITABLE PURPOSES

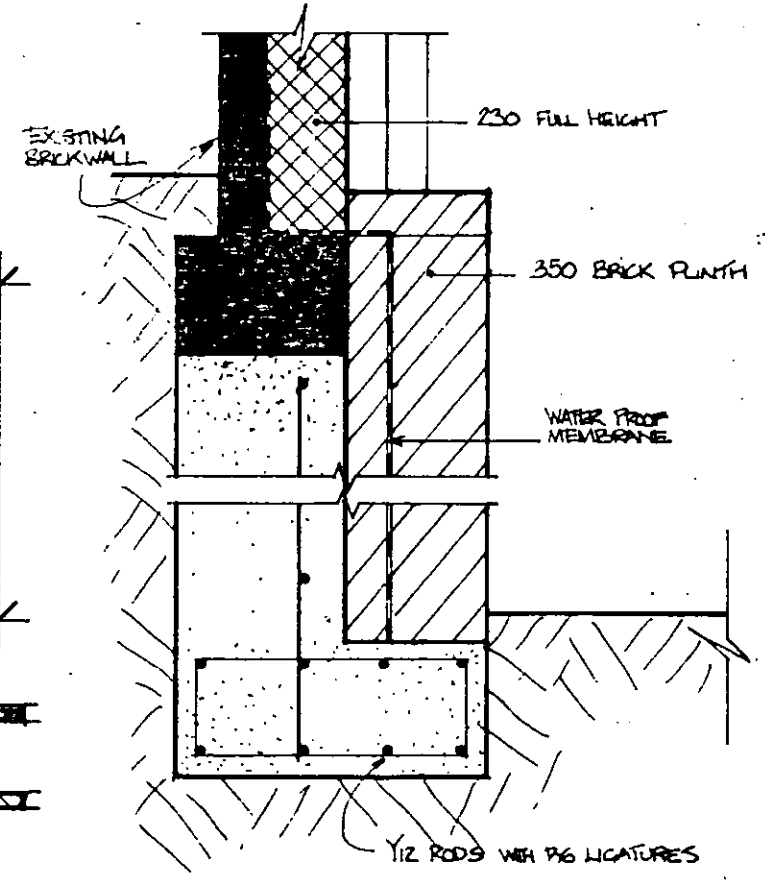
DETAIL

STEPS, LANDINGS, BALUSTRADES TO COMPLY WITH PART D2 BUILDING CODE OF AUSTRALIA

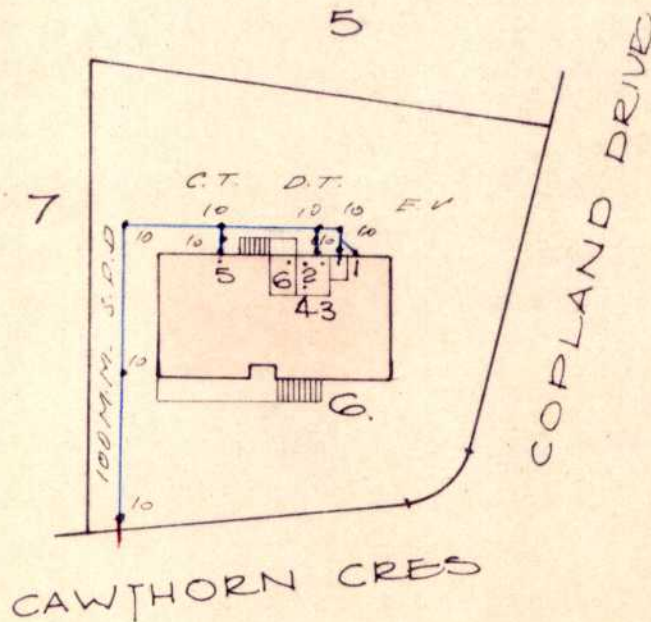
NOTES DRAINS TO BE LAID ARE SHOWN IN BLUE LINES. THIS PLAN TO BE READ IN CONJUNCTION WITH APPROVED ARCHITECTURAL PLANS AND SPECIFICATIONS. DRAINS TO BE DELETED SHOWN BY RED X. EXISTING DRAINS SHOWN IN GREEN LINES. POSITION OF BRANCH TO BE LOCATED BEFORE ANY WORK IS COMMENCED.

- DRAINER:** Seal off existing drains & remove & relocate Educt vent as shown. Provide new 100 sewer drains & connect to existing system to approval. Provide all necessary traps & inspection openings. At 100mm level in Bath Room 2 provide 50 mm built up concrete base to foundation wall & stud wall & project through roof and finish with coal. Provide new S.W. 100 down pipe & connect to existing service. Build in downpipes. Brick fill all drainage in approval.
