PRESALE REPORT

22/58 Shackleton Circuit

Mawson

SITE RECORD

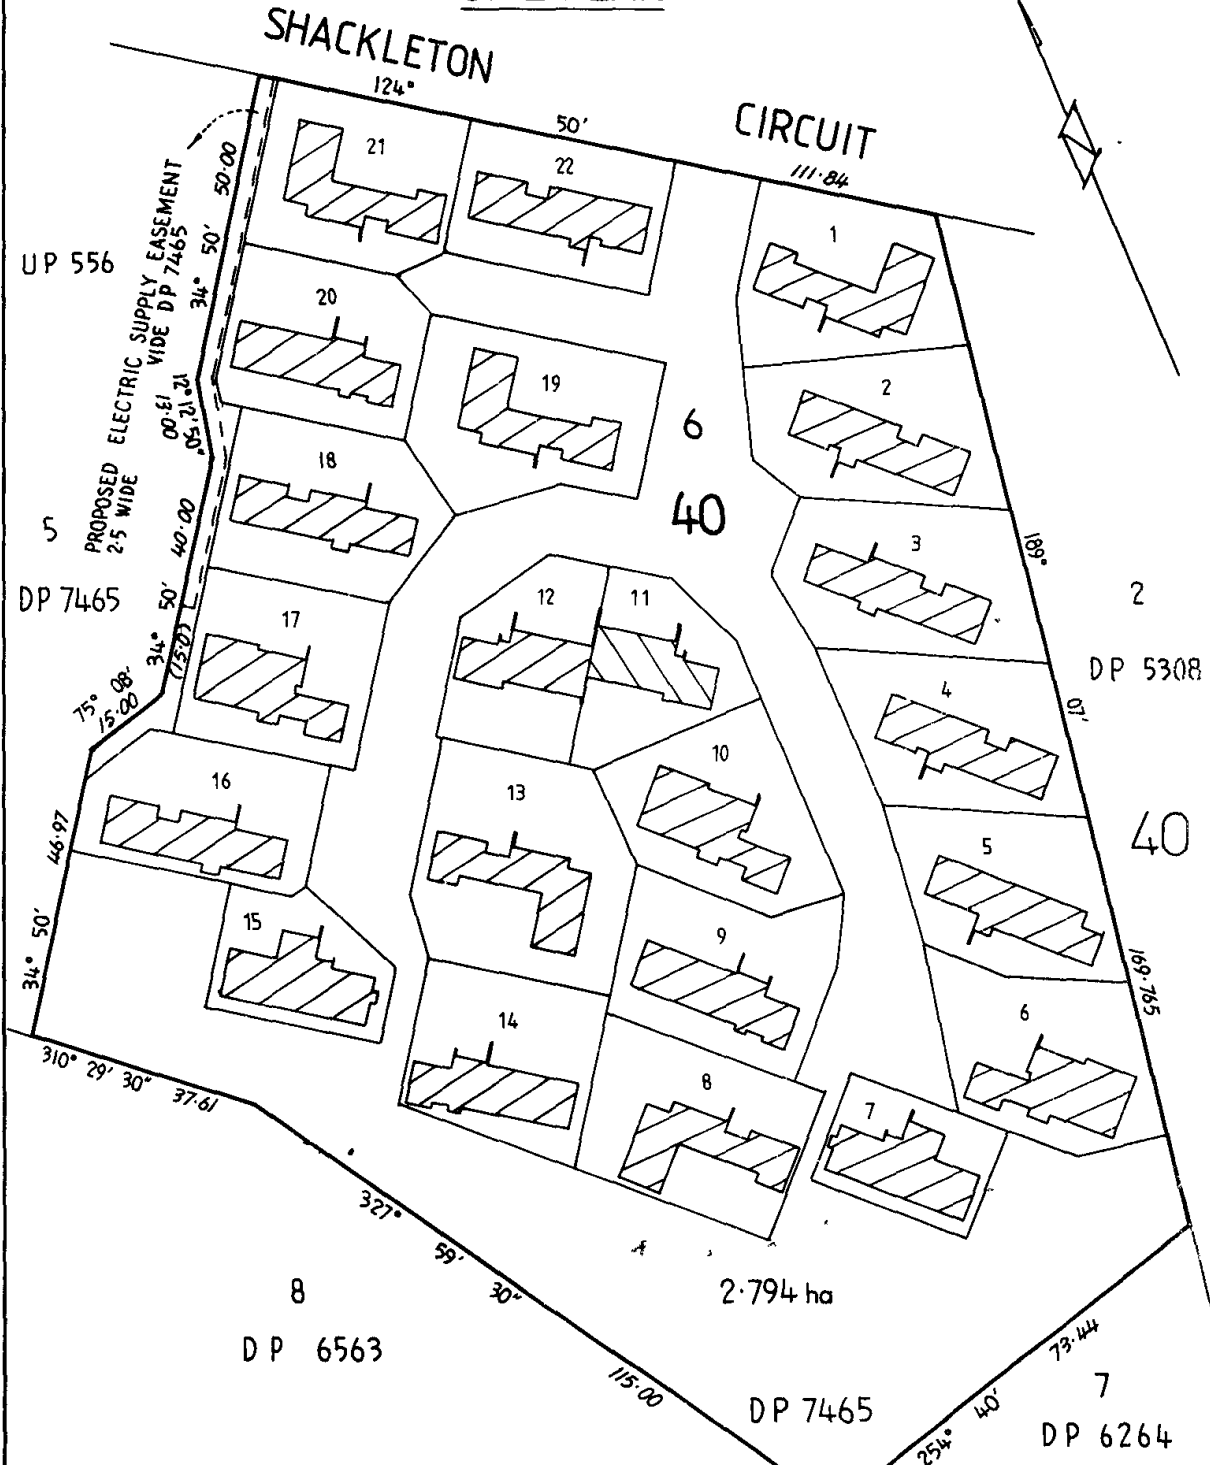
SITE PLAN

NOTE: BUILDING OUTLINES SHOWN ARE SINGLE STOREY BRICK RESIDENCES UNDER CONSTRUCTION

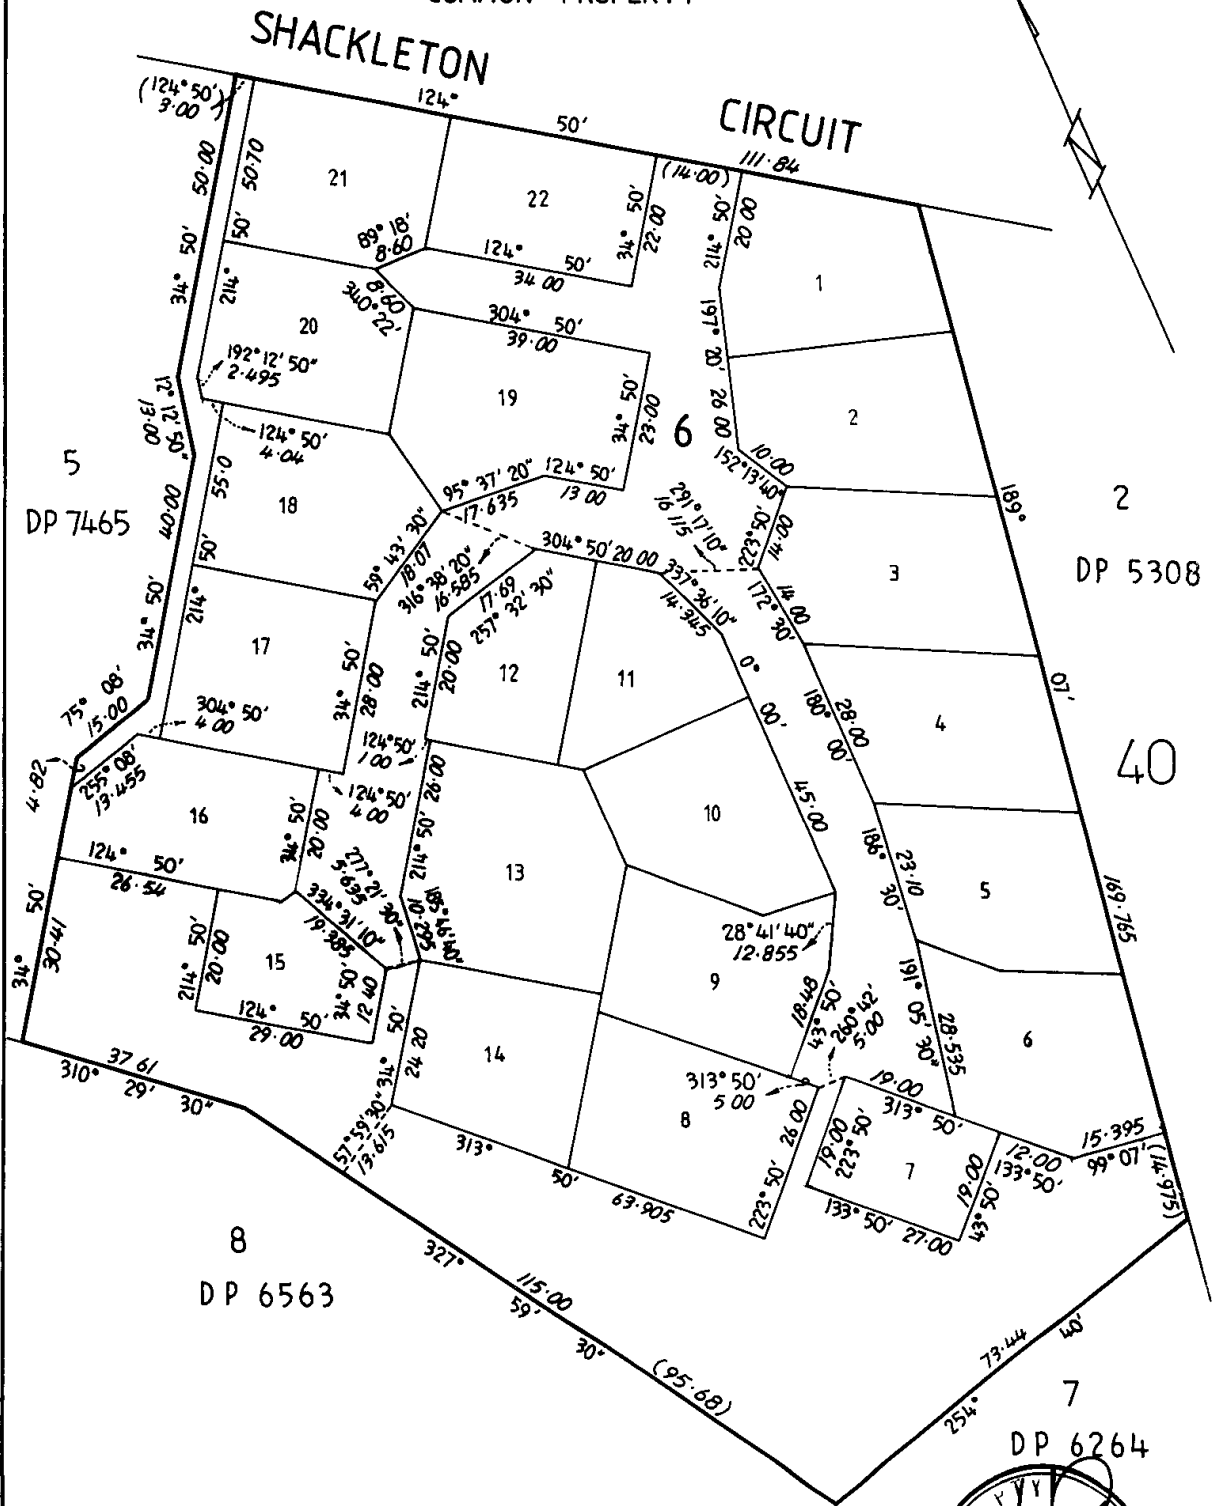
SITE PLAN COMMON PROPERTY

Scale 1 1000

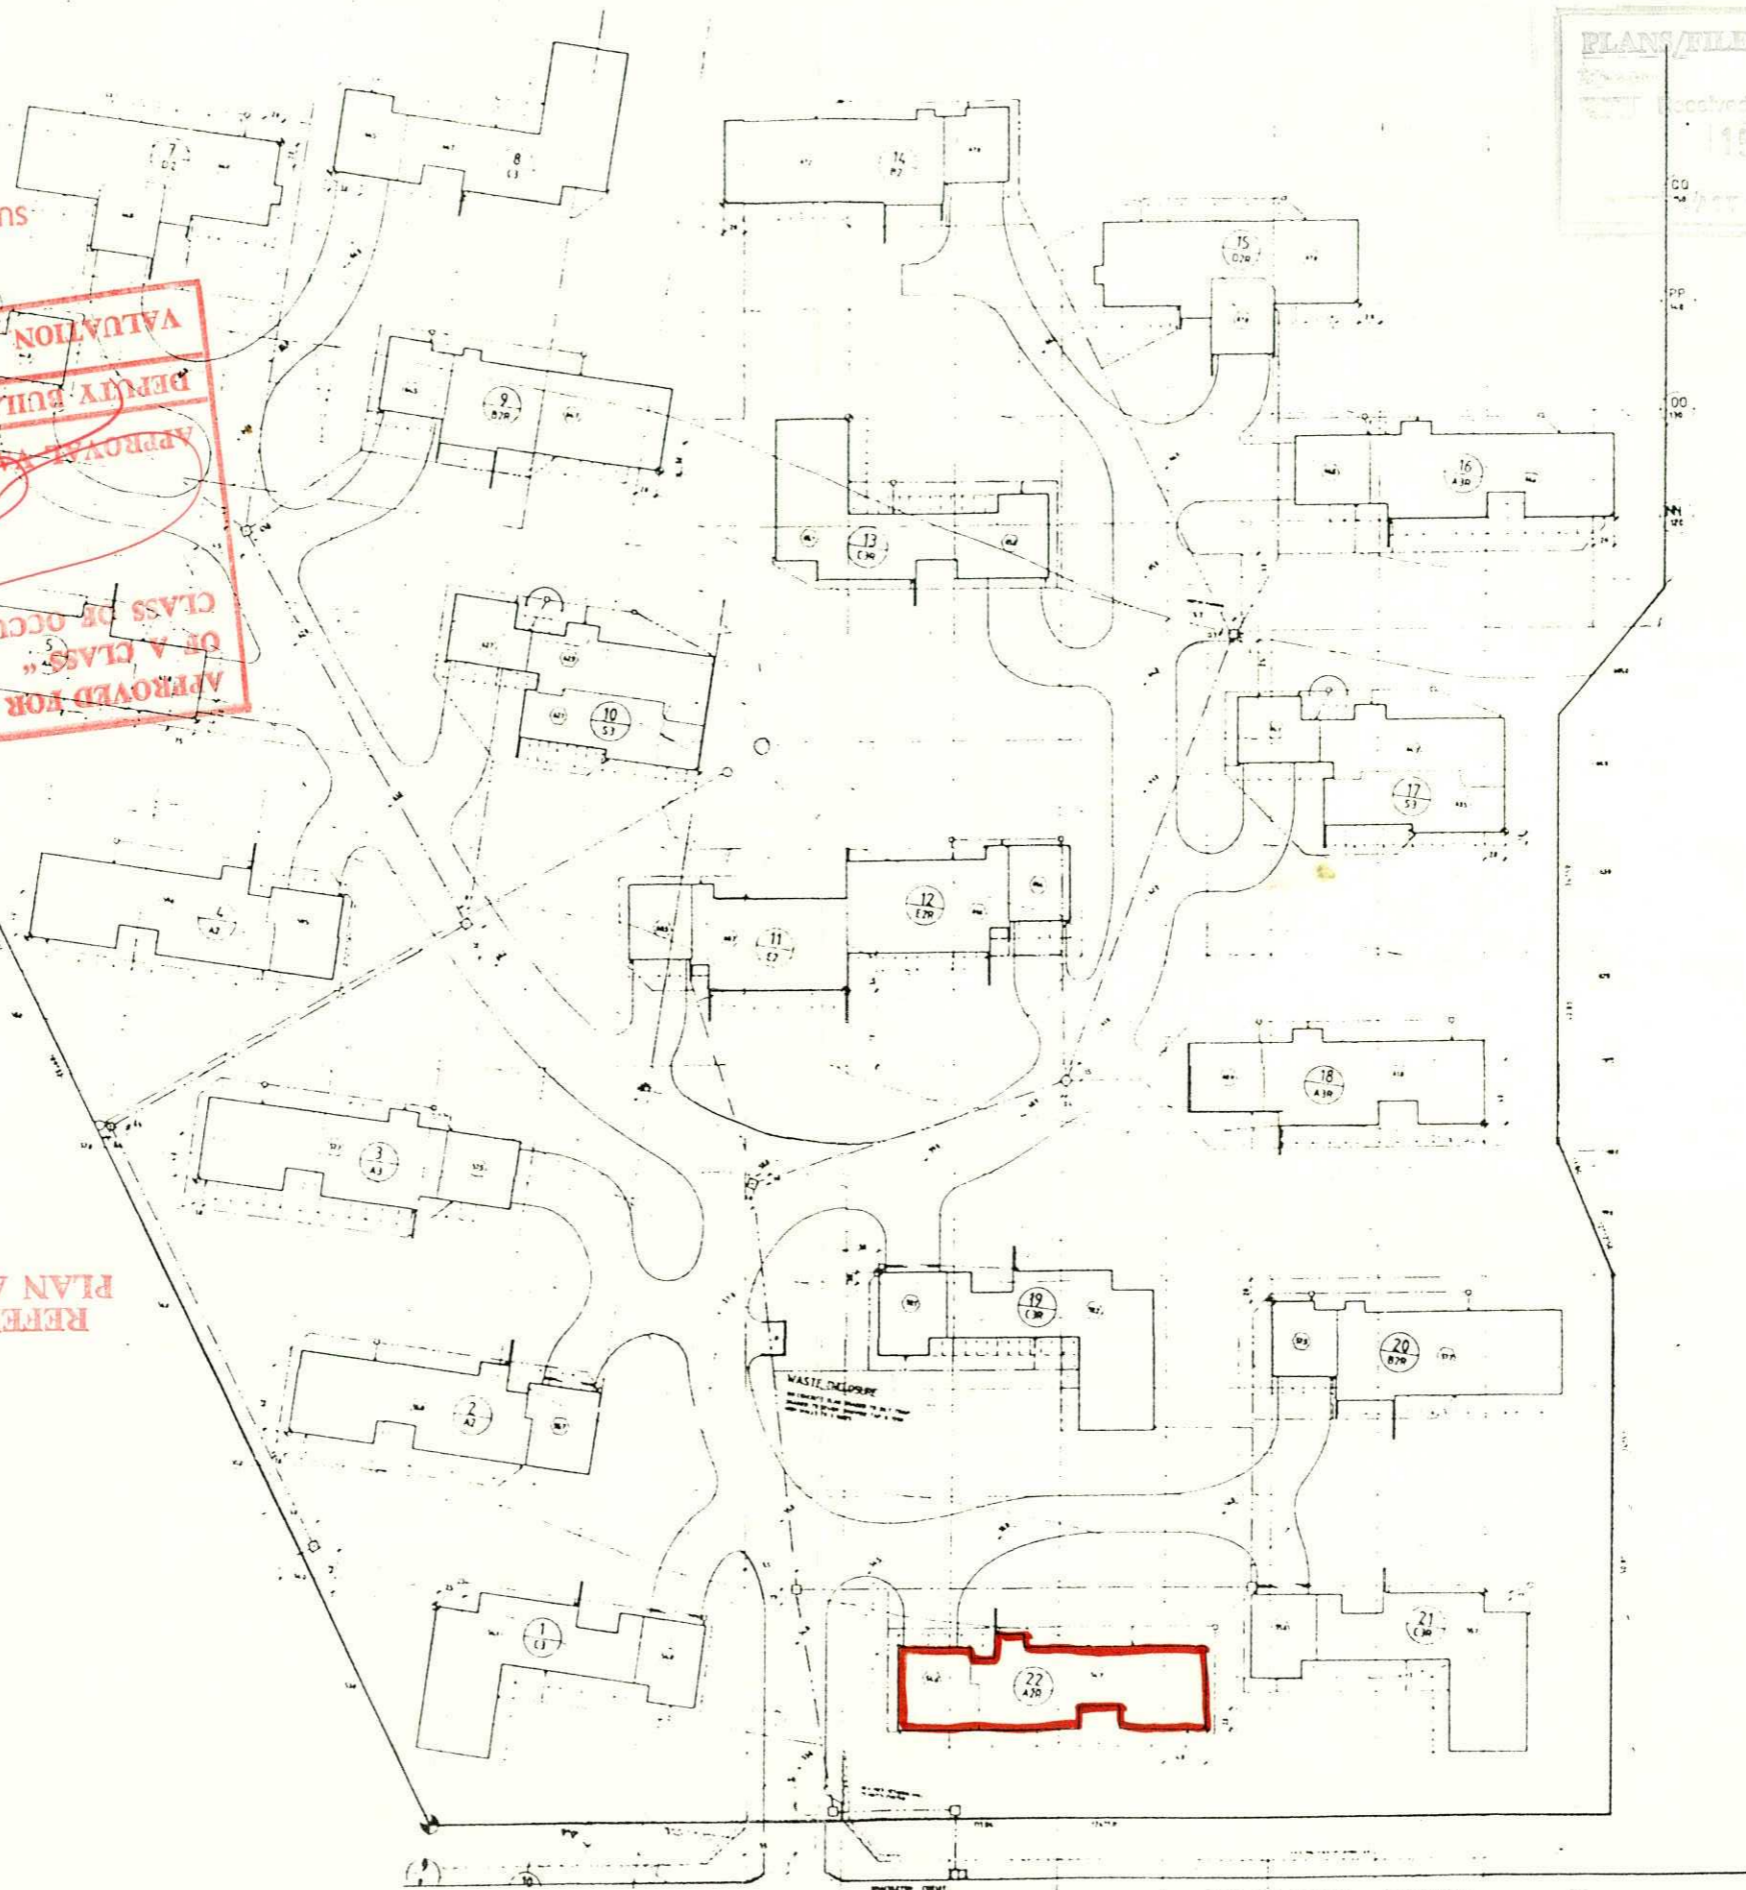
SITE PLAN

SHACKLETON CIRCUIT

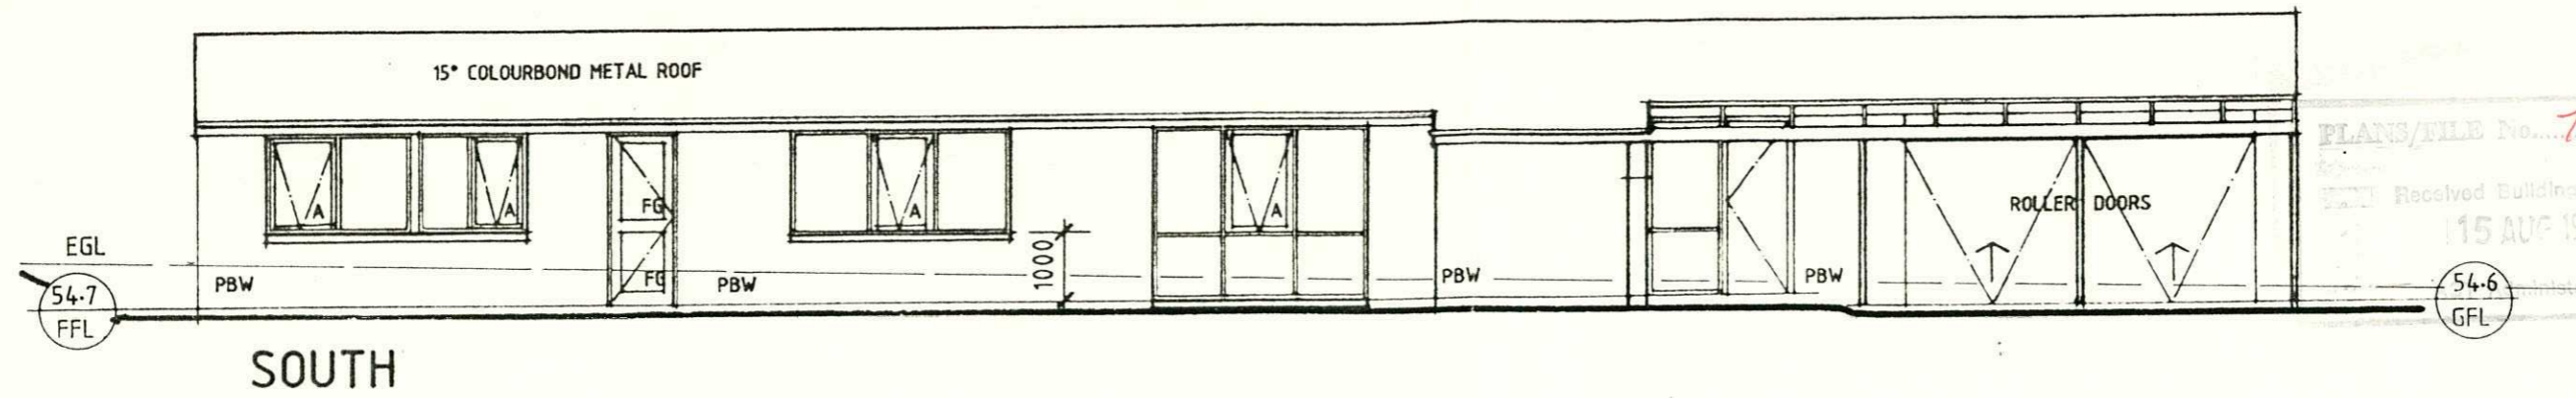
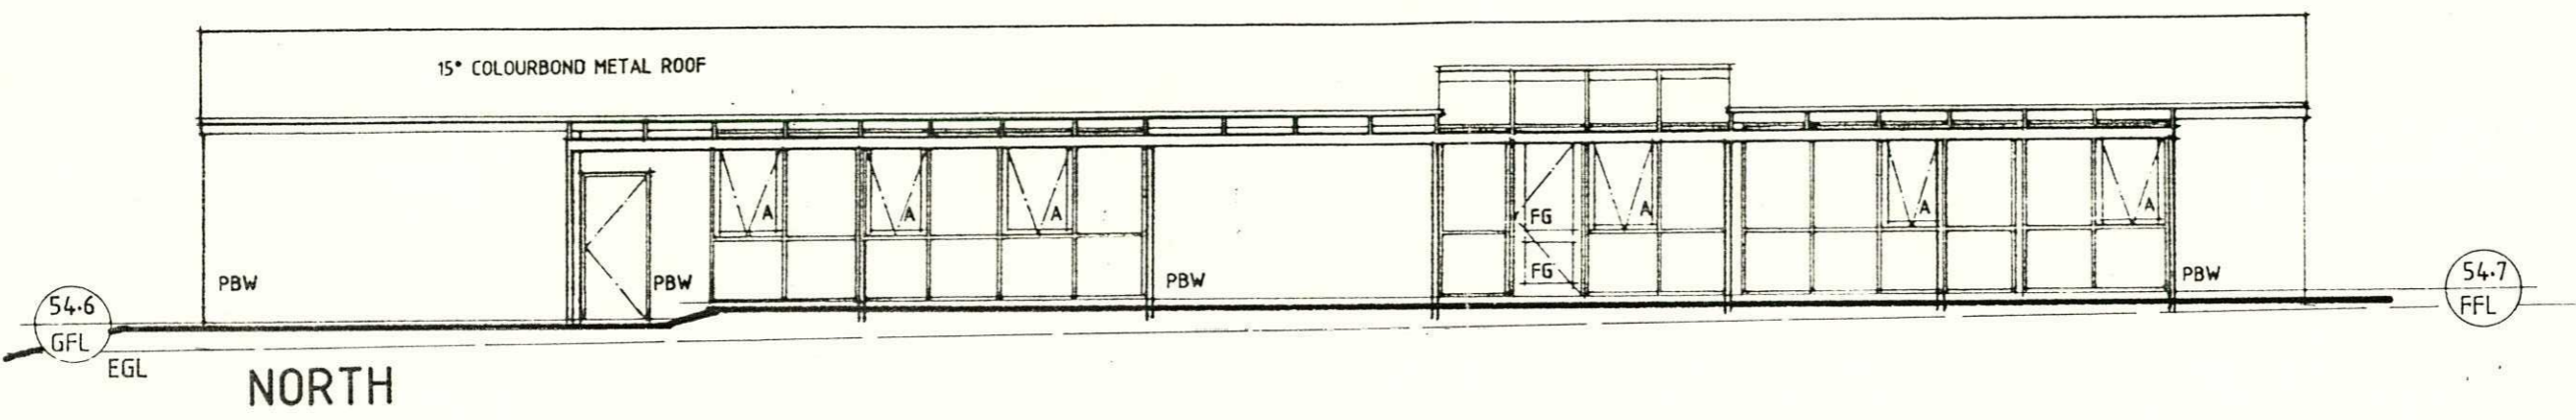
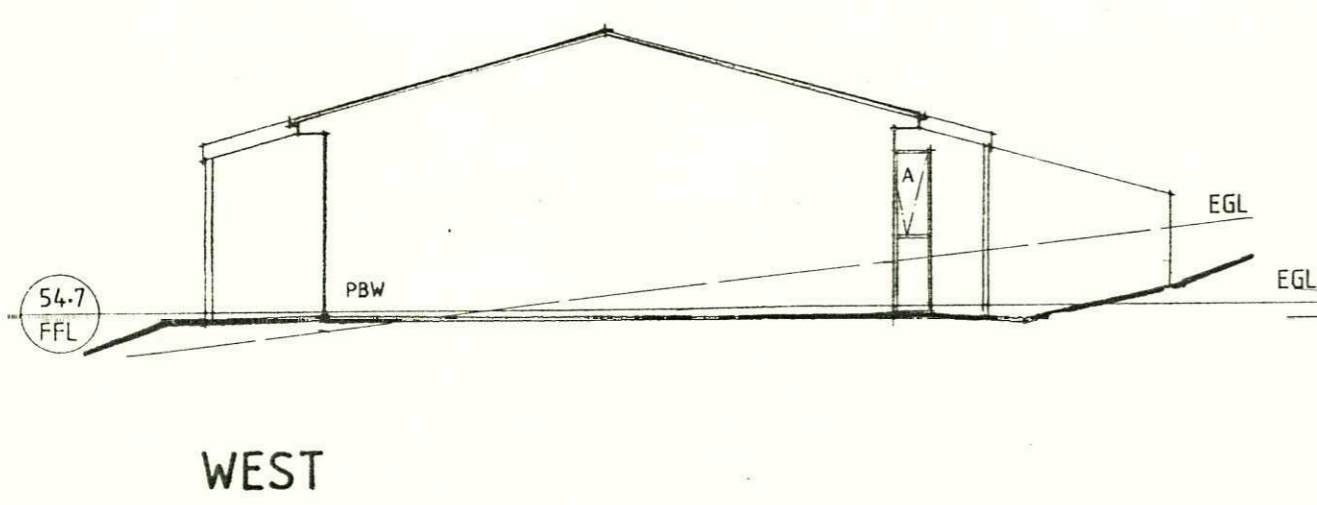
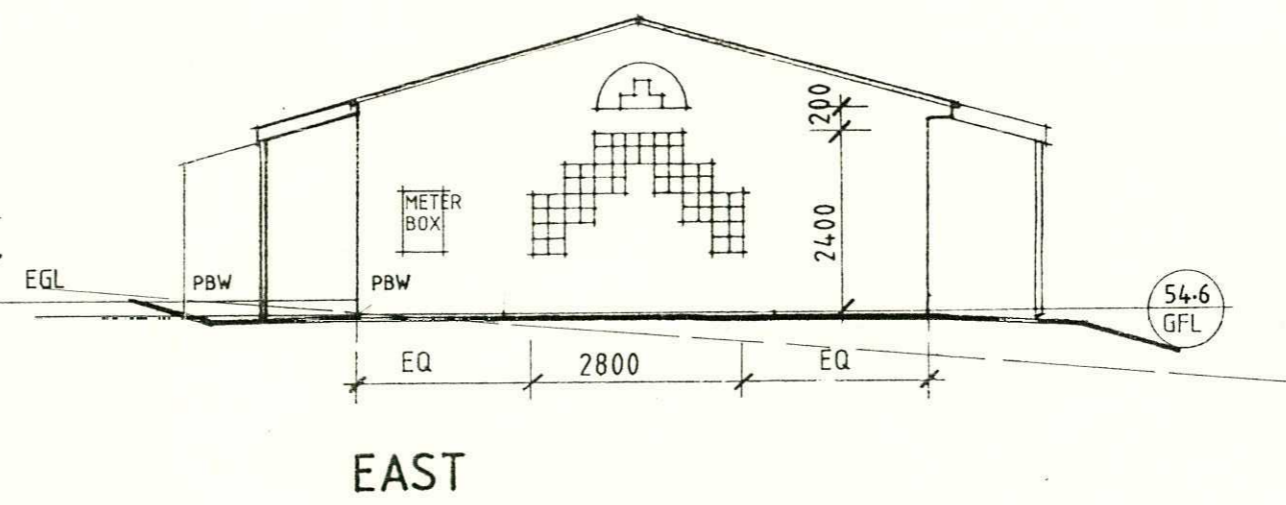
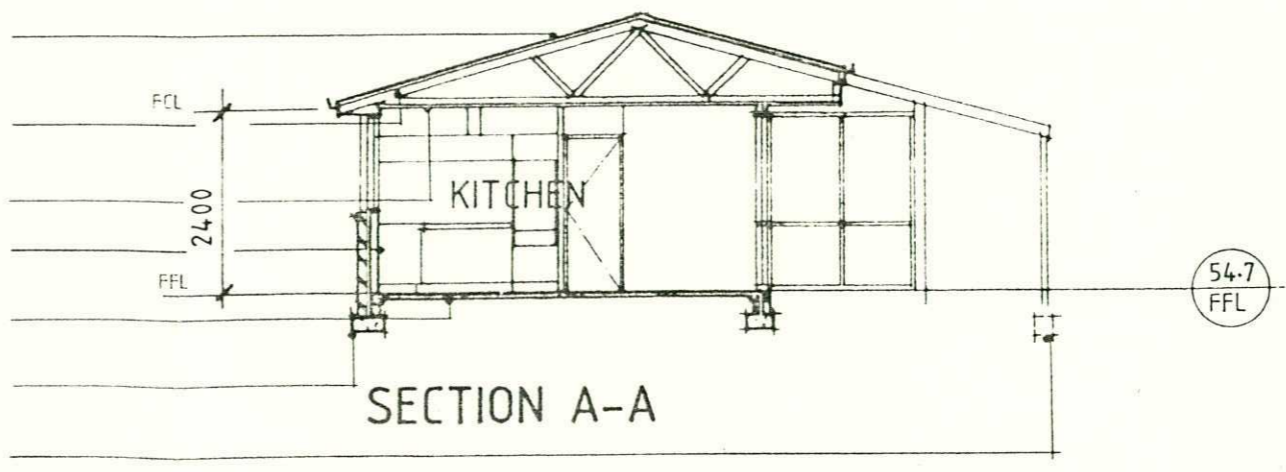
BLOCK 6 SECTION 40 MAWSON
 UNIT 22
 SCALE 1:100
 DATE JULY '89
 DRAWN GW
 D'WG.
 TYPE A2R

COLOURBOND METAL DECK, FIXED TO MANUFACTURERS SPECIFICATIONS WITH DOUBLE SIDED SISALATION & R2.5 INSULATION UNDER

ROOF TRUSSES TO DETAIL AT 900cmts WITH 50x50 PURLINS OVER 100x75 F7 BEAM OVER LOADBEARING CEDAR WINDOW FRAMES. 200x38 R.S. OREGON FASCIA

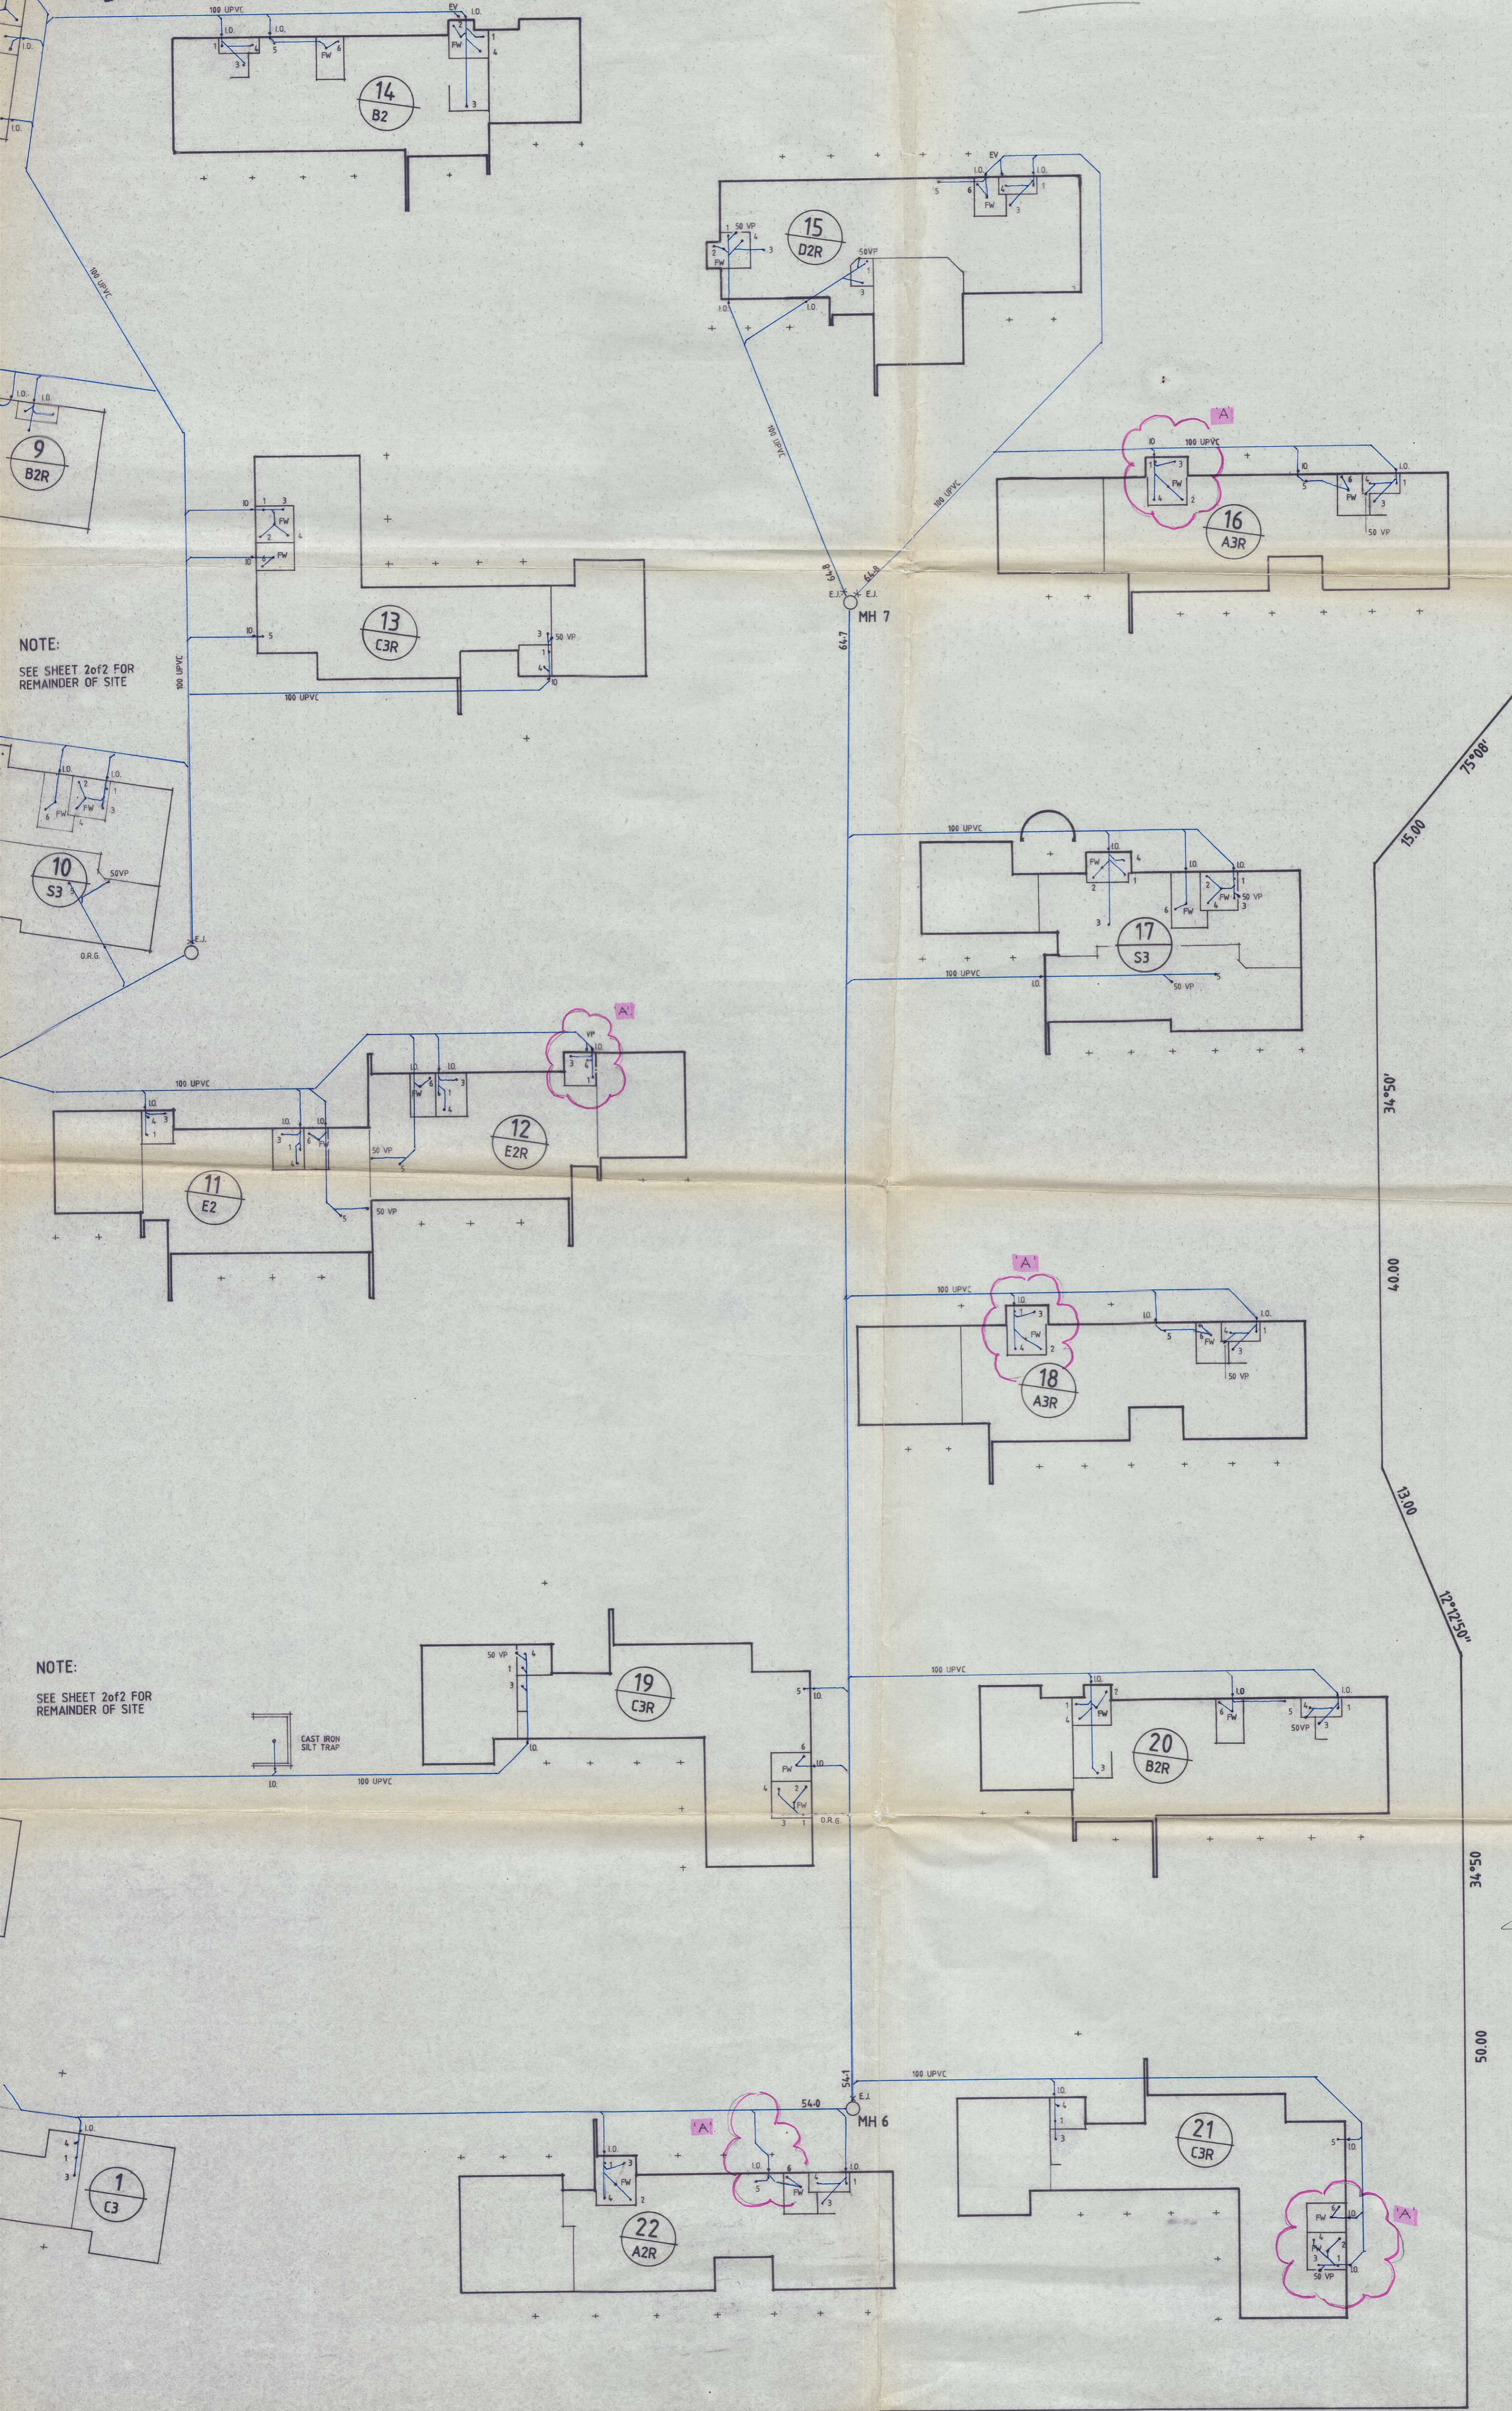
REFERENCE

- I.O. INSPECTION OPENING
- E.J. EXPANSION JOINT
- V.P. VENT PIPE
- M.H. MAN HOLE
- F.W. FLOOR WASTE
- O.R.G. OVERFLOW RELIEF GULLY
- U.P.V.C. UNPLASTICISED POLYVINYL CHLORIDE
