PRESALE REPORT

3 Dobie Place

MacGregor

SITE RECORD

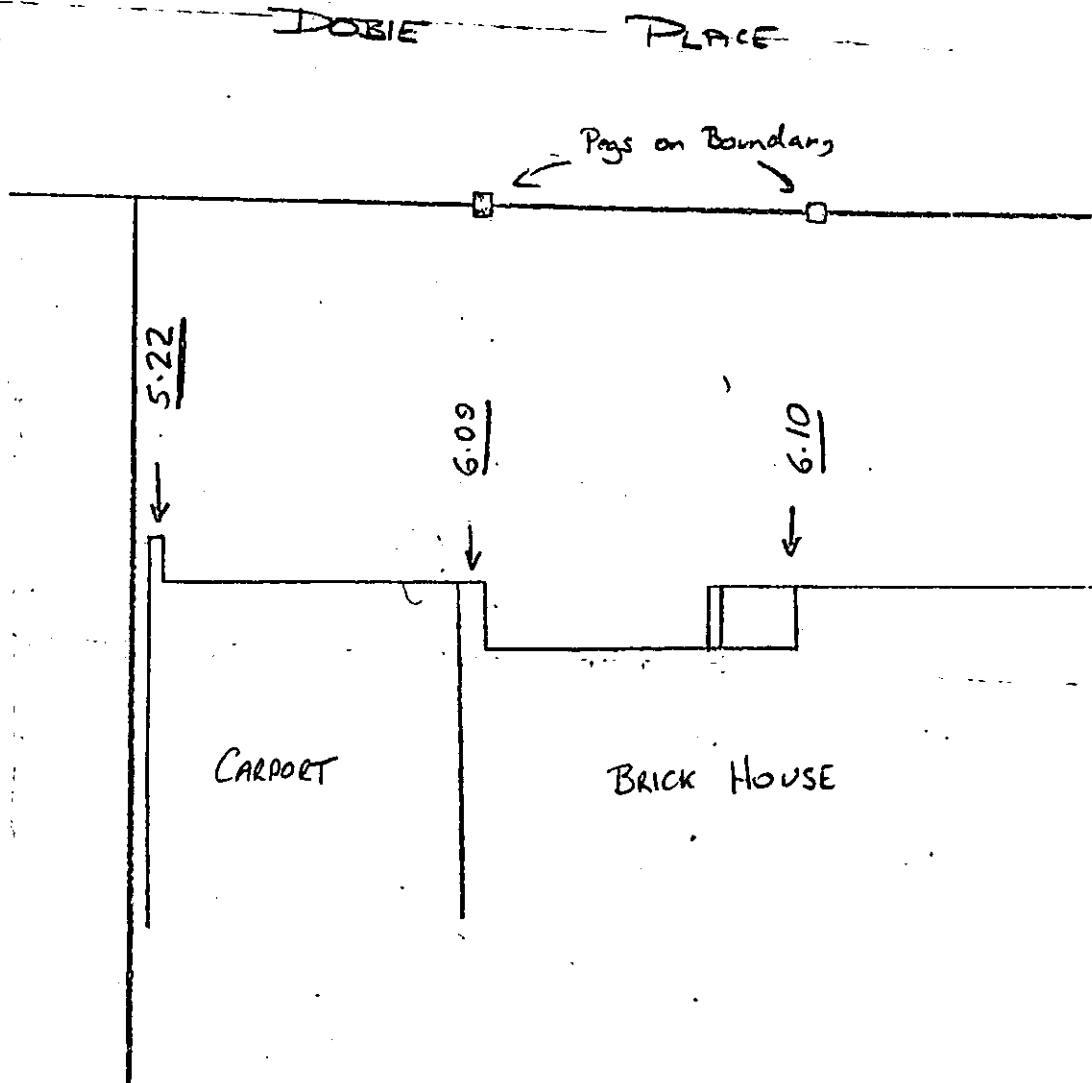
SKETCH PLAN FRONT BOUNDARY

15/102 MACGREGOR

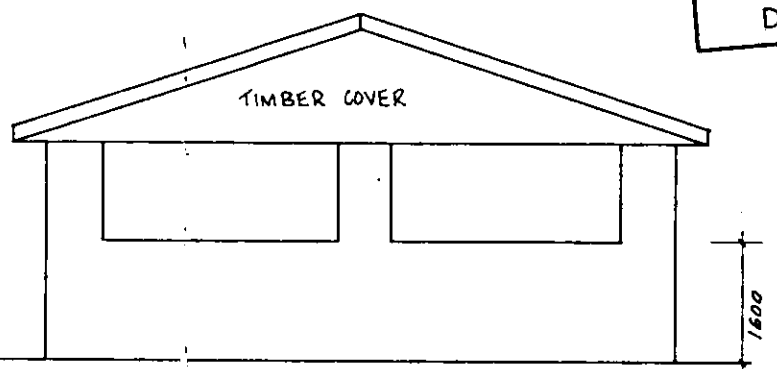
END ELEVATION

SCALE 1:100

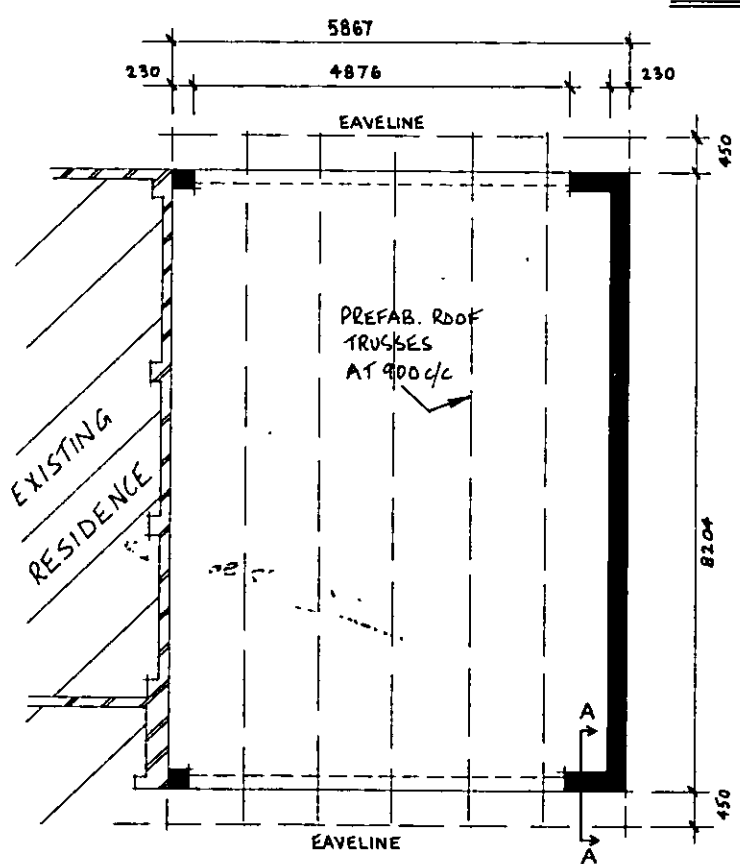
PLAN

LINTEL SIZES AS PER
 TRUSS MANUFACTURERS CHART

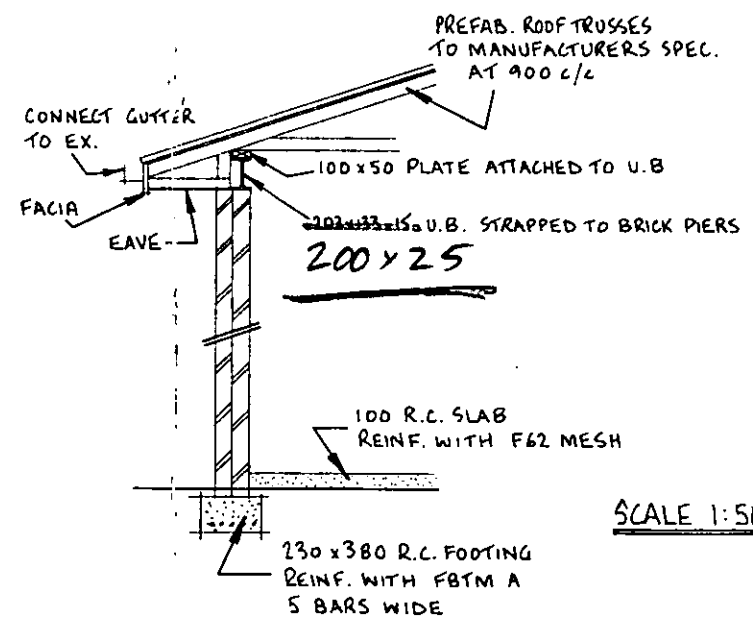
SECTION A-A

SCALE 1:50

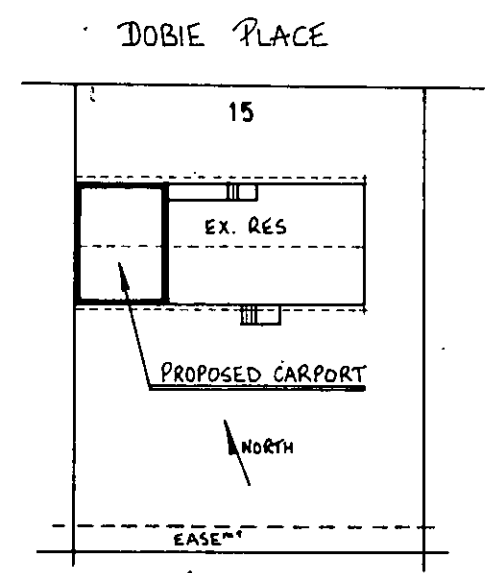
SITE PLAN

SCALE 1:500

DEPTH OF FILL UNDER
 SLAB NOT TO EXCEED 400 mm

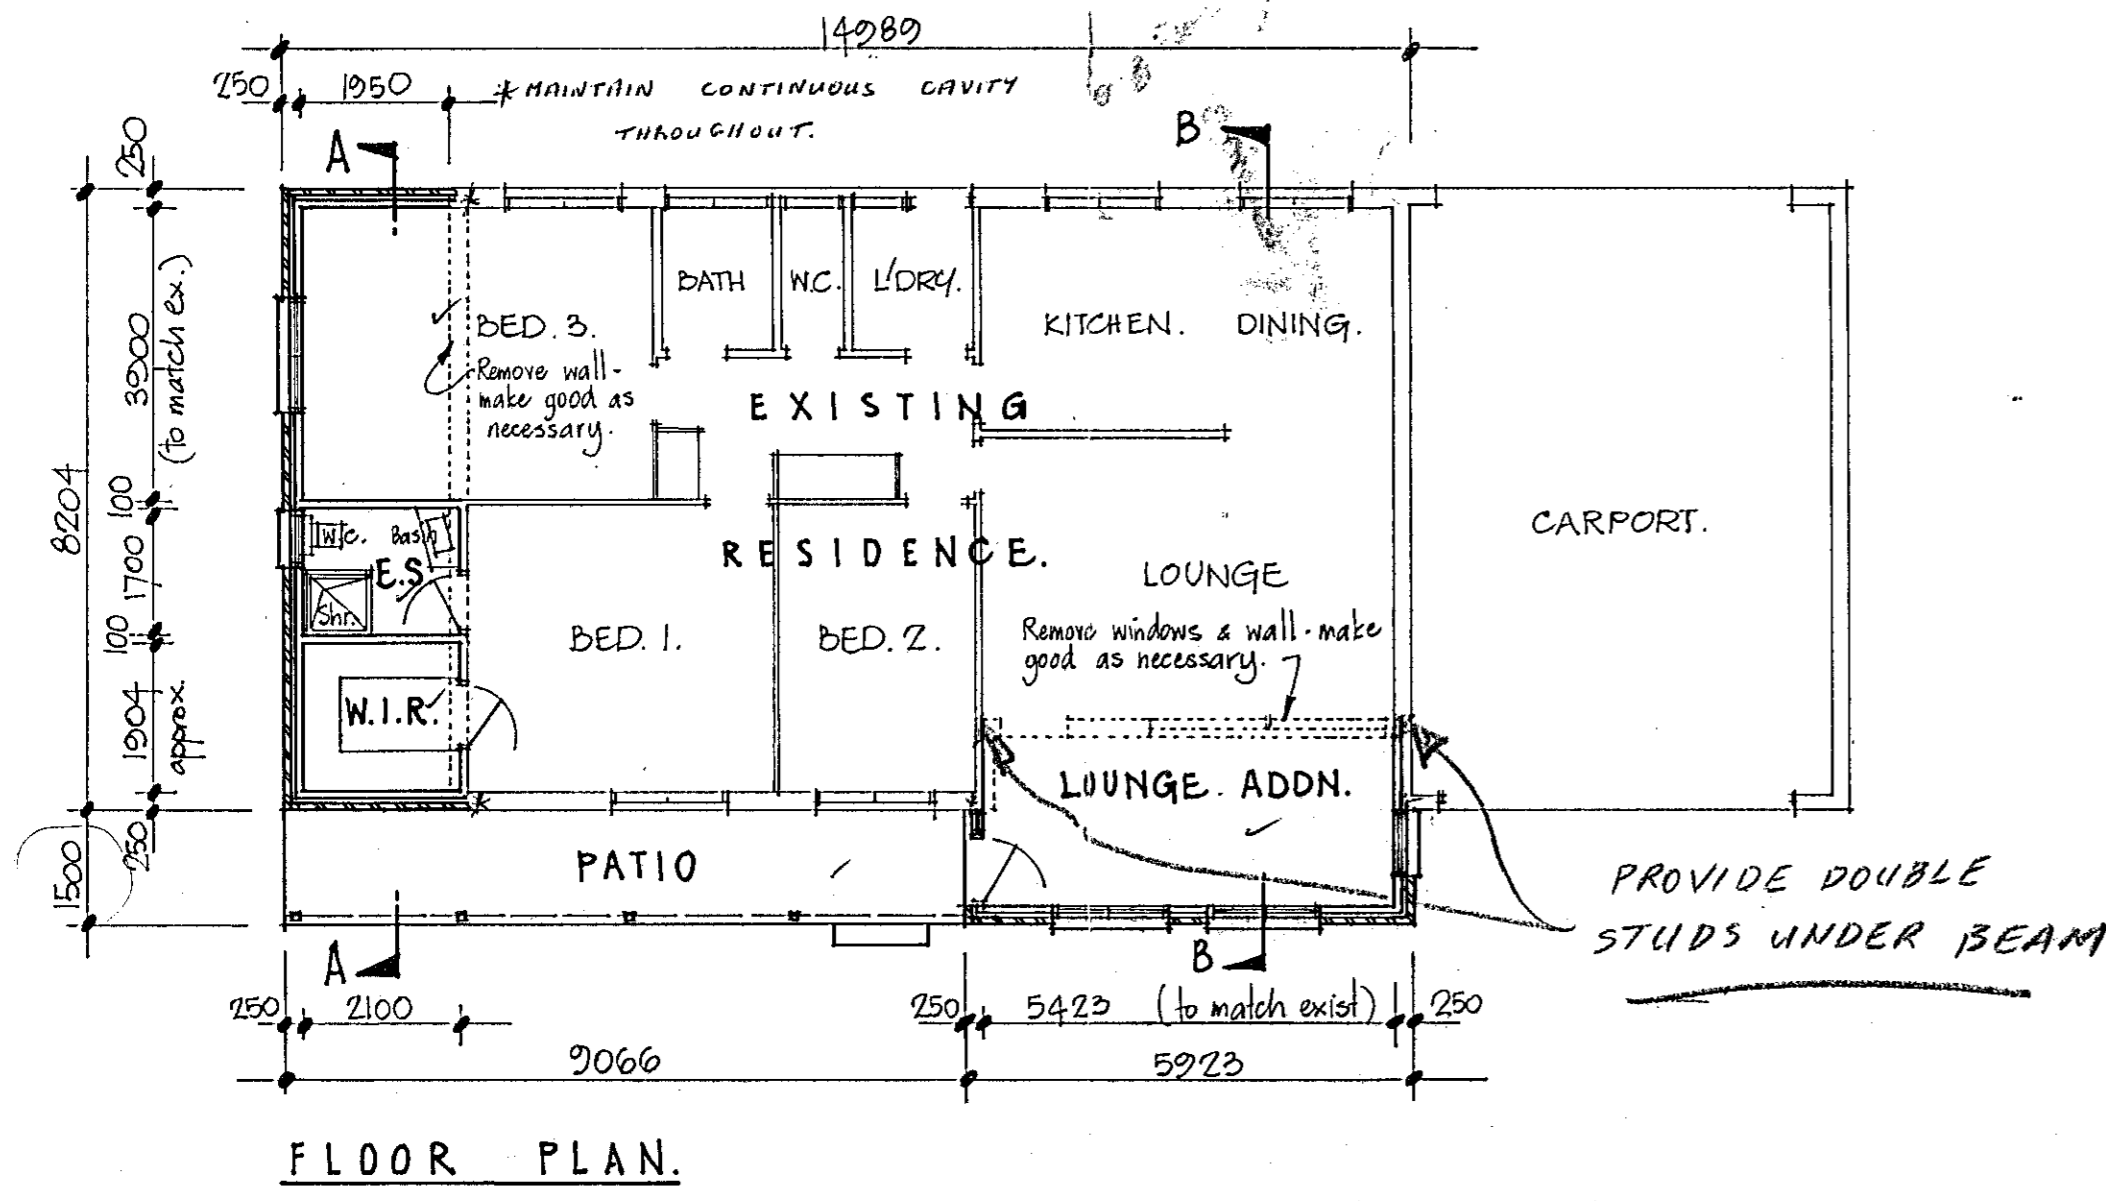
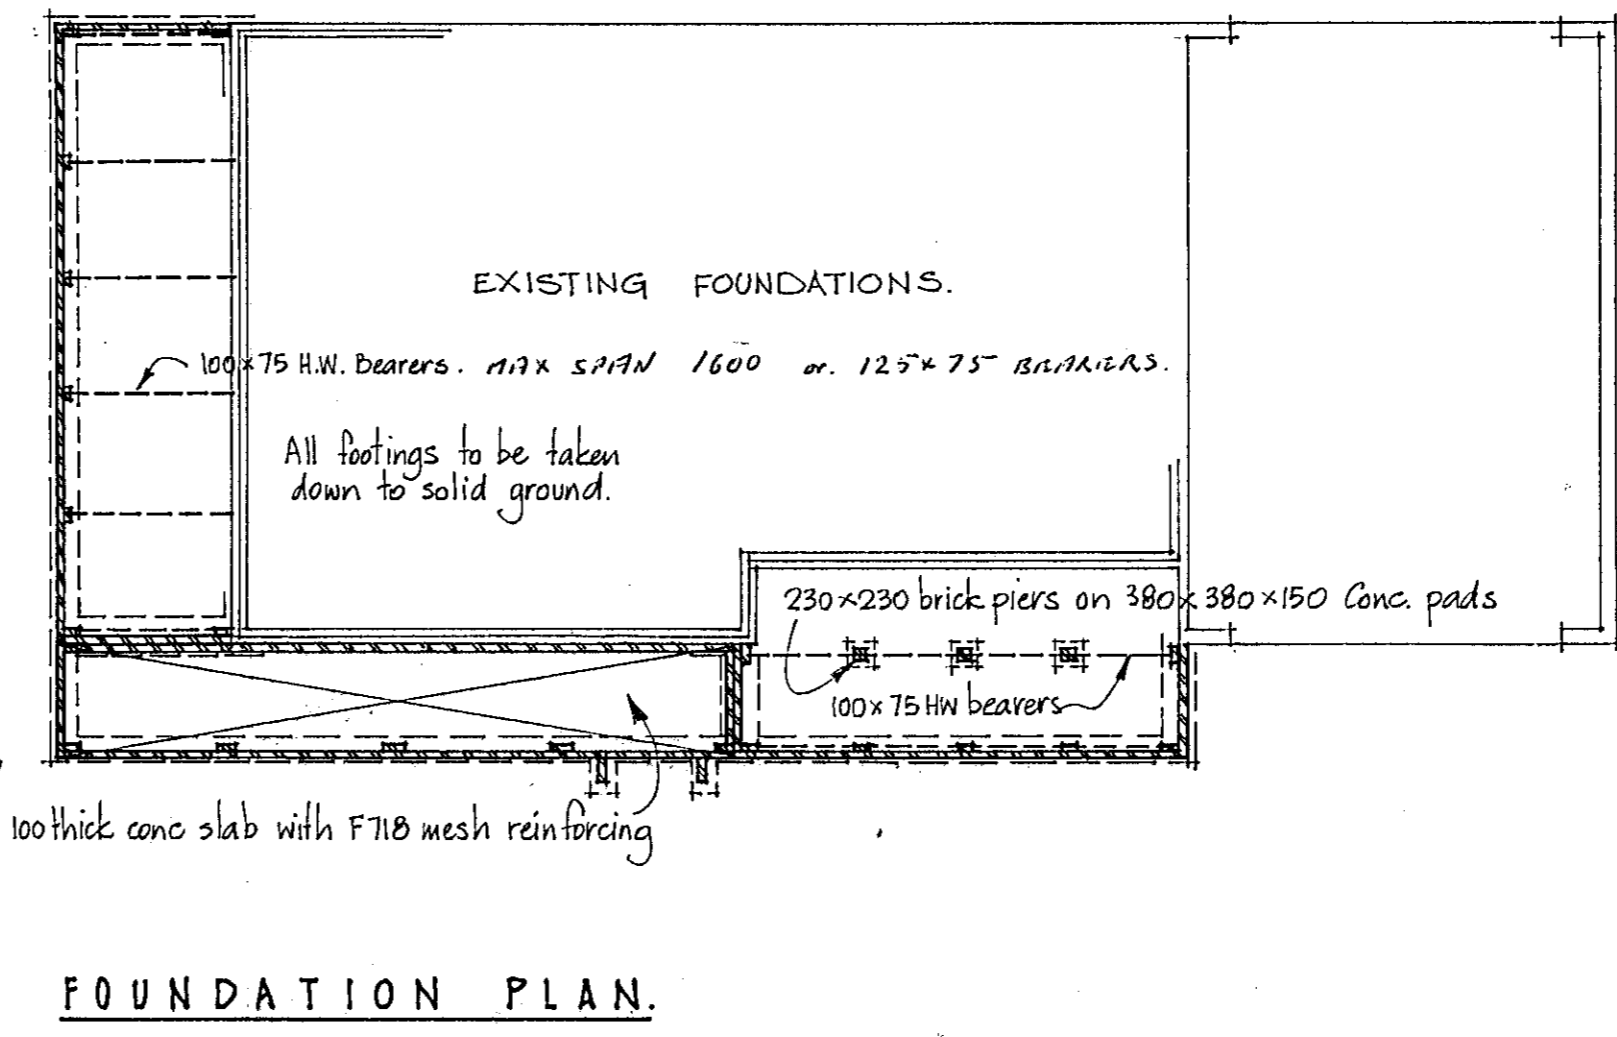
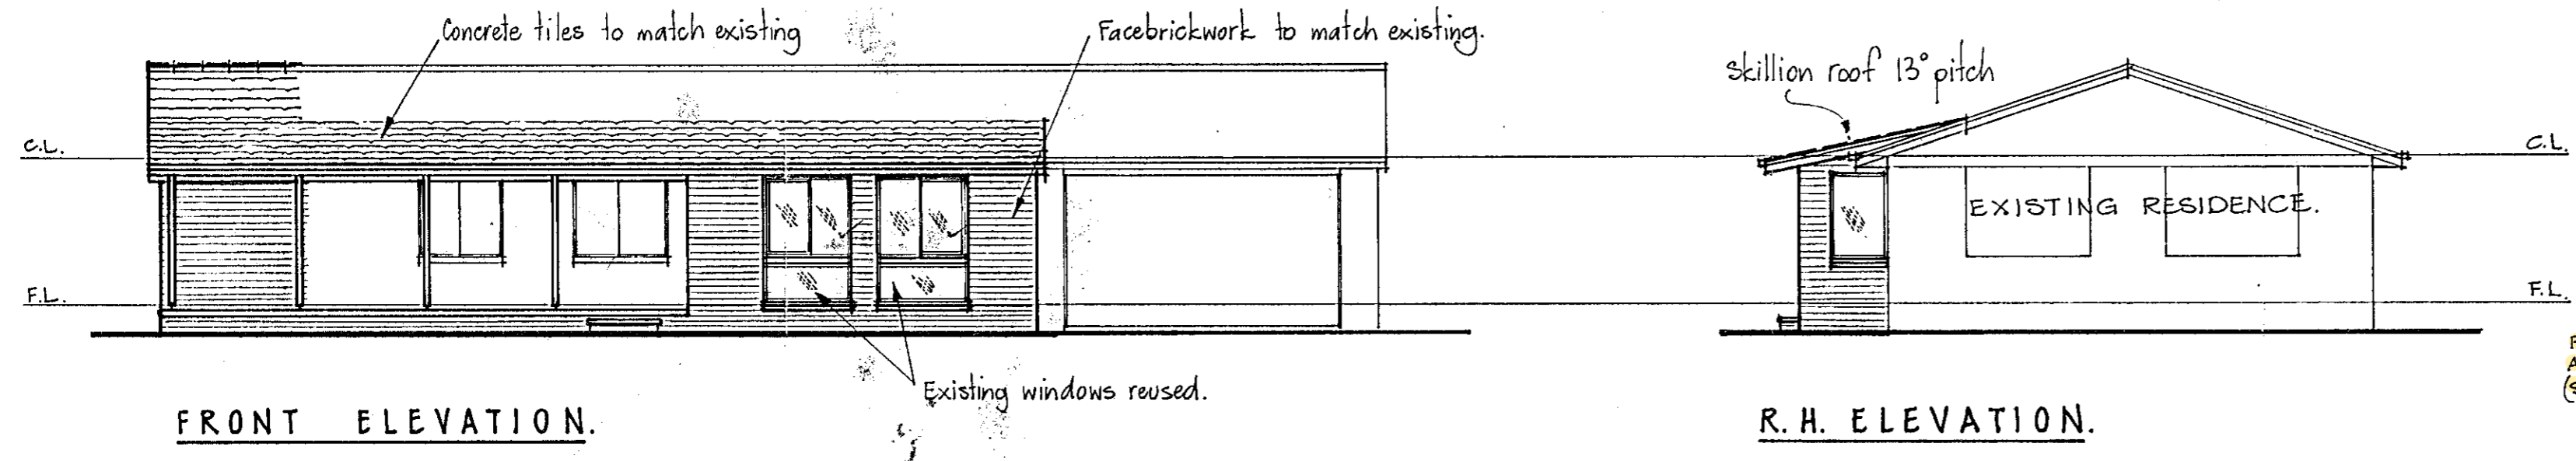
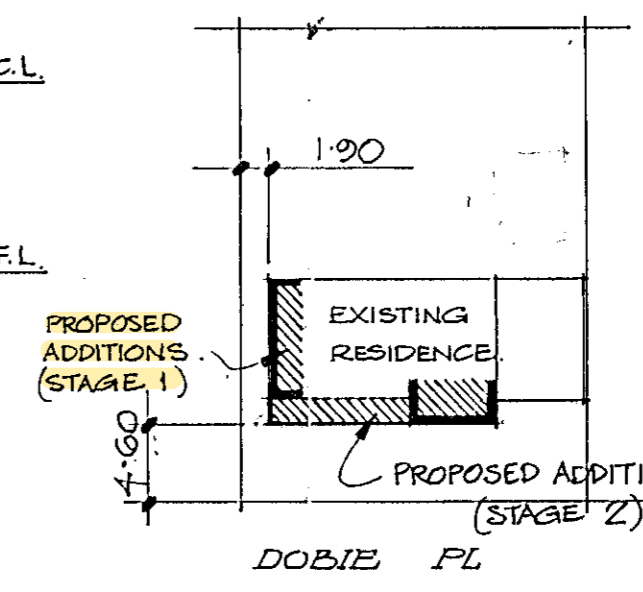
PROPOSED ALTERATIONS & ADDITIONS TO RESIDENCE • BLOCK 15 • SECTION 102 •
 MACGREGOR • A.C.T. • for • MR & MRS L. SHANNON.

CONSTRUCTION MUST COMPLY WITH A.S. 1684.—1975 'LIGHT TIMBER FRAMING CODE'

FOUNDATIONS TO BE TAKEN DOWN TO SOLID GROUND

NOTE: Wet area walls to be smooth and impervious to min 1800 above F.F.L.

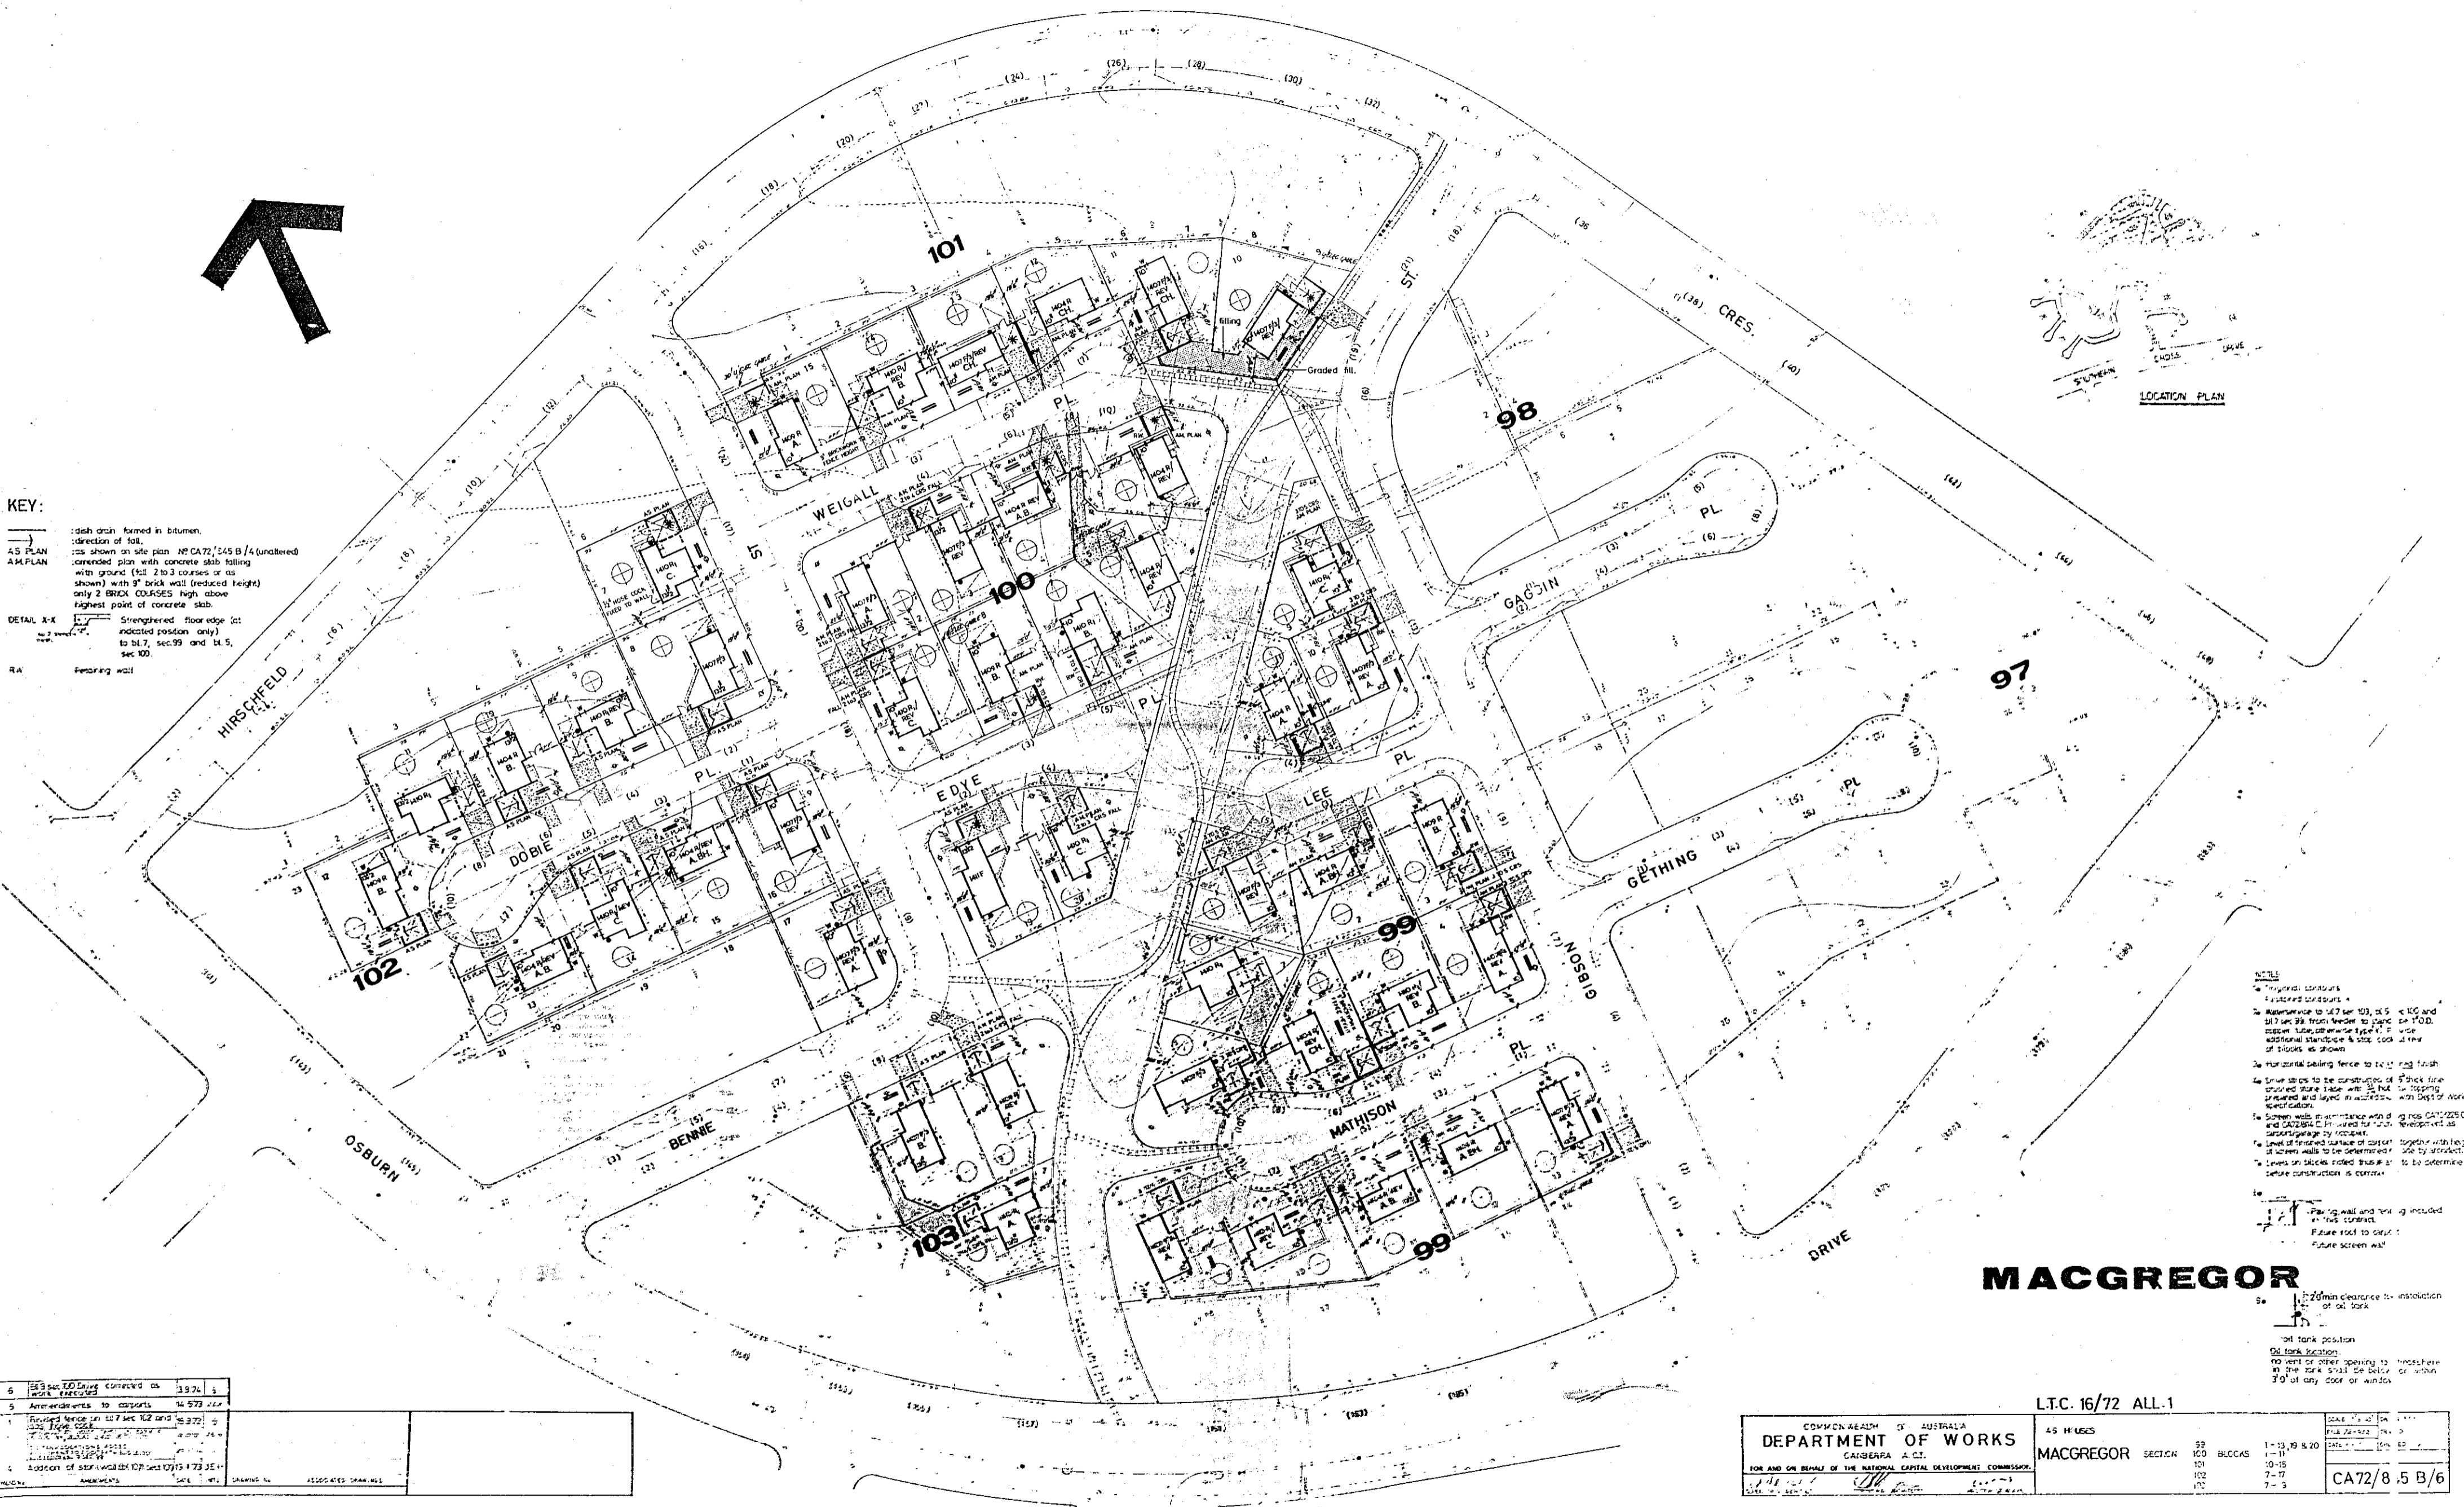
— Dish drain formed in bitumen.
 — direction of fall.
 AS PLAN — as shown on site plan No CA72/545 B/4 (unaltered)
 AM PLAN — amended plan with concrete slab falling with ground (fall 2 to 3 courses or as shown) with 9" brick wall (reduced height) only 2 BRICK COURSES high above highest point of concrete slab.

DETAIL X-X — Strengthened floor edge (at indicated position only) to bt.7, sec.99 and bt.5, sec.100.

RA — Retaining wall.

- Original contours
- Finished contours
- As per note to bt.7 sec.100, bt.5 sec.100 and bt.7 sec.99 from feeder to stand on F.O.D. masonry tubular structure type 11.5 wide additional standards & base coat drive of blocks as shown
- Horizontal piling fence to be 100 mm flush
- Drawings to be constructed of 50 mm fine grained stone base with 50 mm top layer prepared and laid in accordance with Dept of Works specification
- Screen walls in accordance with drawing CA72/545 B/4 and CA72/545 B/5 used for construction. Reservoir as constructed by contract
- Level of finished surface of carpark together with level of screen walls to be determined by contract
- Levels on blocks noted thus: to be determined before construction is commences

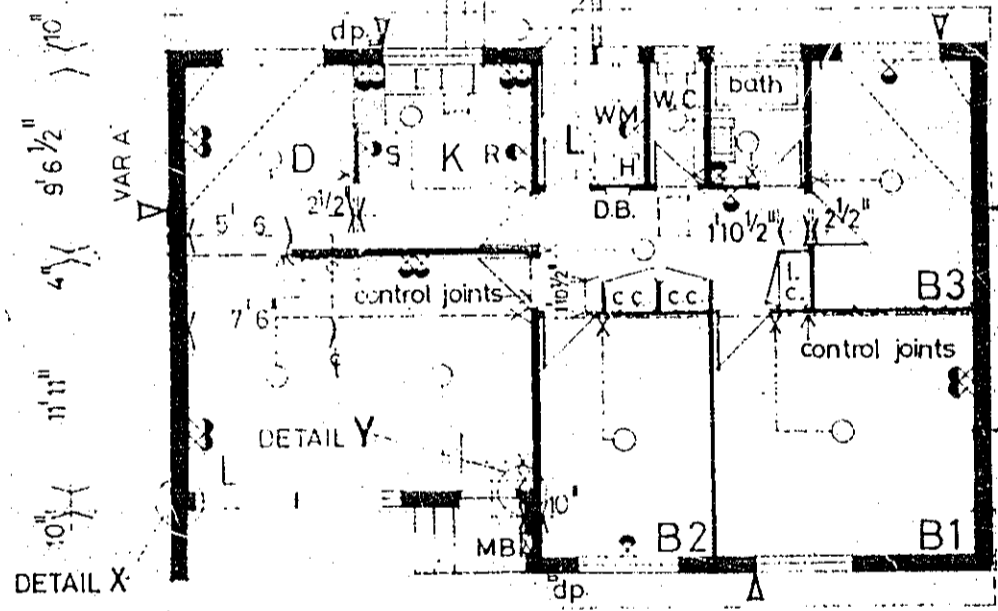
16'2 1/2" 6'3" 11'0" 12'3" 2'1/2" 10' 12'3" 2'1/2" 10'

NOTE:
Hot water heater to be mounted as high as possible on approved brackets
* In lieu of W44R(L)+TRANSOM+W24N single window unit can be used - to approval

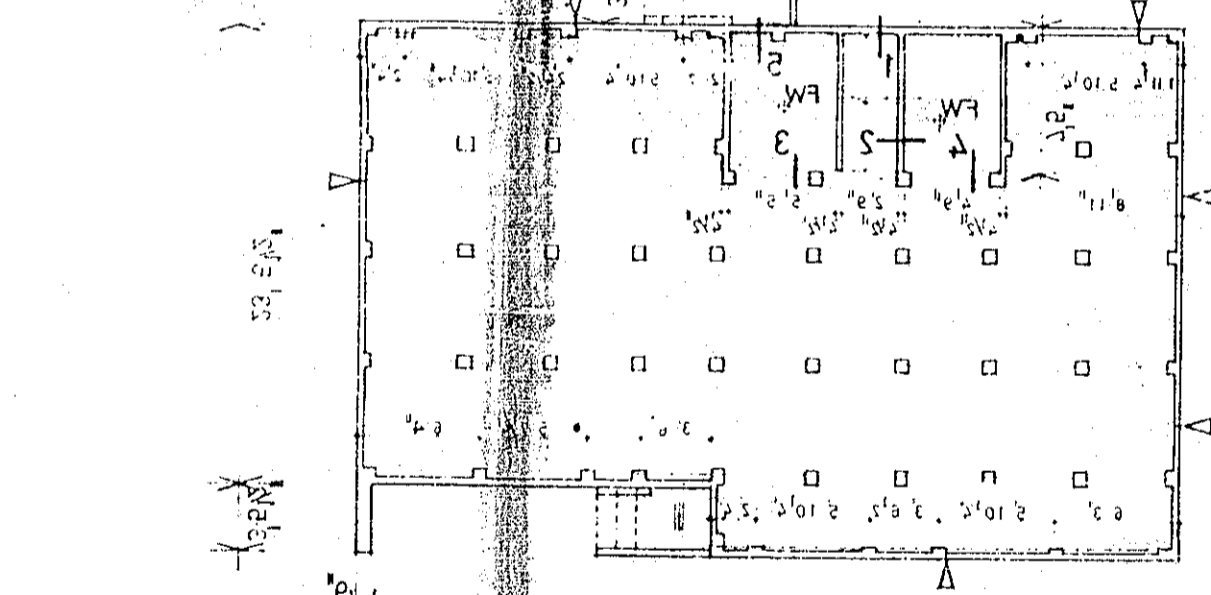
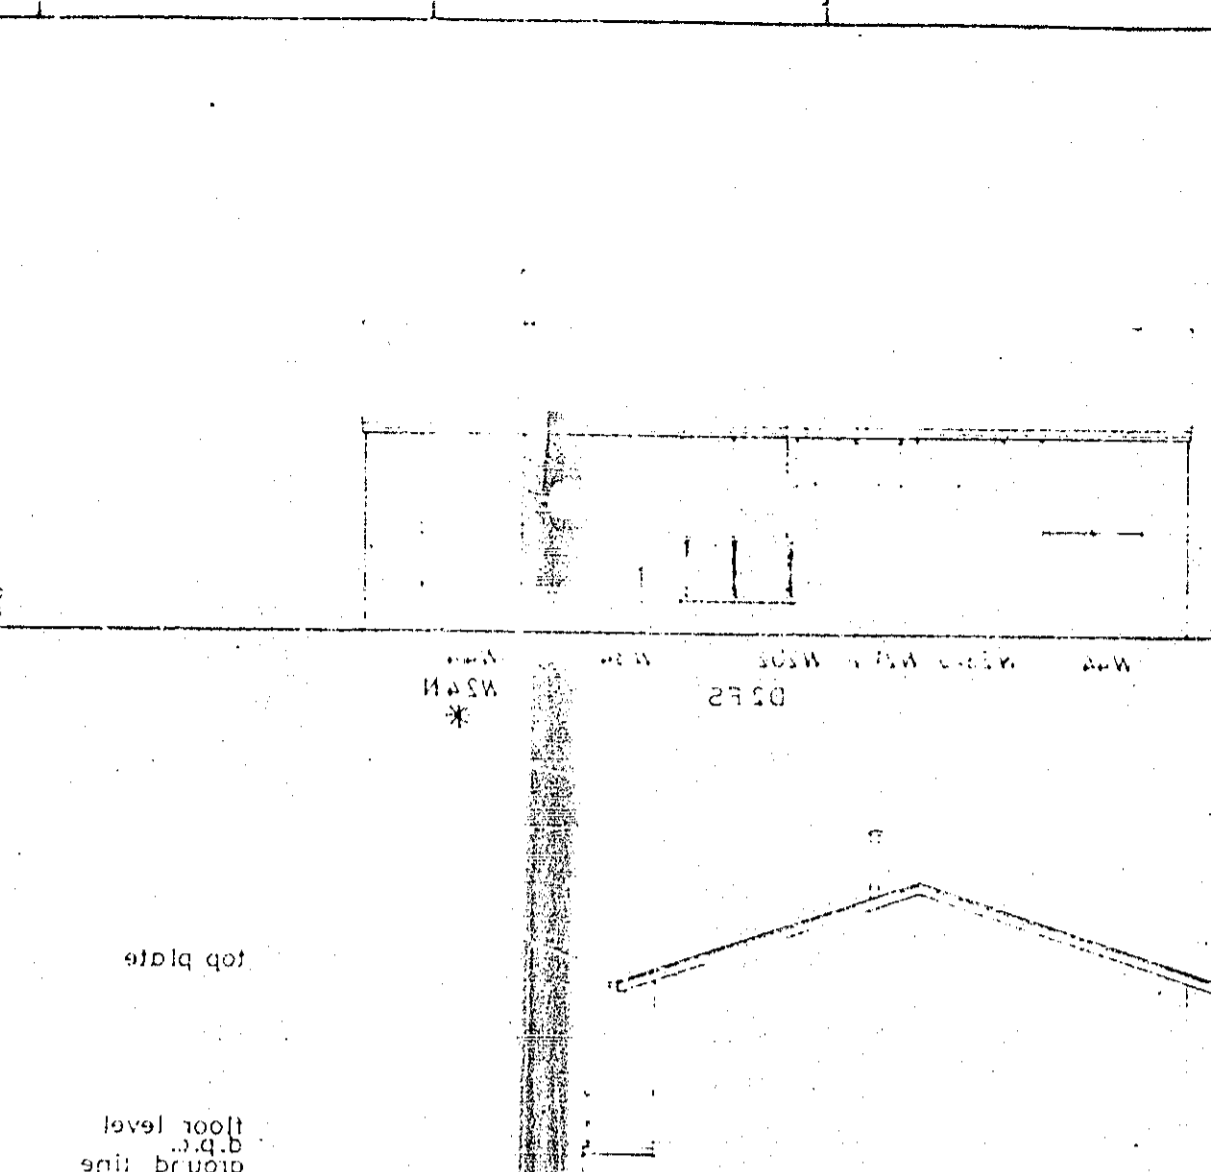
ELEVATIONS

VARIATIONS H
 VAR CH (L) W2AN
 VAR BH (R) W2A

exp. joint in conc. brick construction only

VAR B
W2A

NOTE:
 * In lieu of W4R(L) + TRANOM + W2AN single window unit can be used - to approval
 Hot water heater to be mounted as high as possible on approved brackets

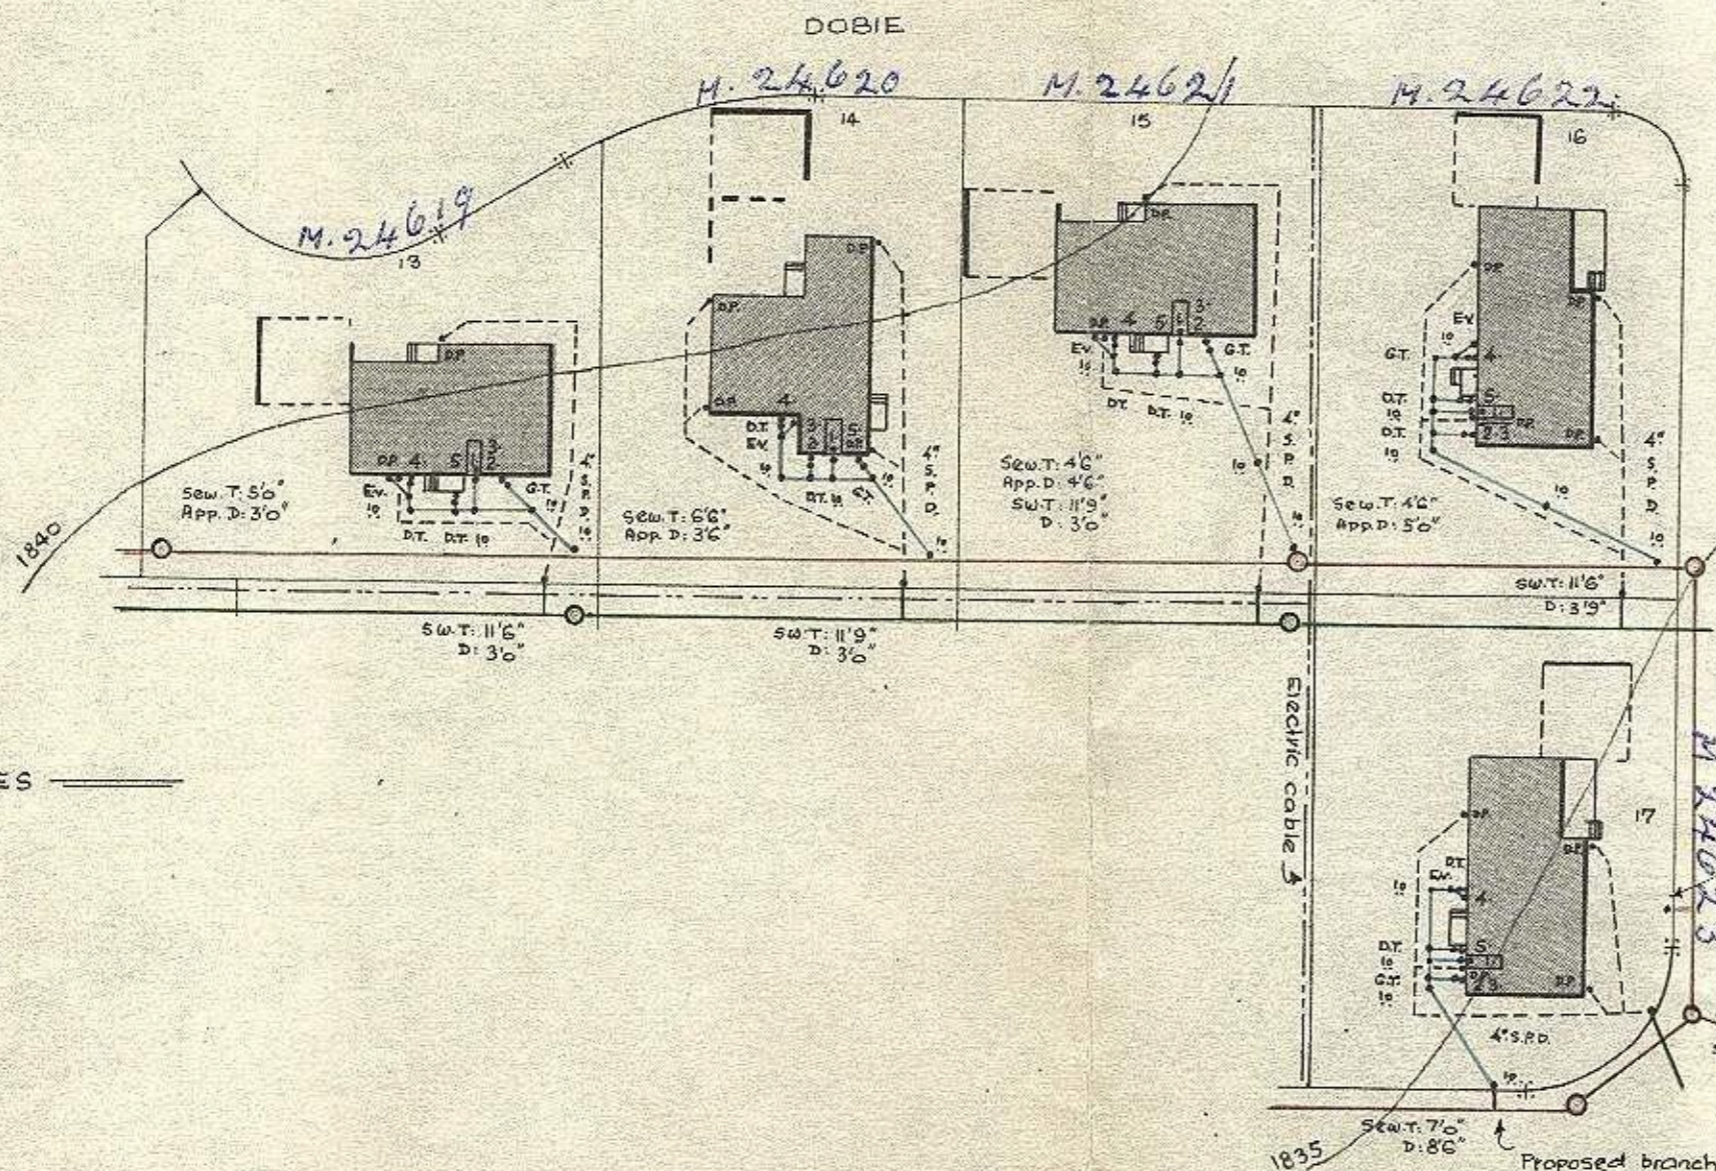
NOTE: All work to be executed in accordance with the Canberra Sewerage and Water Supply Regulations.

Scale—40 feet to 1 inch

Drains to be laid shown in blue lines
Stormwater drains to be laid shown in red lines
This plan to be read in conjunction with architectural plan and specification.
Sew. T.: Sewer Tie
S.W.T.: Stormwater Tie
D.P.: Down pipe
C.P.D.: Concrete pipe drain

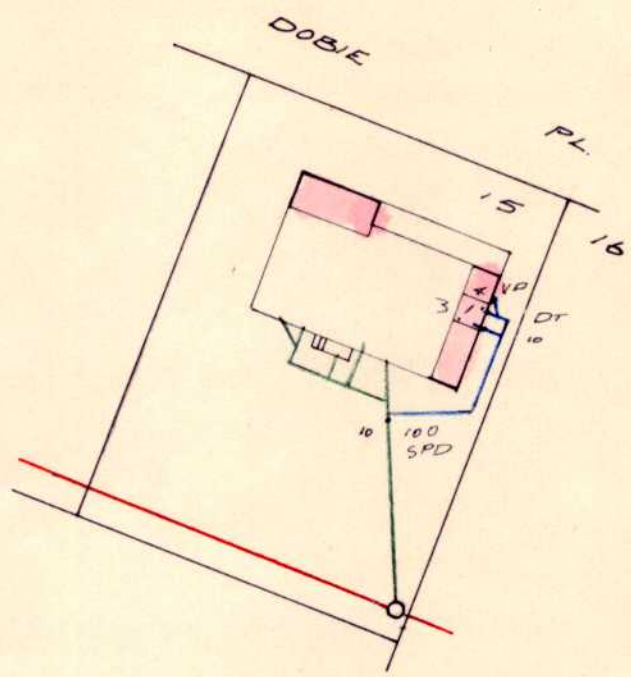
FIXTURES

NO. OFF
1. WATER CLOSET	(/)
2. BATH	()
3. BASIN	(/)
4. SHOWER	(/)
5. SINK	()
6. TROUGHS	()

NOTES: DRAINS TO BE LAID ARE SHOWN IN BLUE LINES. THIS PLAN TO BE READ IN CONJUNCTION WITH APPROVED ARCHITECTURAL PLANS AND SPECIFICATIONS.
 DRAINS TO BE DELETED SHOWN BY RED X. EXISTING DRAINS SHOWN IN GREEN LINES.
 POSITION OF BRANCH TO BE LOCATED BEFORE ANY WORK IS COMMENCED.
