Report

Building Report

CONCLUSION AND SUMMARY

Property Address: 31/1 Rouseabout Street, Lawson ACT 2617
Client: Cox
Inspection Date: Tuesday, May 19th 2026
Inspection carried out by: Joel Griggs

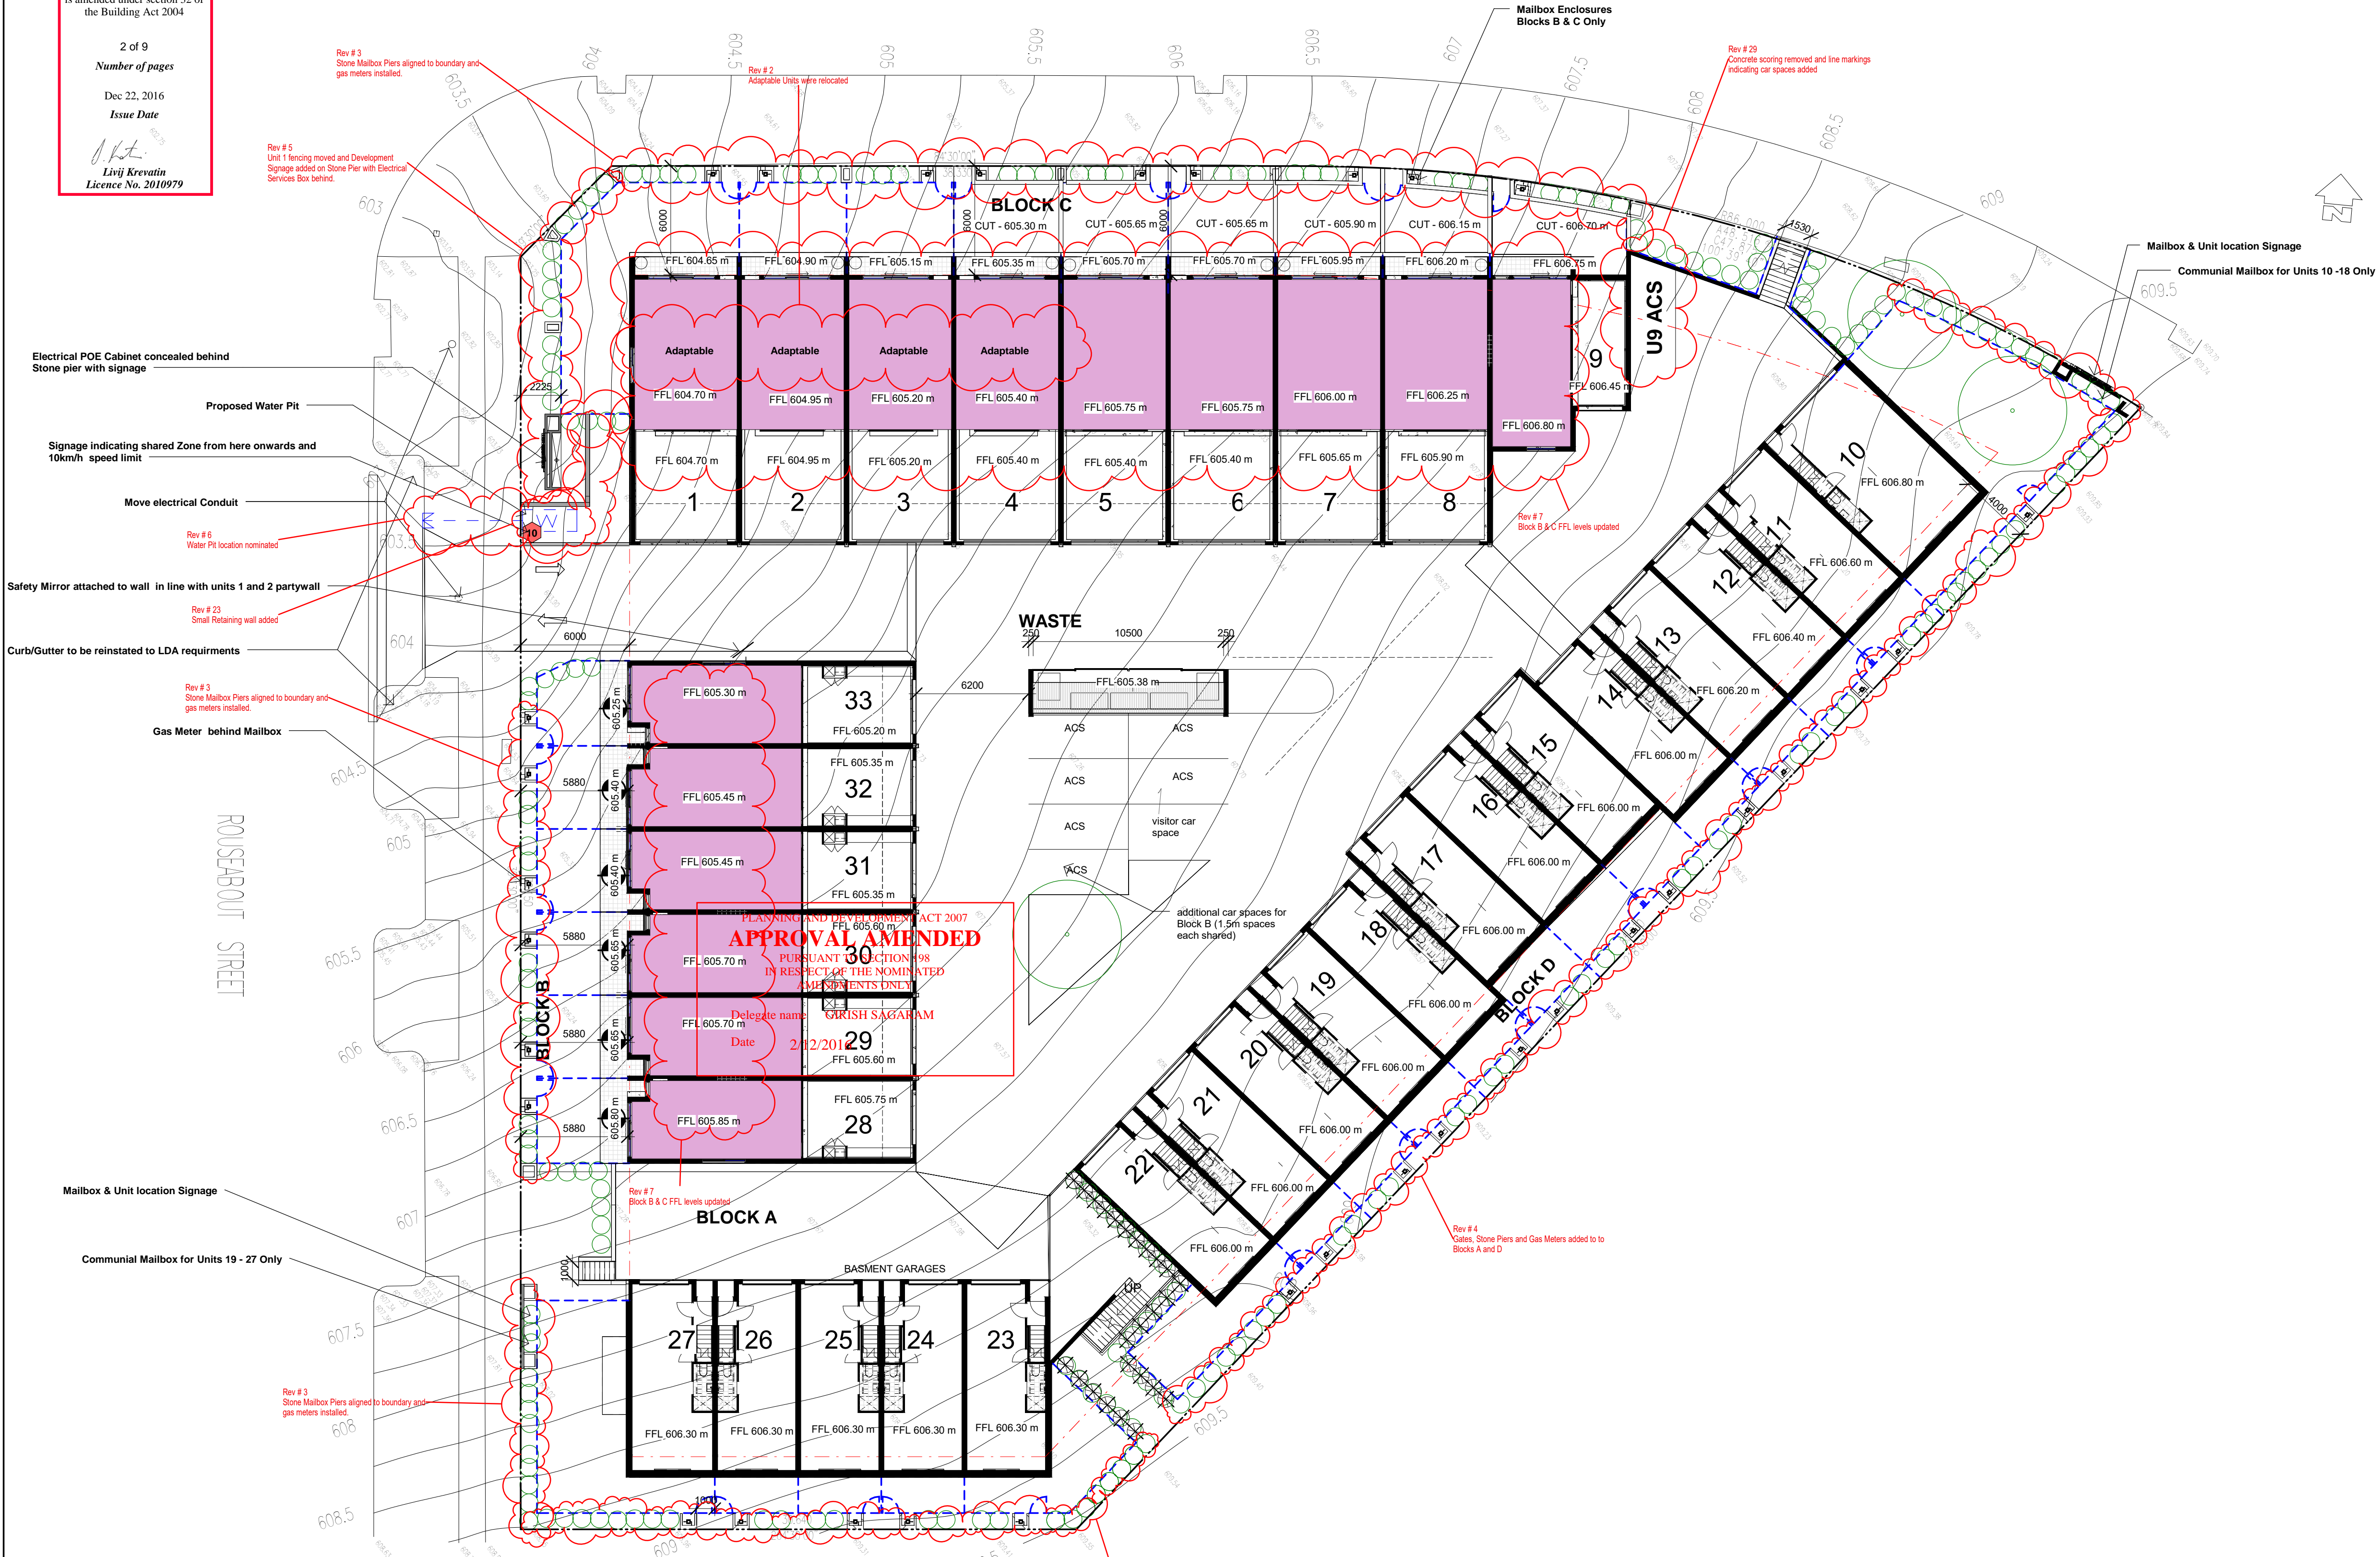
1 Site Plan
 1 : 200

NO	DATE	DESCRIPTION
29	15/11/16	Concrete scoring removed and line markings indicating car spaces added
23	21/11/16	Smart Retaining wall added
7	16/10/16	Block B & C FFL Levels updated
6	16/10/16	Water Pit location nominated
5	16/10/16	Unit 1 fencing moved and Development Signage added on Stone Pier with Electrical Services Box behind
4	16/10/16	Gates, Stone Piers and Gas Meters added to to Blocks A and D
3	16/10/16	Stone Mailbox Piers aligned to boundary and gas meters installed
2	16/10/16	Adaptable Units were relocated

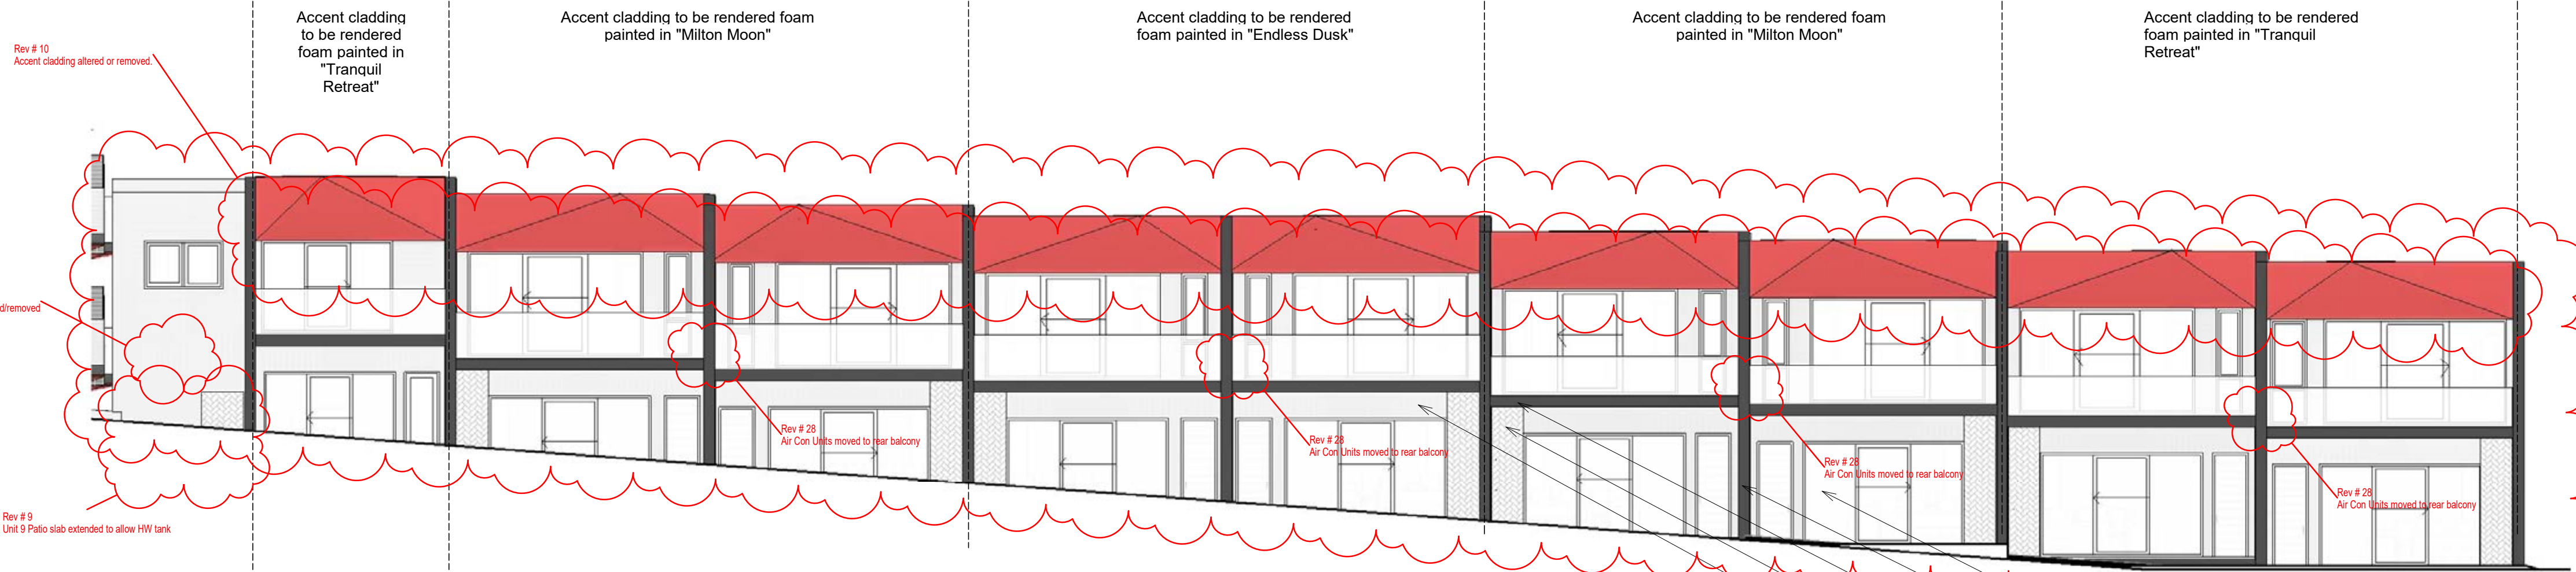
3 BLOCK C NORTH ELEVATION
1:100

- Window and Door frame pre finished in "Monument"
- Rendered brick painted in "Mt Eden"
- Balcony Edges and Balcony Soffits painted in "Mt Eden"
- Corten Feature Screening or equal
- Rendered Foam painted in "Natural White"

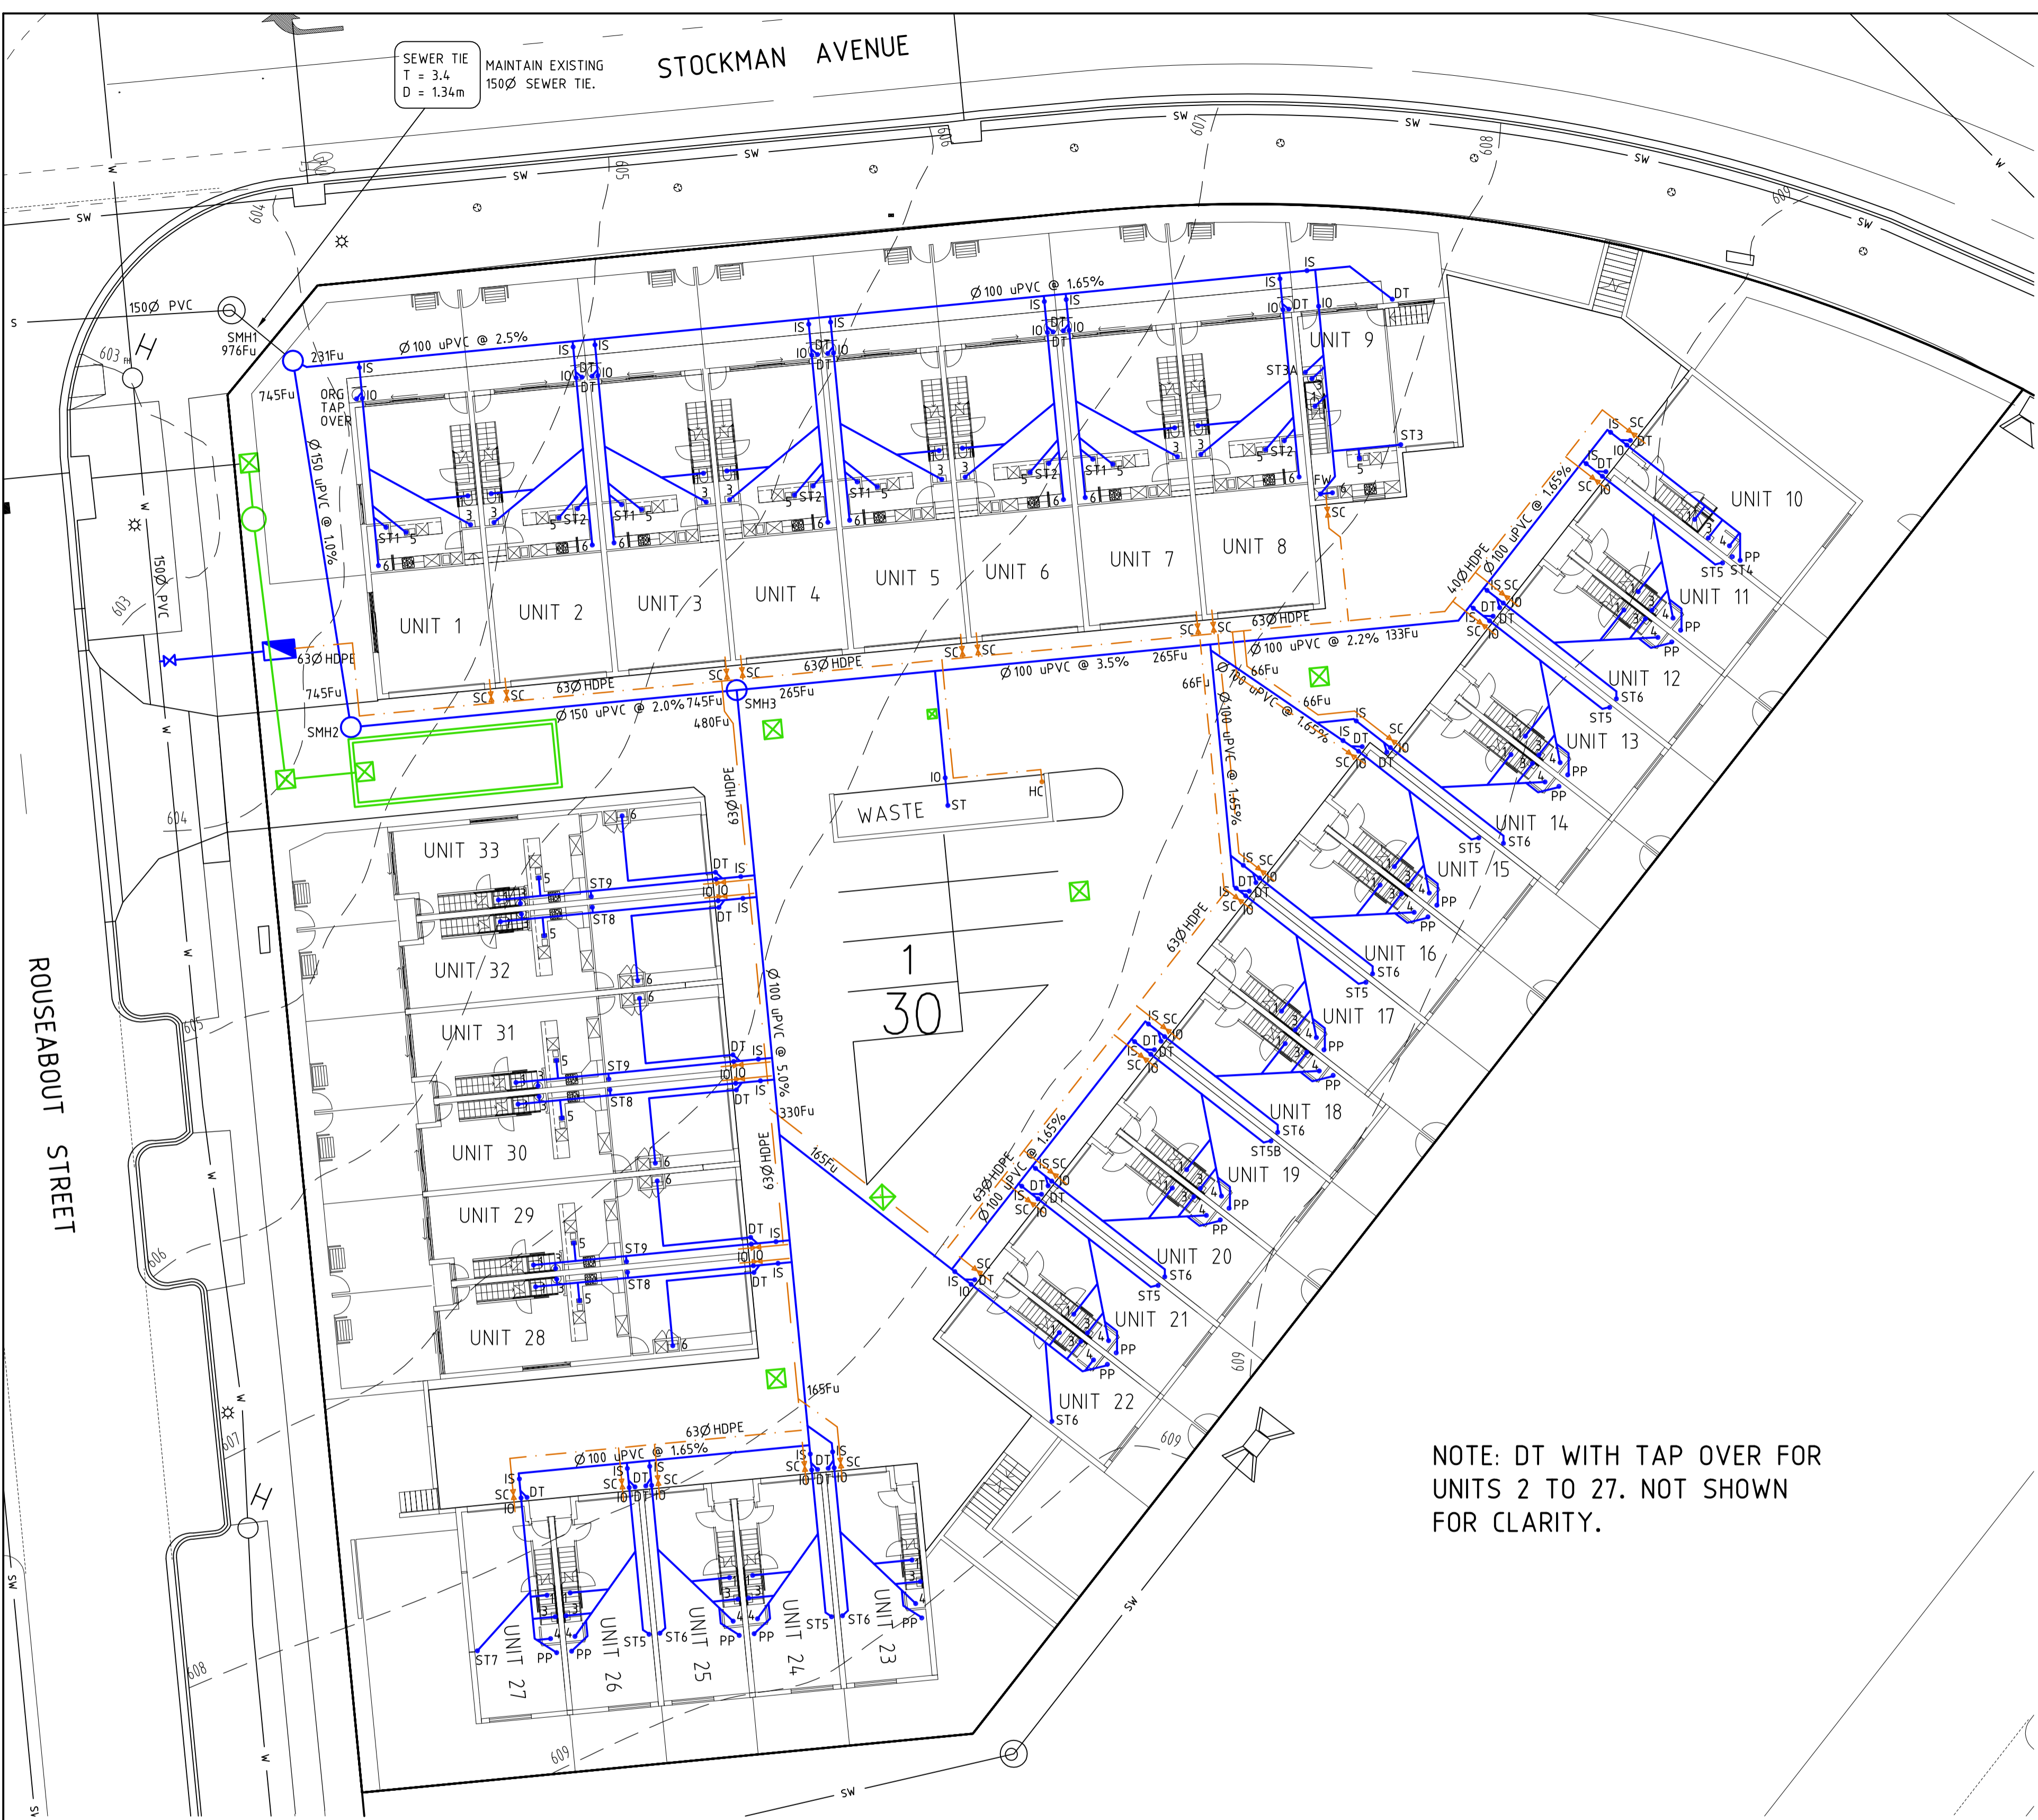
NOTE: DT WITH TAP OVER FOR UNITS 2 TO 27. NOT SHOWN FOR CLARITY.

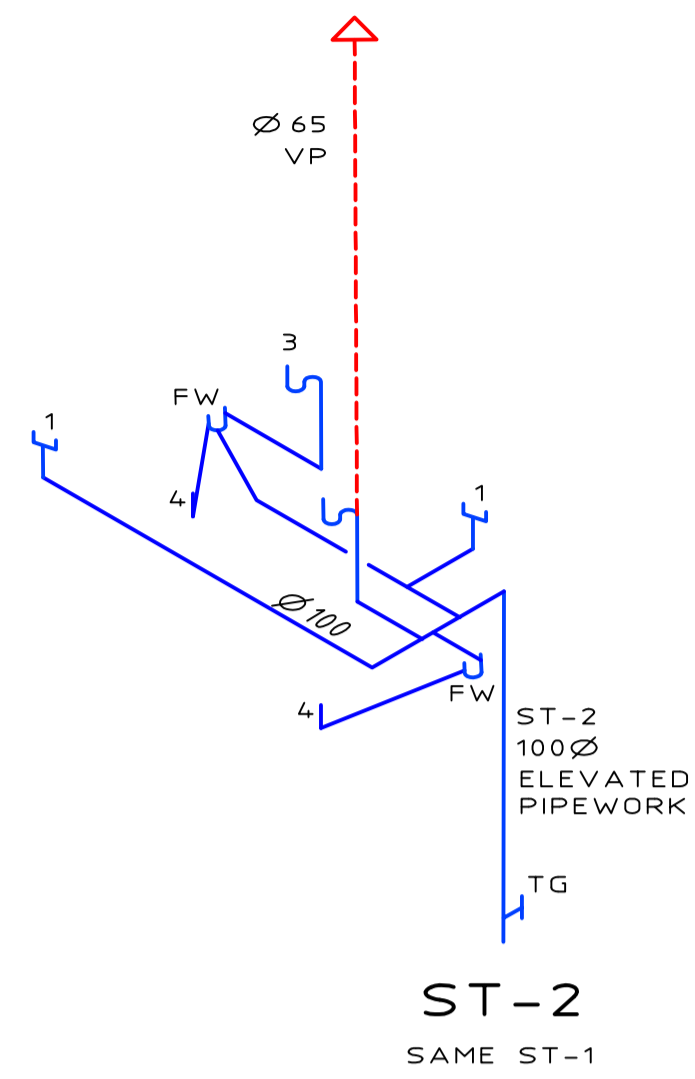
SCALE
1:200 @ A1
JOB NO.
15MANIX2
DRAWING NO.
H03

PLAN OF SANITARY DRAINAGE
DESIGNED TO AS3500

WORK AS EXECUTED
