Report

Building Report

Property Address: 34 May Maxwell Crescent, Gilmore ACT 2905
Client: Chandler
Inspection Date: Tuesday, June 2nd 2026
Inspection carried out by: Thomas Dryburgh and Duncan Clark

PROPOSED ADDITIONS TO
 RESIDENCE AT
 2 / 37 GILMORE

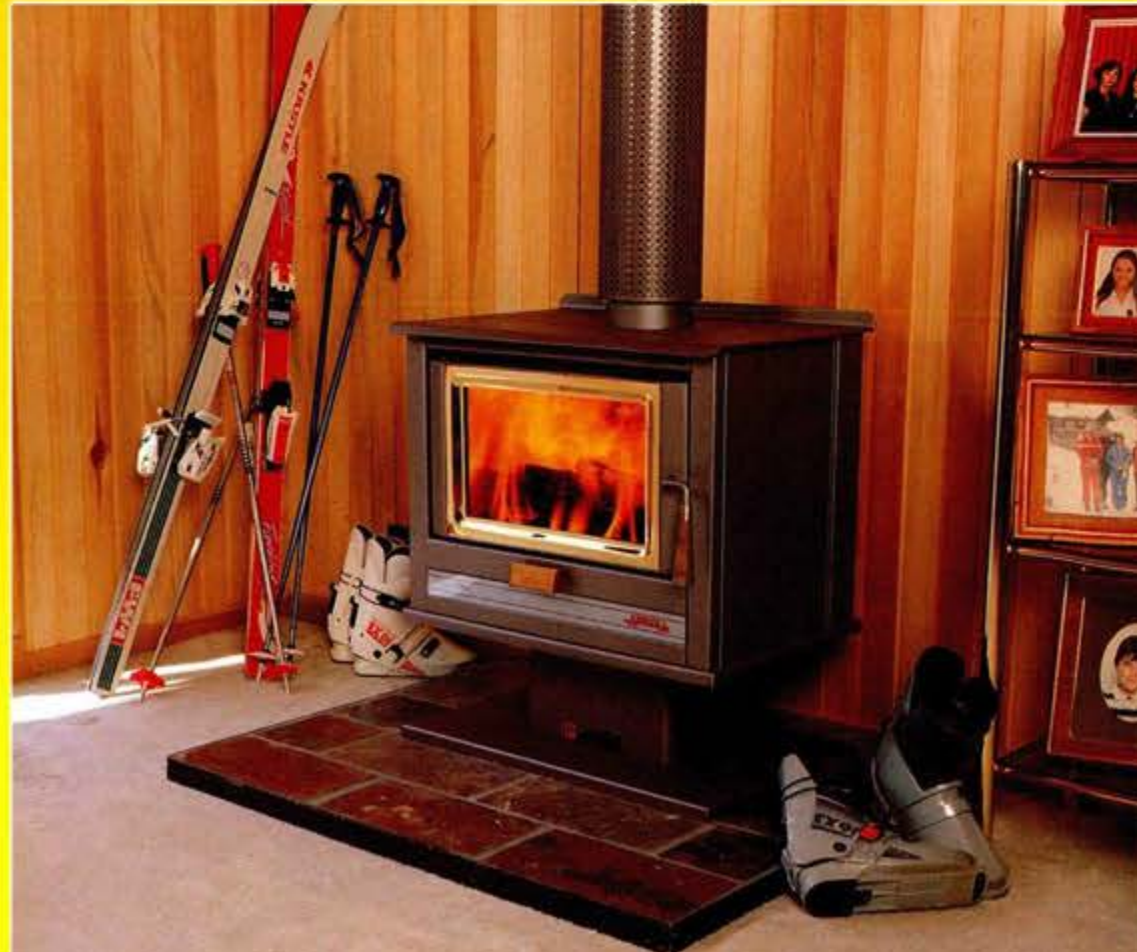
The 1700 is designed for the normal size home and with correct location and use the powerful inbuilt 2 speed fan will comfortably heat a number of rooms of your home. The firebox holds logs up to 18" long (460mm).

The 1700 photographed features optional gold door trim.

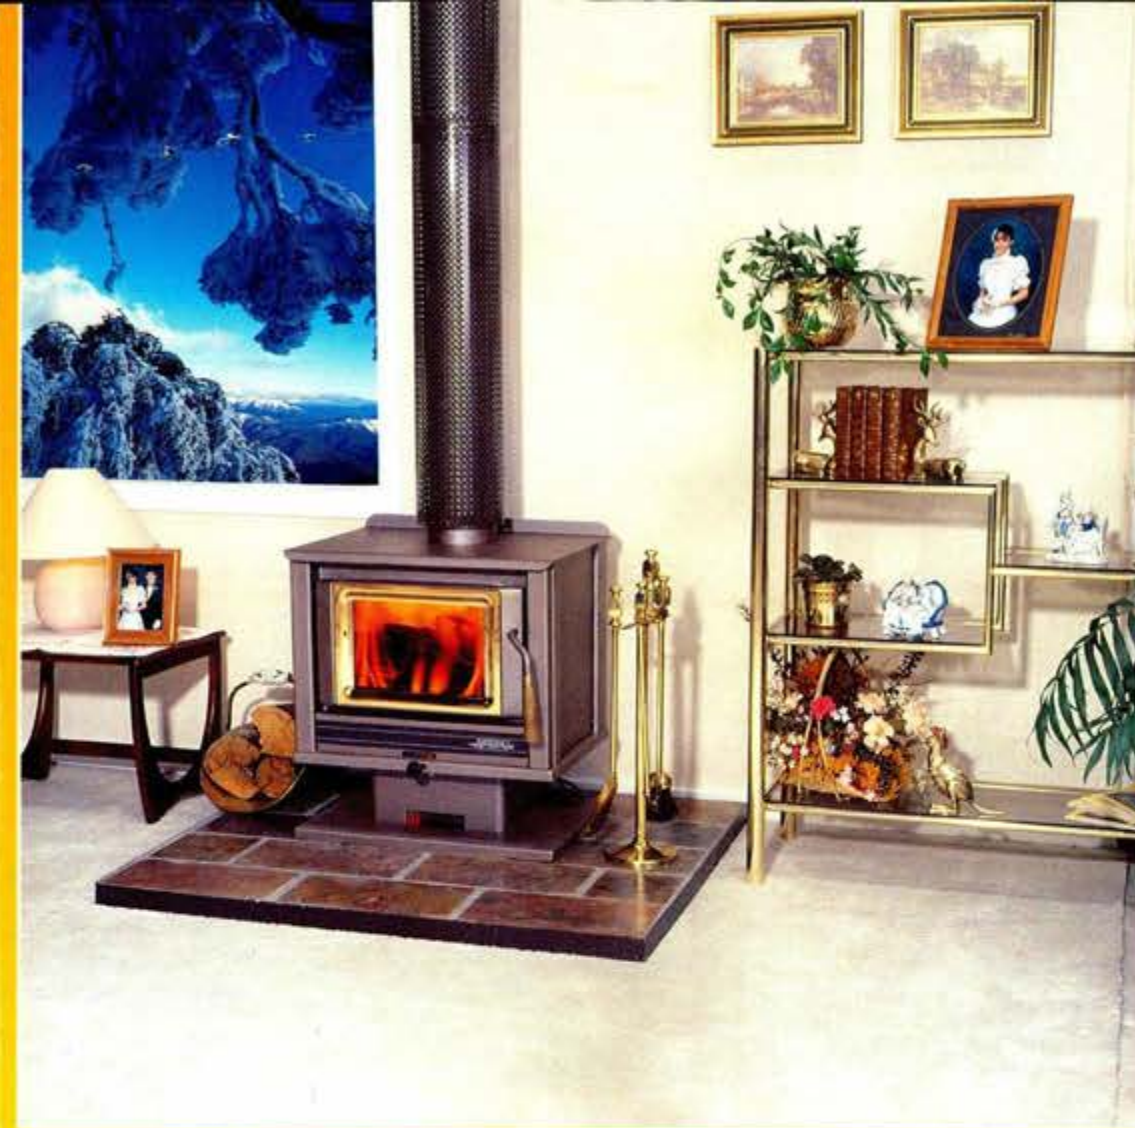
Model 1200

The 1200 has been a huge success for Arrow. Designed to heat the compact home, the 1200 heats up to 12 squares.
