Building Report

Property Address: 35 Dunphy Street, Wright ACT 2611
Client: D'avila Sa Brito & Cassar
Inspection Date: Wednesday, June 3rd 2026
Inspection carried out by: Duncan Clark

Drawn: T.A	BLOCK: 12 SECTION: 11	PROPOSED RESIDENCE	KARDNA KARDNA DESIGN & DRAFTING Unit 5, 160 LYSAGHT ST, MITCHELL, A.C.T 2911 Ph: (02) 6242 0416 Mob: 0408 800 559
Date: 03/02/12	SUBURB: WRIGHT		
Sheet No: 2 Of 4	FOR: CHARM PROJECTS

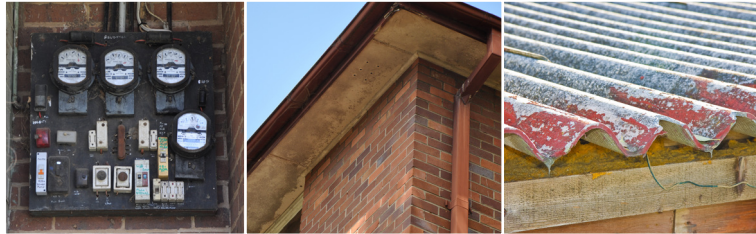
1. Exterior
roof sheeting, gutters, downpipes, ridge capping, eaves, cladding, electrical switchboards

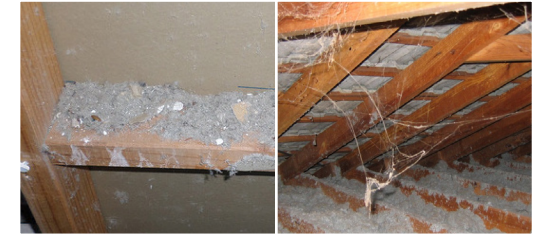
5. Building cavities
A small number of homes may still contain loose fill asbestos insulation in the roof cavity, wall cavities or sub-floor space

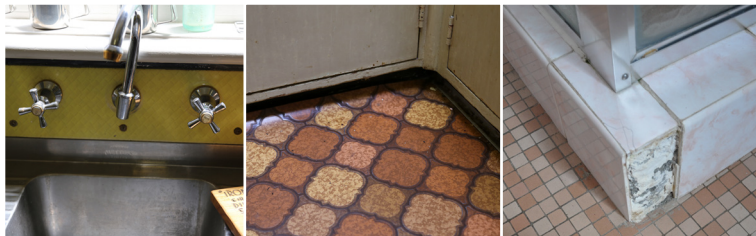
2. Wet areas - bathroom, laundry and kitchen
wall and ceiling panels, vinyl floor tiles, backing for wall tiles and splashbacks, hot water pipe insulation

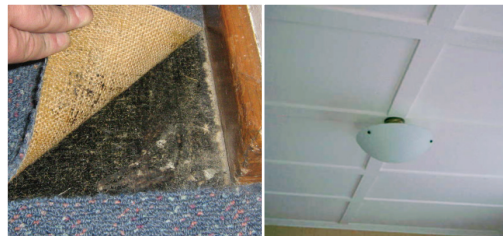
3. Internal areas
wall and ceiling panels, carpet underlay, textured panels, insulation in domestic heaters

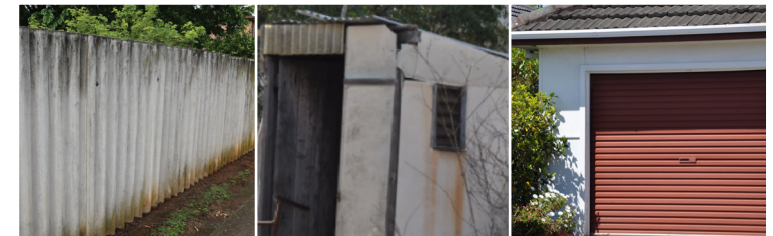
4. Backyard
fences, sheds, garages, carports, dog kennels, buried or dumped waste, letterboxes, swimming pools
