Report

Building Report

CONCLUSION AND SUMMARY

Property Address: 51 Steve Irwin Ave, Wright ACT 2611
Client: Vasu & Kiran
Inspection Date: Friday, May 29th 2026
Inspection carried out by: Michael Kane

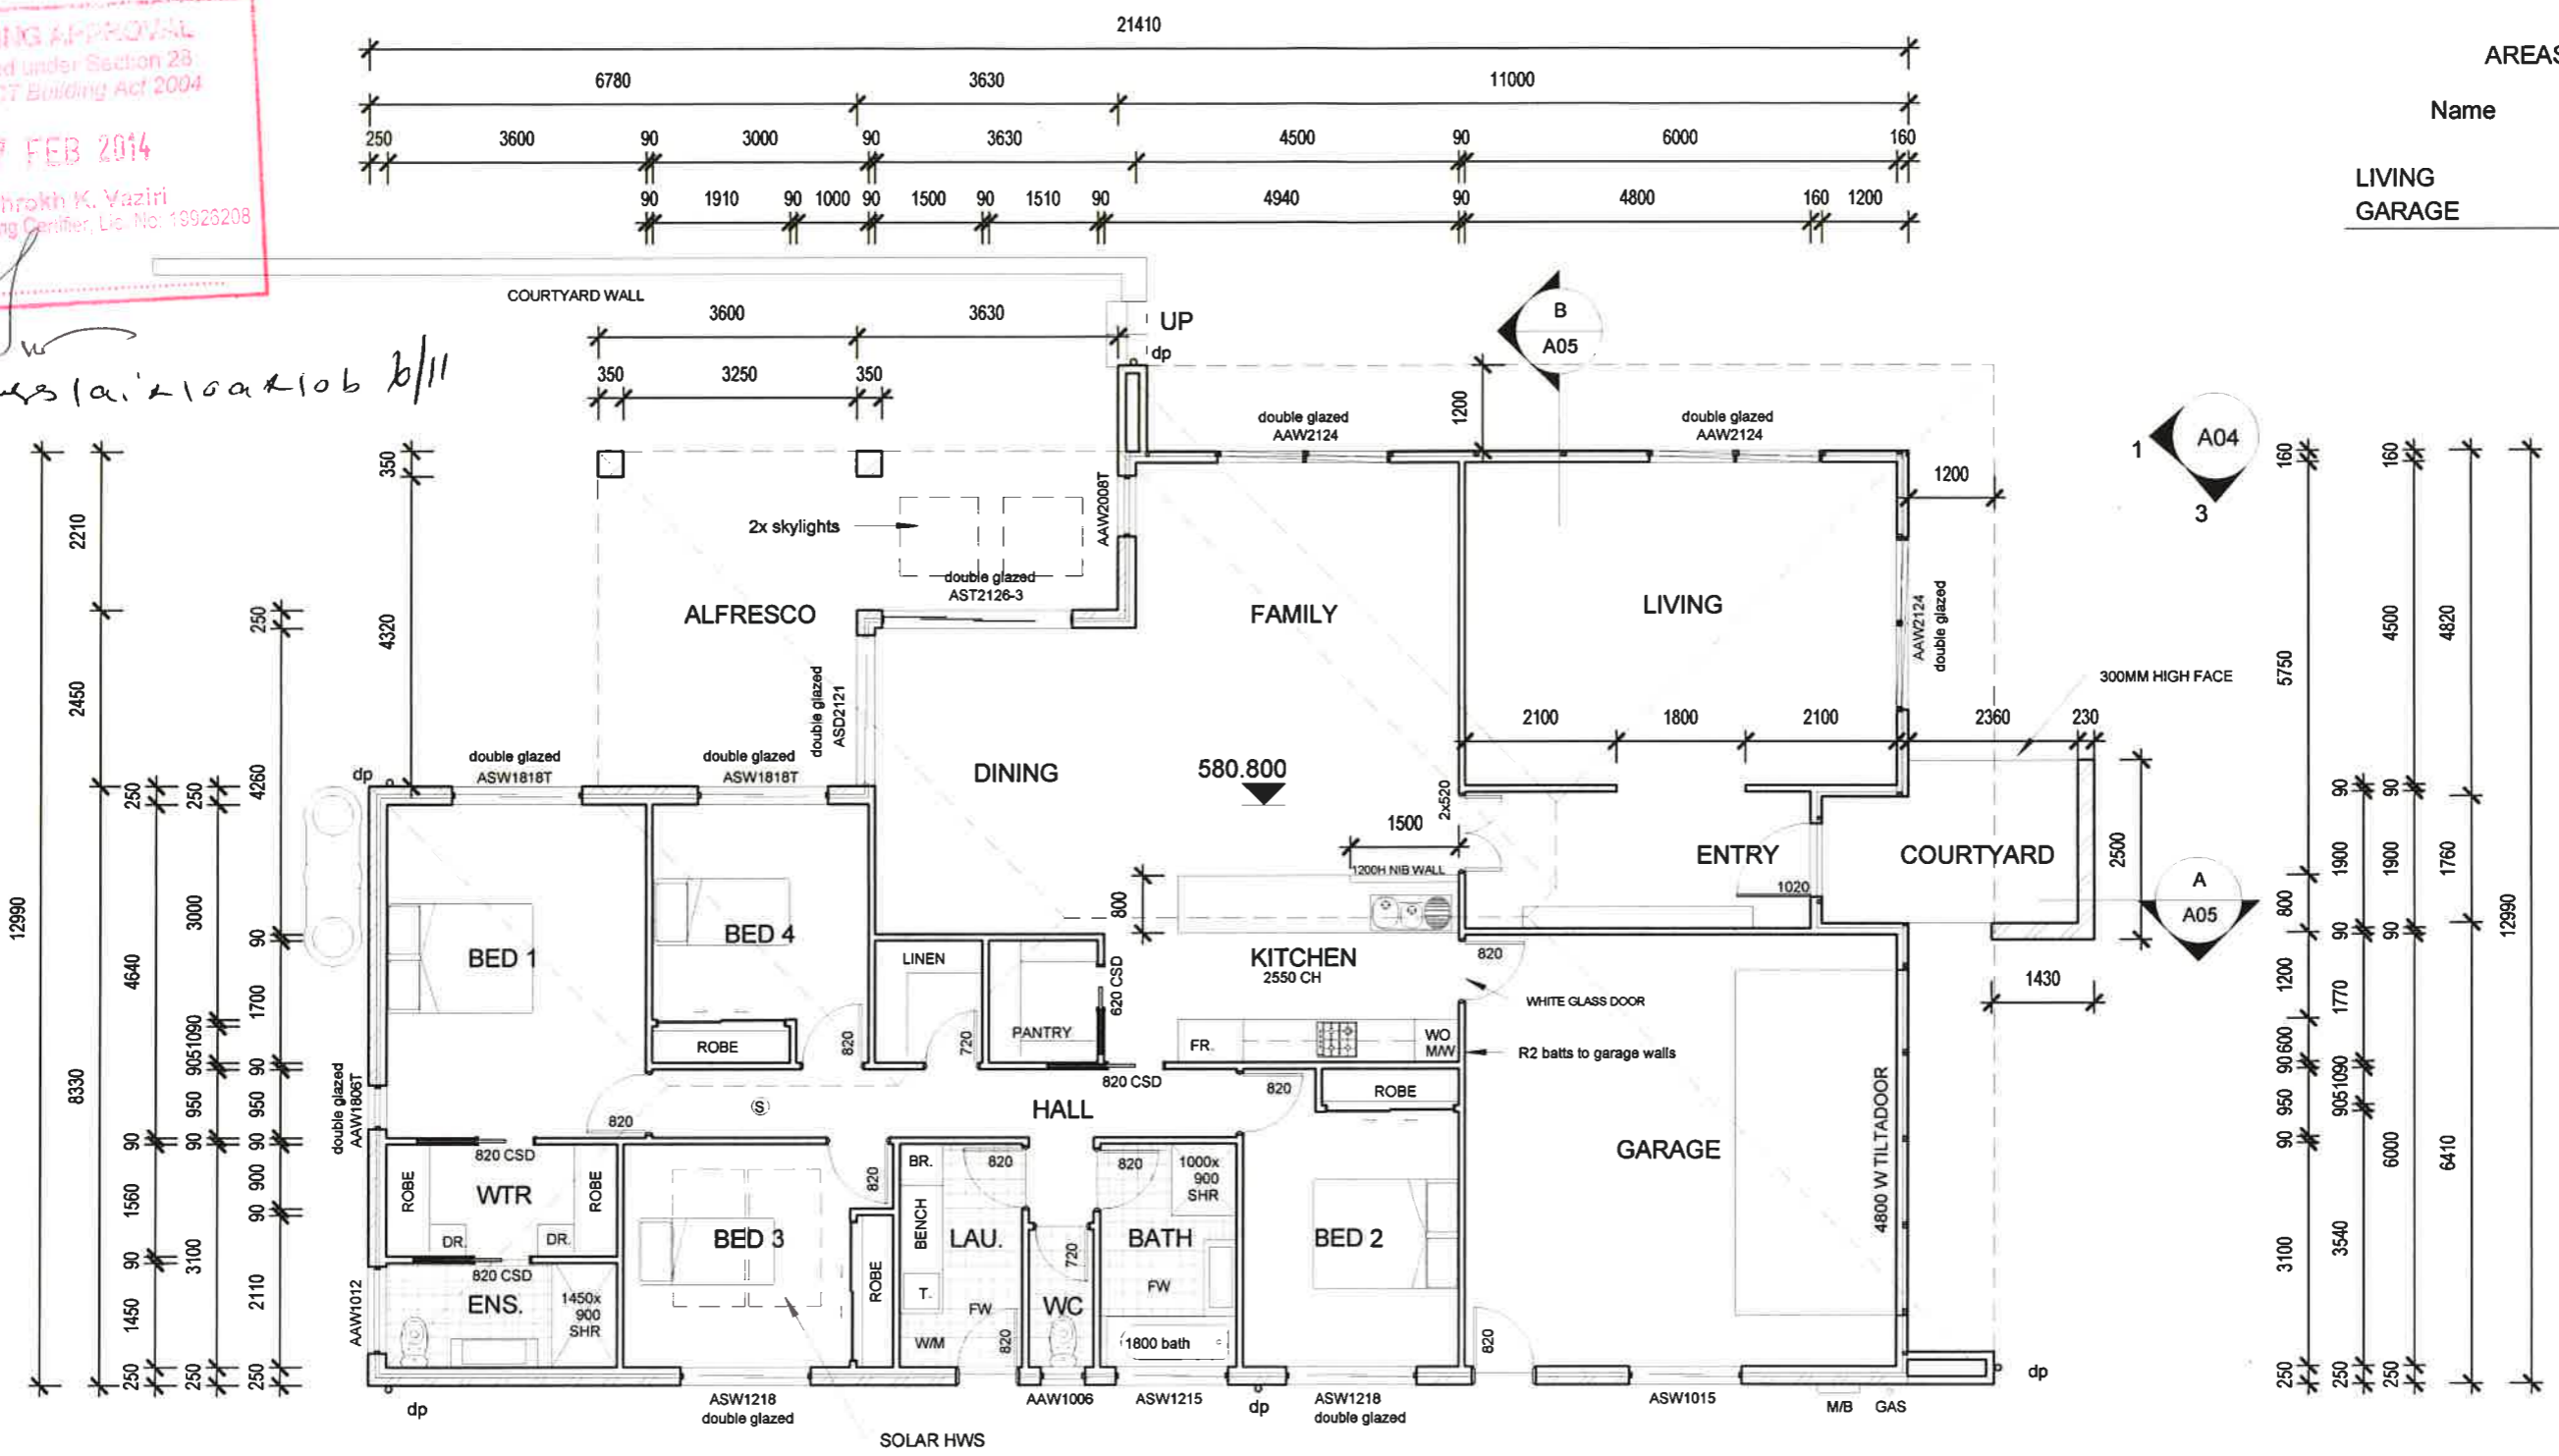
PROJECT TITLE DISPLAY HOME		TITLE FLOOR PLAN		SCALES 1 : 100	PROJECT No. S&H DISPLAY
BLOCK 10 SECTION 31 23 GORNALL STREET, WRIGHT		CLIENT SUTTON AND HORSLEY		DRAWN JLG	DRAWING No A02
ISSUE	DATE	AMENDMENT		CHECKED MT	APPROVALS
				DATE 9/12/13

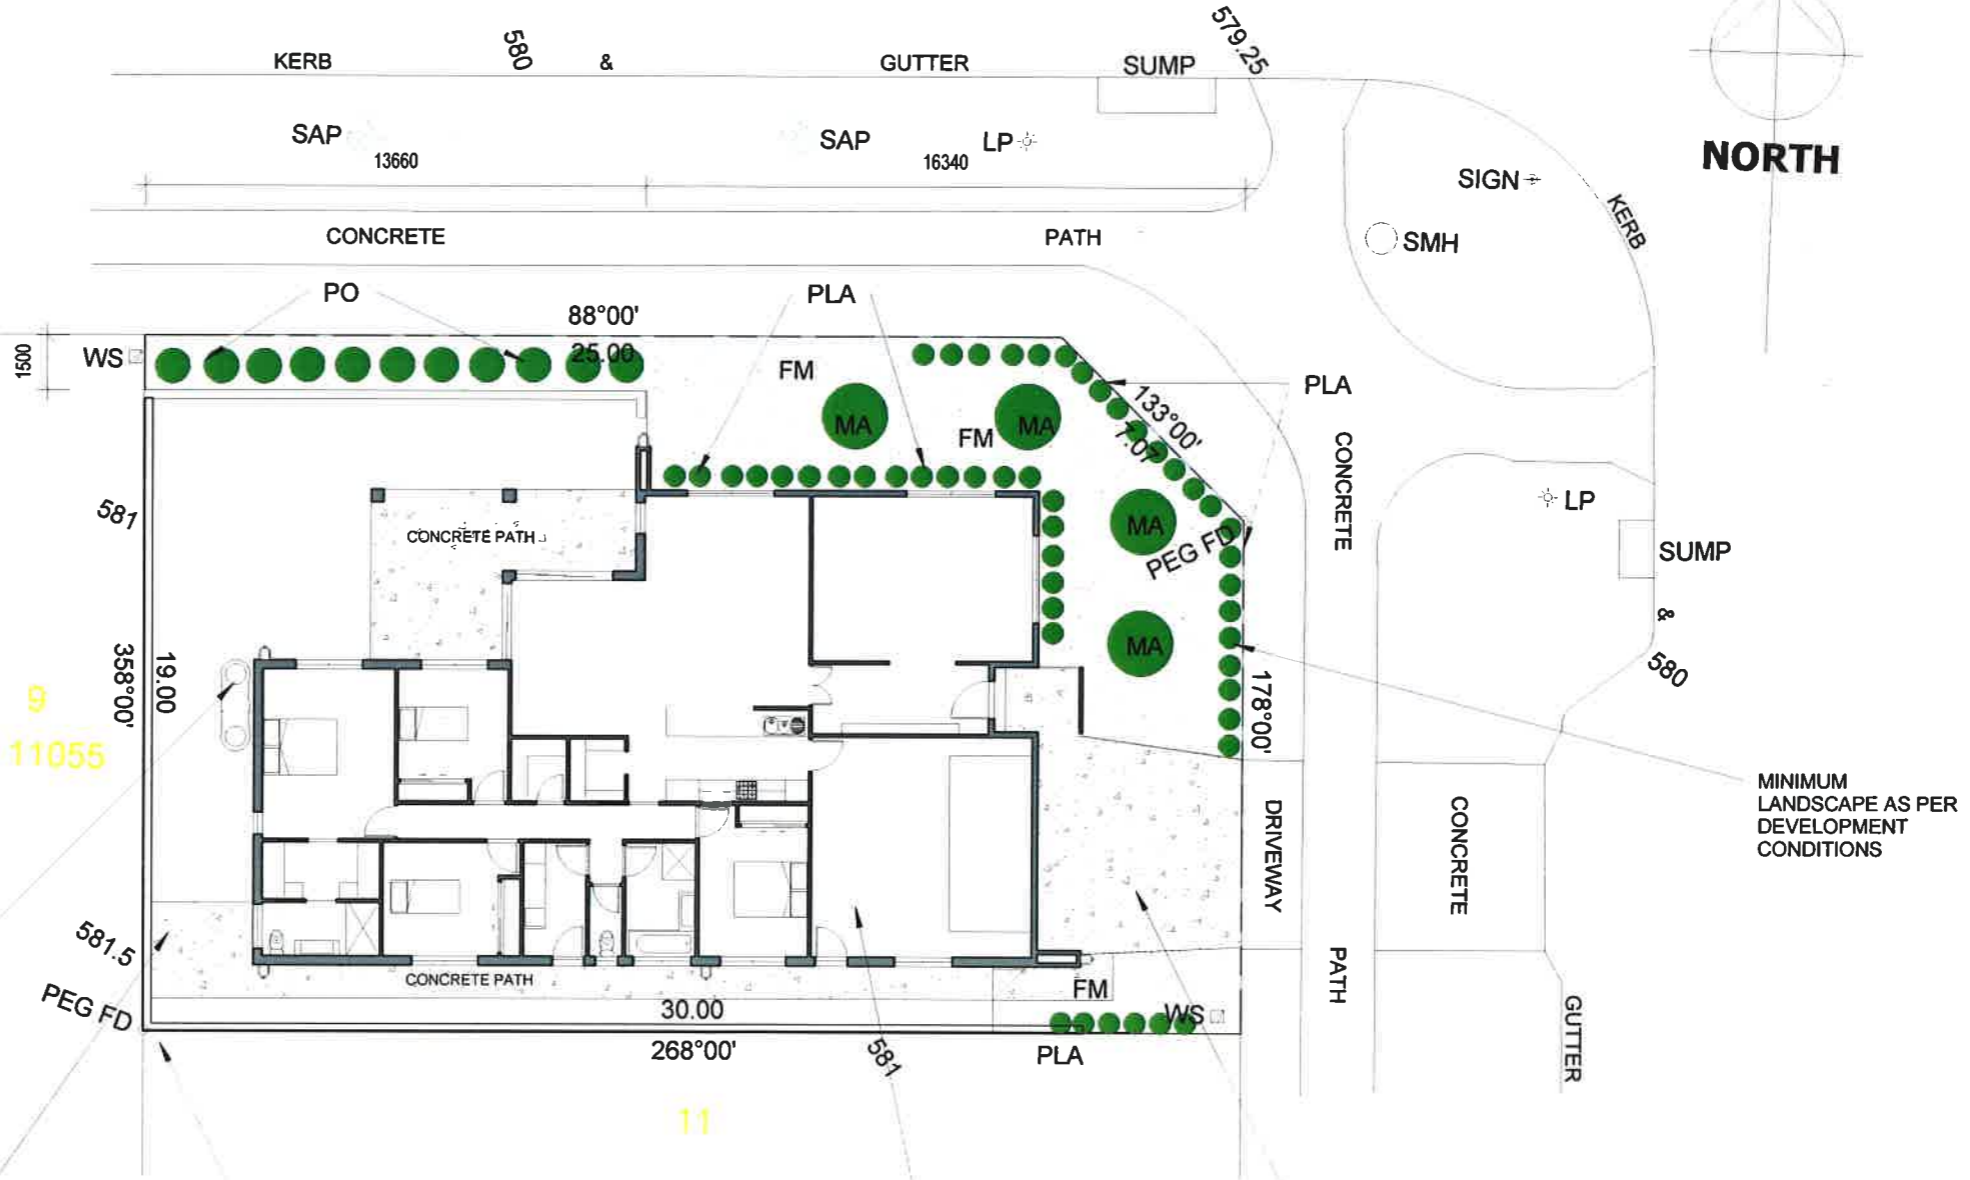
RETAINING WALL TO SIDE
BOUNDARY.
MAX 1M HIGH TO CORNER

FINISHED FLOOR LEVEL
580.80

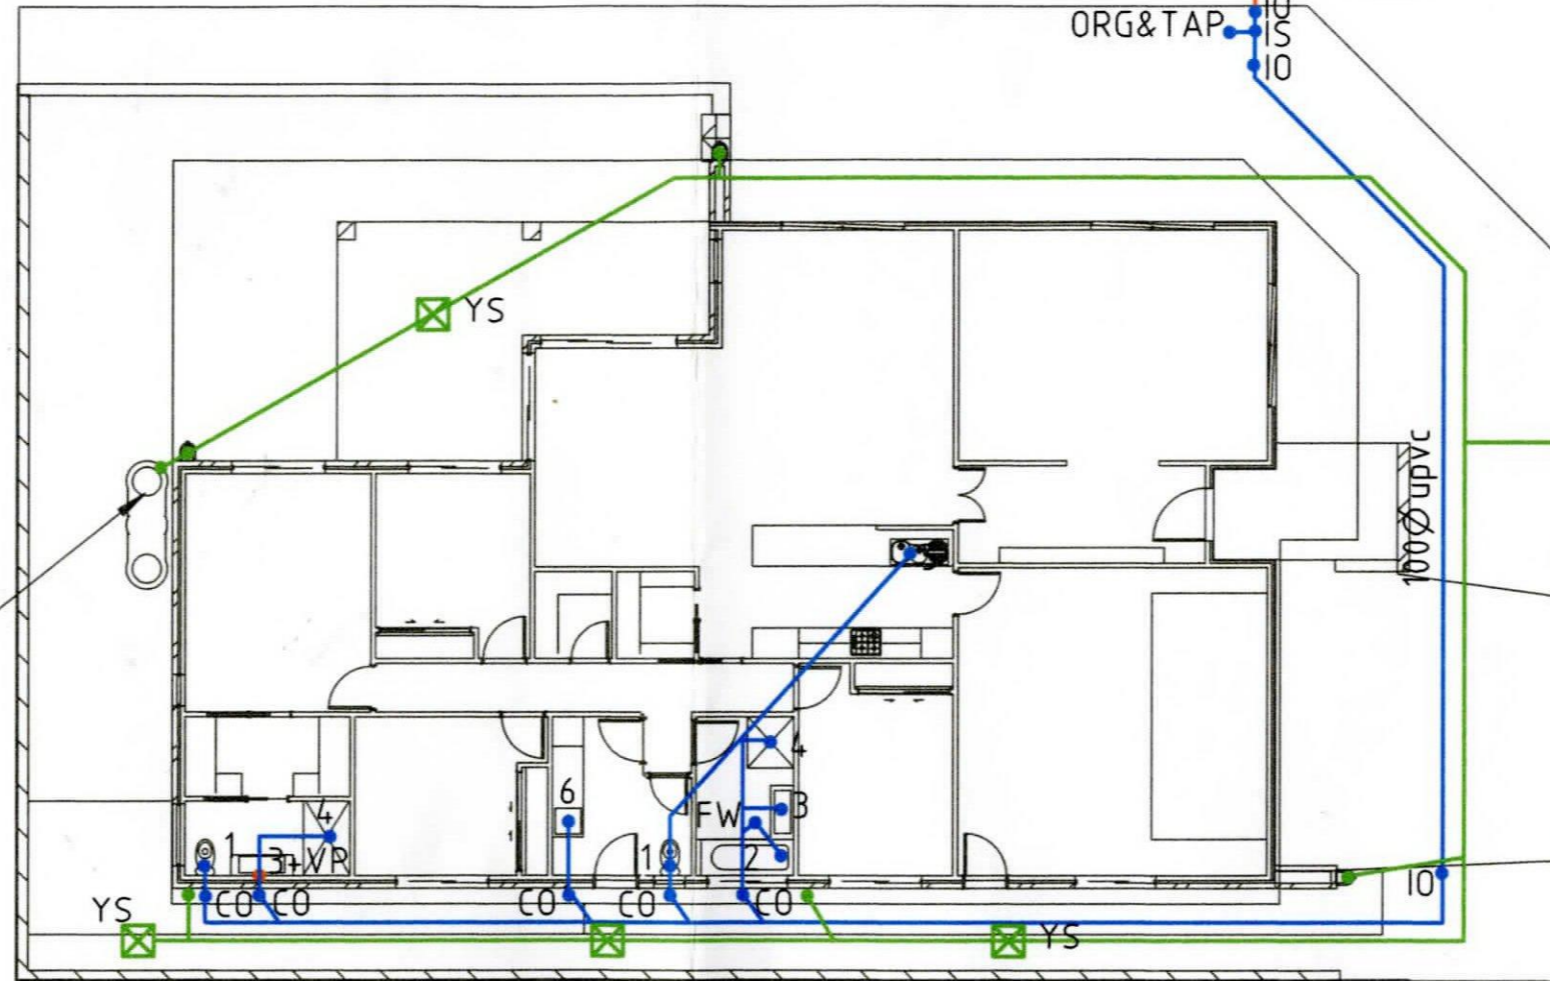
DRAINAGE PLAN
 NUMBER: 125978
 OWNER
 BLOCK 10 SECTION 31
 WRIGHT ACT
PLAN OF SANITARY DRAINAGE

DESIGNED TO AS3500
GENERAL NOTES
