# Report

# Building Report

## CONCLUSION AND SUMMARY

**CONVEYANCING BUILDING FILE INDEX**

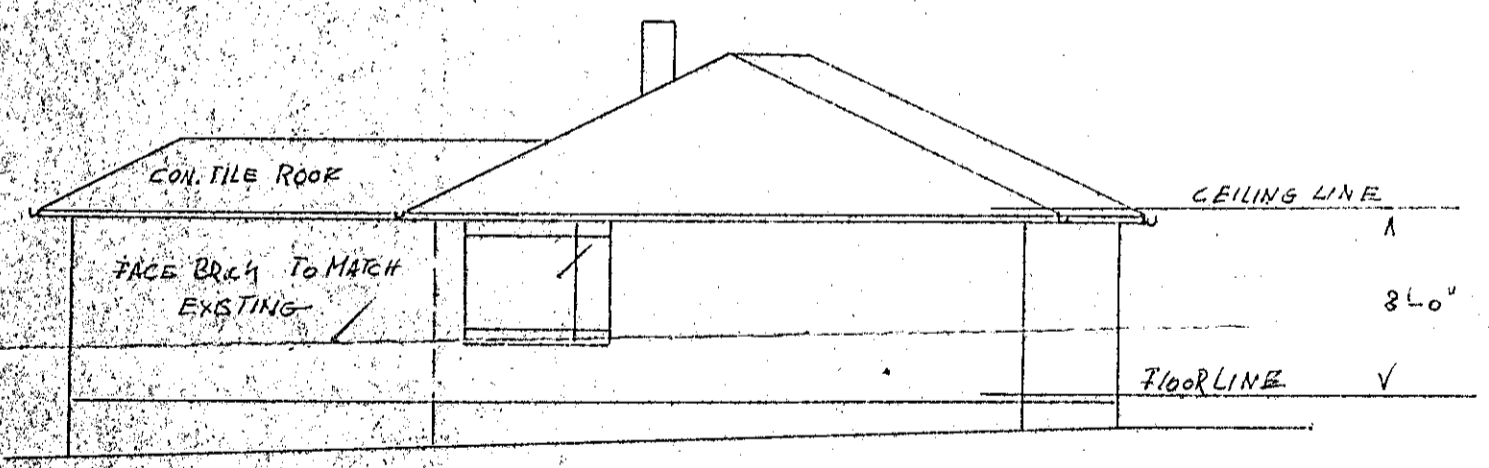
**DEPARTMENT OF WORKS**  
 DEPARTMENTAL RECORDS INDICATE THAT PORTION OF THE EXISTING SANITARY DRAINAGE SERVICE WILL BE UNDER THE PROPOSED STRUCTURE. AN APPROVED SANITARY DRAINAGE PLAN SHOWING WHAT ACTION IS TO BE TAKEN TO PROTECT OR RELOCATE DRAINS UNDER THE PROPOSED STRUCTURE, AND ANY OTHER ALTERATIONS OR ADDITIONS TO SEWER CONNECTIONS NECESSARY MUST BE OBTAINED AND PAID FOR BY THE WORK CONNECTED WITH THIS PROJECT.

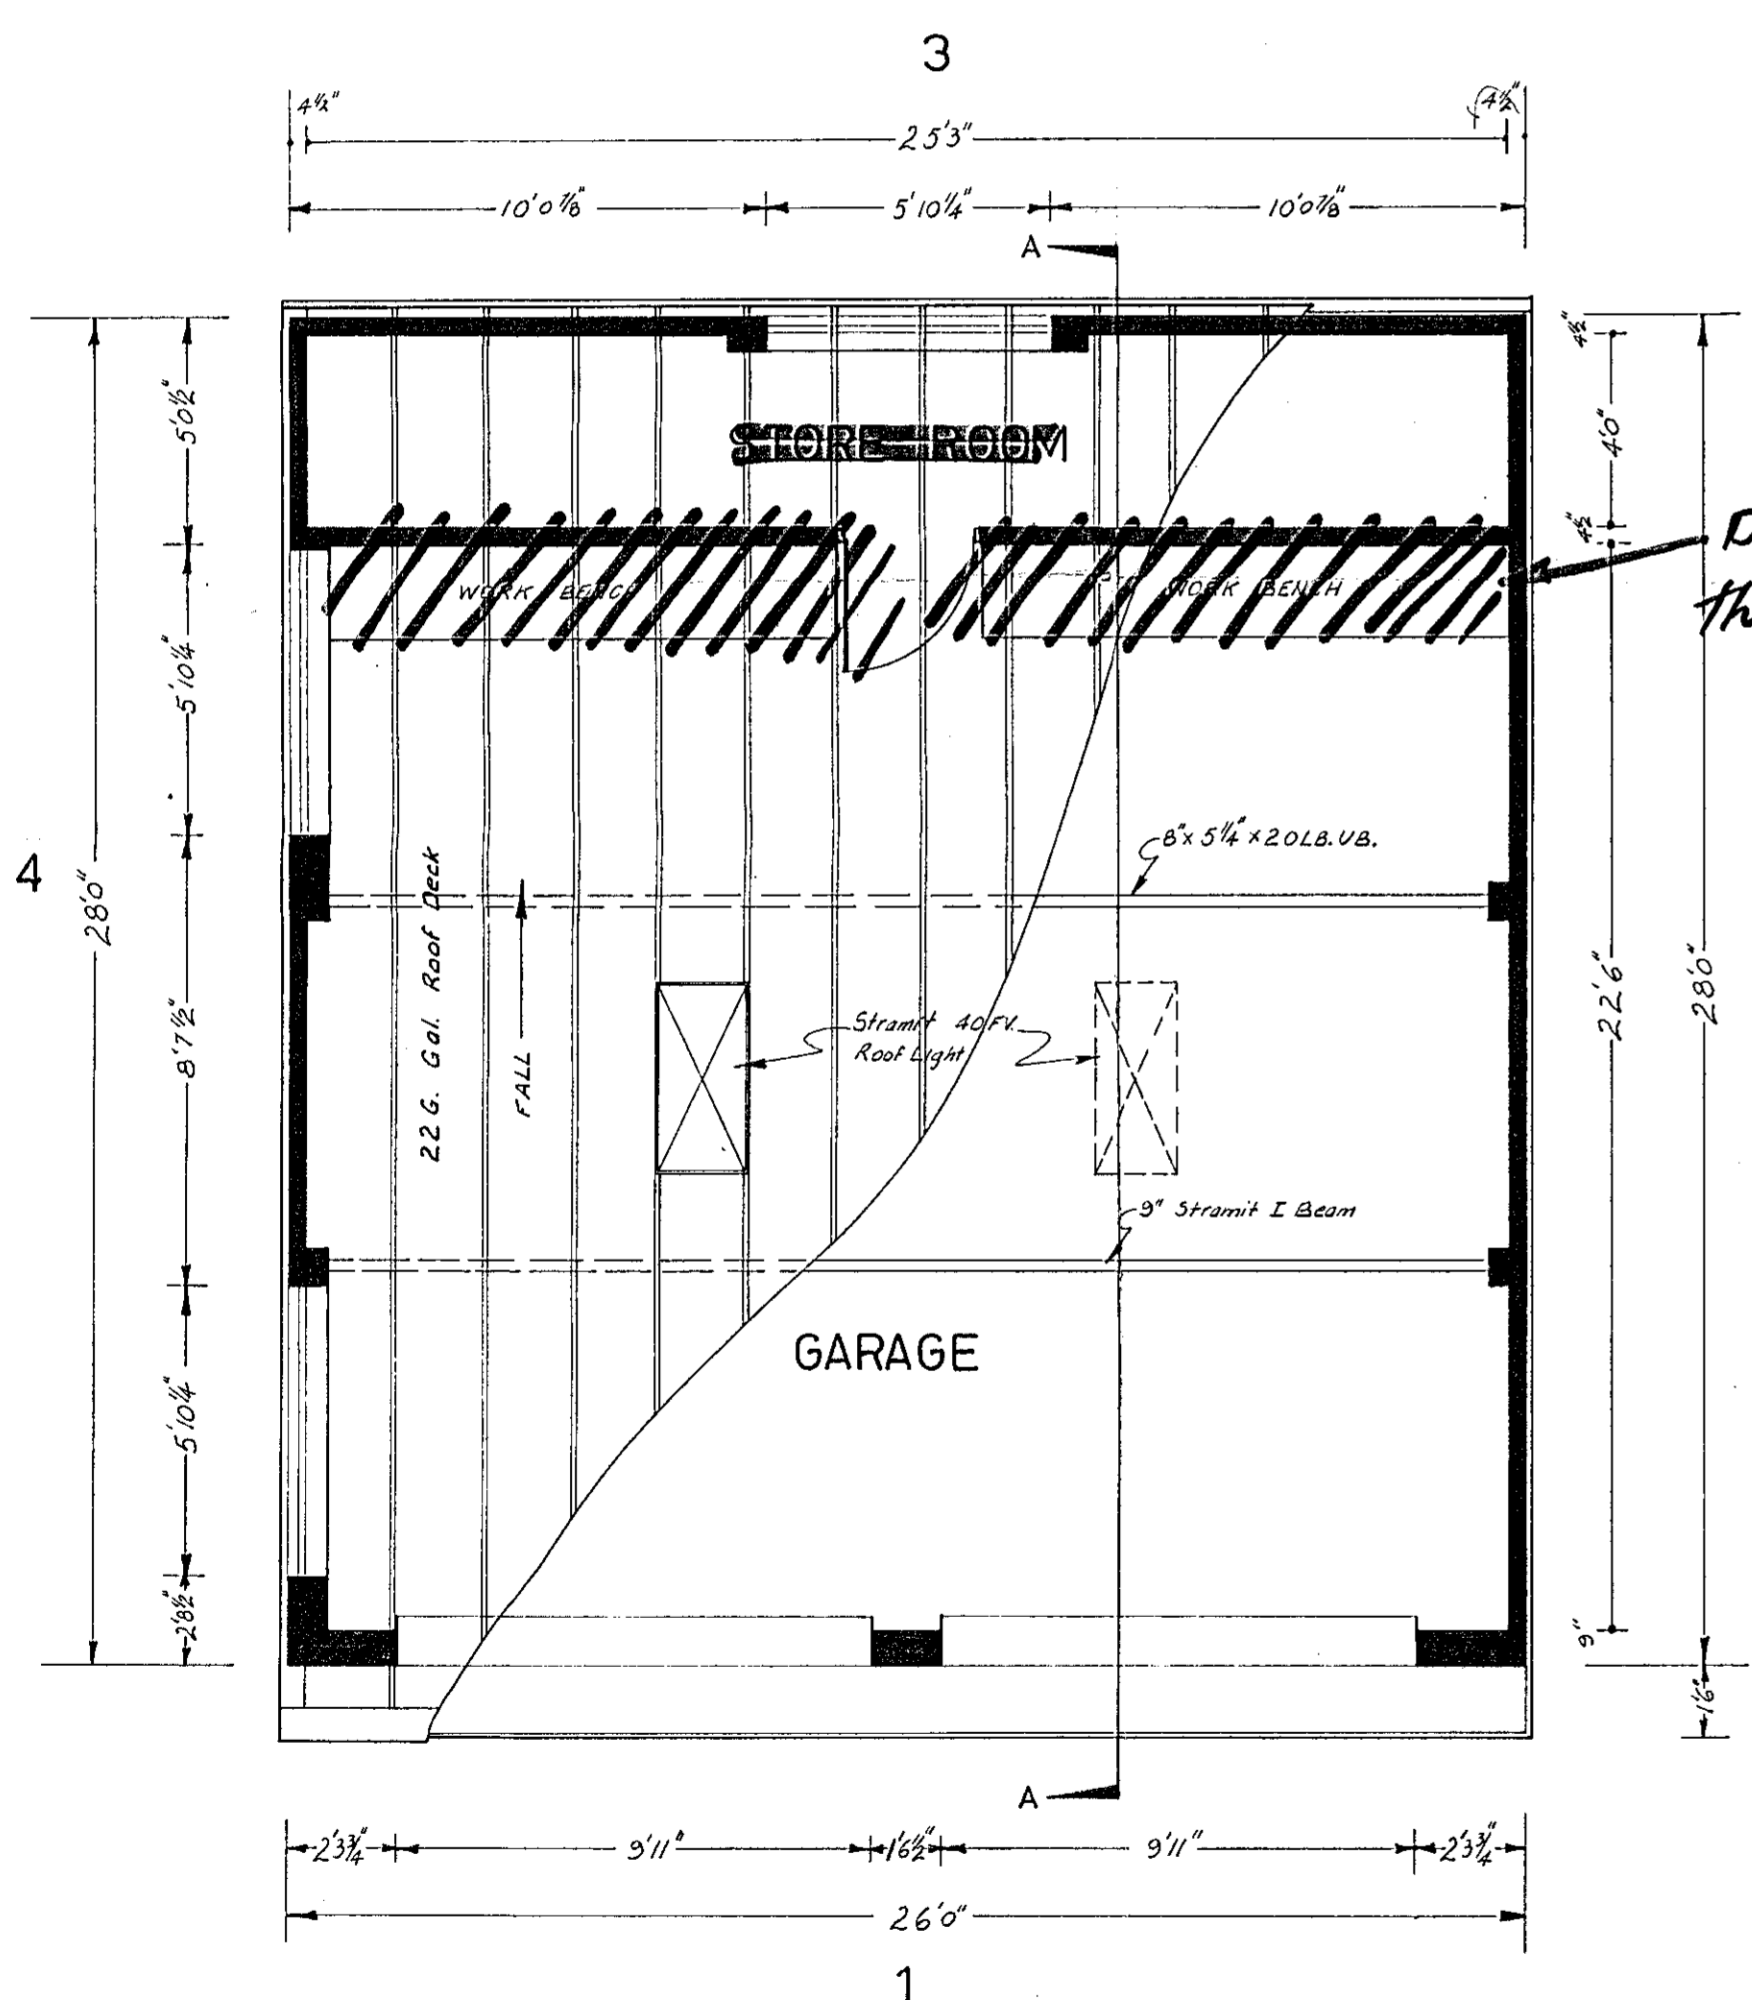
FLOOR PLAN

**PROPOSED  
BRICK GARAGE**

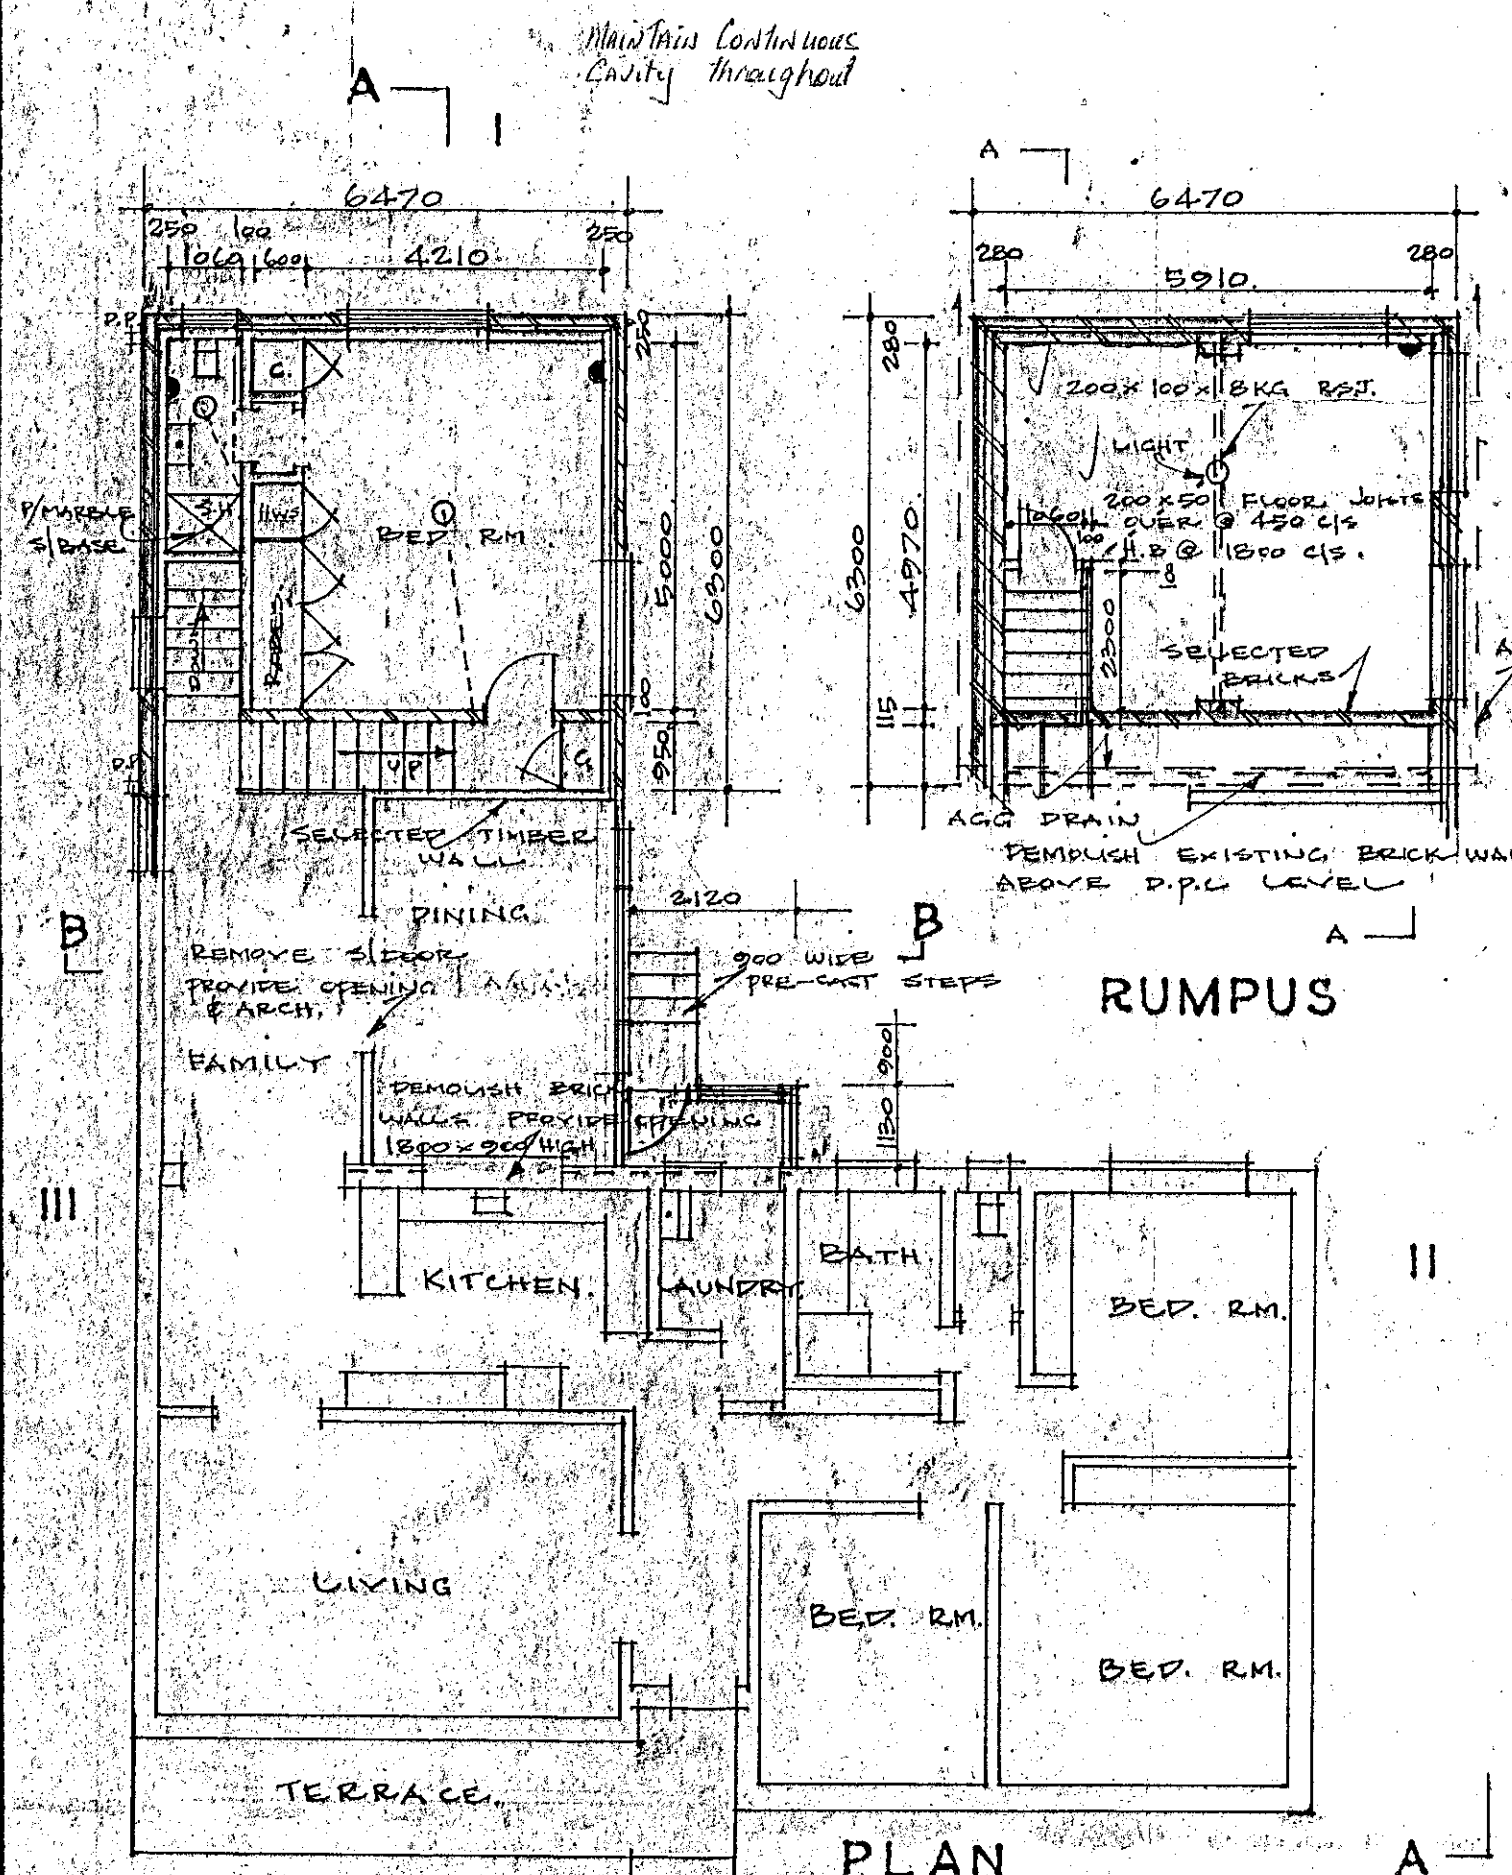
PLAN

CONSTRUCTION MUST COMPLY WITH A.S. 1684-1975 'LIGHT TIMBER FRAMING CODE'

PROPOSED ADDITIONS & ALTERATIONS FOR MR. G. J. THORNTON,  
BLOCK 10 SECTION 36 HACKETT. A.C.T.

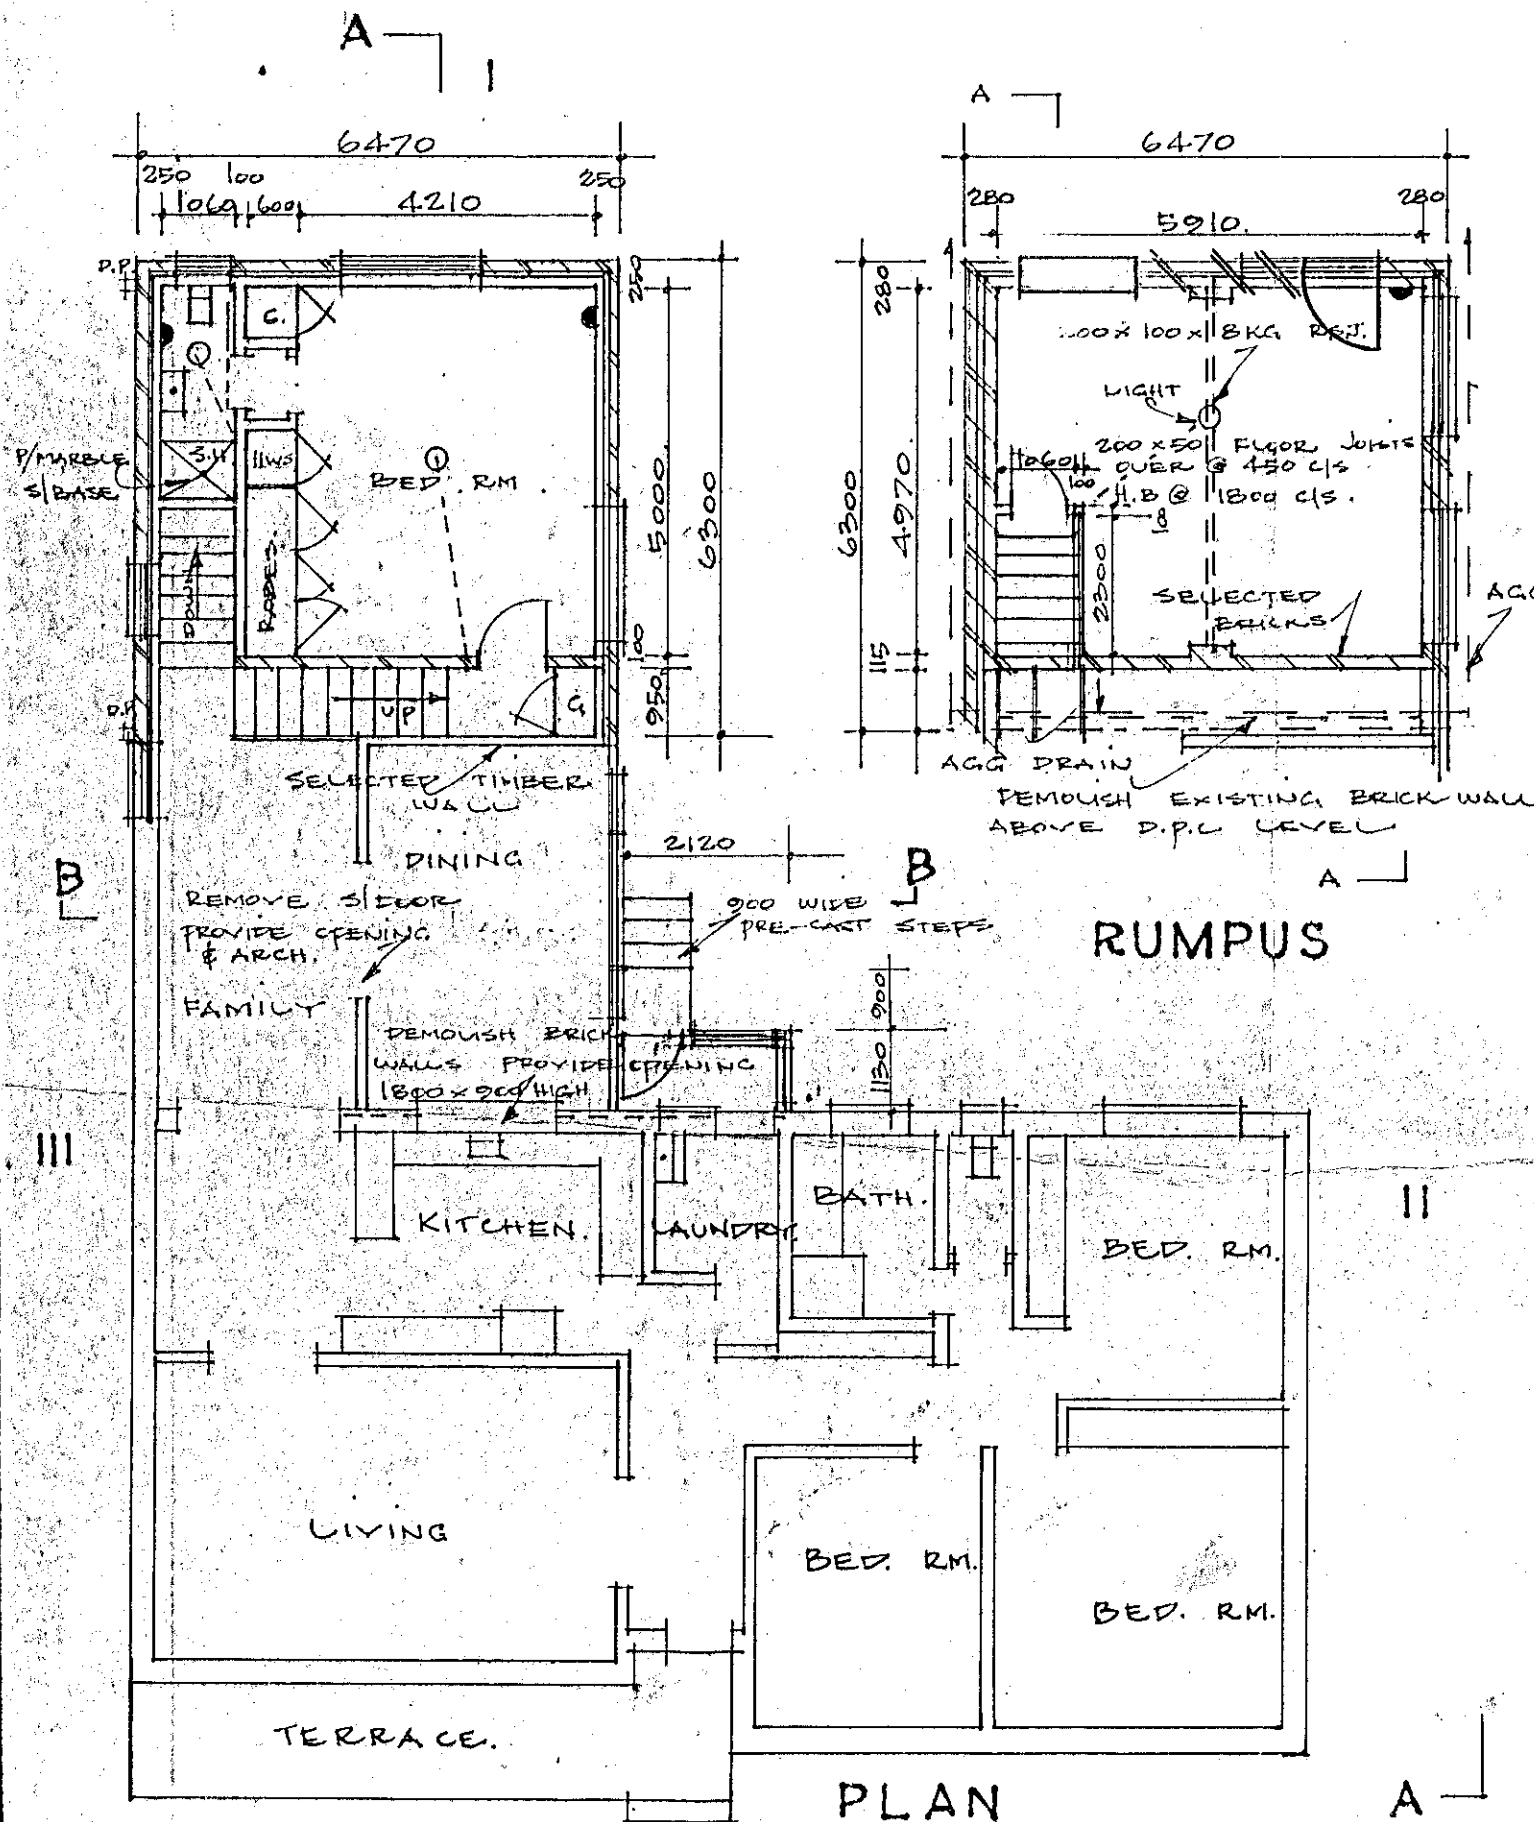
PLAN

- AMENDMENTS
- 1 NEW DOOR
  - 2 STORMWATER LAYOUT
  - 3 ELEVATION HEIGHTS
  - 4 NEW WINDOW

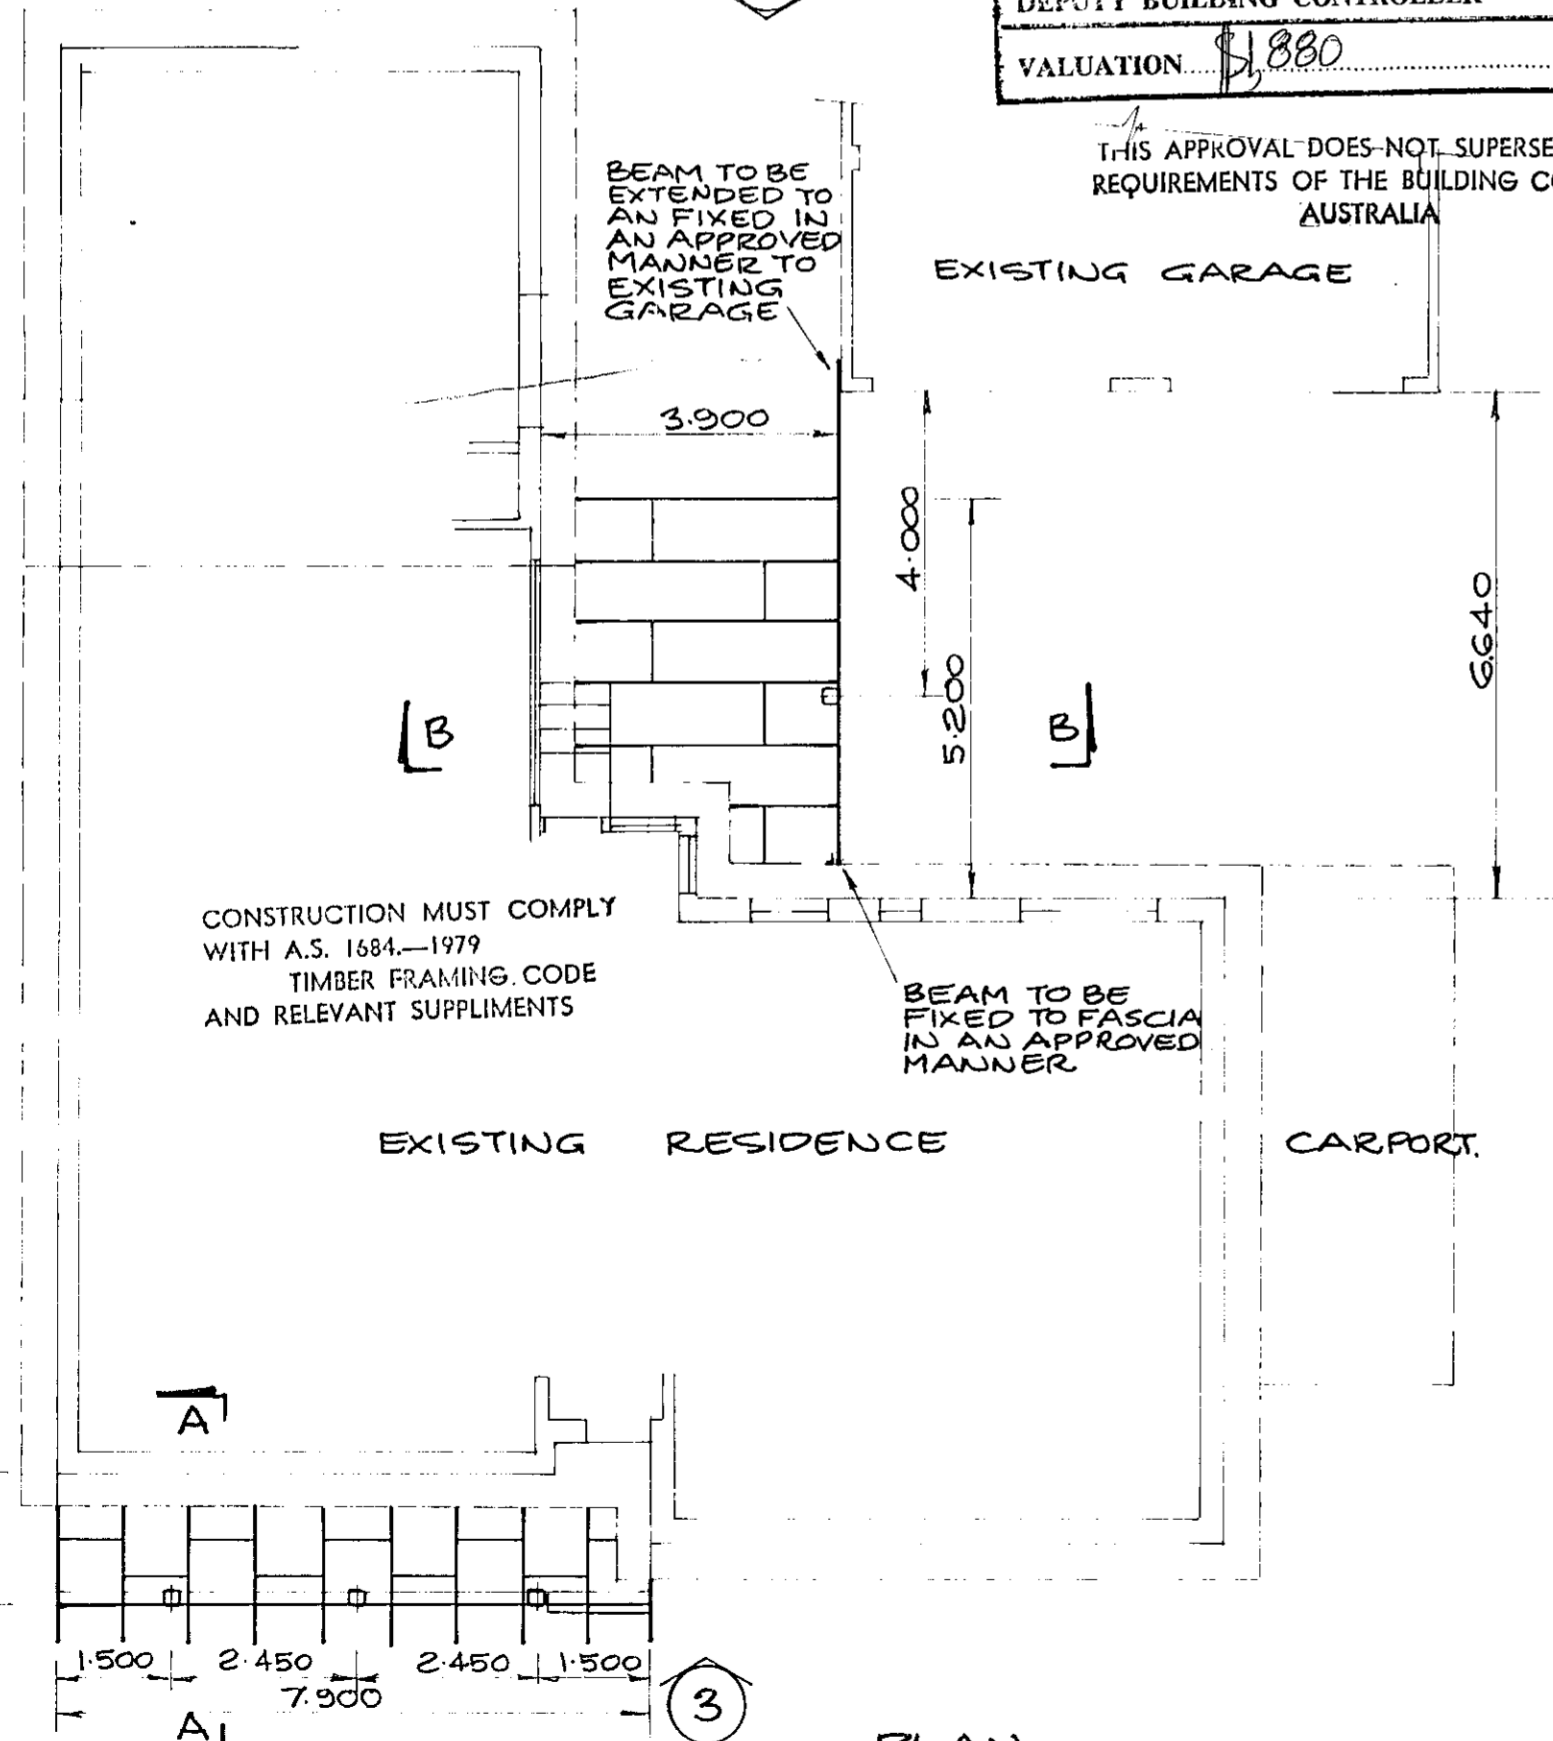
BEAM TO BE  
 EXTENDED TO  
 AN FIXED IN  
 AN APPROVED  
 MANNER TO  
 EXISTING  
 GARAGE

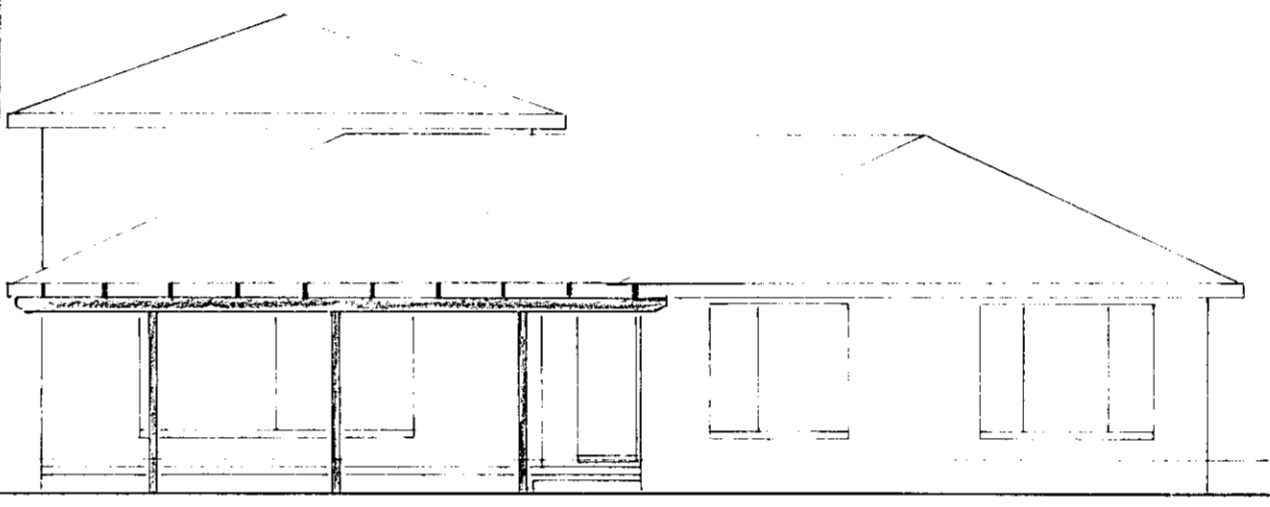
ELEVATION 3  
 1:100

DEPARTMENT RECORDS INDICATE THAT PORTION  
 OF THE EXISTING SANITARY DRAINAGE SERVICE  
 WILL BE UNDER THE PROPOSED STRUCTURE PROVIDED  
 THE MINIMUM COVER IS MAINTAINED OVER THE  
 PIPES NO FURTHER ACTION IS NECESSARY

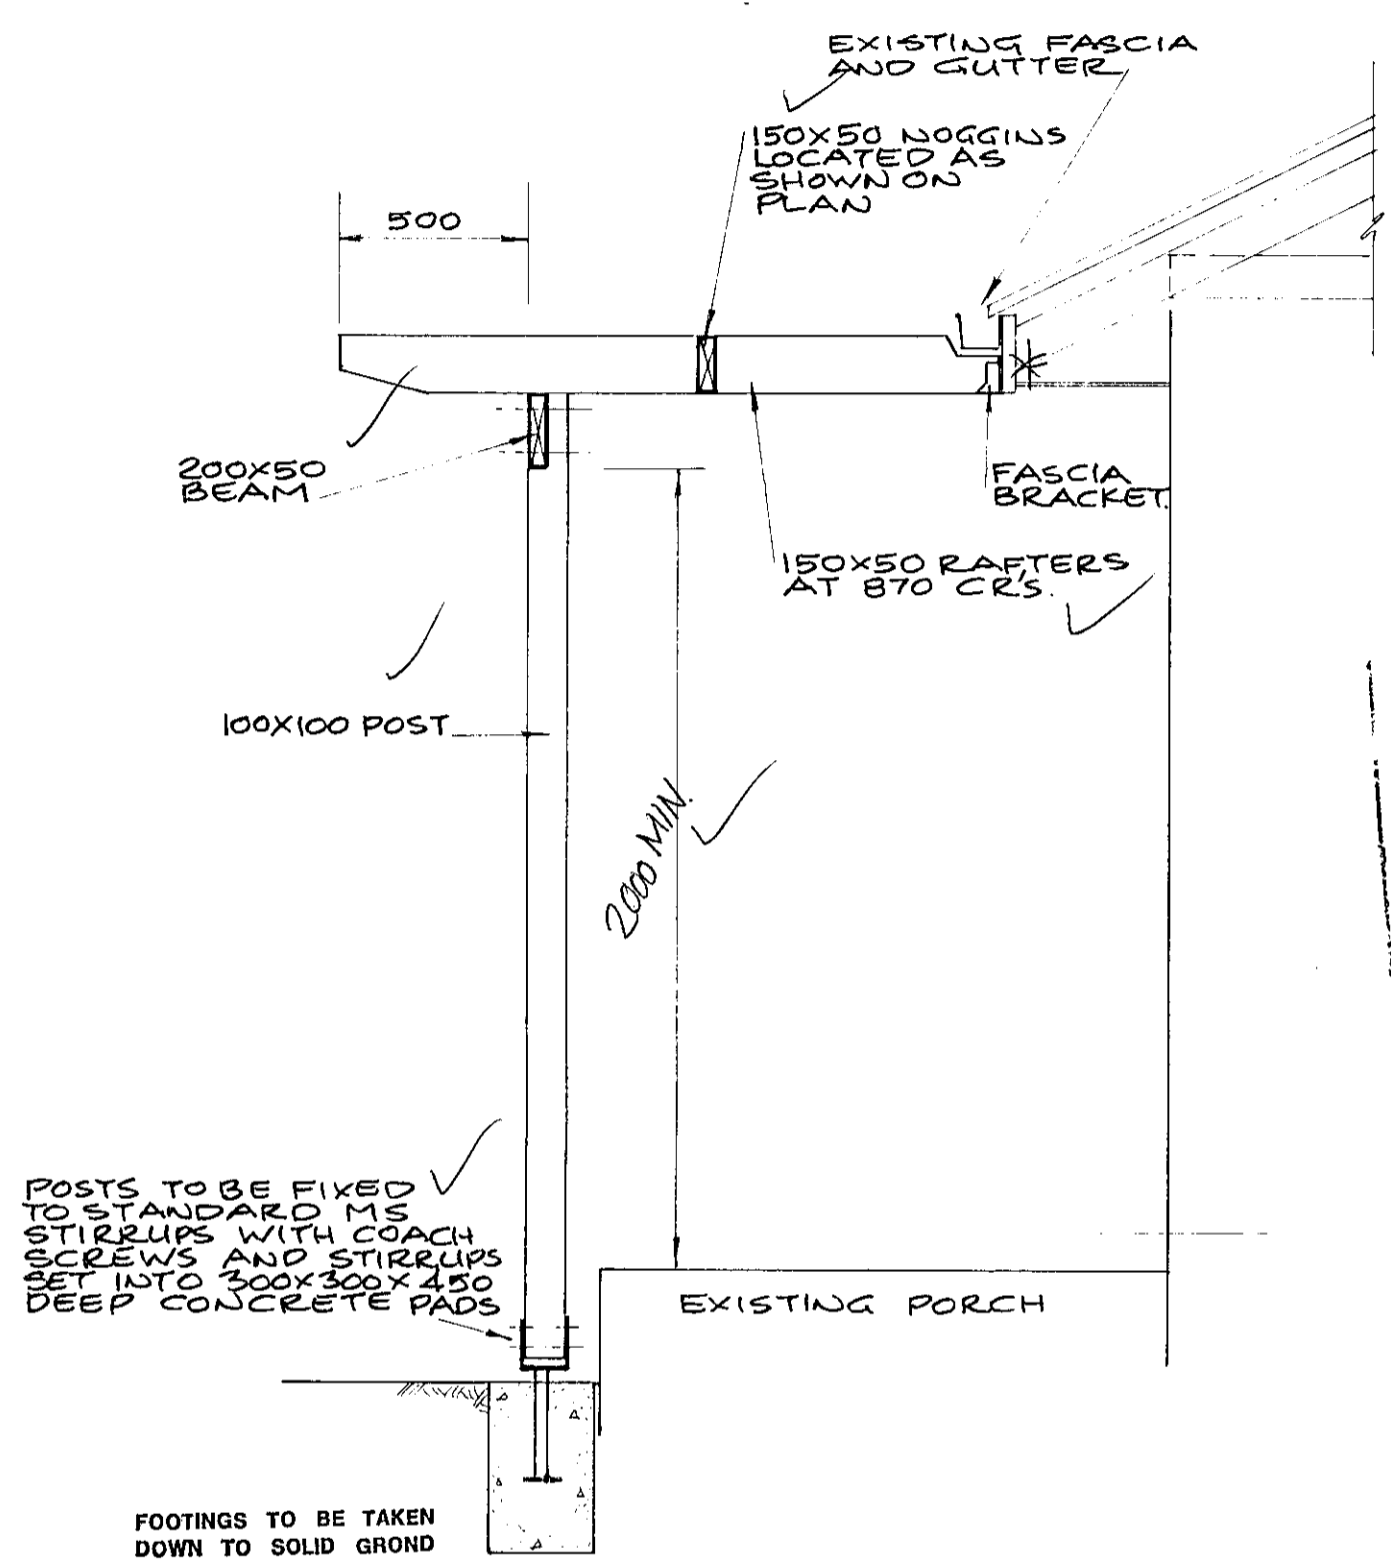
TYPICAL SECTION A-A  
1:20

\* PROVIDE ADDITIONAL SUPPORT FOR FASCIA.

POSTS TO BE FIXED TO STANDARD M.S. STIRRUPS WITH COACH SCREWS AND STIRRUPS SET INTO 300X300X450 DEEP CONCRETE PADS

FOOTINGS TO BE TAKEN DOWN TO SOLID GROUND

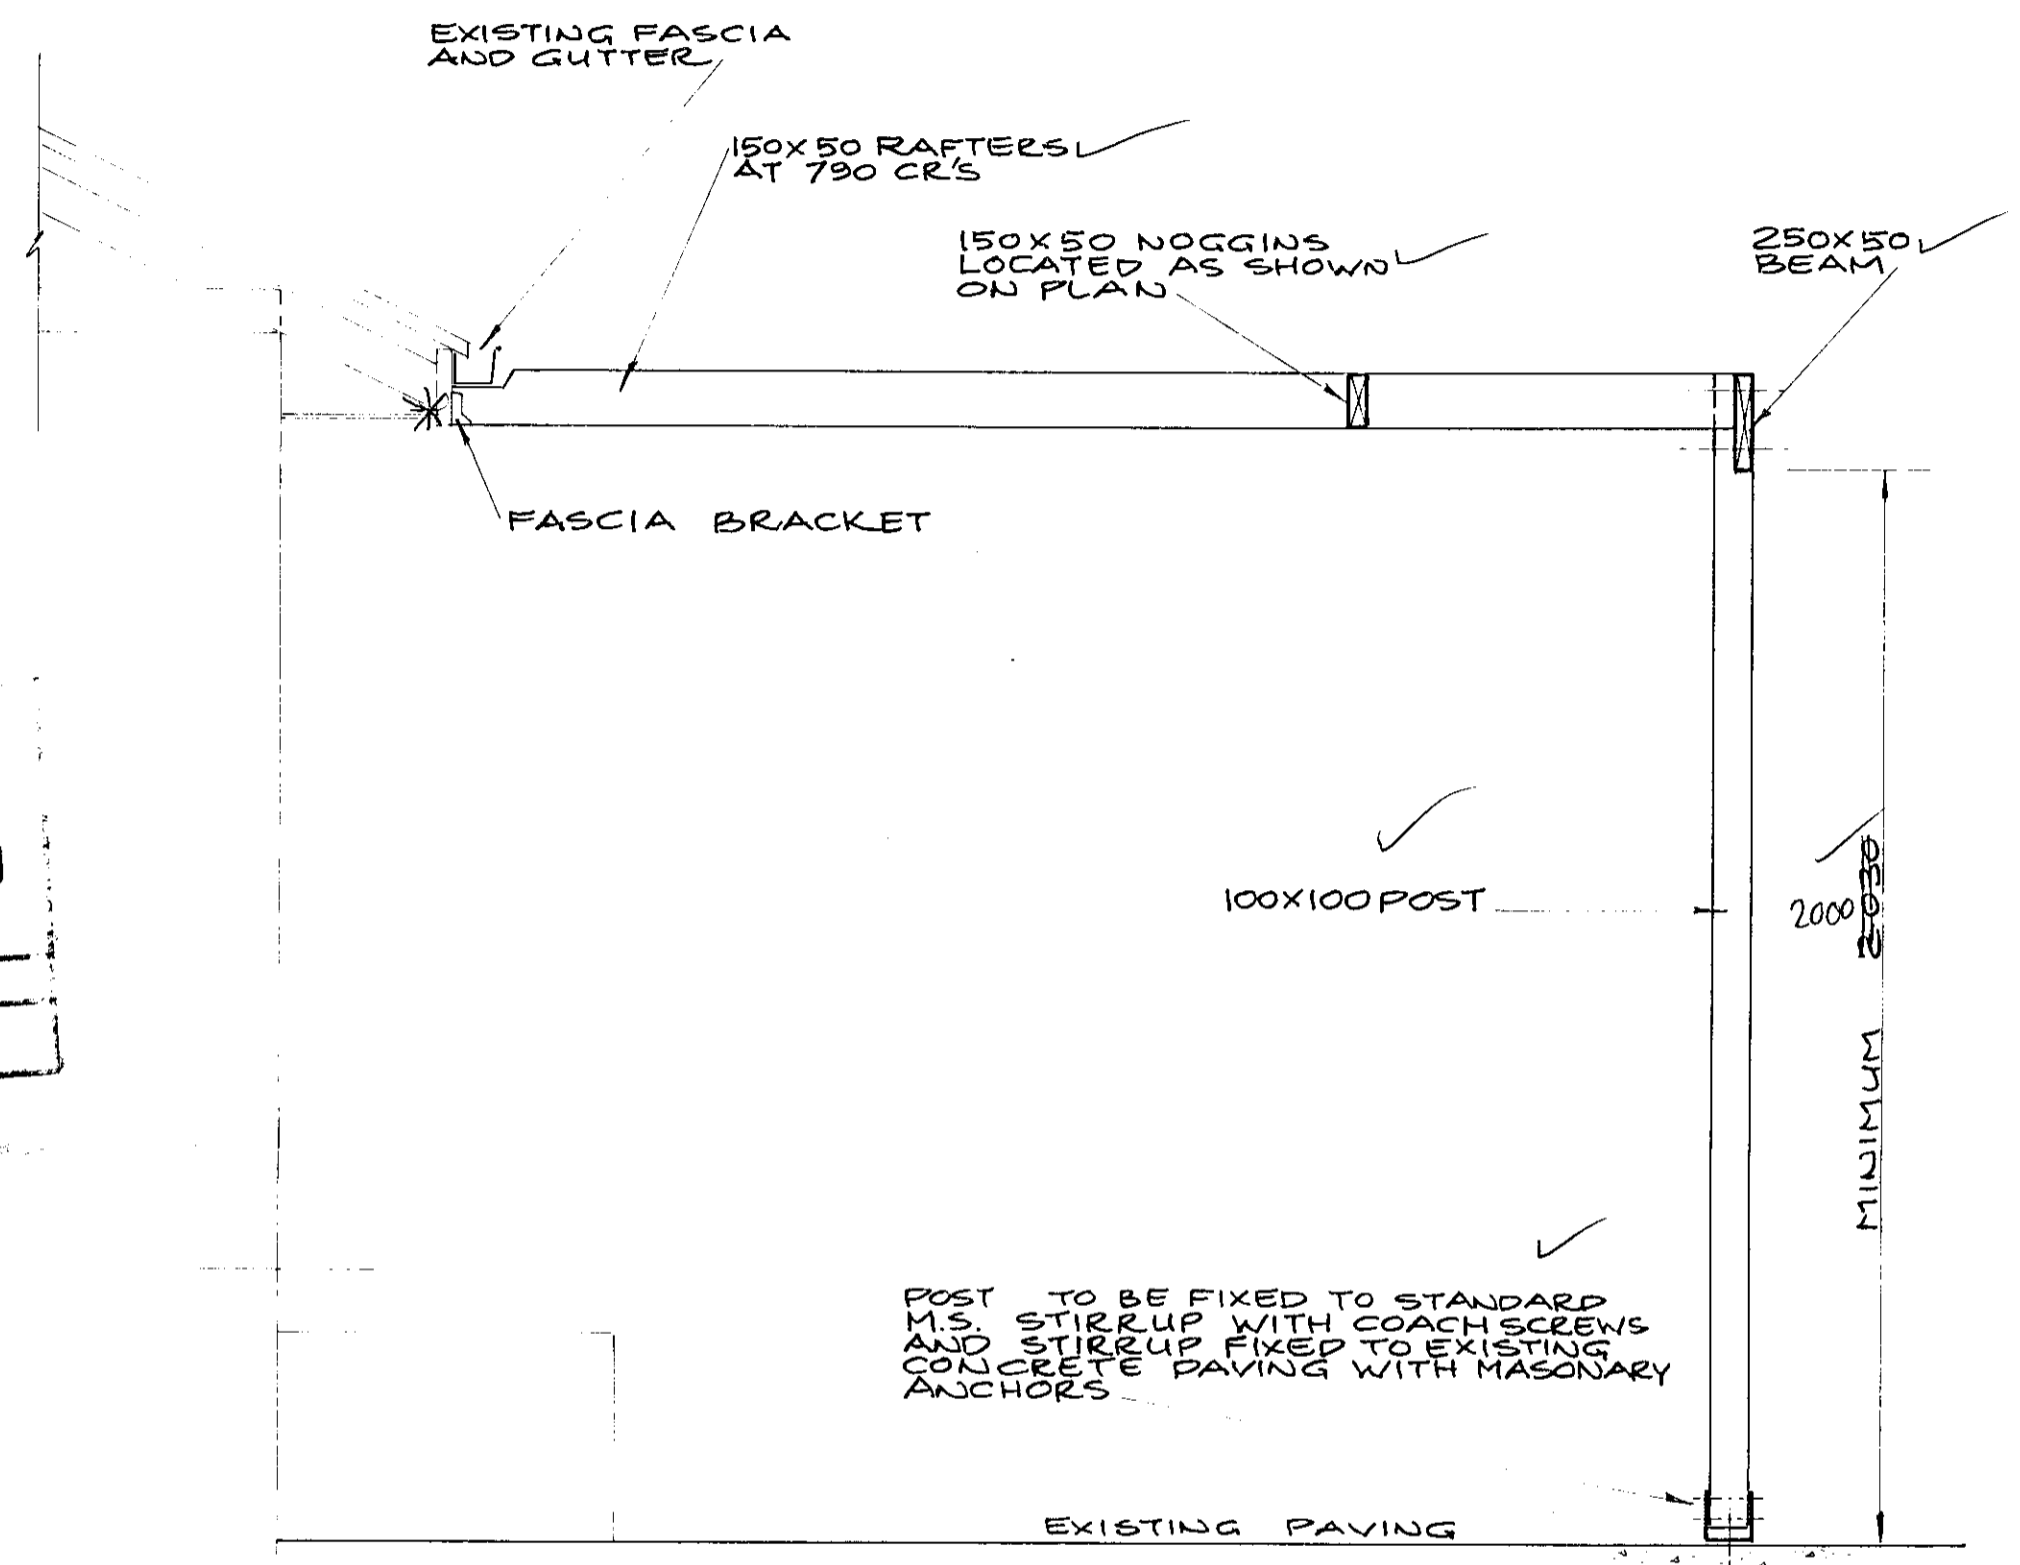
TYPICAL SECTION B-B  
1:20

POST TO BE FIXED TO STANDARD M.S. STIRRUP WITH COACH SCREWS AND STIRRUP FIXED TO EXISTING CONCRETE PAVING WITH MASONRY ANCHORS

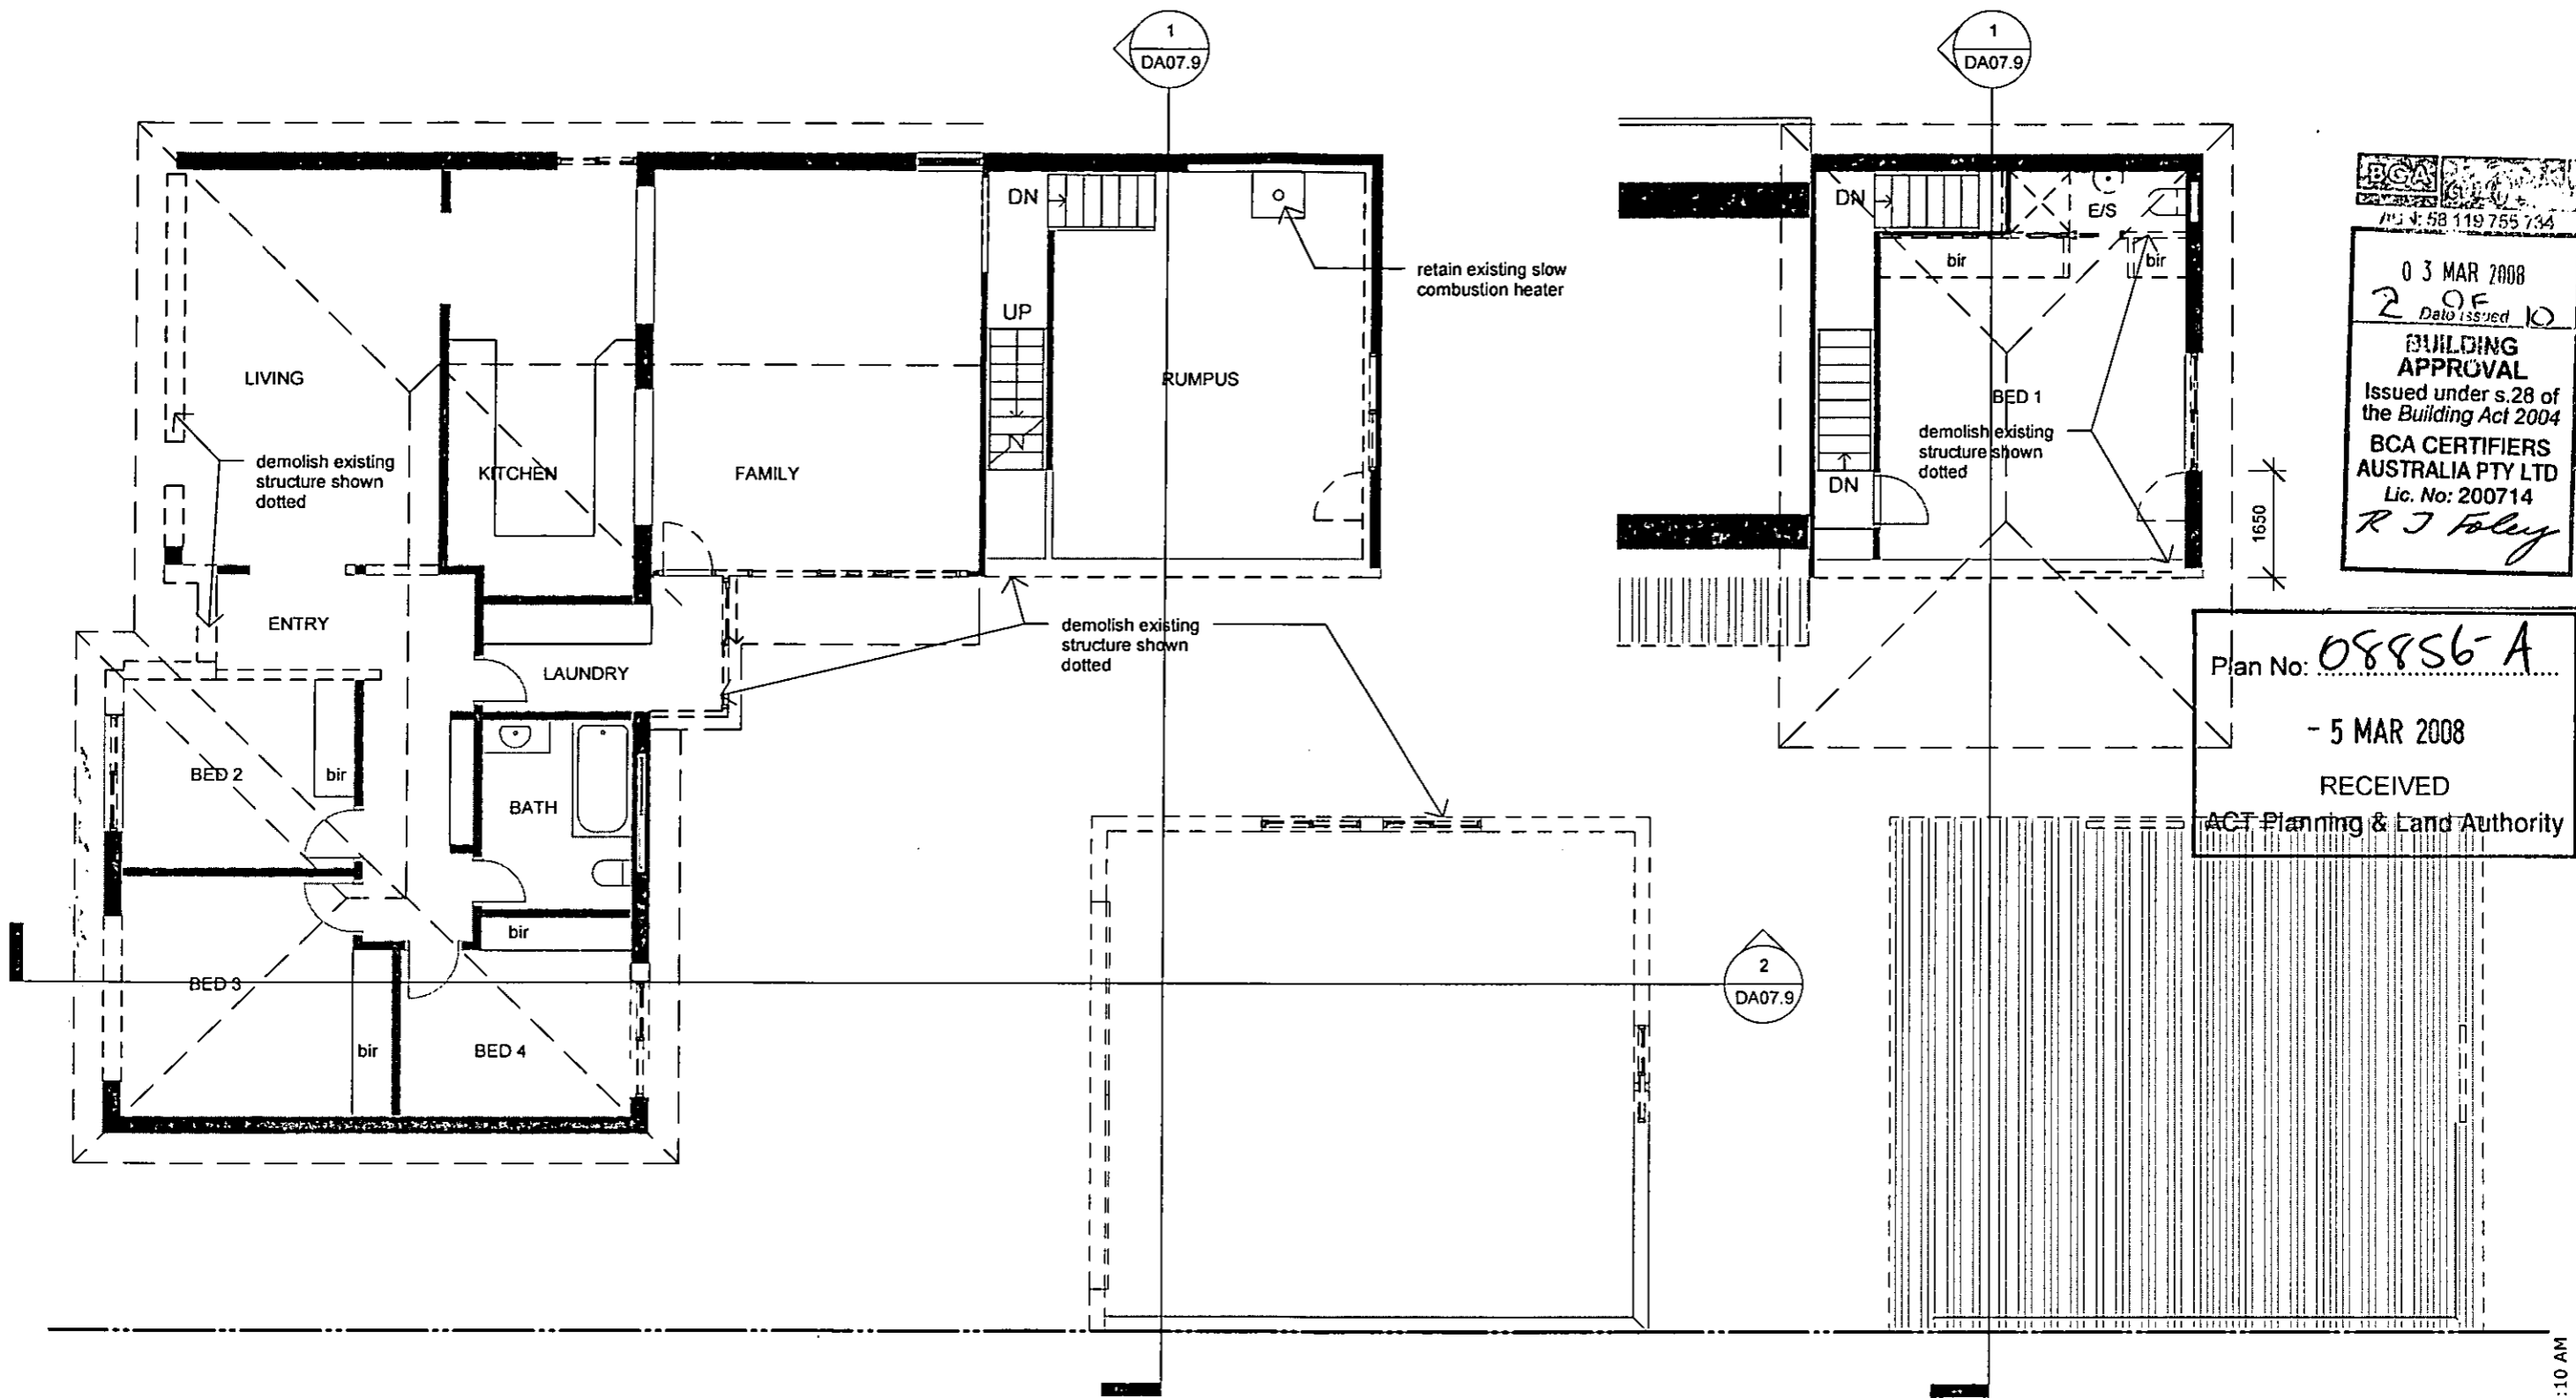
1 EXISTING CONDITIONS & DEMOLITION PLAN - LOWER LEVELS  
 1 : 100

2 EXISTING CONDITIONS & DEMOLITION - UPPER LEVEL  
 1 : 100
