# Report

# Building Report

## CONCLUSION AND SUMMARY

**CONVEYANCING BUILDING FILE INDEX**

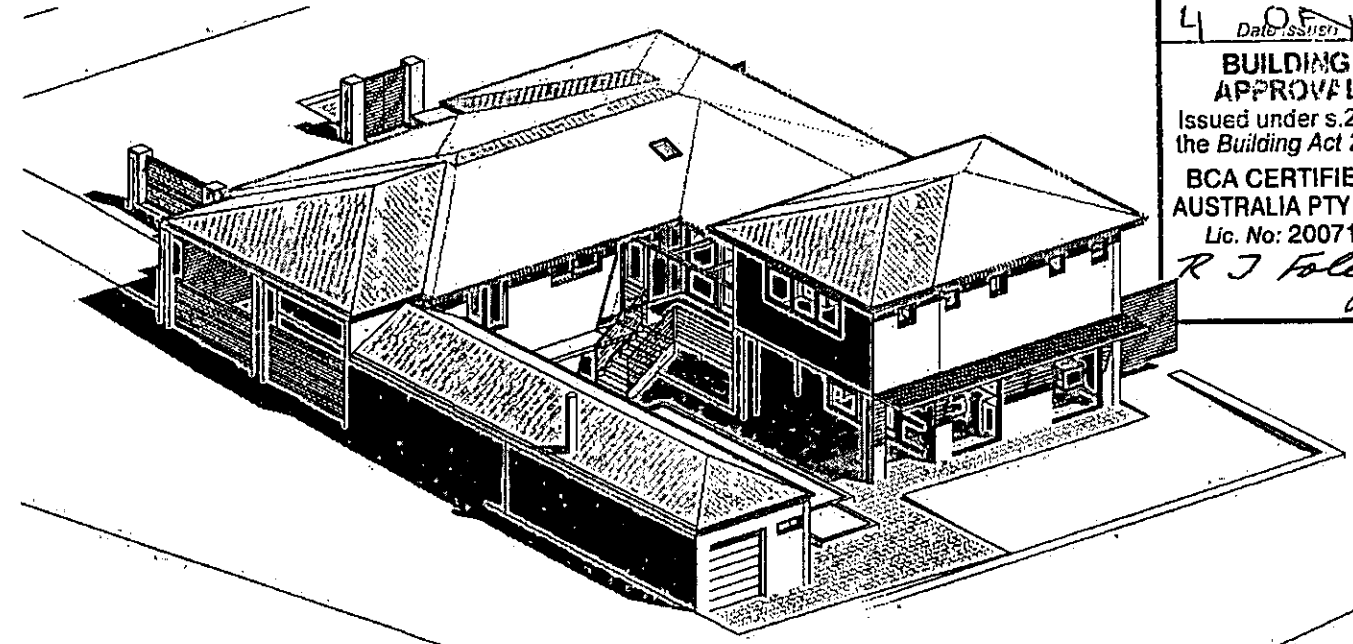
2 ISO VIEW

9  
 NOTE: ALL FENCING INTO POOL AREA TO MEET REQUIREMENTS OF THE BCA

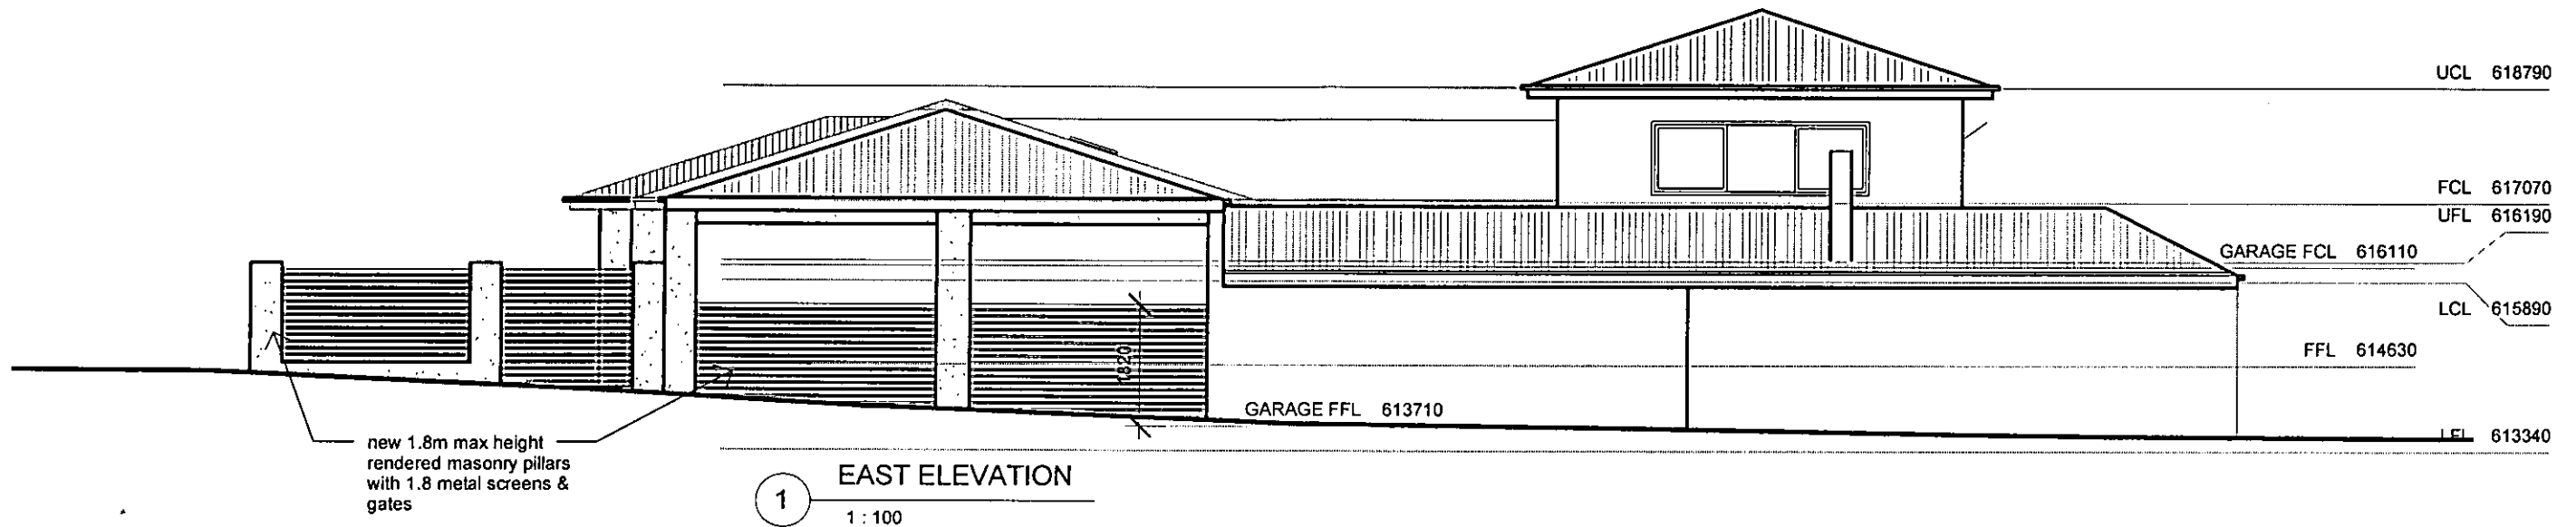
1 EAST ELEVATION  
1:100

External materials:  
 walls render existing and new masonry  
 roof gull grey colorbond custom orb to replace existing concrete tiles  
 door & window frames anodised aluminium

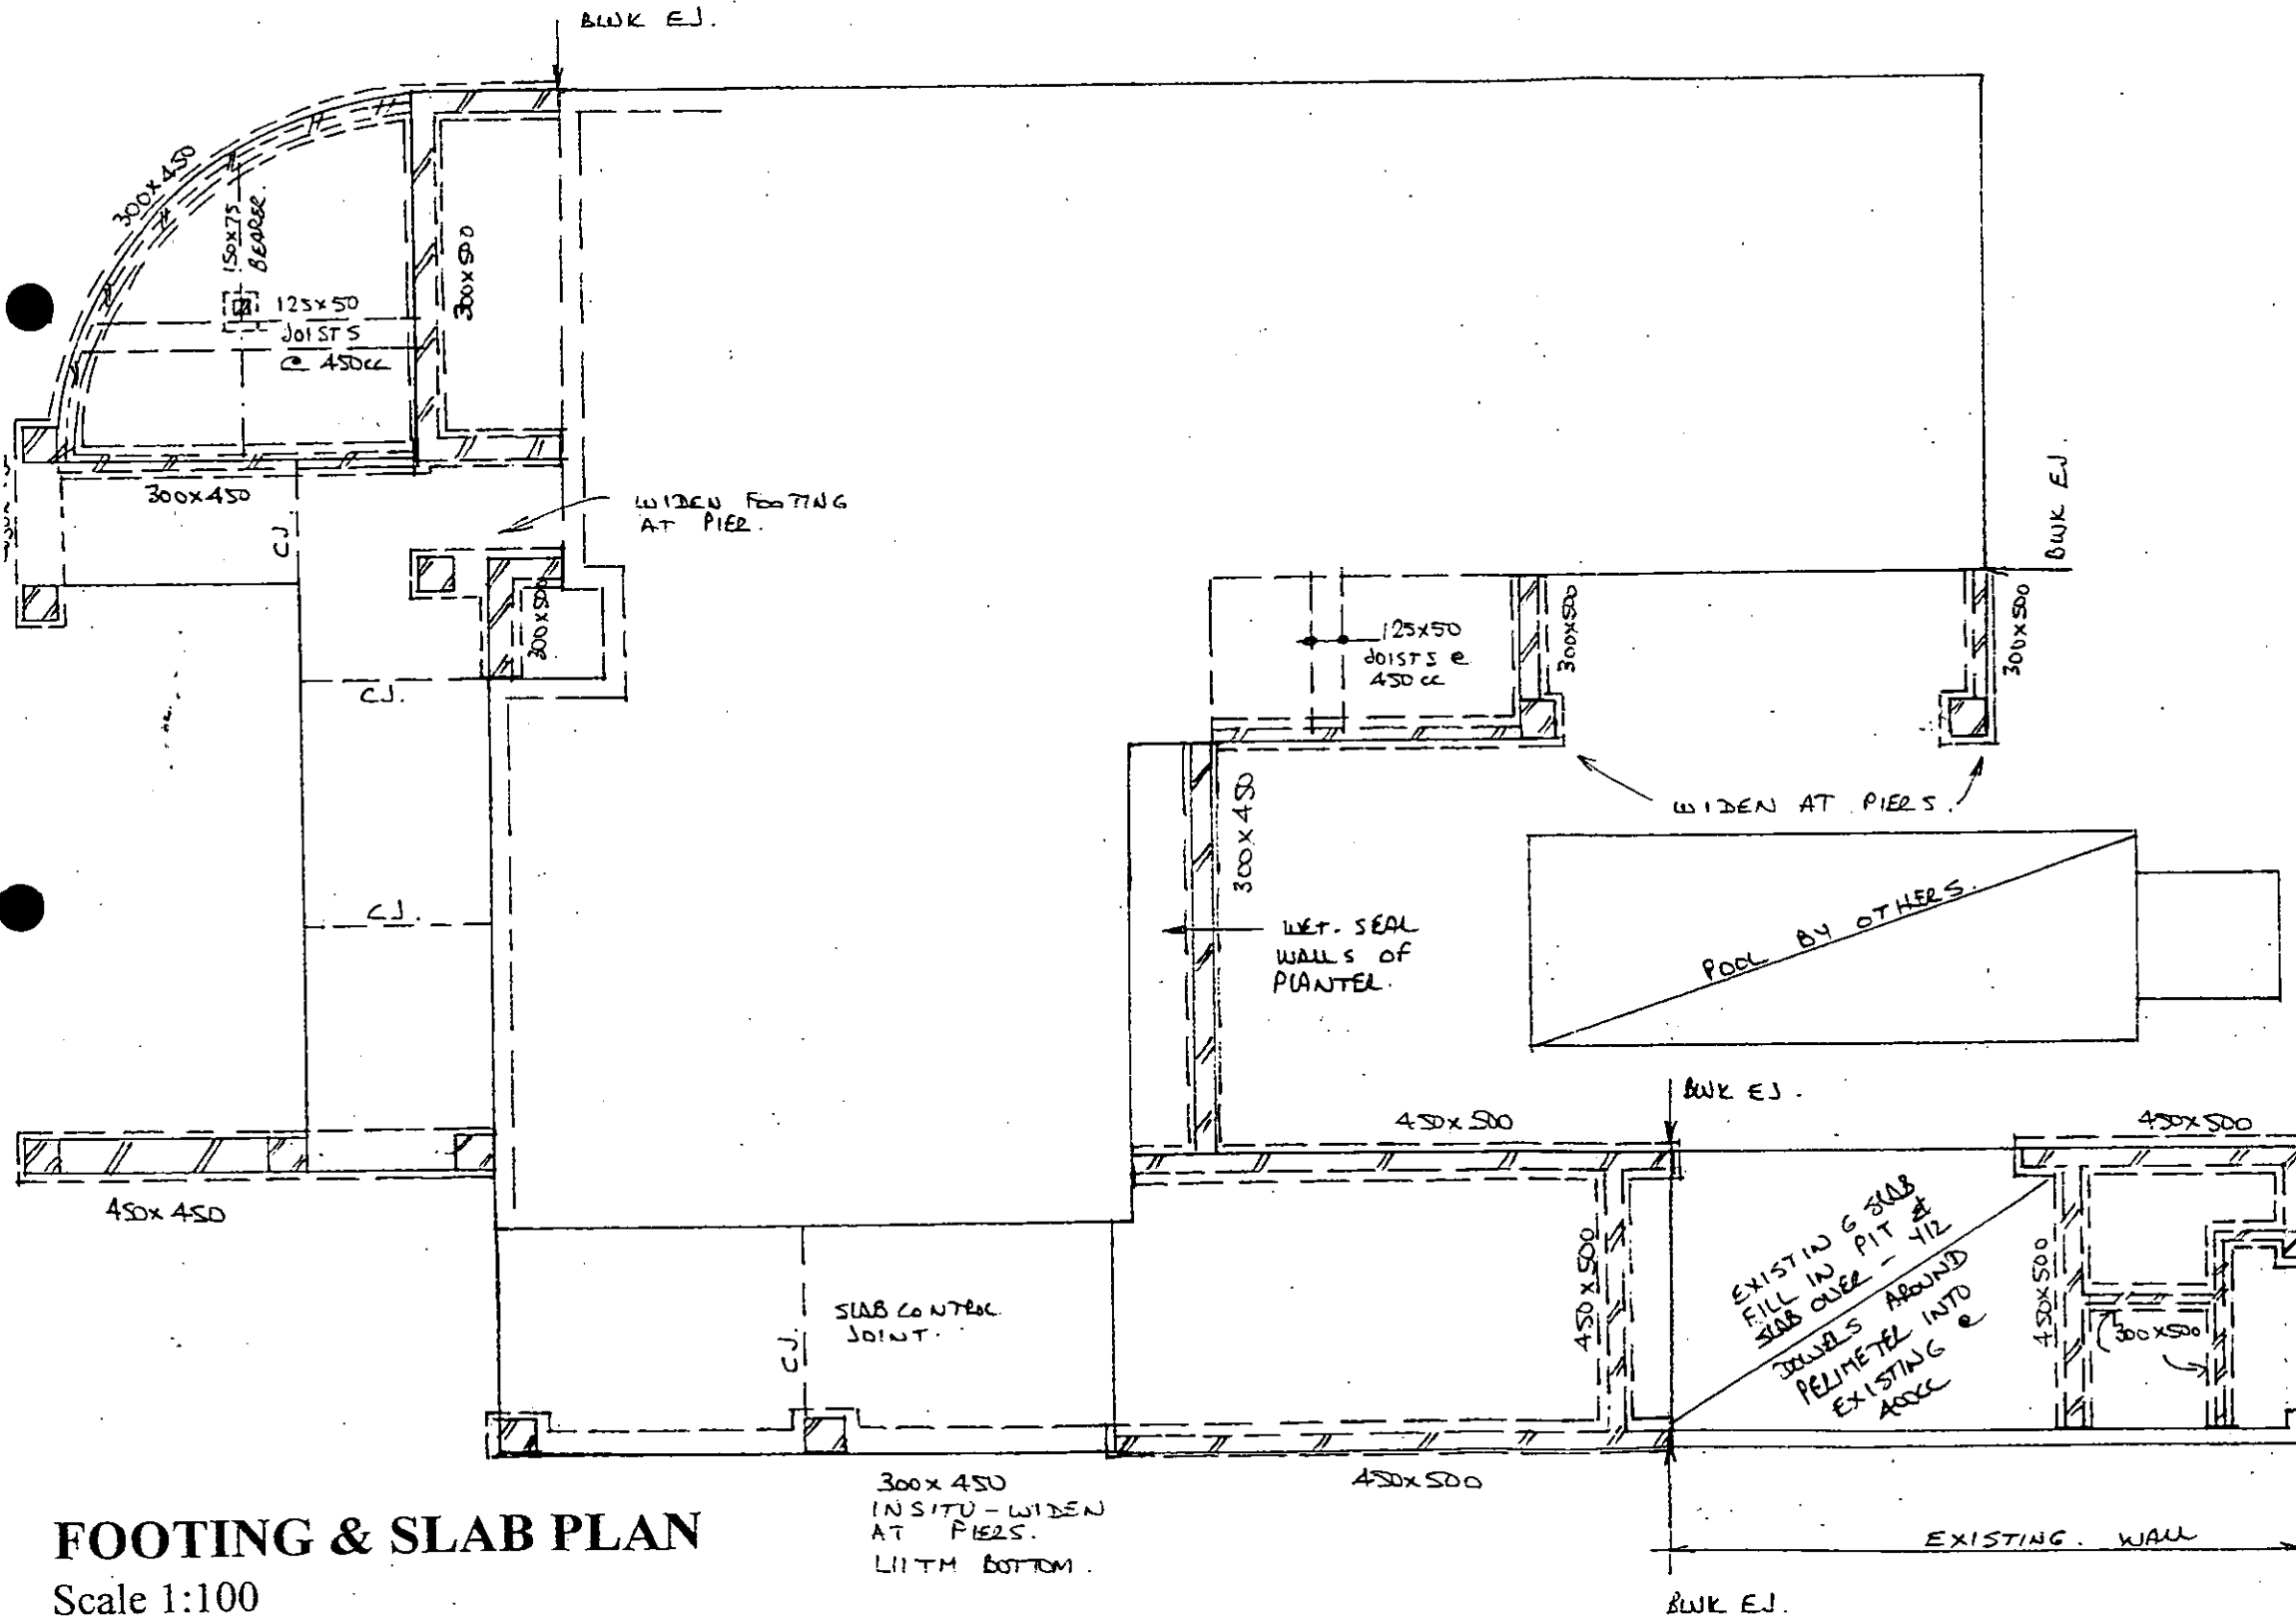
**FOOTING & SLAB PLAN**  
 Scale 1:100  
 See arch plan for setting out dimensions

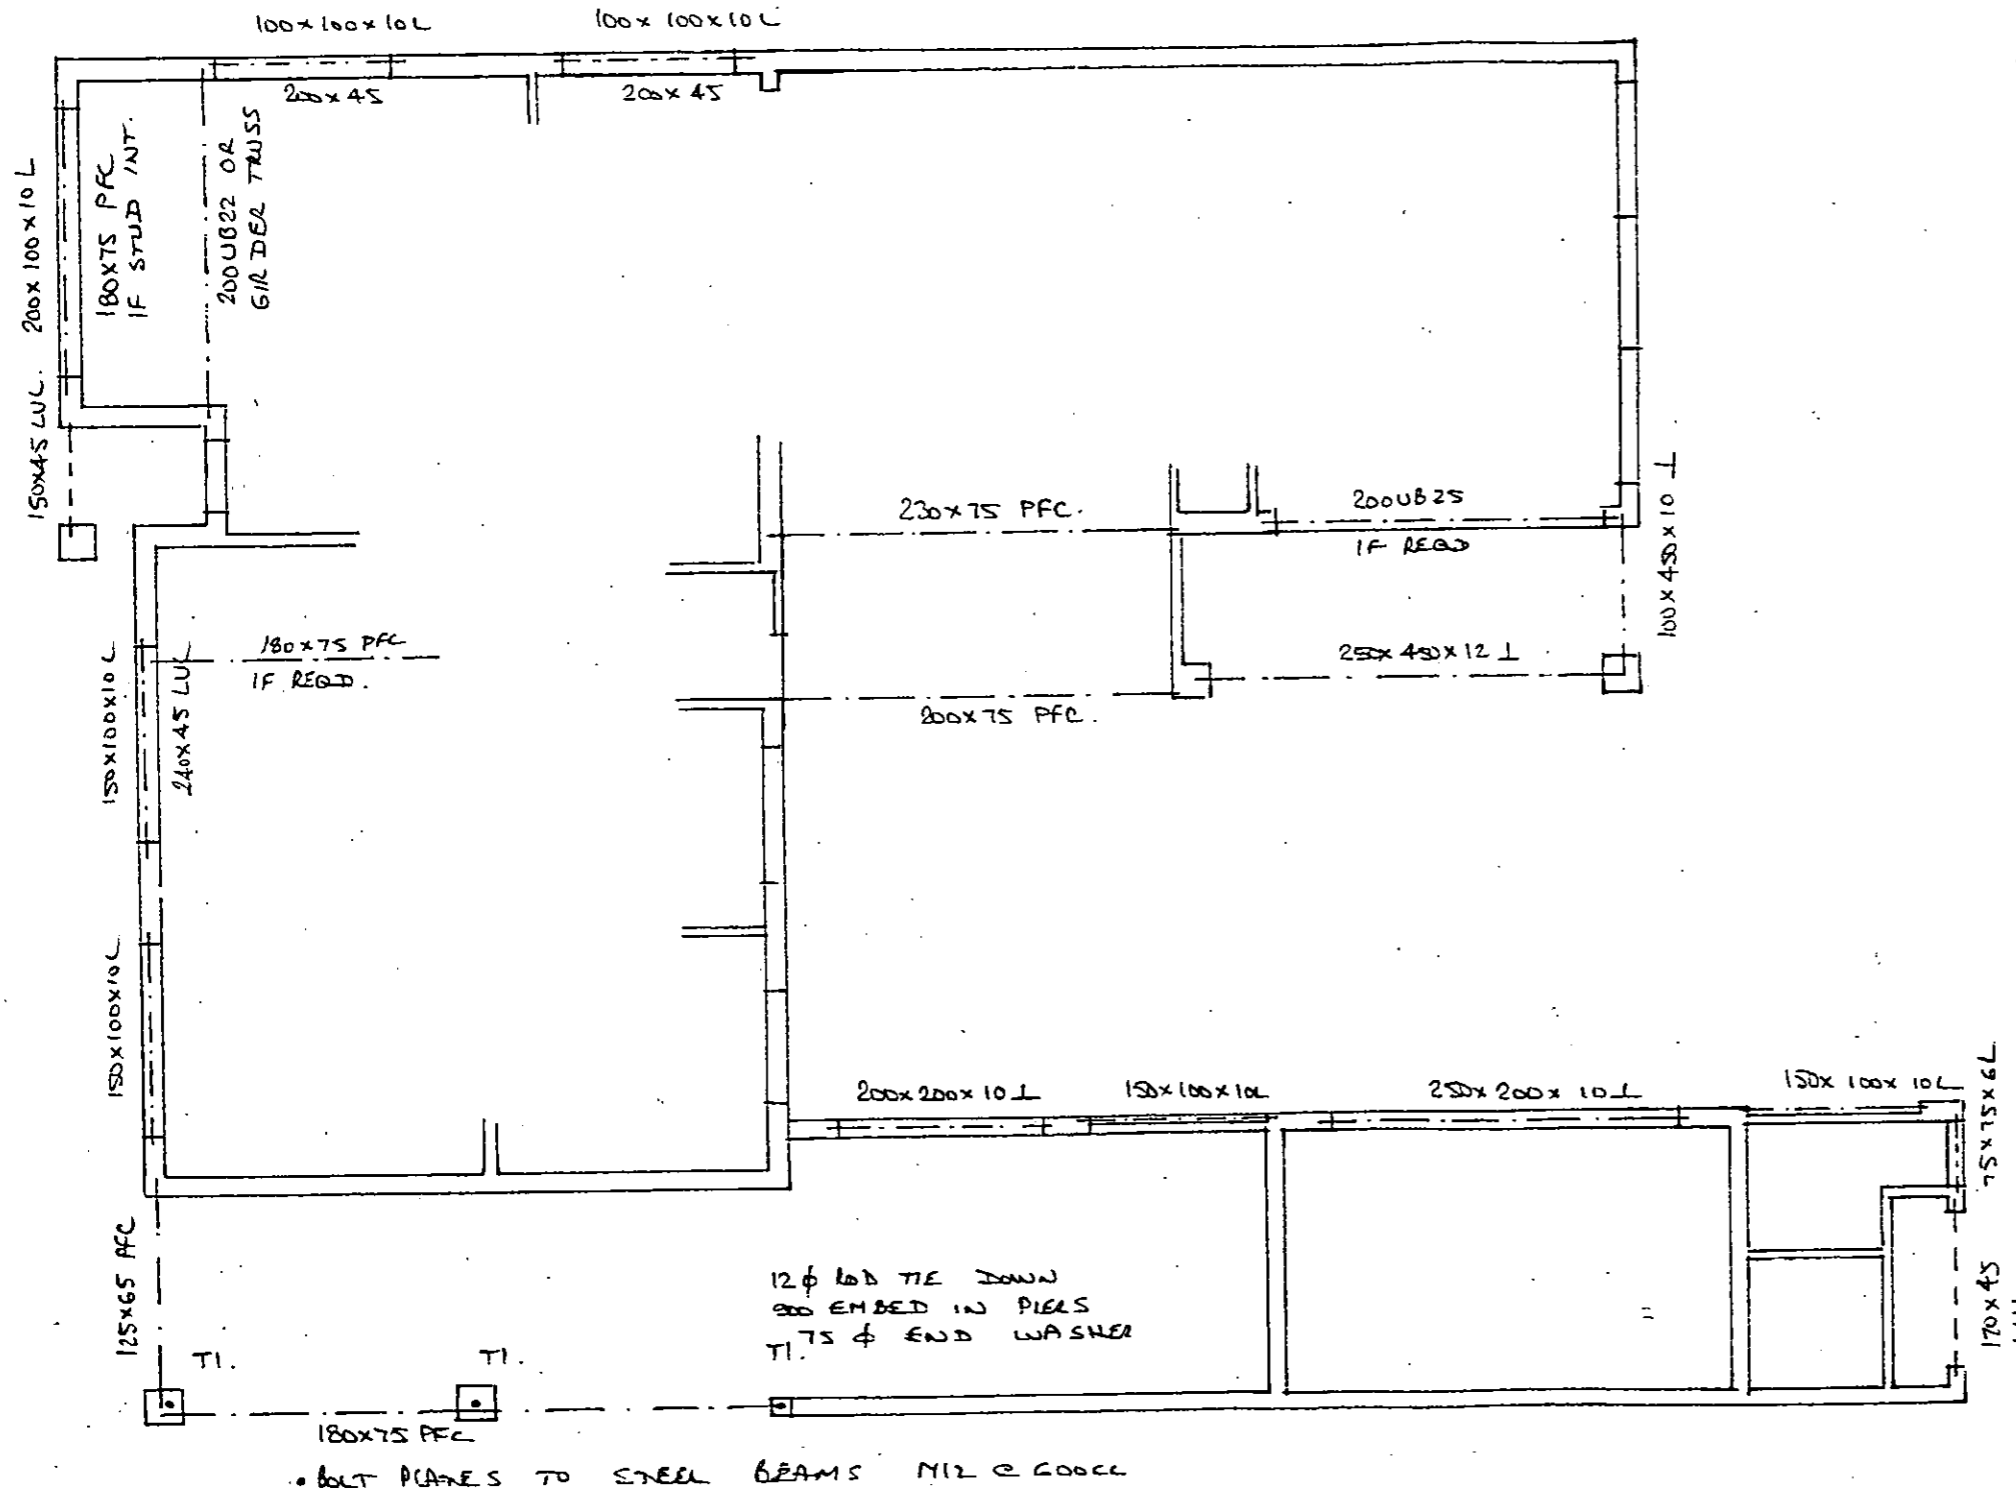
- BUGEL SCREW FIX BATTENS TO TRUSSES
- DOUBLE TRIPL. GRIP FIX TRUSSES TO FRAMES
- TEMPORARY PROP ROOF UNTIL NEW BEAMS IN POSITION
- MAINTAIN STRUCTURE IN STABLE CONDITION AT ALL TIMES
- ALL WORKMANSHIP TO COMPLY WITH BCA REQUIREMENTS

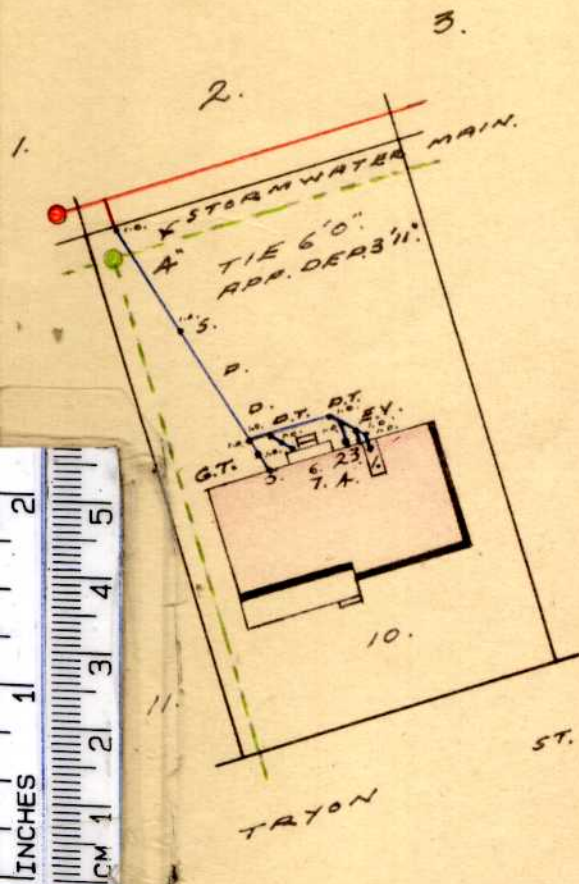
Scale—40 feet to 1 inch.

**FIXTURES**

No. 1.	W. Closet (Internal)
No. 2.	Bath.
No. 3.	Basin.
No. 4.	Shower.
No. 5.	Sink.
No. 6.	Trough.
No. 7.	W. Machine.

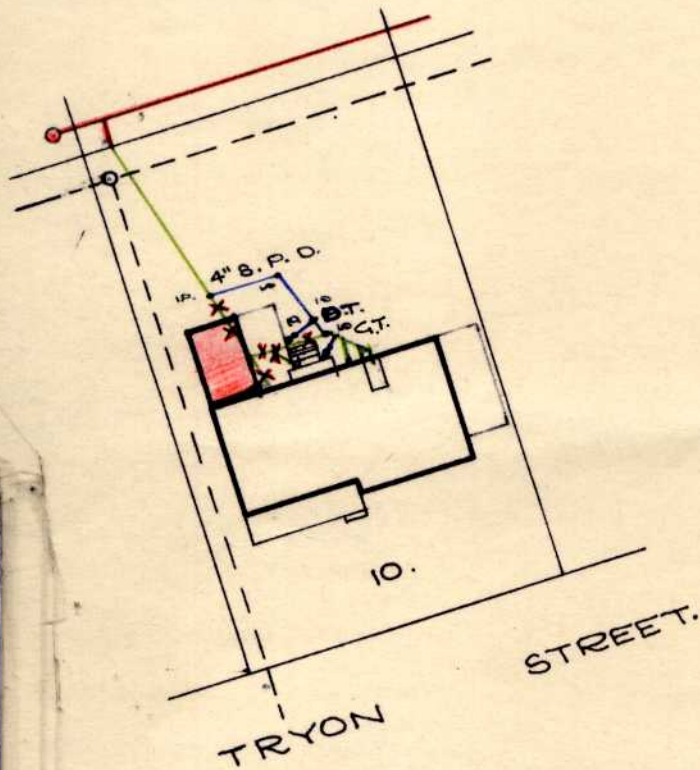
ADDITIONAL WORK.

NOTES.

DRAINS TO BE LAID SHOWN IN BLUE LINES.  
EXISTING DRAINS SHOWN IN GREEN LINES.  
PROPOSED EXTENSIONS SHOWN TINTED PINK  
DRAINS XED IN RED TO BE ABOLISHED.  
THIS PLAN TO BE READ IN CONJUNCTION  
WITH APPROVED ARCHITECTURAL PLAN  
AND SPECIFICATION.

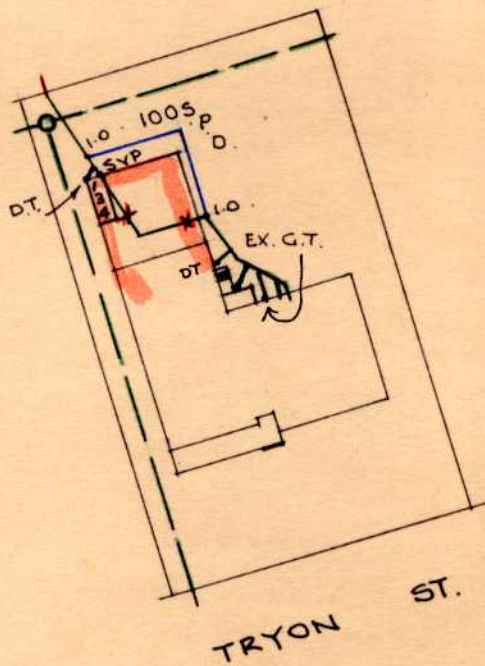
ADDITIONAL WORK

NOTES

- DRAINS TO BE LAID ARE SHOWN IN BLUE LINES. THIS PLAN TO BE READ IN CONJUNCTION WITH APPROVED ARCHITECTURAL PLANS AND SPECIFICATIONS.
- DRAINS TO BE DELETED SHOWN BY RED X. EXISTING DRAINS SHOWN IN GREEN LINES. POSITION OF BRANCH TO BE LOCATED BEFORE ANY WORK IS COMMENCED
- DRAINS TO BE LAID IN (U.P.V.C.) UNPLASTICISED POLYVINYL CHLORIDE IN ACCORDANCE WITH A.S.A. GA 67-1972 AND CANBERRA CODE OF PRACTICE ISSUE 1 JULY 1974.
- DRAINS BELOW BUILDINGS MUST BE RETESTED. DRAINS HAVING CEMENT JOINTS MUST BE TOTALLY SURROUNDED BY CEMENT CONCRETE 150 mm THICK.
